**Item No. 15.4.1**  
**Halifax Regional Council**  
**August 6, 2024**

**TO:** Mayor Savage and Members of Halifax Regional Council  
**FROM:** Tyler Brothers, Vice Chair, Heritage Advisory Committee  
**DATE:** June 28, 2024  
**SUBJECT:** **Case HRTG-2024-00259: Substantial Alteration to a municipally registered heritage property within the Carlton Street Streetscape, Halifax**

Heritage Impact Statement

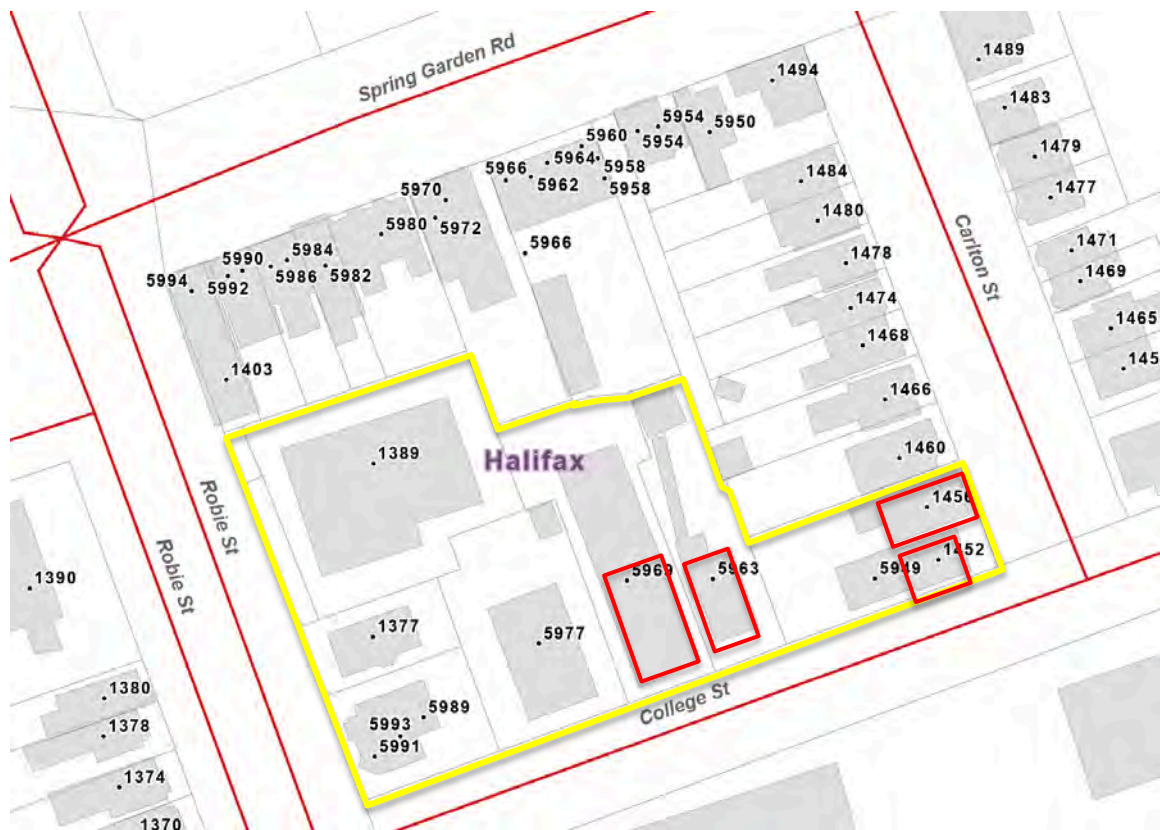
**Figure 2: Subject site, outlined (yellow), and portions of buildings proposed to be retained as part of the original DA outlined (red)**

The development site comprises seven properties on the south half of this block bounded by Robie Street, College Street and Carlton Street. In 2022, a Development Approval (“DA”) was issued for the subject site that included provision for two residential towers, each 26 and 20 storeys, and retention of four historic buildings on site: 1452 Carleton Street, 1456 Carleton Street, 5963 College Street and 5969 College Street (Figure 2).

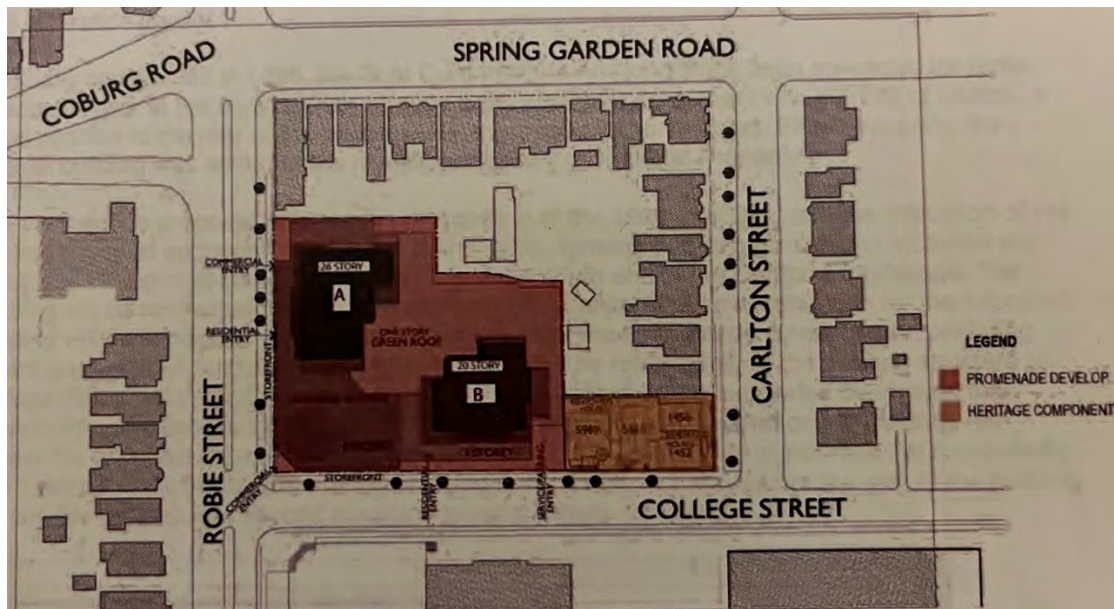
**Figure 3: Development Proposal – Promenade (Original DA)**  
Source: Kassner Goodspeed Architects Ltd.

The original development proposal was presented in two sections, the westerly and largest section featuring two residential towers and the easterly heritage precinct incorporating the four retained heritage buildings (Figure 3).

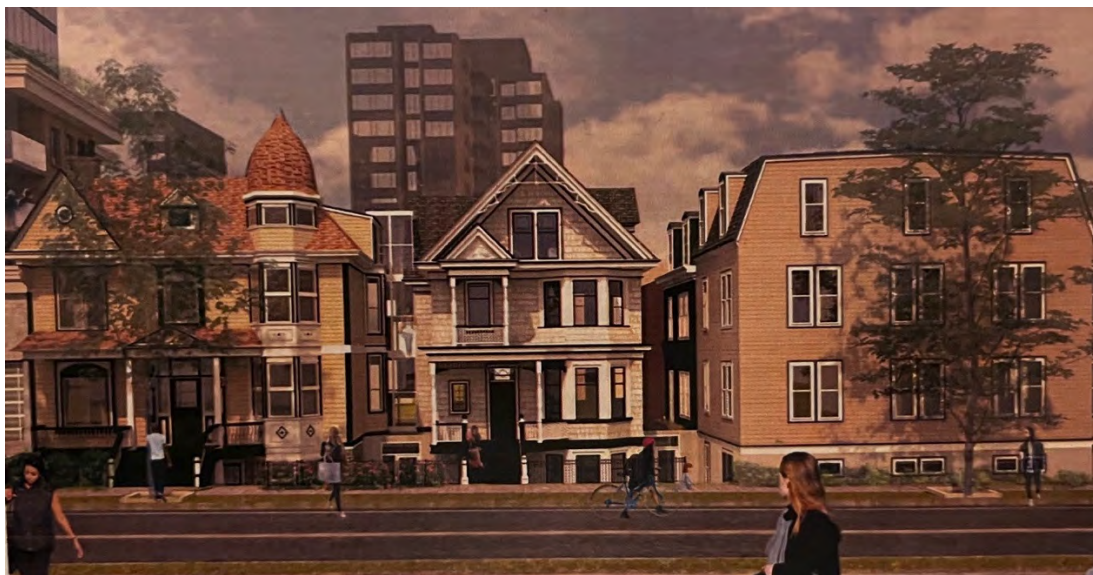
**Figure 4: Promenade Development -College Street Rendering (Original DA)**  
Source: Kassner Goodspeed Architects Ltd.

The two buildings on College Street were to be shifted to the east and placed directly behind 1452 and 1456 Carlton Street on the “panhandle” of the development site, at the corner of College and Carlton Streets (Figure 4).

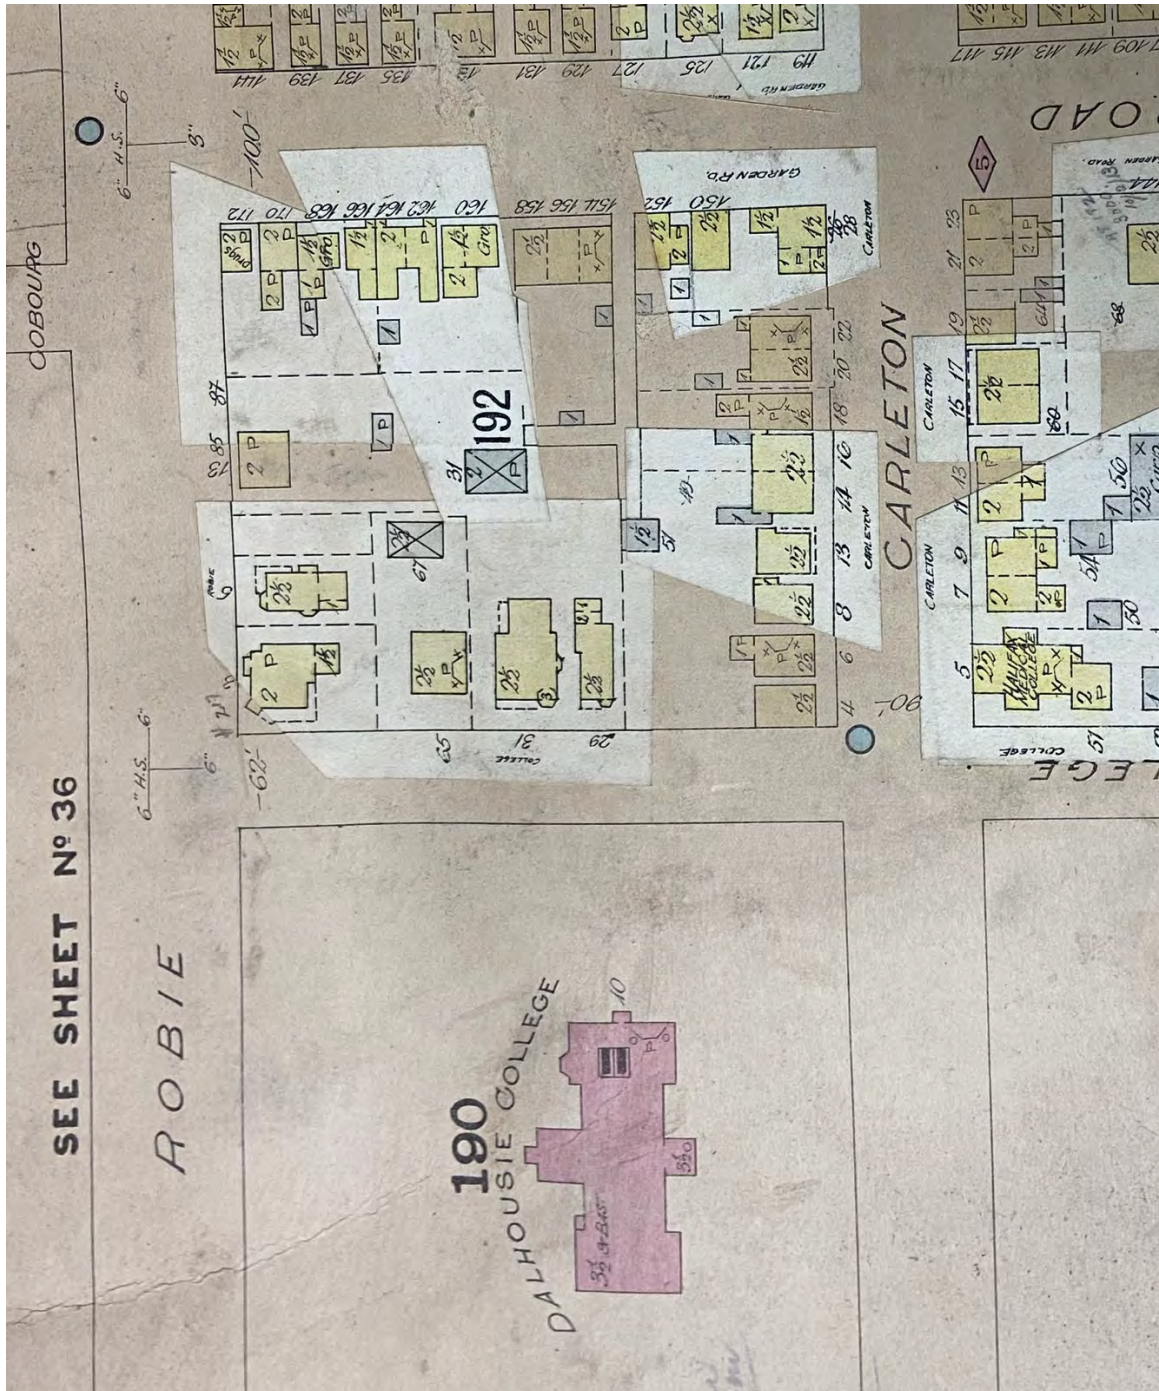
Figure 14: 1895 Fire Insurance Plan with revisions to 1907  
Source: Nova Scotia Archives

The infill of the block bounded by Robie, College and Carlton Street and Spring Garden Road was essentially complete by the very late 1890s, as illustrated in the Fire Insurance Plan and Assessment Plans from that time (Figures 14 and 15).

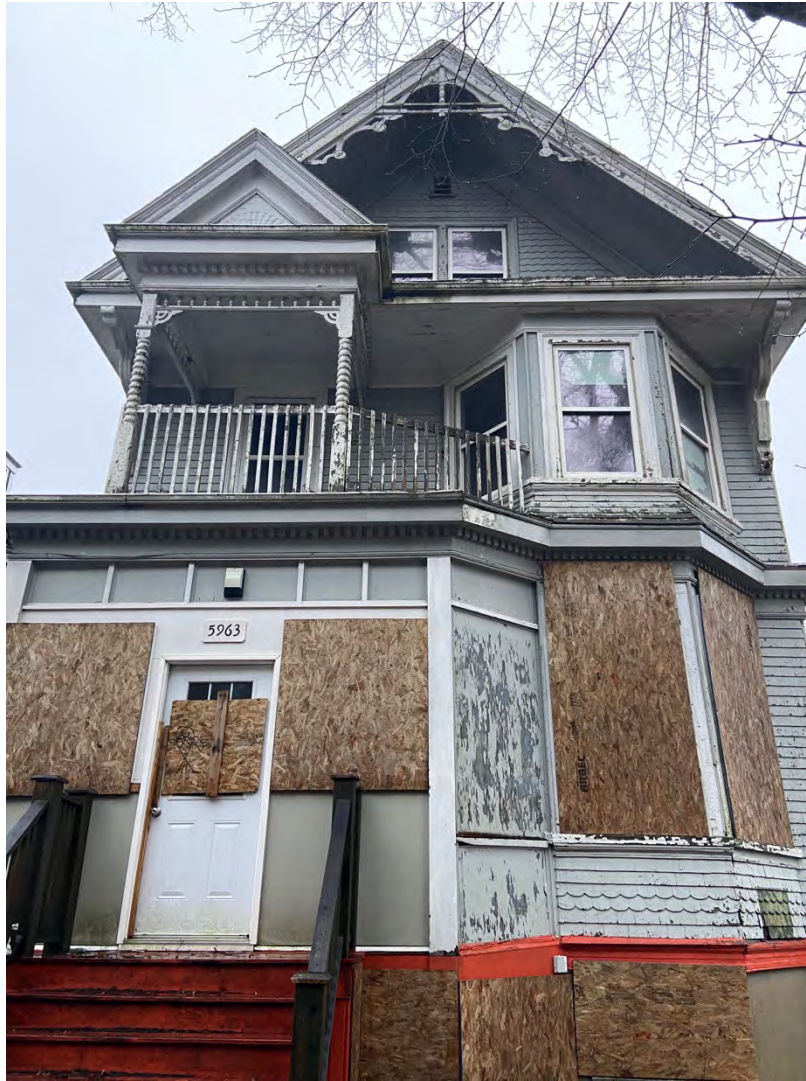
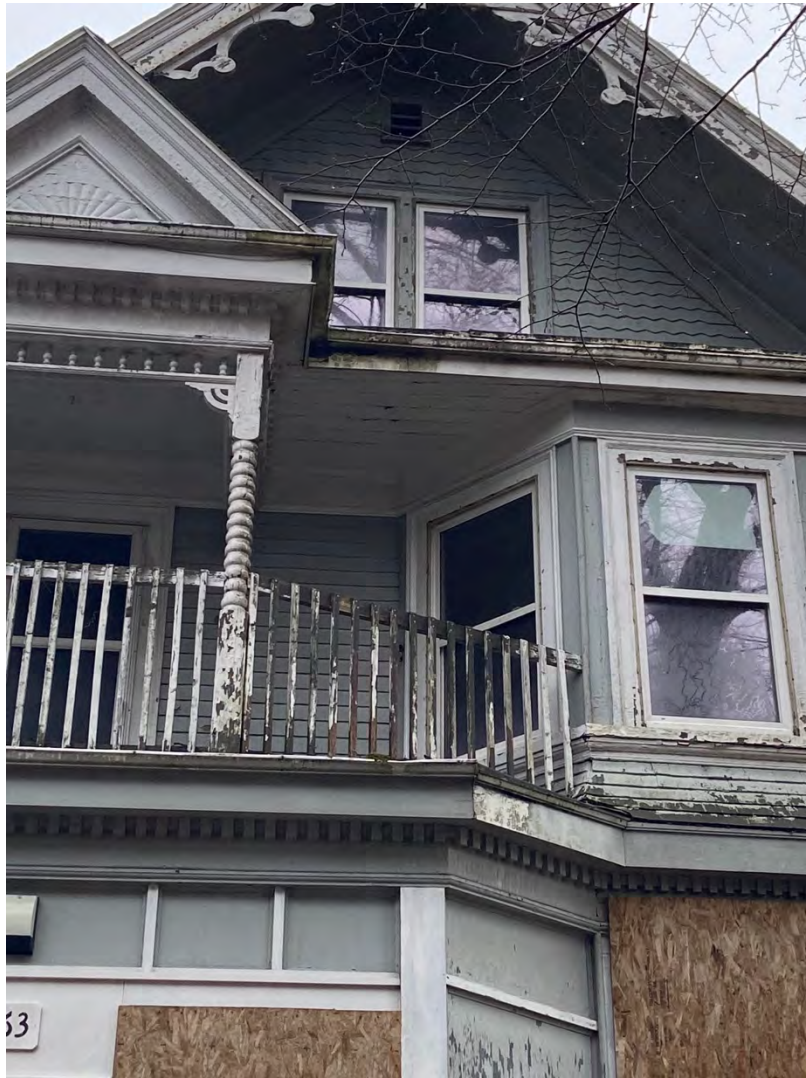
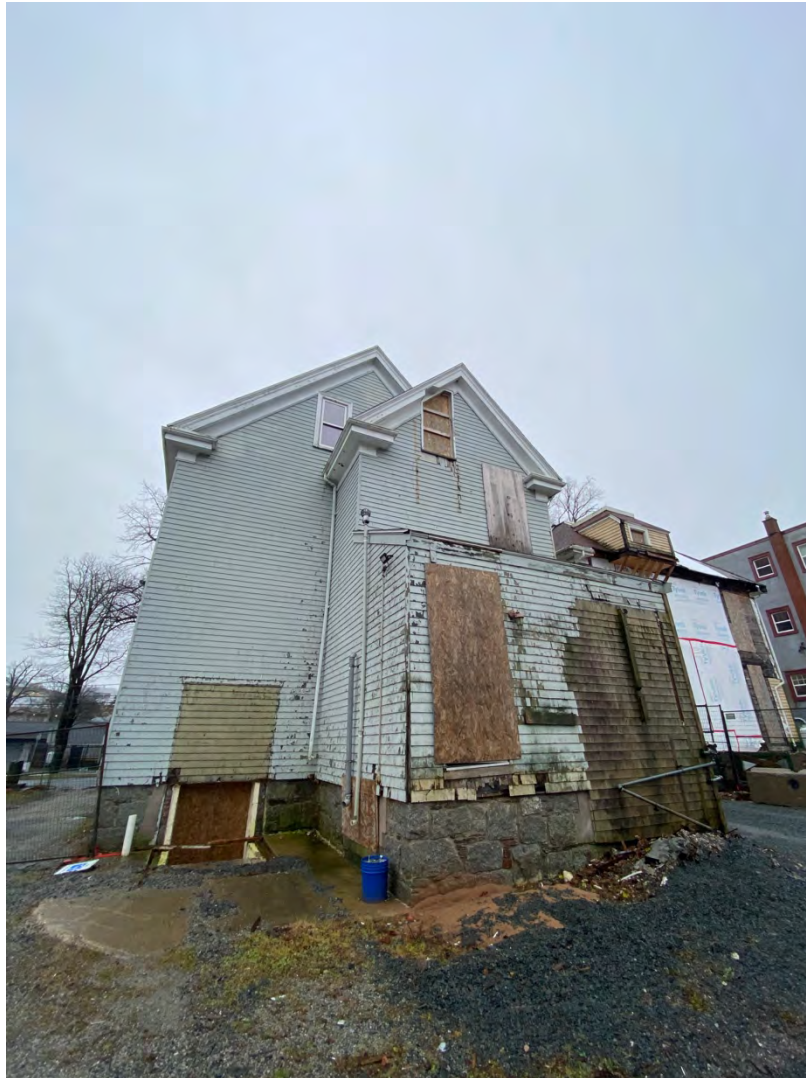
Its front-gabled form is common to the Queen Anne style, with the primary gable set dominantly above a half-width entry porch and a secondary porch situated above and a wall dormer protruding from the east side. There is a secondary gable toward the rear, along the west side (Figure 21).

Figure 21a: Front of 5963 College Street

**Figure 21b: Upper floor detail of 5963 College Street**

**Figure 21c: Rear of 5963 College Street**

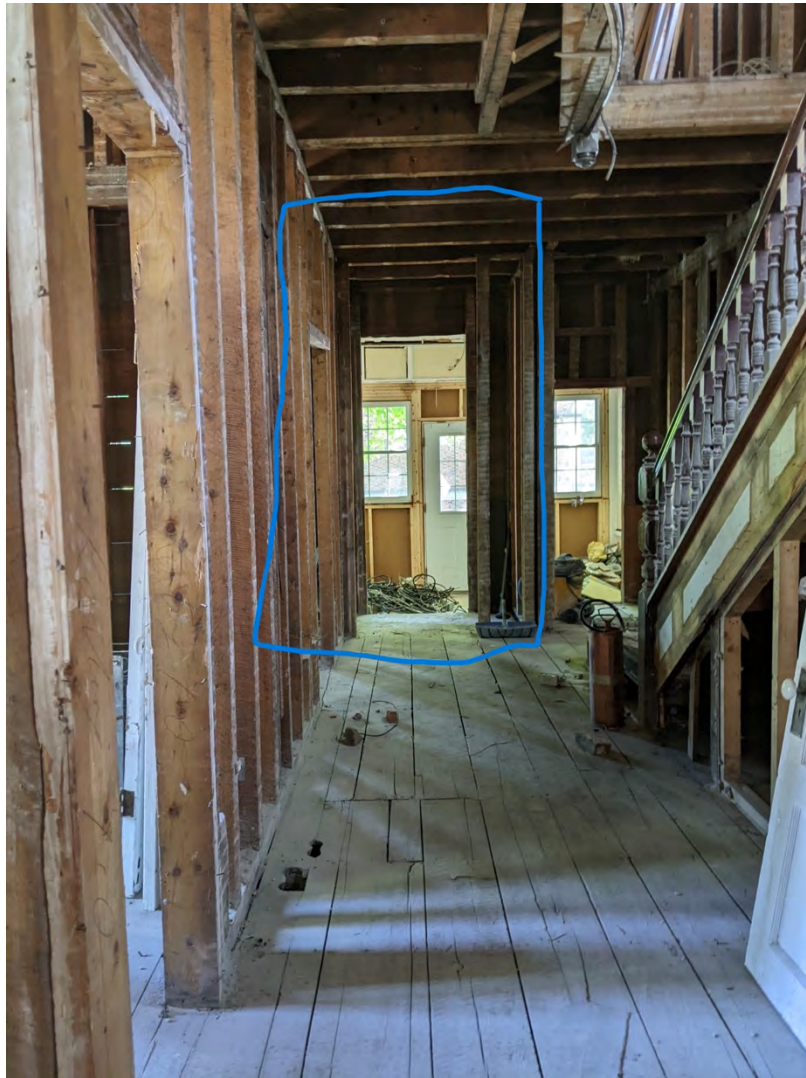
**Figure 21d: Interior view of front door and window openings behind enclosed porch, 5963 College Street**

The front door is currently obscured by the enclosed porch, but the front door opening is original, as is the separate “sidelight” window, visible in a recent interior photograph (Figure 21d).

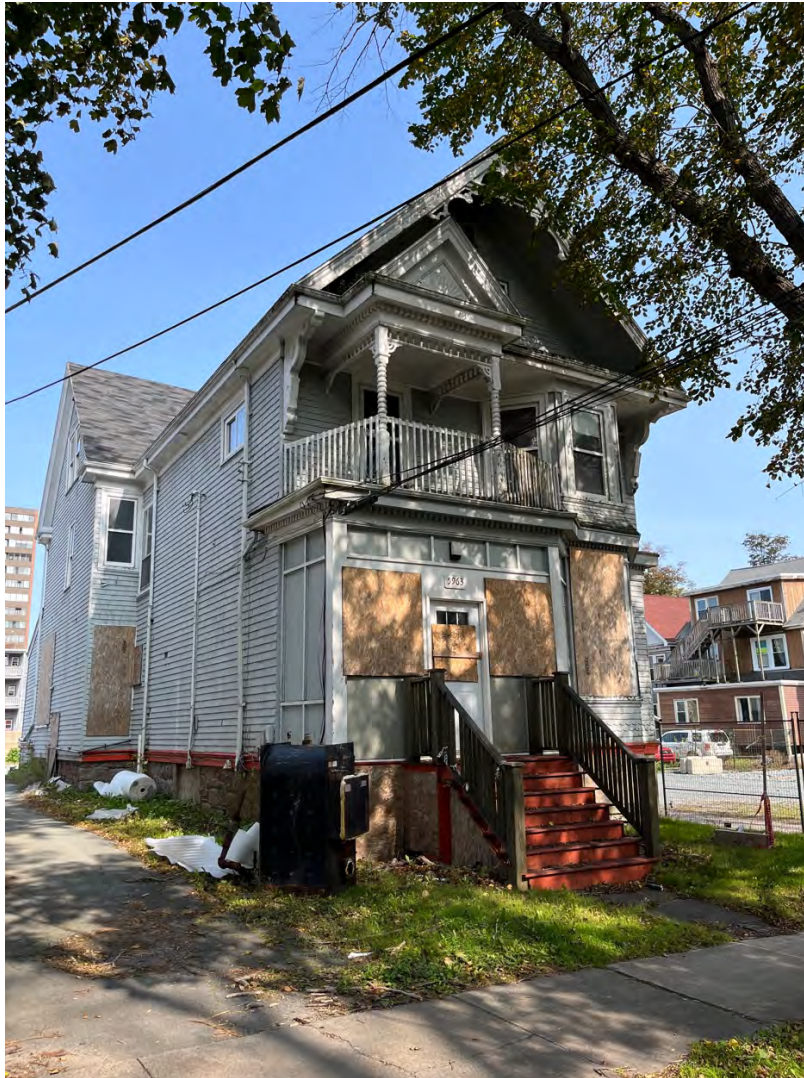
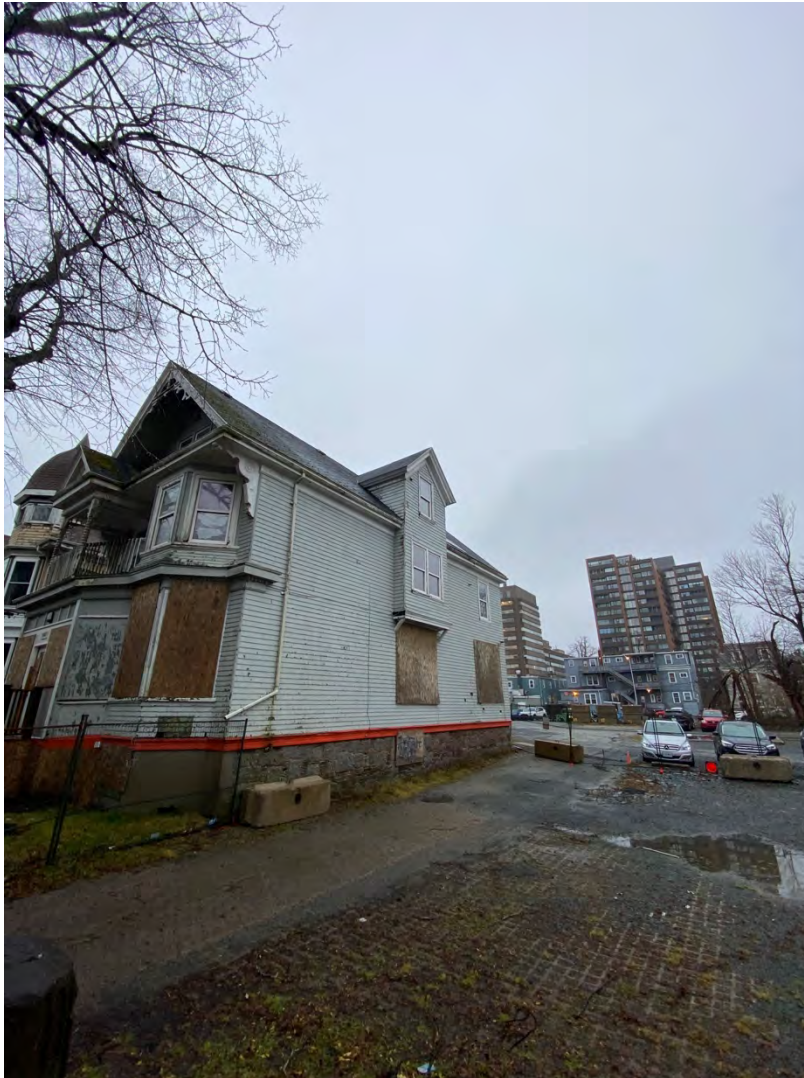
These elements are illustrated in Figure 22.

Figure 22a: MacCoy Residence, 5963 College Street – front and west side

Figure 22b: MacCoy Residence, 5963 College Street – front and east side

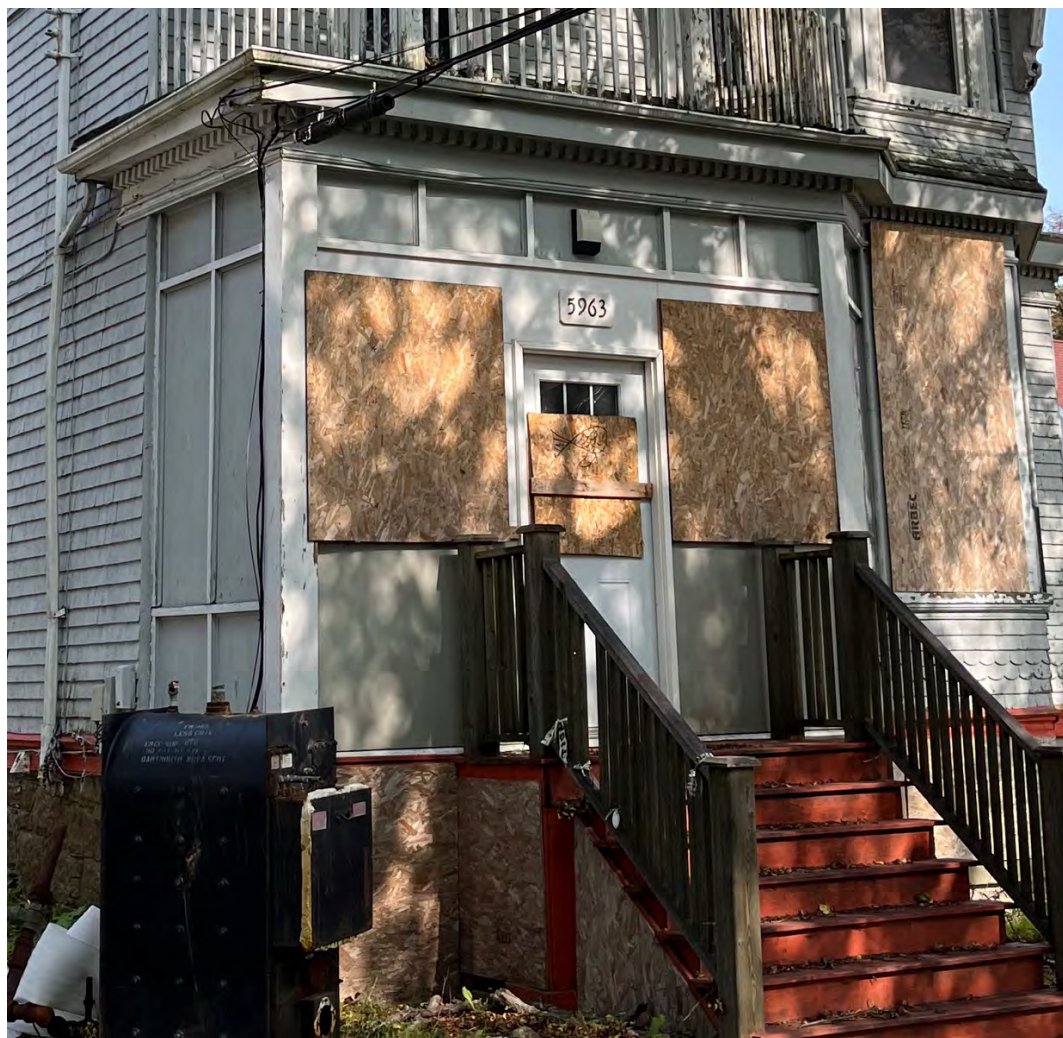
**Figure 23a: Front porch enclosure of 5963 College Street**

Overall, the integrity of the MacCoy Residence is excellent. The only notable alteration, on the front, is the enclosure of the small entry porch (Figure 23a).

This enclosure obscures the original entry and a single-set window to the left that would be considered a “sidelight”. The openings are intact, but the single-set door and transom (seen in the archival photos) and the sidelight window are not. The other notable alteration is at the rear which includes a shed roof extension (Figure 23b).

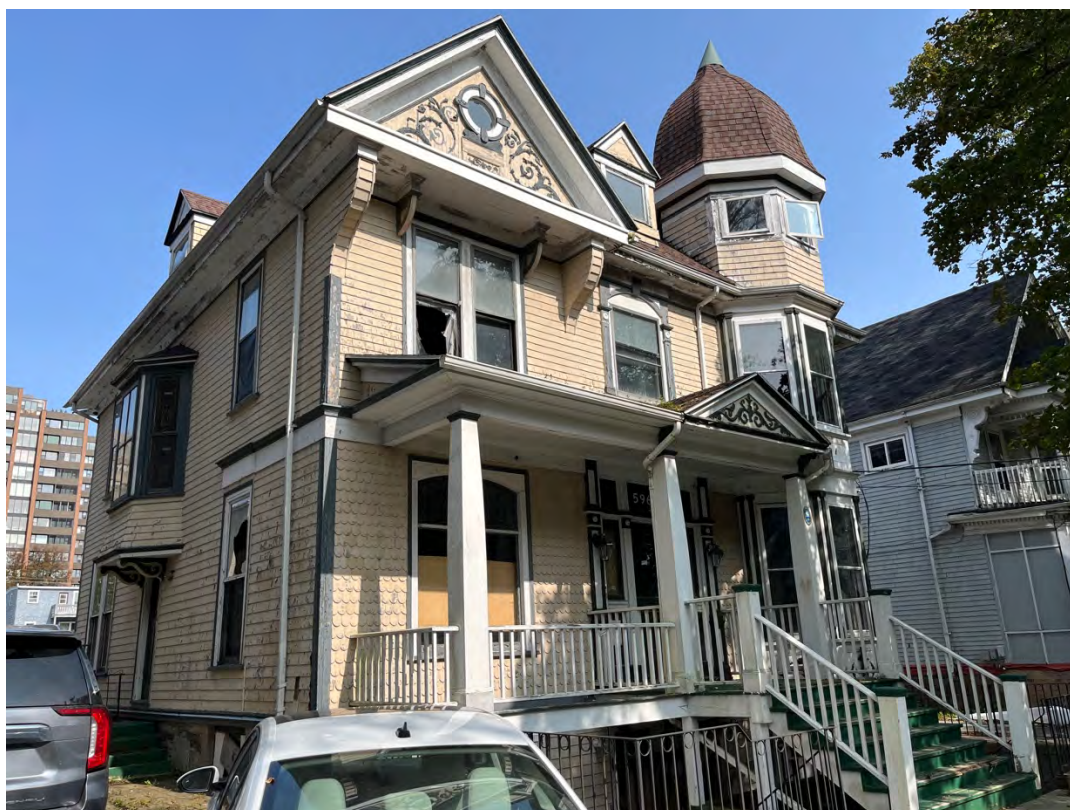
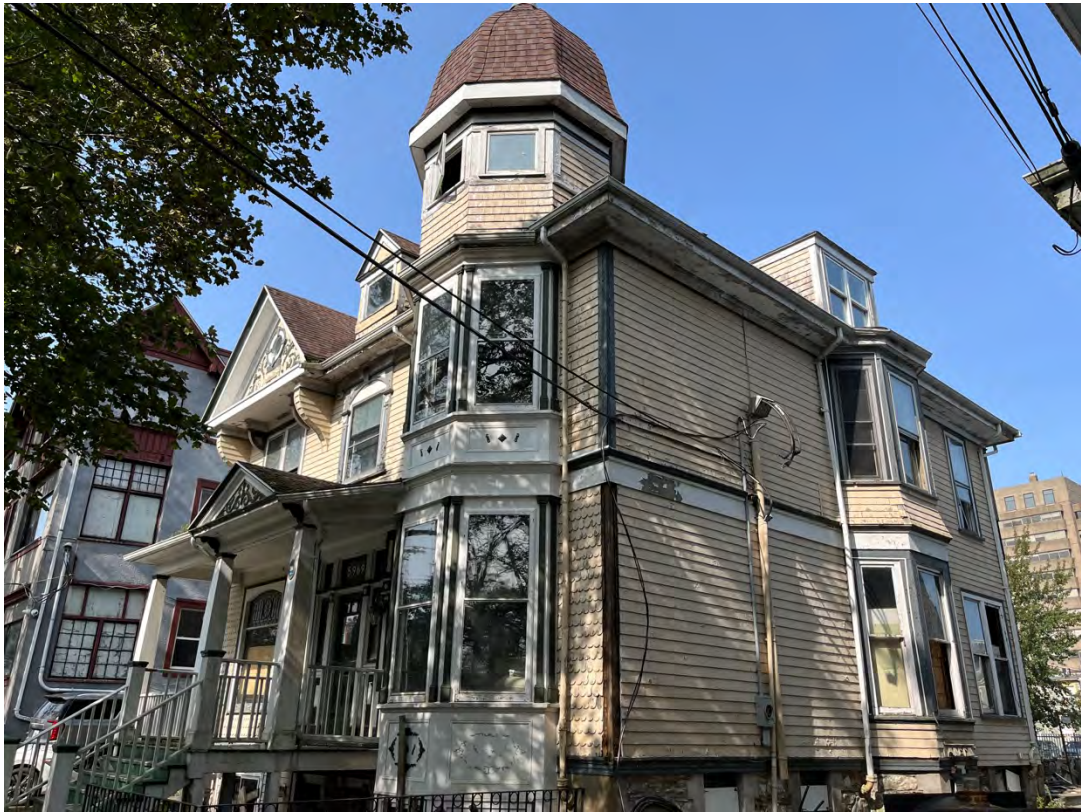
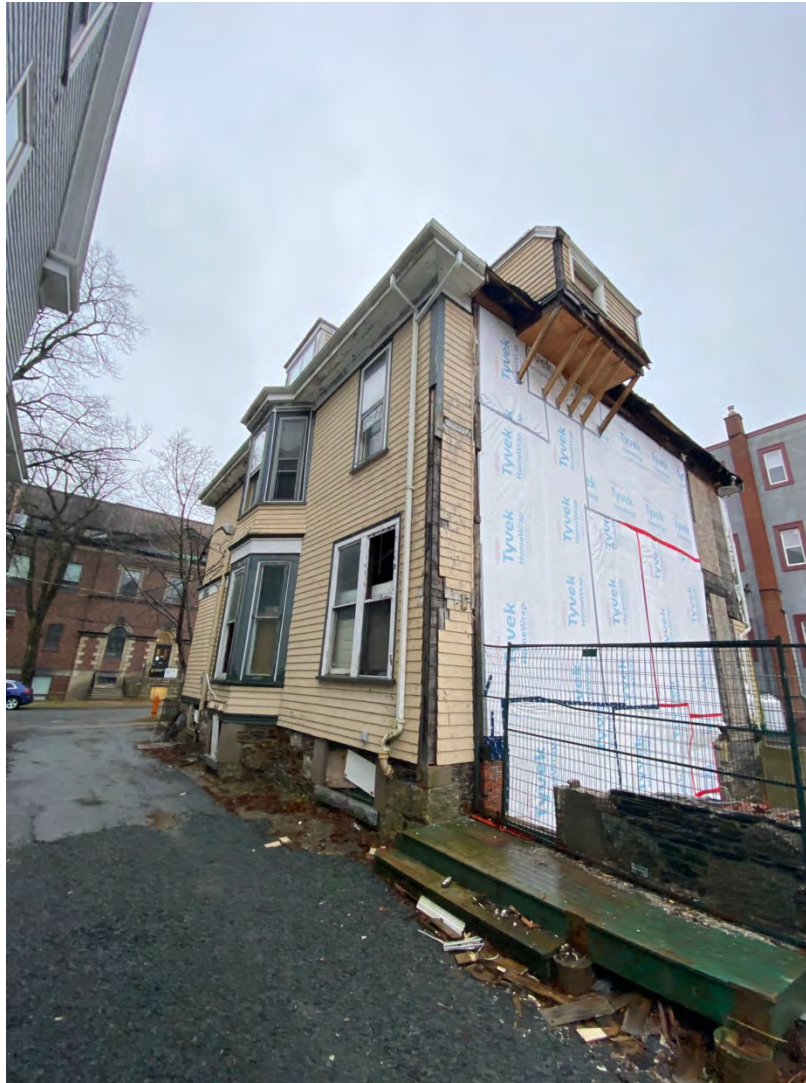
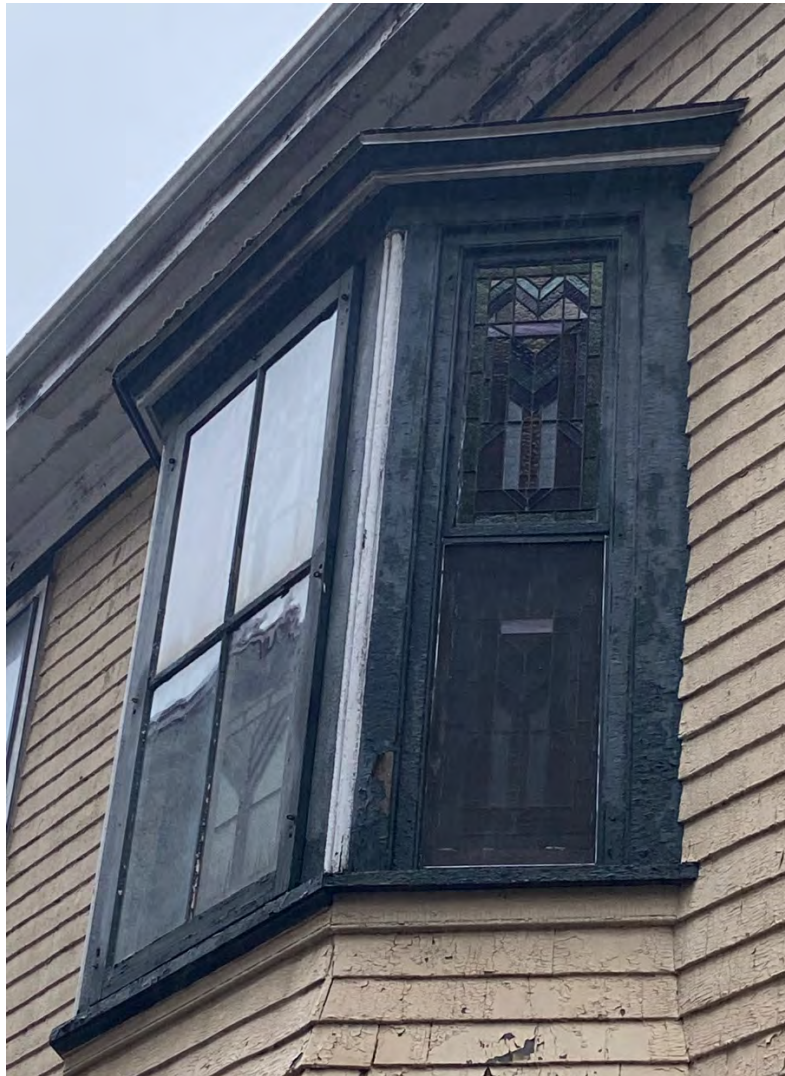
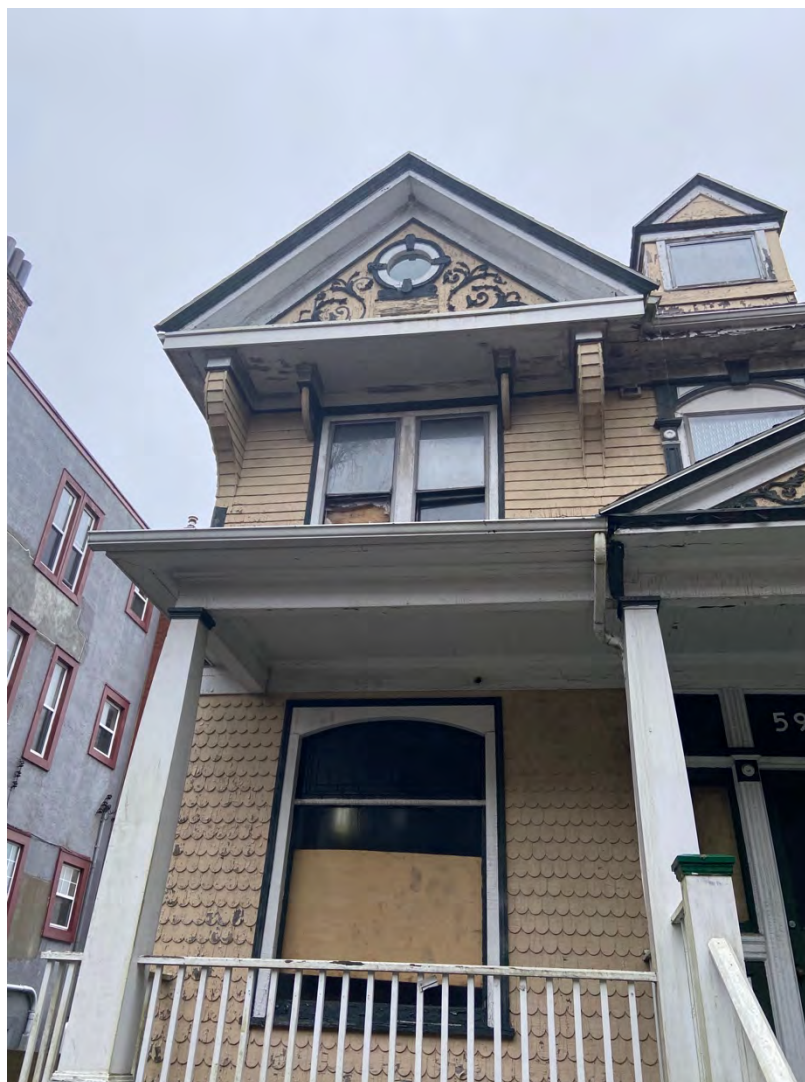
These elements are illustrated in Figures 27a to 27e.

Figure 27a: Gold Cure Institute, 5969 College Street – front and west side

**Figure 27b: Gold Cure Institute, 5969 College Street – front and east side**

Figure 27c: Gold Cure Institute, 5969 College Street – rear

Figure 27d: Gold Cure Institute, 5969 College Street – stained glass in side bay

Figure 27e: Gold Cure Institute, 5969 College Street – ornate detailing

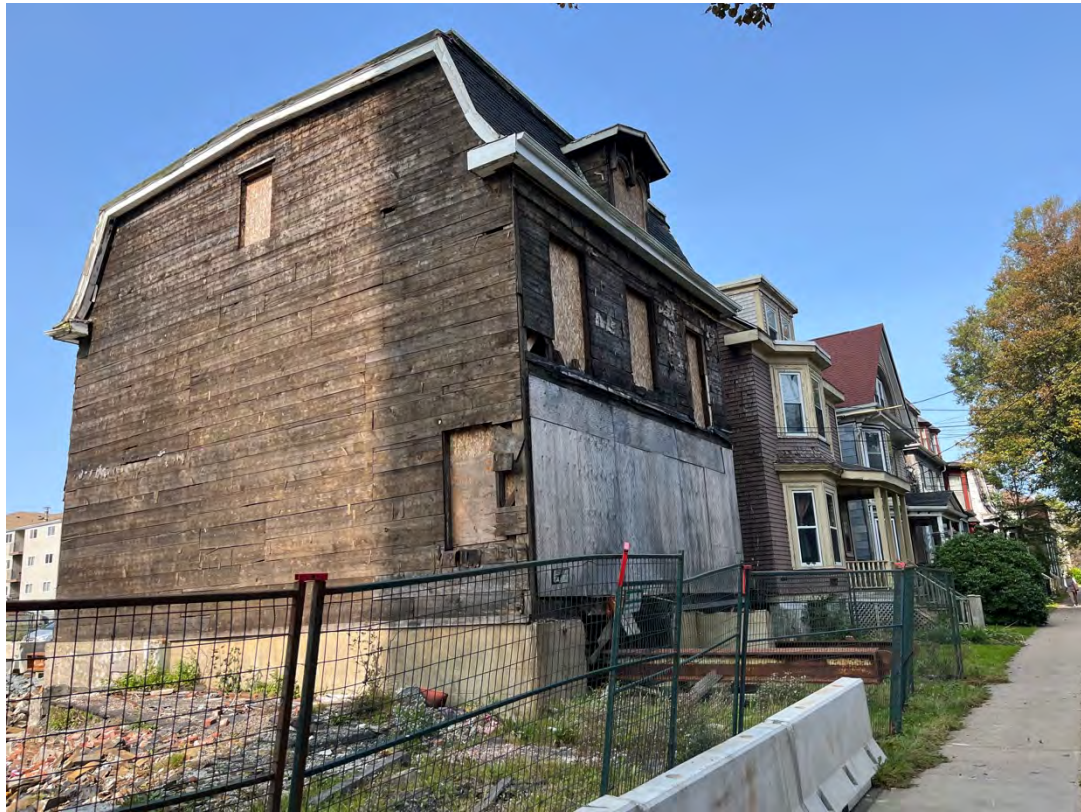
**Figure 33: 1456 Carlton Street following unauthorized alterations (front and south side)**

These alterations included the removal of the entire front porch, and all fenestration including windows, doors and cladding (Figure 33).

Significant character-defining elements of the Crosskill Building were removed, including shingle cladding, cornice, windows, and front porch. A principle of the Standards indicates that intact or repairable character-defining elements should not be removed, replaced, or substantially altered. The Crosskill Building must be completely restored to its original condition, in accordance with the approved substantial alterations from 2019. Every measure should be taken within the new development agreement to identify intact or repairable exterior architectural features of the Mary Belcher Building and to ensure that these architectural features are not lost or replaced unnecessarily before or after it is moved to its new location.

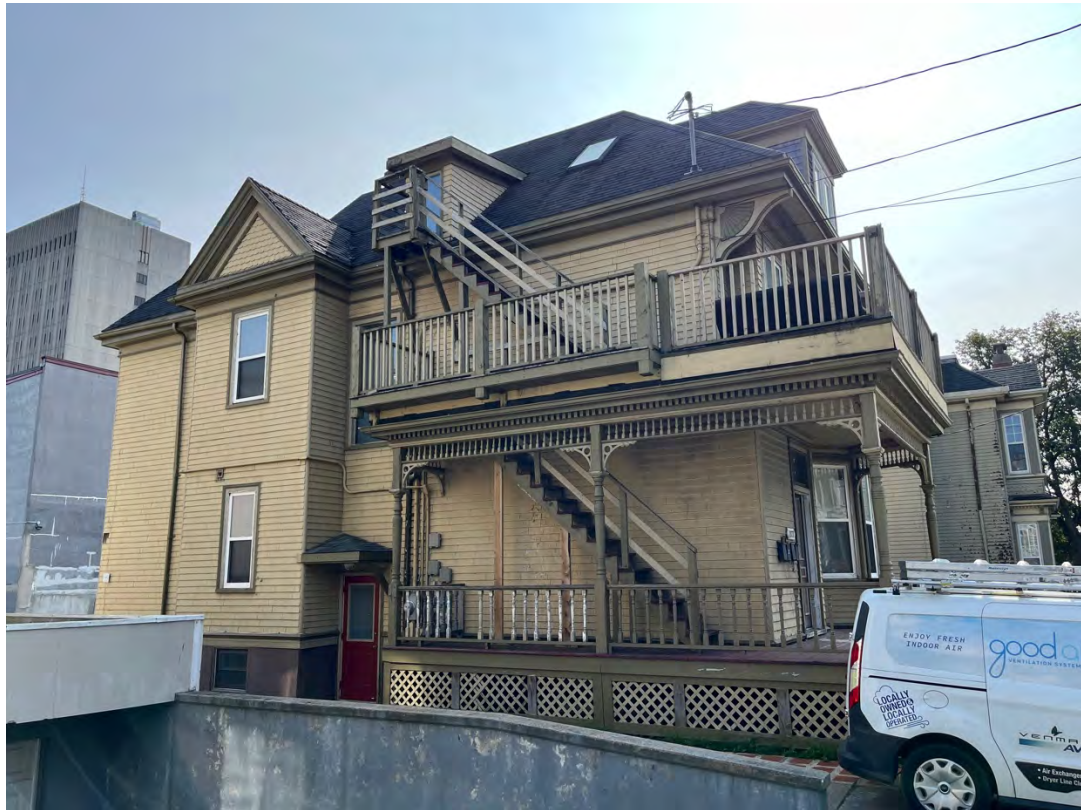
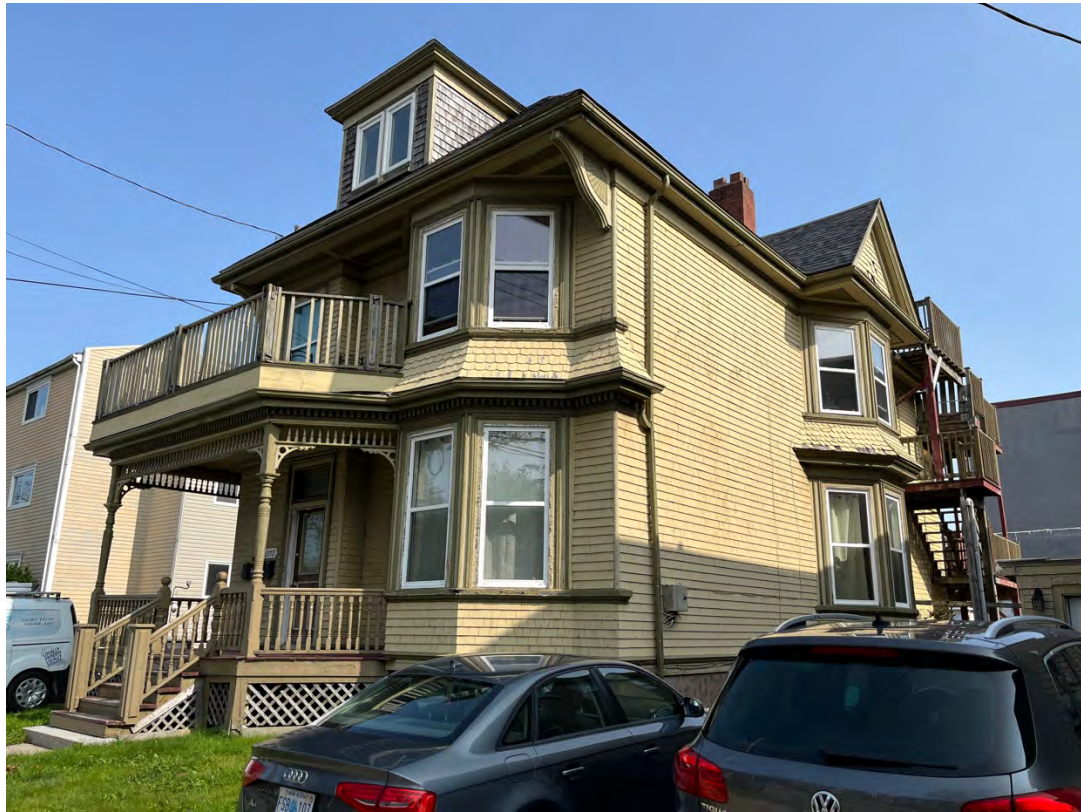
**Figure 37b: Mary Belcher Residence, 1377 Robie Street (North side, which upon relocation, will become the south side)**

**Figure 37c: Mary Belcher Residence, 1377 Robie Street (North side, which upon relocation, will become the south side)**
