**Item No. 13.2.1**  
**Transportation Standing Committee**  
**February 22, 2024**

**SUBJECT:** **CNIB Halifax: Cycling Infrastructure Guidelines**

Final Report and Recommendations  
September 2023

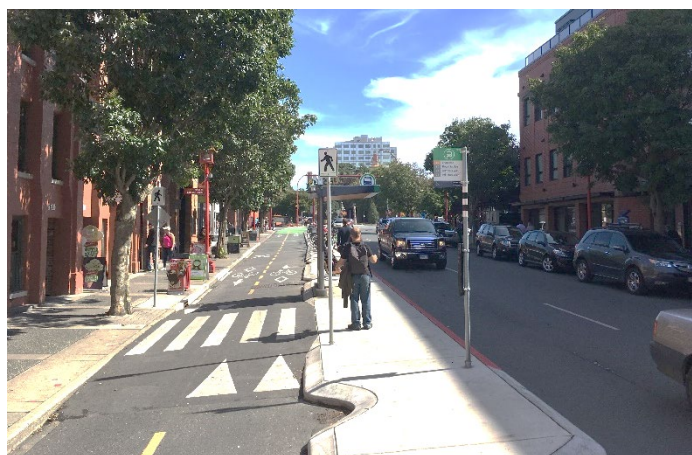
Figure 1: An island platform bus stop in Victoria that was the subject of a BC Human Rights Tribunal case in 2020. The photo is from 2018, and changes were made to the design following the ruling.

In 2020, a BC Human Rights Tribunal ruling drew attention to the ways in which the existing design of a floating bus stop in Victoria discriminated against people who are blind, affirming the challenges being faced by visually impaired individuals as new forms of multi-modal infrastructure were planned, designed and implemented. This landmark decision has contributed to a nationwide re-evaluation of bus stop designs by transit agencies, with an increased focus on accessibility.

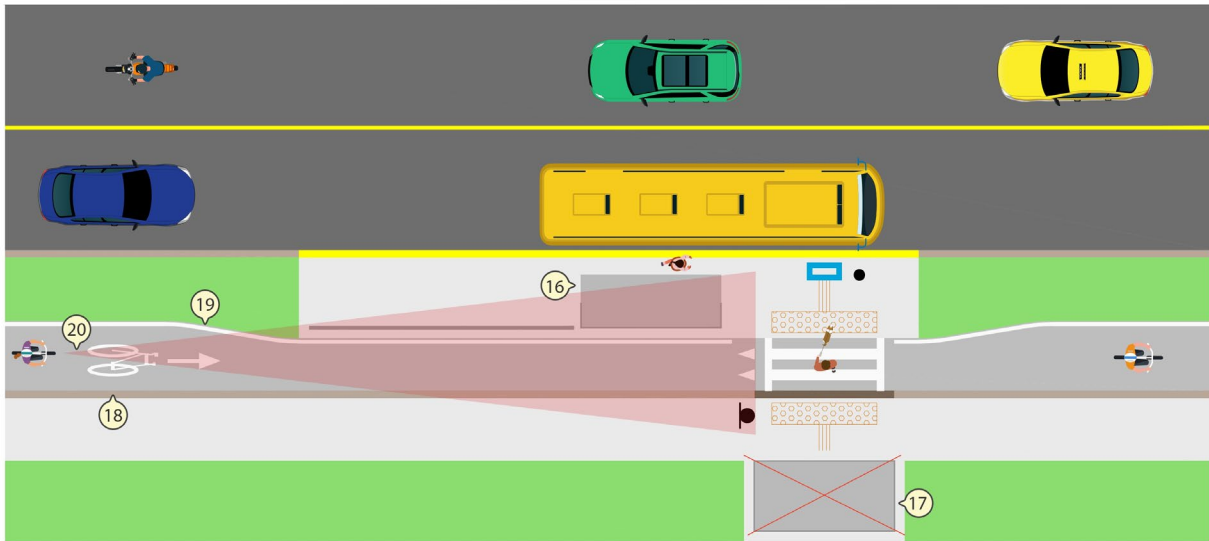
Figure 4: Example #3, constrained application. The guidance associated with each callout number is as follows:

This example conveys a commonly-encountered situation where insufficient boulevard space is available to accommodate all of the desired elements.

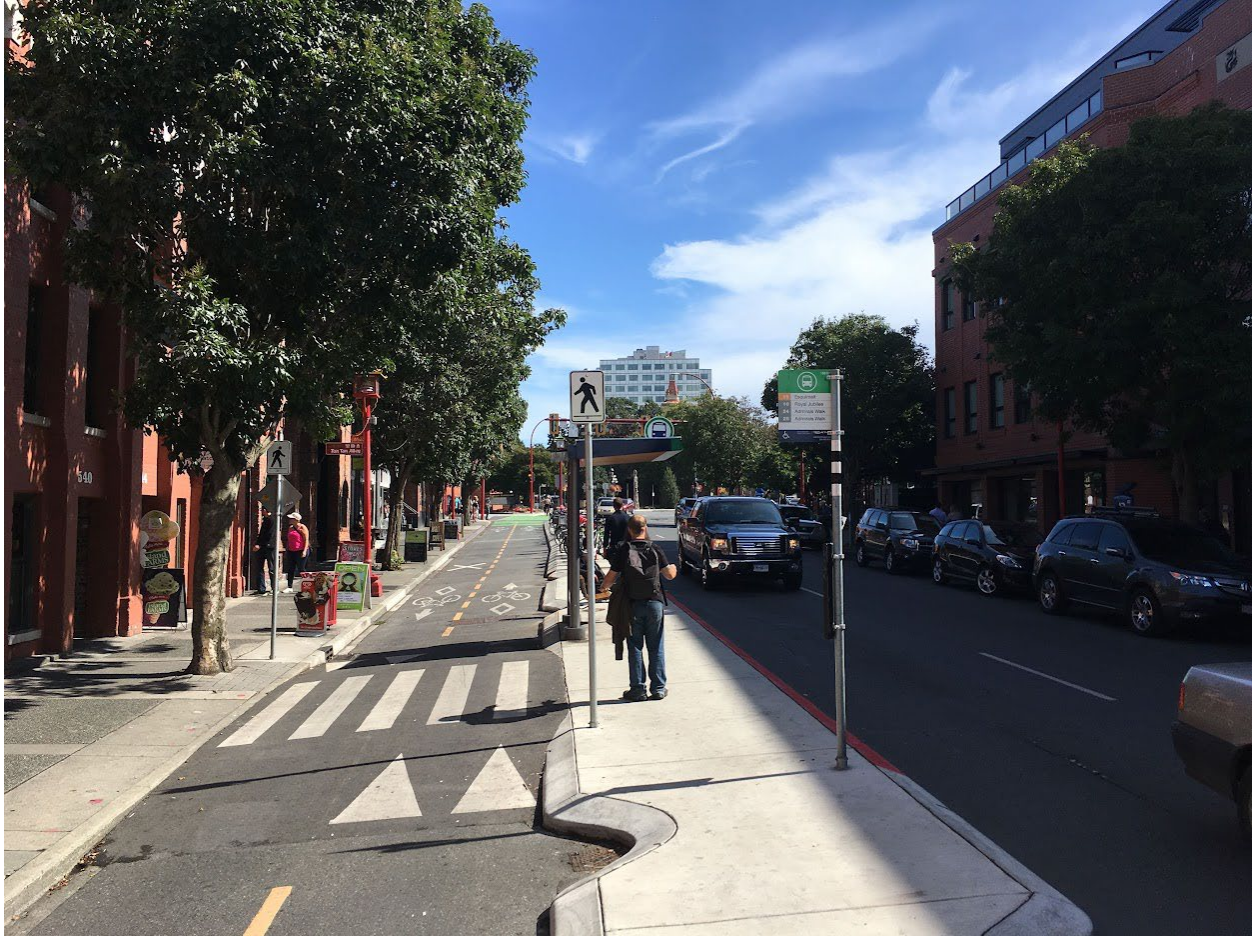
Figure 6: Island platform bus stop on Pandora Avenue in Victoria, BC (photo from 2018 prior to Human Rights Tribunal ruling)

In 2020, a judge at the BC Human Rights Tribunal ruled in favour of Oriano Belusic and the Canadian Federation of the Blind, finding that the City of Victoria had discriminated against people who are blind by introducing floating bus stops along Pandora Avenue in Victoria, one of which is shown in **Figure 3**. The ruling served to demonstrate the care and attention that must be paid when designing new infrastructure, leading many municipalities and transit agencies to integrate a stronger accessibility lens when designing new places where people on bikes and people walking or wheeling interact.

In the judge’s reasons for decision, published November 13, 2020, the key design challenge of the bus stop in question was that people with vision loss are unable to see an approaching cyclist on the Pandora Bikeway, and that ambient urban noise from the street eliminates people’s ability to hear the approach of a bicycle.

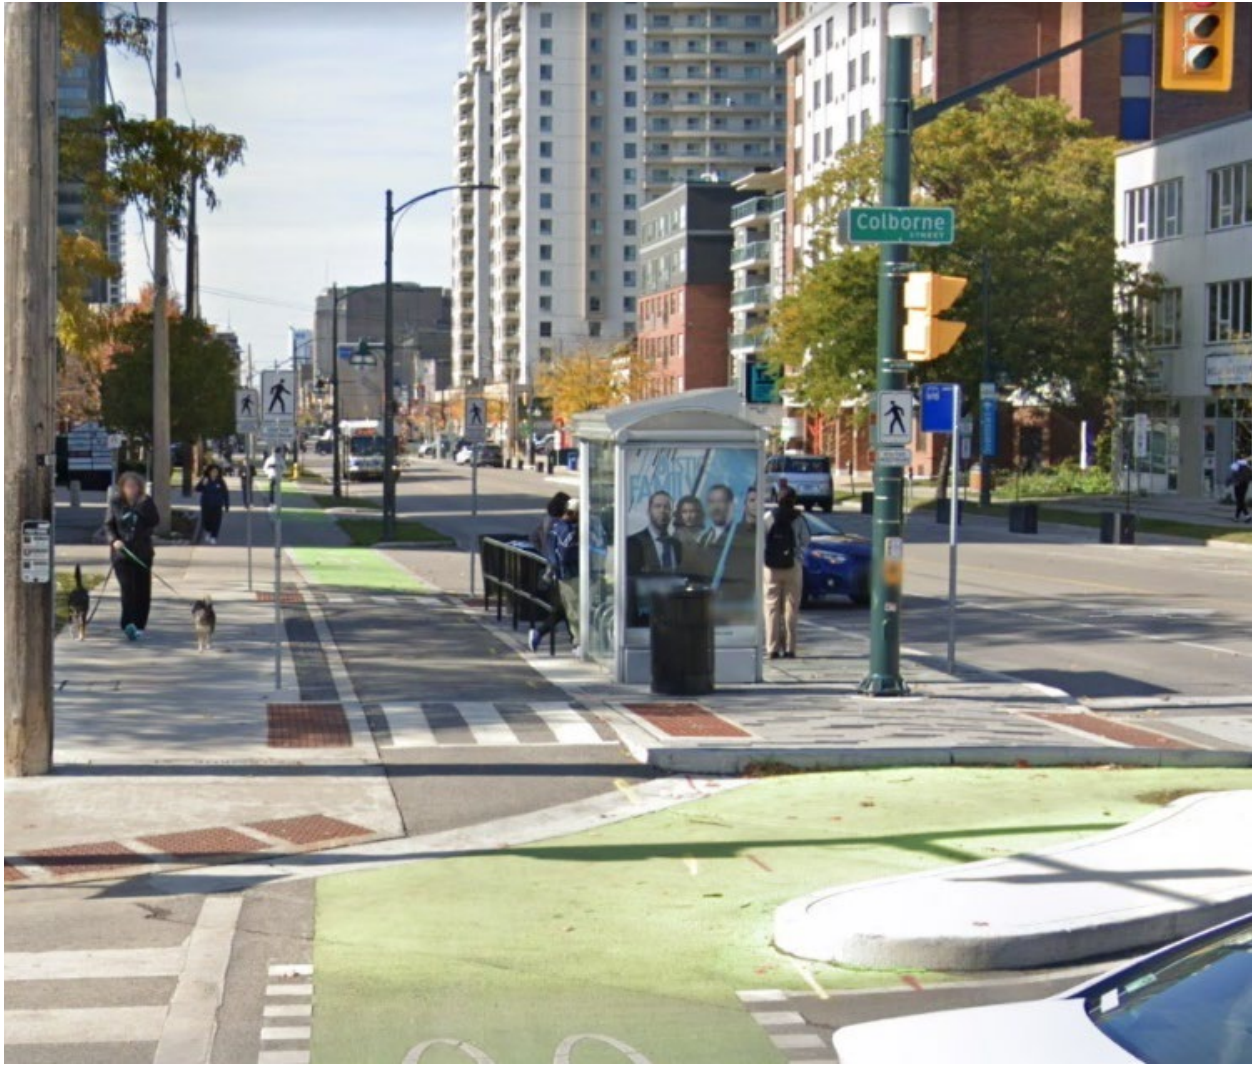
The accessibility elements incorporated into the design include:

- ✓ Attention TWSI
- ✓ Channelization
- ✓ Crosswalk marking
- ✓ Accessible pedestrian signals (on platform)

Figure 12: London Site at Dundas St/ Colborne St

- The wide sidewalks had a detrimental effect of finding the bus stop as it was too far from the bus shelter. Shelters are usually found using echolocation as it blocks the sound from traffic.
- The placement of the stop at the intersection with the pedestrian signal at the platform was confusing to many users because initially they walked past the bus stop to the other crossing of the intersection.

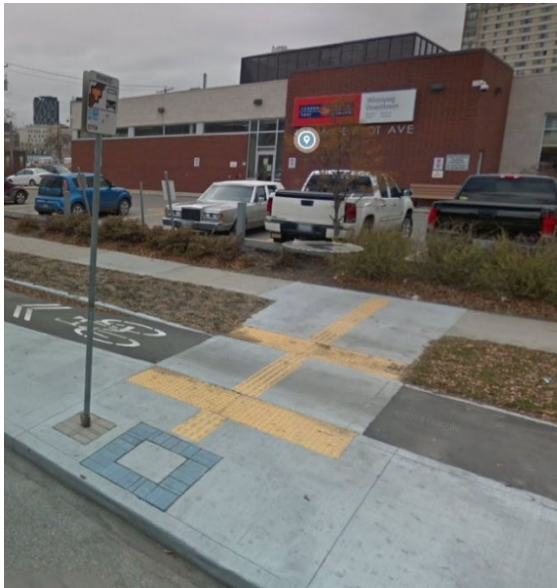
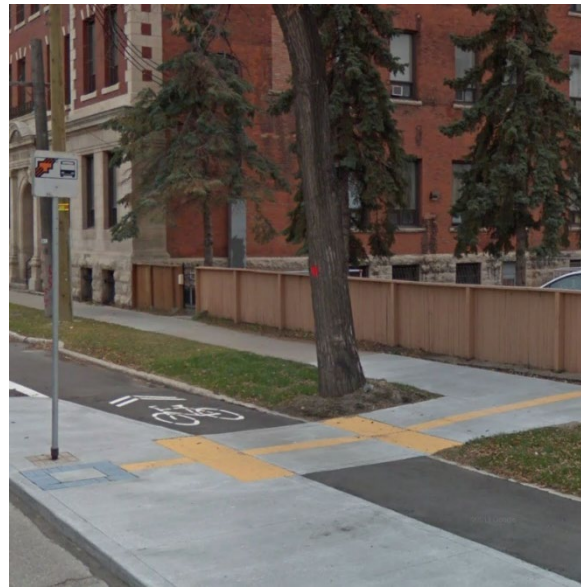
- ✓ Attention TWSI
- ✓ Directional TWSI
- ✓ Crosswalk (concrete surface)

- ✓ Tactile delineation (grass buffer)

Figure 13: Winnipeg site at McDermot Ave / Frances St to the left and Winnipeg site at McDermot Ave / Hargrave St to the right

The site at McDermot Ave / Frances St is a midblock bus stop served by Winnipeg Transit bus route 17. Notably, this site stands out as the only one which leverages both warning and directional TWSIs.

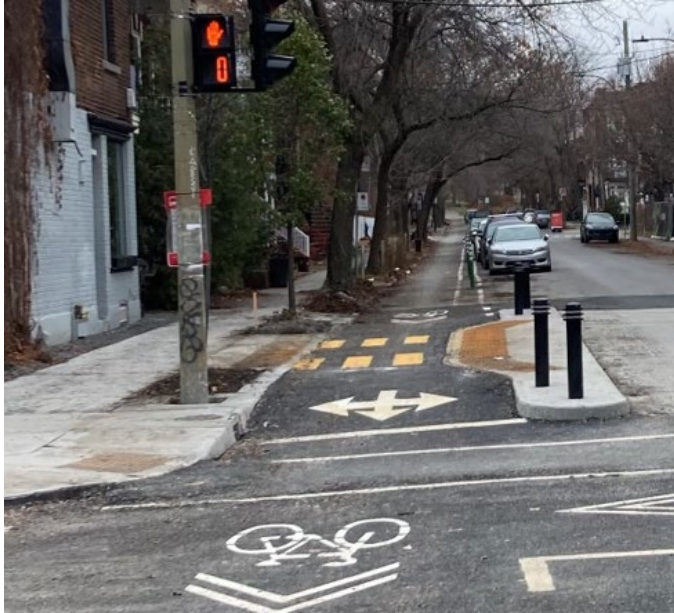
The accessibility elements incorporated into the design include:

- ✓ Attention TWSI
- ✓ Crosswalk marking
- ✓ Bus flag on sidewalk

Figure 14: Montreal Site at Christophe-Colomb Ave / Gilford St

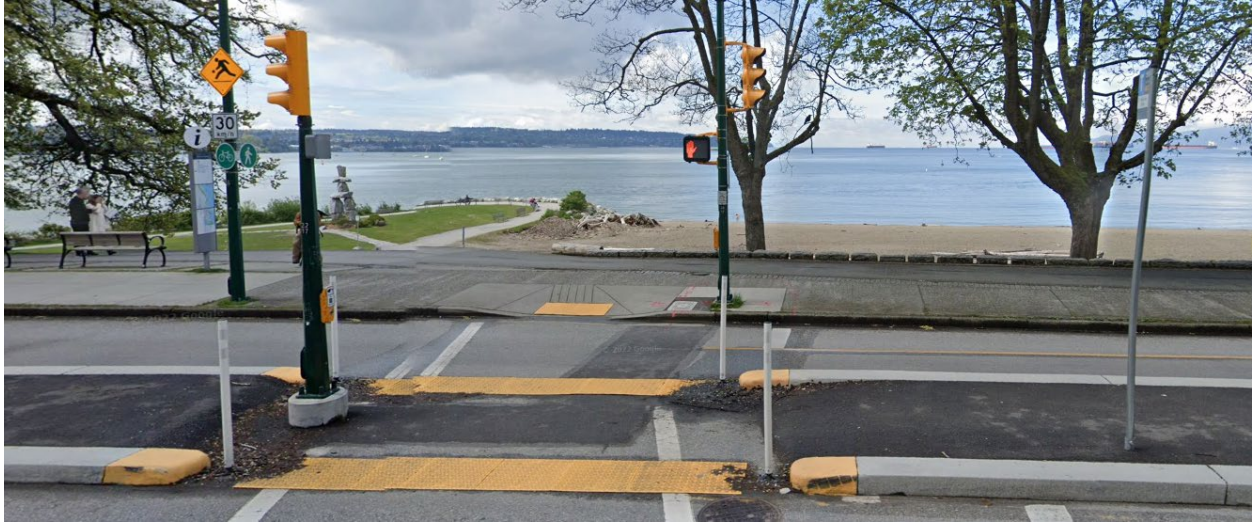
The accessibility elements incorporated into the design include:

- ✓ Attention TWSI
- ✓ Crosswalk marking
- ✓ Accessible pedestrian signal
- ✓ Tactile delineation (full-height curb)

Figure 16: Vancouver site at Beach Ave / Bidwell St

The sites along Beach Avenue are at intersection bus stops served by Translink bus route 023. The sites are signalized. Also, this corridor had the highest volume of cyclists observed during the field testing.

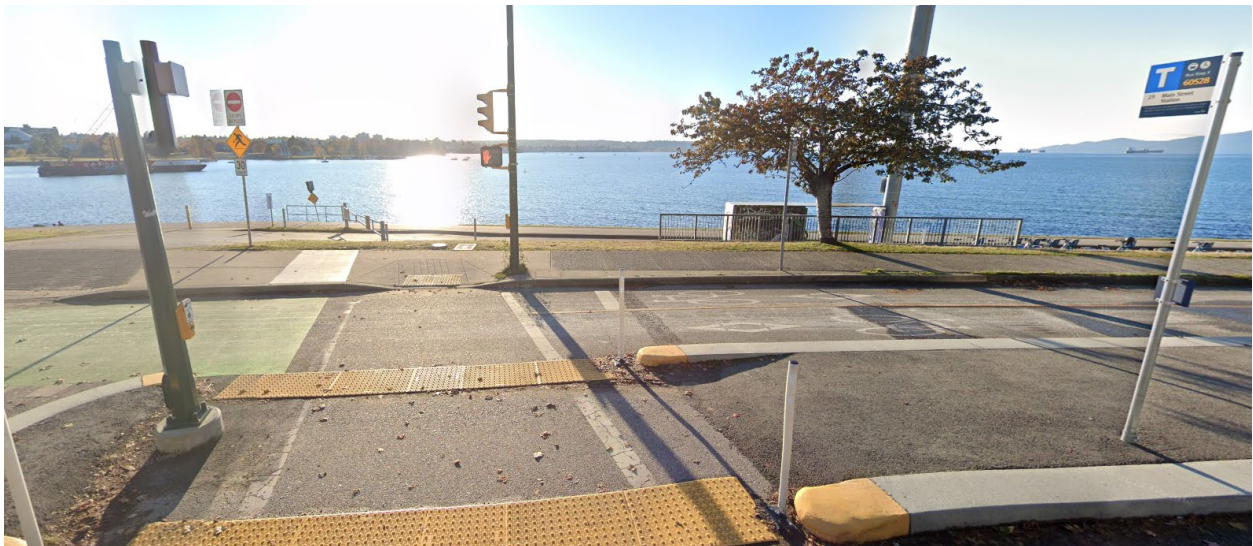
Figure 17: Vancouver site at Beach Ave / Cardero St

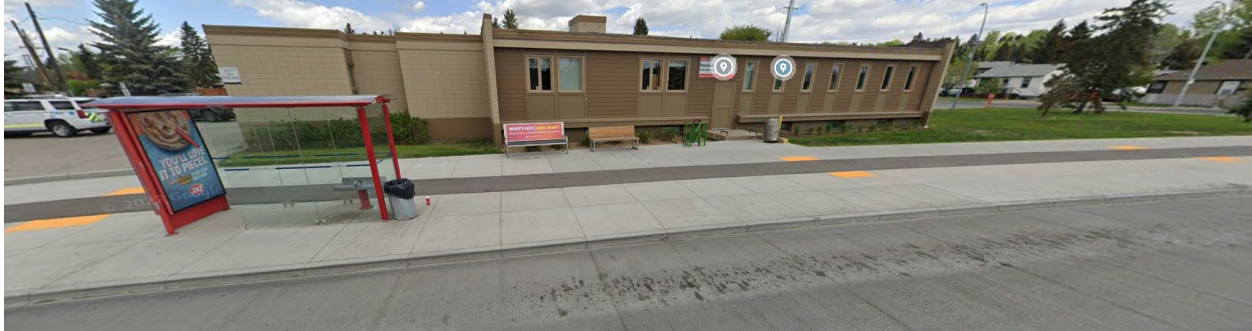
- ✓ The accessibility elements incorporated into the design include:
- ✓ Attention TWSI

Figure 18: Calgary site at Home Road / Bowness Road (north corner)

The site assessed in Calgary is Home Road / Bowness Road, shown in **Figure 15** and **Figure 16**. For this site, participants boarded at the north corner and alighted at the south corner. The two sites are identical in their design and are across the street from each other.

The bus stop is served by several lines: Calgary Transit bus routes 1, 40, 53 and 306. This platform design for this site is similar to the design of that in London, Ontario. The design uses a shelter and multiple crossing locations over a distance.

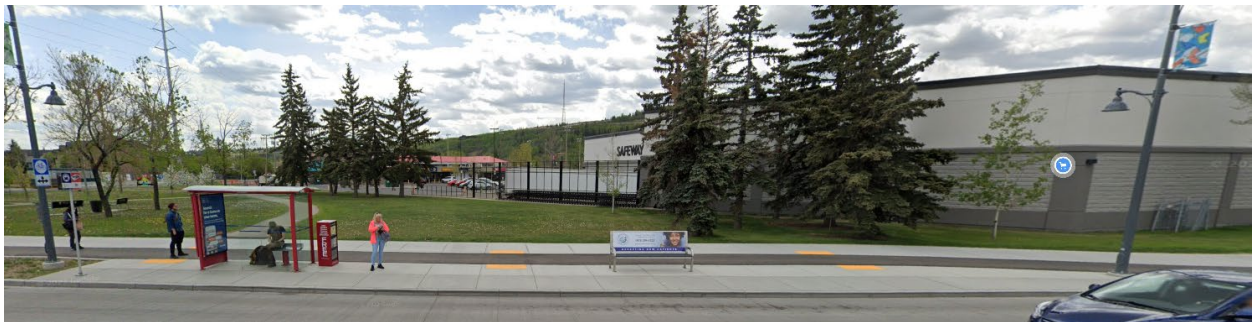
Figure 19: Calgary site at Home Road / Bowness Road (north corner)

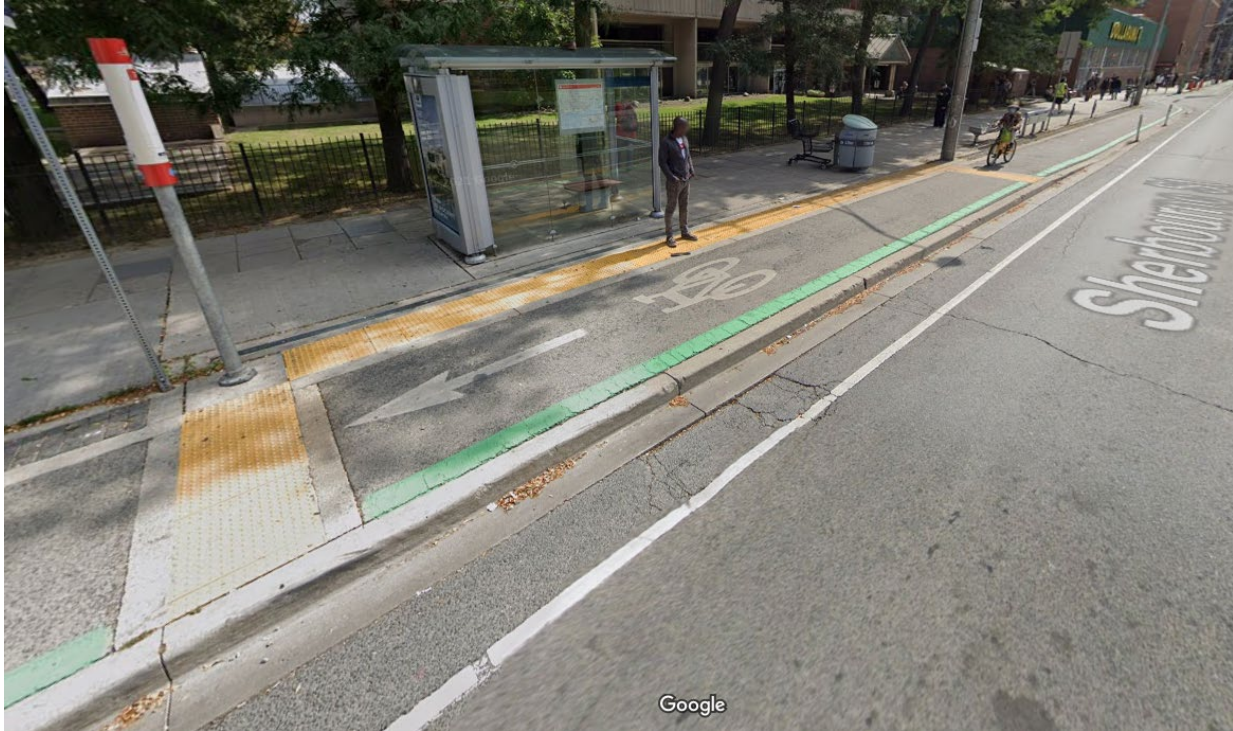
Figure 21: Example of an "integrated bus stop" in Toronto
