# Bayers Rd and Joseph Howe Dr

MicroTraffic Video Diagnostic Findings and Recommendations

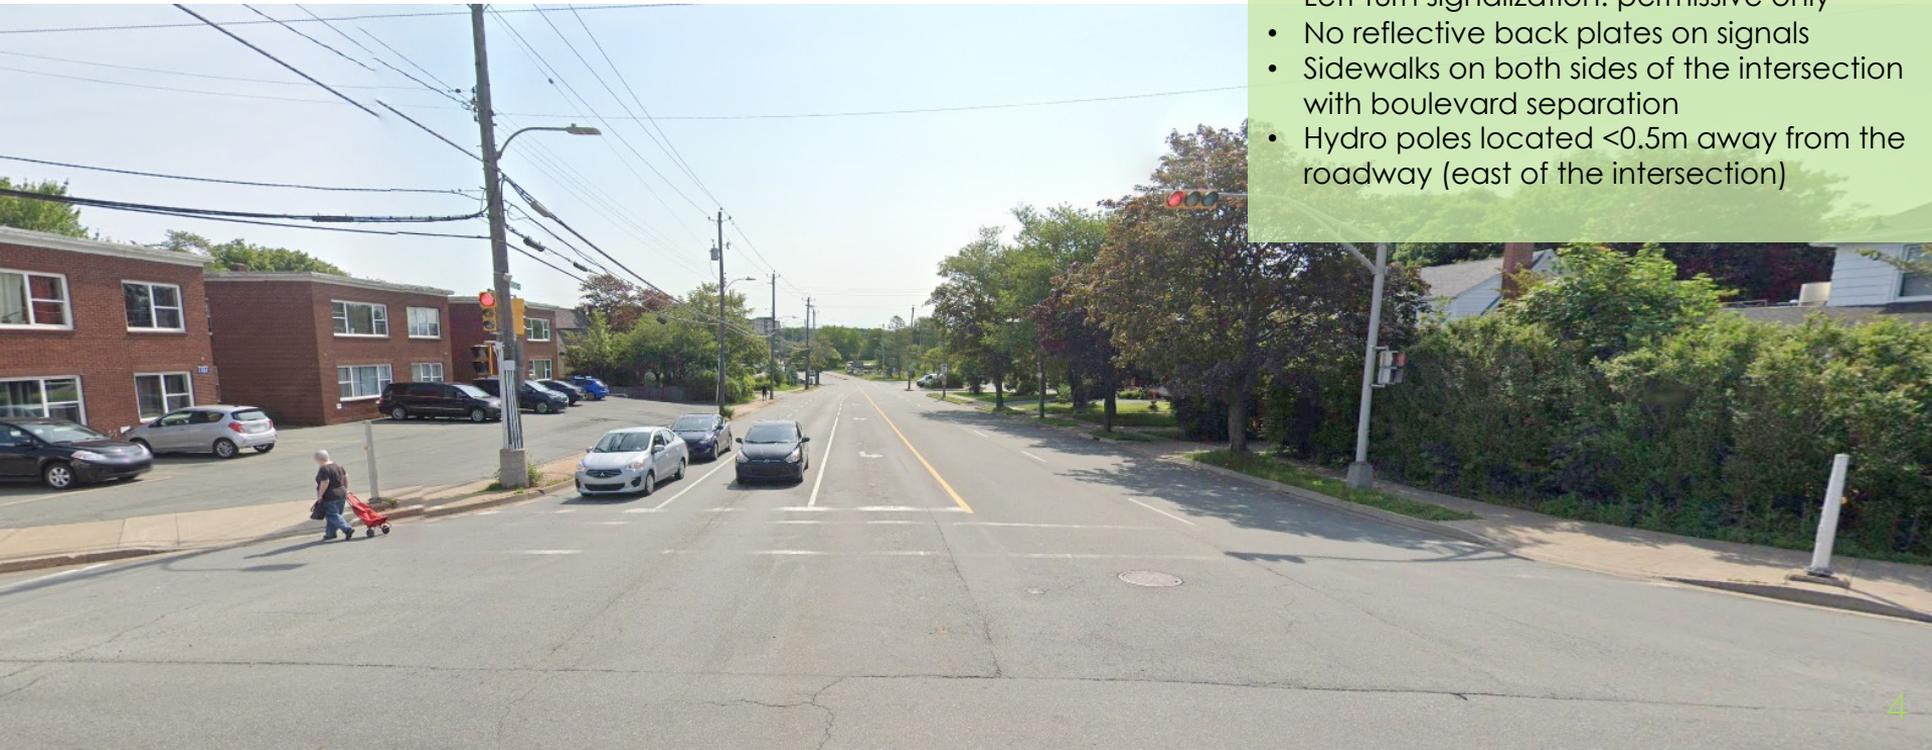
Bayers Rd. Looking East

### Bayers Rd. Features:

- One through lane, one left turn auxiliary lane and one right turn only lane.
- Right turn channelization island for EBR
- High turn radii for WBR (high speed)
- 50 km/h posted speed limit
- Three signal heads EB and WB (one nearside)
- Left turn signalization: permissive only
- No reflective back plates on signals
- Sidewalks on both sides of the intersection with boulevard separation
- Hydro poles located <0.5m away from the roadway (east of the intersection)

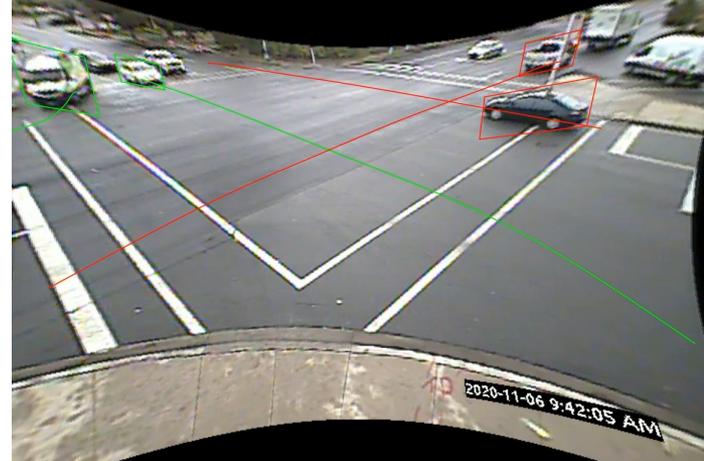
- 4 through vs through conflicts were detected during the 56-hour analysis period (east-through vs south-through).
- 10 Left-Turning vs Through Vehicle from Left conflicts were detected (north-left vs east-through).
- These conflict types require a signal violation, which are typically infrequent events, or occur at the signal phase change at relatively low vehicle speeds.

Signal Phase Change: south-through vs east-through

Key Issue	Recommendation
<p><b>Angle Vehicle events:</b></p> <ul style="list-style-type: none"><li>• 13% of collisions were Angle collisions, several of which listed red light running as a contributing factor.</li><li>• 4 conflict events were detected in the 56-hour analysis period for through vs through vehicles- these events were typically at a signal phase change and at relatively low speeds.</li><li>• Signal perception improvements would be valuable at improving safety at the intersection.</li></ul>	<ul style="list-style-type: none"><li>• Add reflective back plates to all signal heads to improve visibility of signals.</li><li>• Upgrade any signals &lt; 300mm to 300 mm.</li><li>• Check all-red phase for possible extensions; ensure technical guidance is followed at a minimum.</li></ul>
<p><b>Cyclist Safety:</b></p> <ul style="list-style-type: none"><li>• Only 3 conflicts were measured, but risk potential is higher. Exposure was low due to November study period and the MUP presents human factors issues with SBR geometry and permissive portion of NBL phase.</li></ul>	<ul style="list-style-type: none"><li>• Previously mentioned reduction of NW quadrant radius will reduce vehicle speed for SBR hook vs MUP cyclist conflicts.</li><li>• Previously mentioned protected NBL will reduce NBL conflict risk.</li></ul>

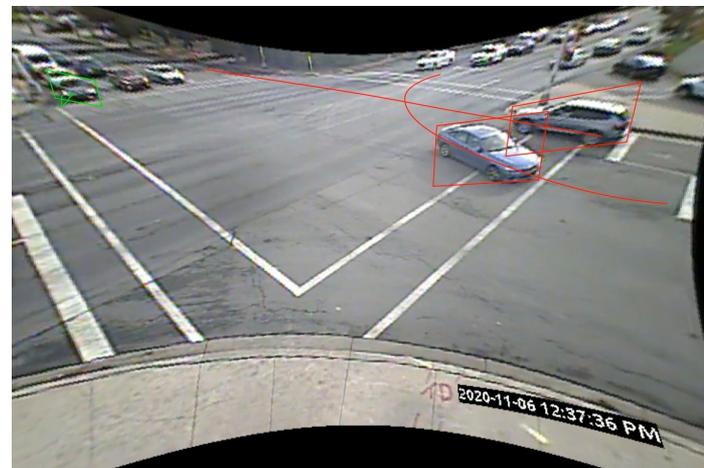
Signal Phase Change: north-left vs east-through

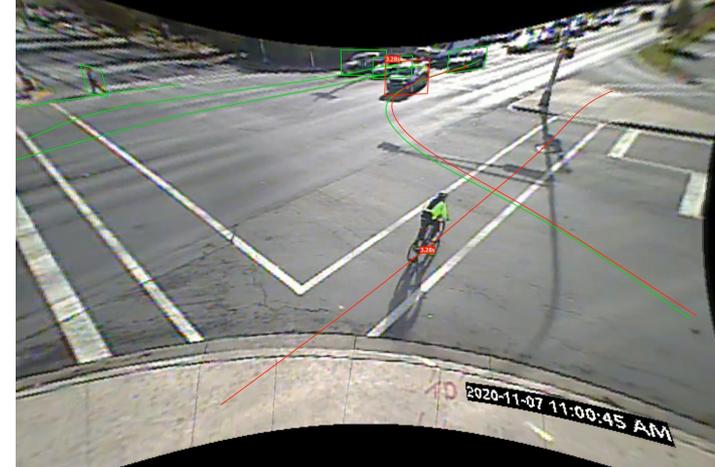
- The cyclist volumes were relatively low, with less than 20 cyclists per crossing from 5:00 – 24:00.
- Although only a limited number of cyclist conflicts were detected, 2.6% of all cyclists that used the West Crossing were involved in a north-left hook medium-risk conflict and 3% of all cyclists that used the North Crossing were involved in an east-left hook medium-risk conflict.
- Cyclists on the Chain of Lakes multi-use path may travel at high speeds (refer to conflict clip) and arrive faster than expected for left-turning vehicles. Because this path is bidirectional, it presents human factors issues for NBL and SBR vehicles.
- The mixing area between cyclists and pedestrians where the MUP meets the intersection may pose risks to pedestrians.

Cyclist North Left-Hook:  
T2 = 2.5s, vehicle speed: 21 km/h, cyclist speed: 25 km/h

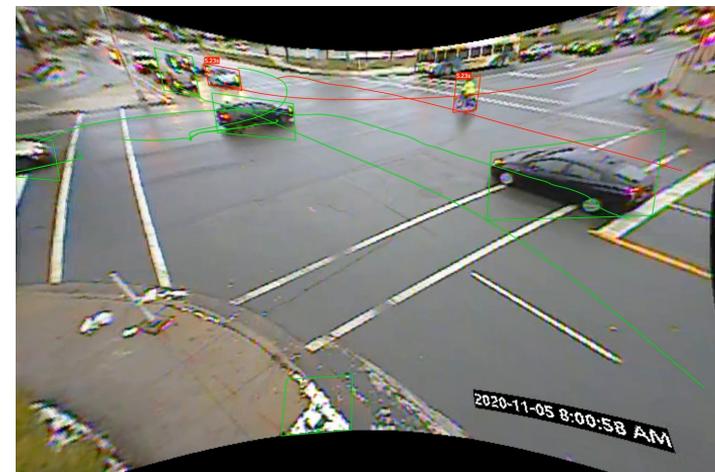
Cyclist East Left-Hook:  
T2 = 2.5s, vehicle speed: 20 km/h, cyclist speed: 18 km/h

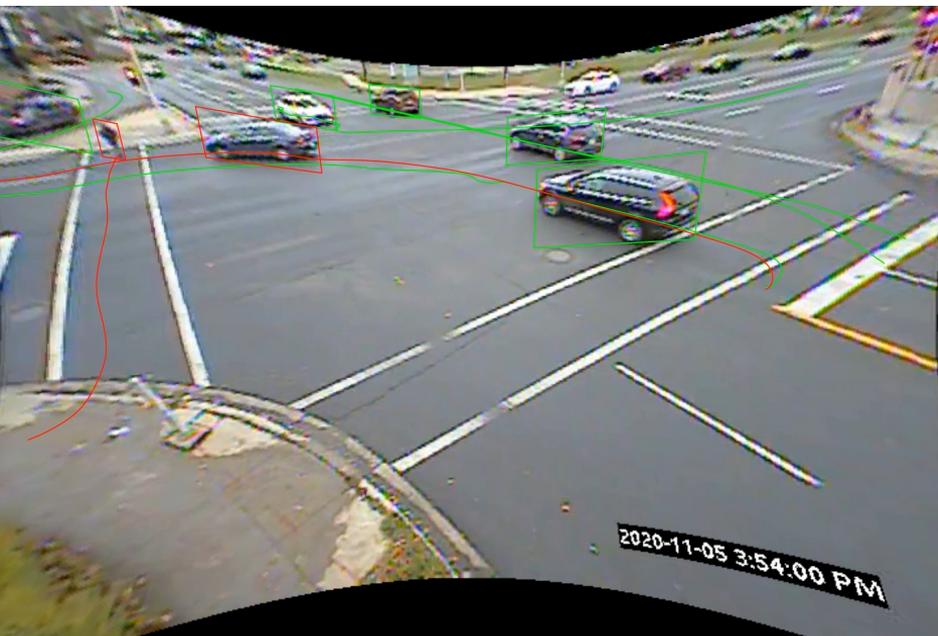
- On multiple occasions, the left turning driver did not notice the crossing pedestrian until they initiated their left turn movement. As vehicles yield to the right-of-way pedestrian, they become exposed to a potential conflict with oncoming through vehicles.

Pedestrian West Left-Hook:  $T_2 = 2.6s$ , vehicle speed 14 km/h

<p><b>Pedestrian Safety:</b></p> <ul style="list-style-type: none"><li>• Approximately 850 pedestrians crossed the intersection in a day (in November). The north crossing is most commonly used and has a long crossing length (~27m).</li><li>• The 3 pedestrian collision events and 7 conflict events occurred for a variety of right and left-hook configurations. Several conflict clips indicate that permissive left turning drivers did not initially observe pedestrians crossing with the right-of-way.</li><li>• General improvements to pedestrian visibility at the crossing would be valuable, especially considering potential desire lines between residential areas, commercial establishments and the multi-use path.</li></ul>	<ul style="list-style-type: none"><li>• Reduce turn radii on NE and NW quadrants. If possible, provide directional vs diagonal curb ramps.</li><li>• Provide left turn traffic calming through vertical post centerline extensions.</li><li>• Provide bike vs ped travel path delineation on NW and SW quadrants.</li><li>• LPIs or the above-mentioned protected lefts will reduce turning conflicts with peds.</li></ul>
