Quinpool Rd and Oxford St

MicroTraffic Video Diagnostic Findings and Recommendations

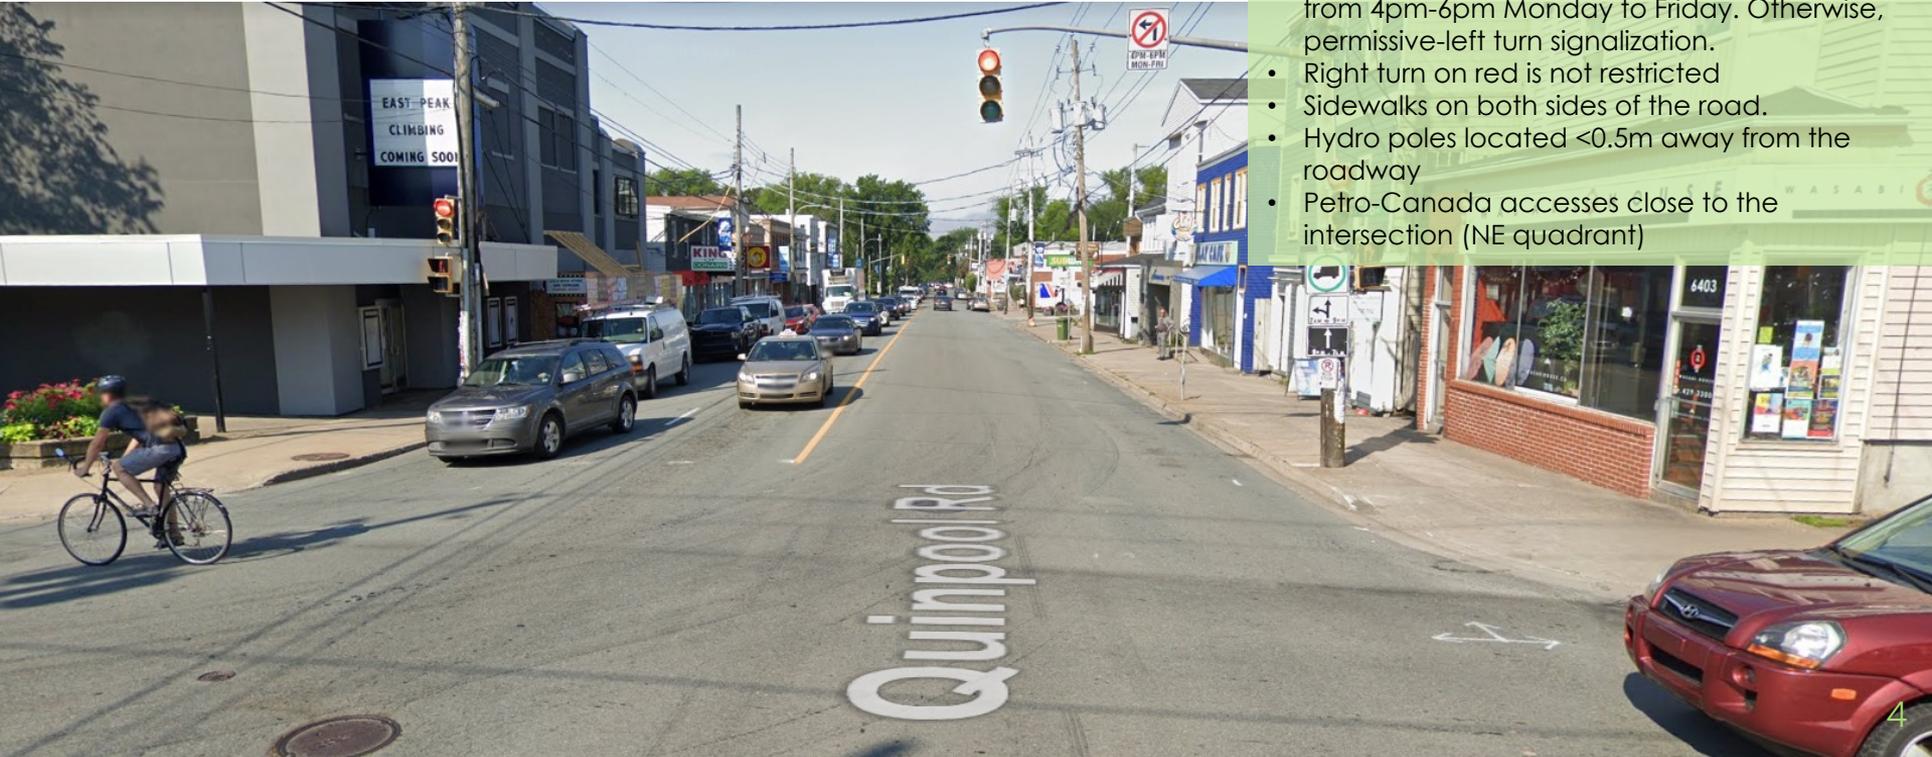
Quinpool Rd. Looking West

Quinpool Rd. Features:

- Two through lanes in each direction
- Far side bus stop westbound and eastbound
- 50 km/h posted speed limit (assumed)
- Three signal heads EB and WB with no reflective back plates. One signal head is cantilevered over the lane in each direction.
- Pedestrian countdown timers
- Eastbound/Westbound left turns not permitted from 4pm-6pm Monday to Friday. Otherwise, permissive-left turn signalization.
- Right turn on red is not restricted
- Sidewalks on both sides of the road.
- Hydro poles located <0.5m away from the roadway
- Petro-Canada accesses close to the intersection (NE quadrant)

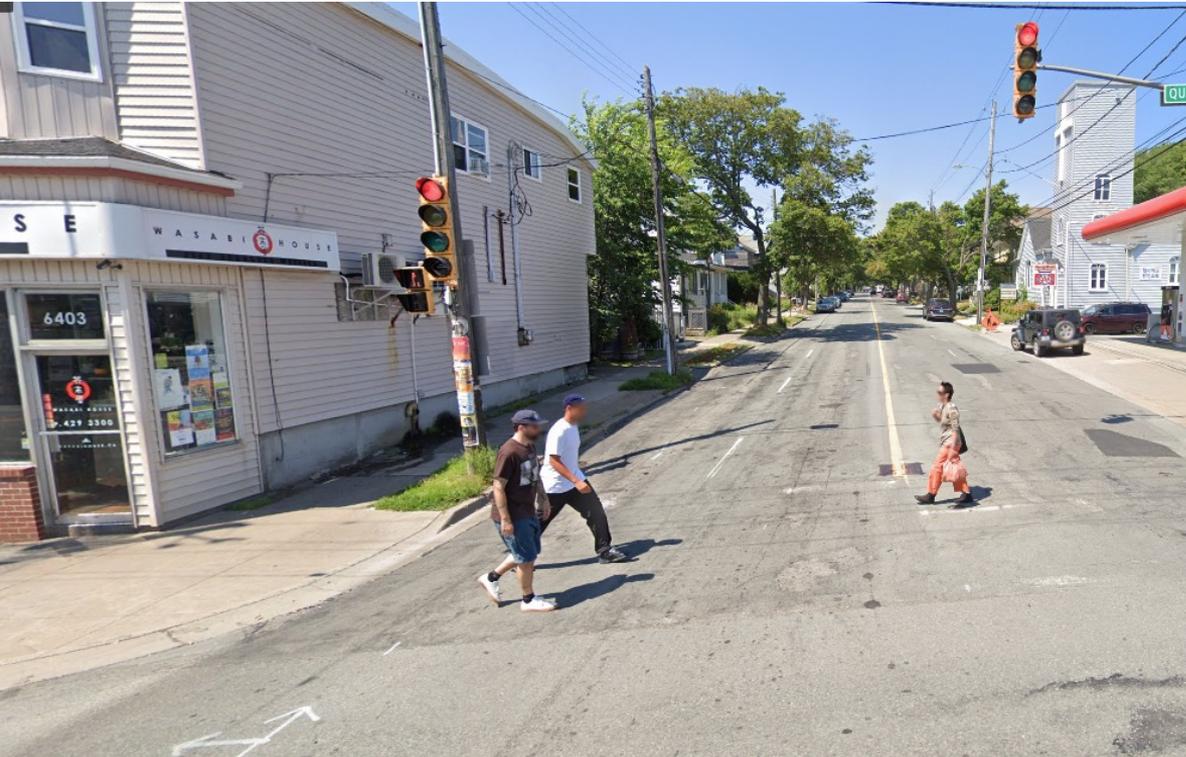
Oxford St. Looking North

Oxford St. Features:

- Two through lanes NB (transitions to one lane north of the intersection). Two approaching through lanes SB, but only one receiving lane (~6m in width). No lane designation signs (pavement markings may have been present but faded in Google Streetview).
- 50 km/h posted speed limit
- Pedestrian countdown timers
- Two signal heads each NB and SB (cantilevered over lane in NB direction only)
- No reflective back plates on signals
- Southbound left turns not permitted from 4pm-6pm Monday to Friday. Otherwise, permissive-left turn signalization.
- Protective/permissive left turn signalization for NBL
- Sidewalks on both sides of the road
- Hydro poles and trees located <0.5m away from the roadway
- Nearside transit stop NB and farside transit stop SB
- Right turn on red is not restricted
- Petro-Canada accesses close to the intersection (NE quadrant)

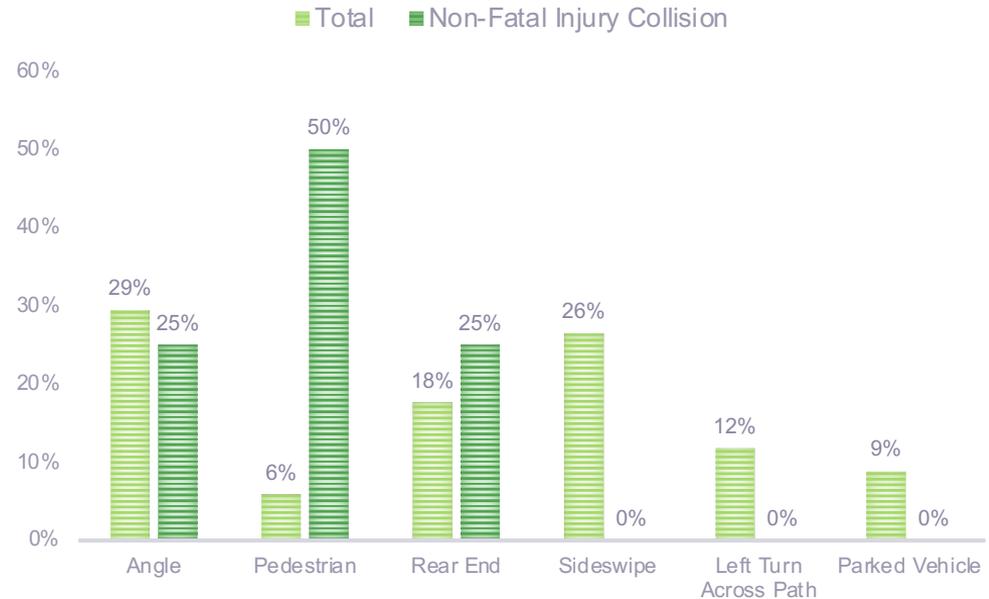
CONFIGURATION DISTRIBUTION OF COLLISIONS

- The provided collision data included 34 collision records from January 1, 2018 to April 12, 2021. Of the 34 records, 12% were classified as non-fatal injury collisions and 88% as property damage only collisions.
- The collisions were classified into the general descriptions shown in the adjacent figure based on the initial impact type and provided directional information.

- Pedestrian collisions represent 50% (2 events) of the non-fatal injury collisions. The pedestrian collisions involved a westbound-through vehicle (midblock crossing) and a northbound-through vehicle (nearside); both events list that the pedestrians were crossing without the right-of-way.
- Angle collisions represent 29% (10) of total collisions. Two angle events include vehicles turning left from the gas station access. Three of the through vs through angle impact events list that the westbound vehicle ran the red light.
- Rear End collisions represent 18% of total collisions and 25% of the non-fatal injury collisions. Of the known directions, the distribution was 20%, 20% and 60% for Eastbound, Westbound and Northbound respectively.

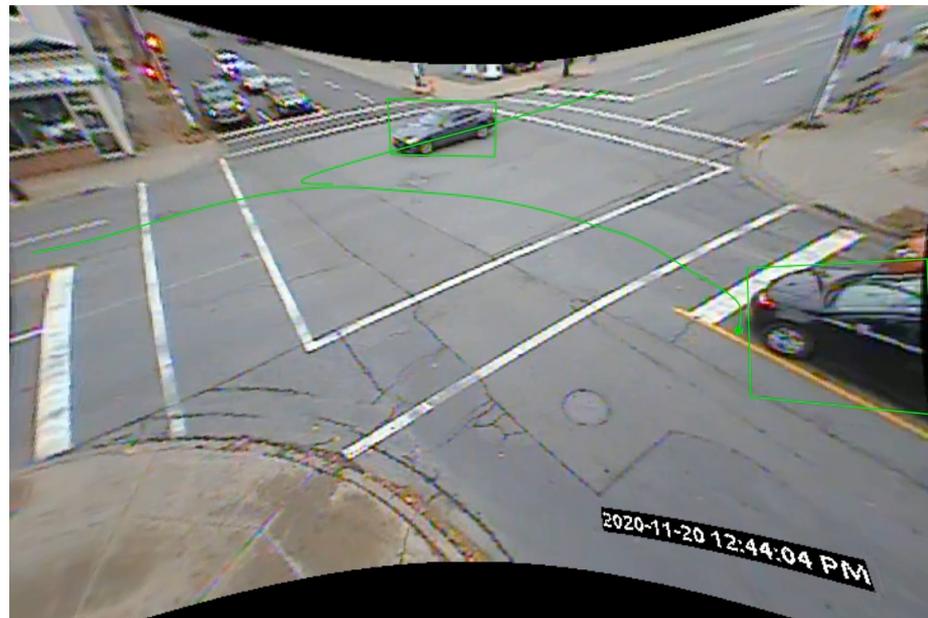
- 2 left-turning vs through from left conflicts were detected during the 57-hour analysis period (north-left vs east-through and south-left vs west-through).
- One through vs through right-angle conflict configuration was also detected (east-through vs north-through).
- These conflict types occurred at the end of a signal phase at relatively low through vehicle speeds.

East-through vs North-through: PET = 2.8s, vehicle speed 20 km/h
(low severity phase change clearance conflict)

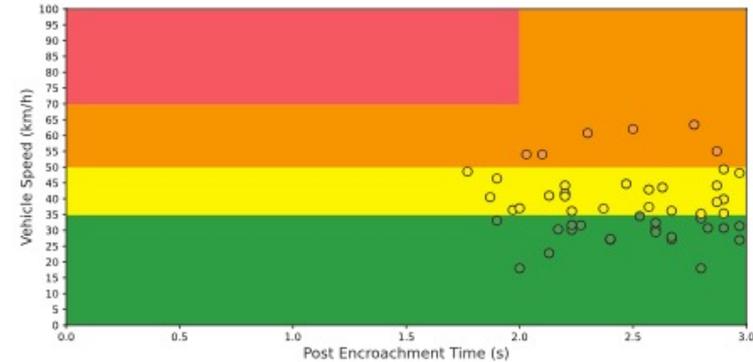
- Several left turn across path conflicts were detected during the 57-hour analysis period, as follows:
 - 90 North-Left vs South-Through conflicts
 - This movement is protected-permissive
 - 44 South-Left vs North-Through conflicts
 - 17 East-Left vs West-Through conflicts
 - 50 West-Left vs East-Through conflicts
- EBL, WBL and SBL turns are not permitted from 16:00 – 18:00 from Monday-Friday. Otherwise, these have permissive-only signalization.

West-left vs East-through conflict data shows several conflicts occurring with through vehicle speeds exceeding the 50 km/h posted speed limit (up to 65 km/h).

At impact speeds of 50 km/h, opposing drivers have a 40% chance of a severe injury (MAIS 3+), which increases to >75% at 65 km/h.

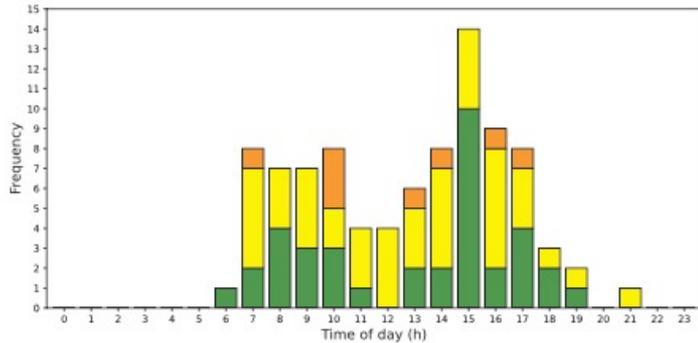
North-Left vs South-Through hourly temporal distribution

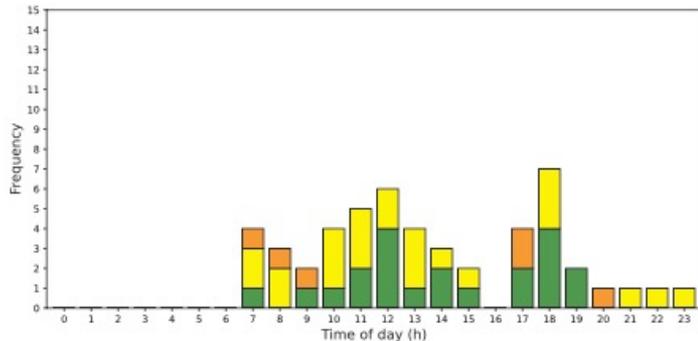
West-Left vs East-Through hourly temporal distribution

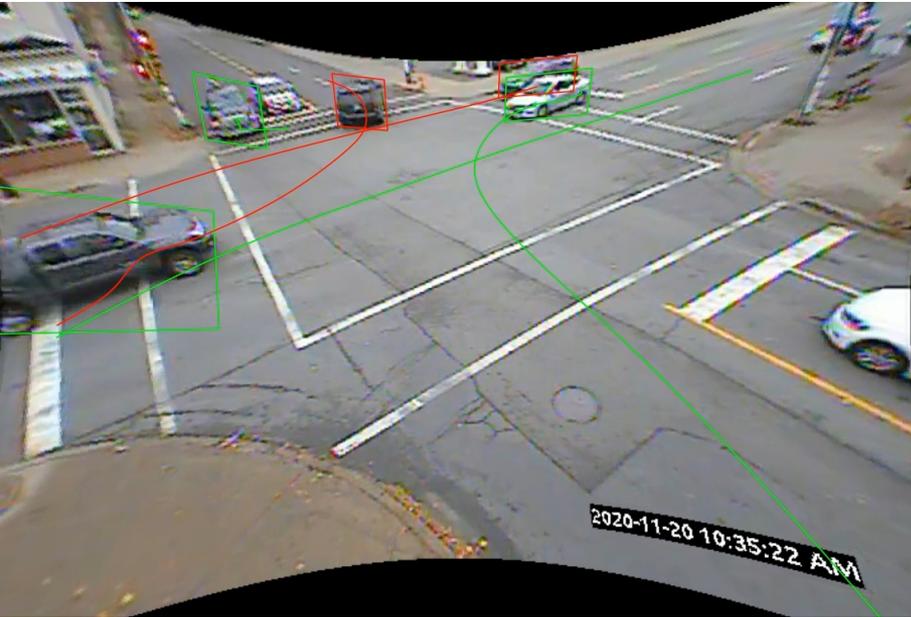
East-left vs West-through: PET = 1.8, vehicle speed 36 km/h

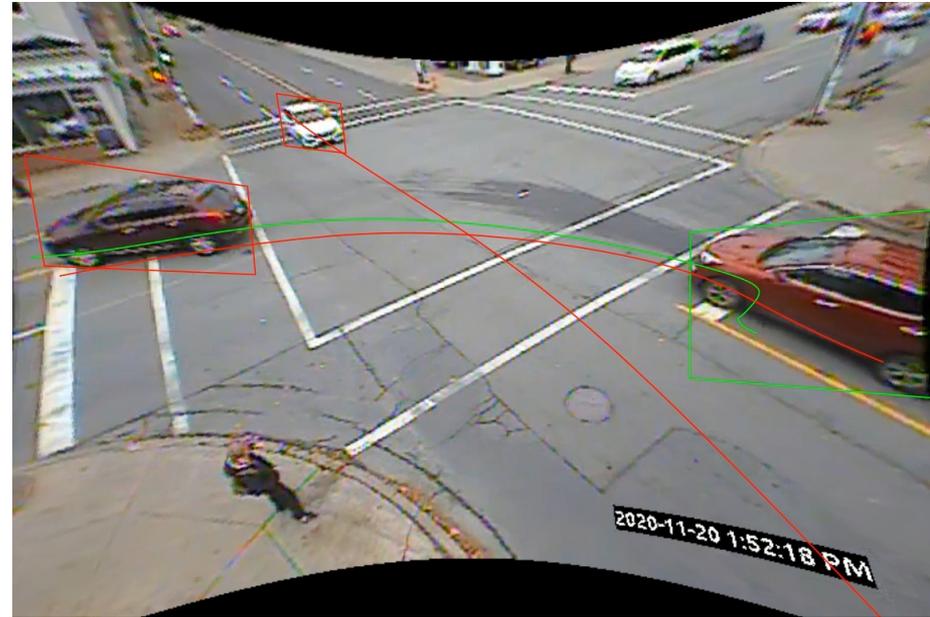
North-left vs South-through: PET = 2.5s, vehicle speed 52 km/h

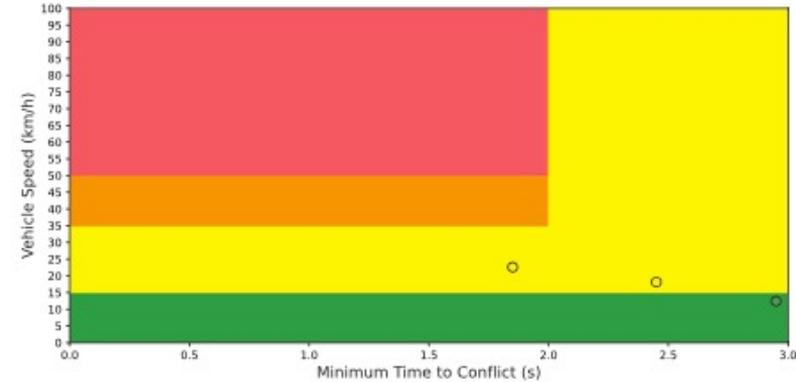
Pedestrian South-Left Hook conflict data shows conflicts occurring with through vehicle speeds of nearly 25 km/h. At impact speeds of 25km/h, pedestrians have a ~15% chance of a severe injury (MAIS 3+).

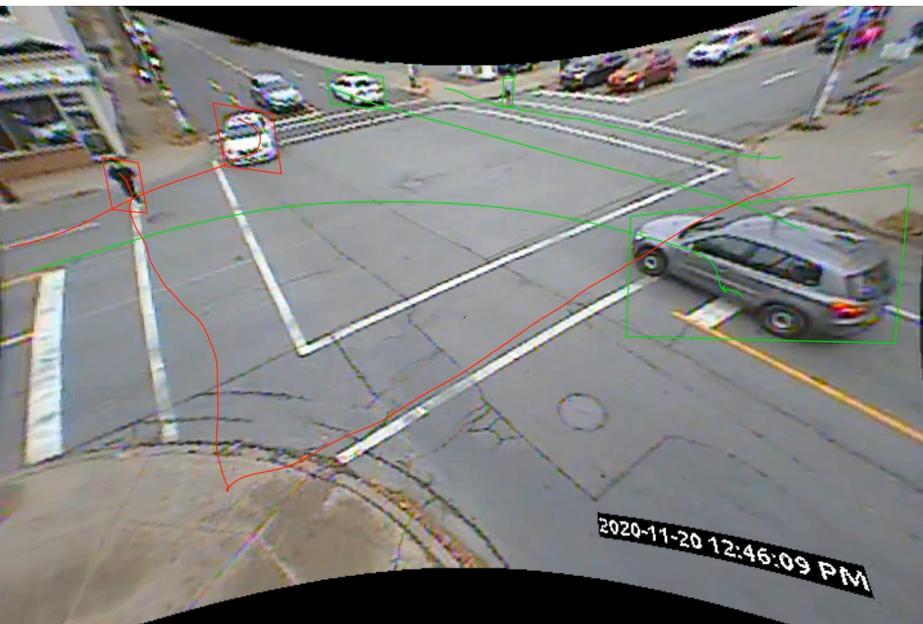
Pedestrian South-Right Hook: $T_2 = 1.8$, vehicle speed 14 km/h

The building on the NW quadrant is close to the corner of the intersection and may restrict the sightline between SB drivers and EB pedestrians. In this conflict event, the pedestrian emerged from behind the building just prior to stepping onto the roadway. This event may have been higher risk if the vehicle was moving faster and the driver was not paying close attention.

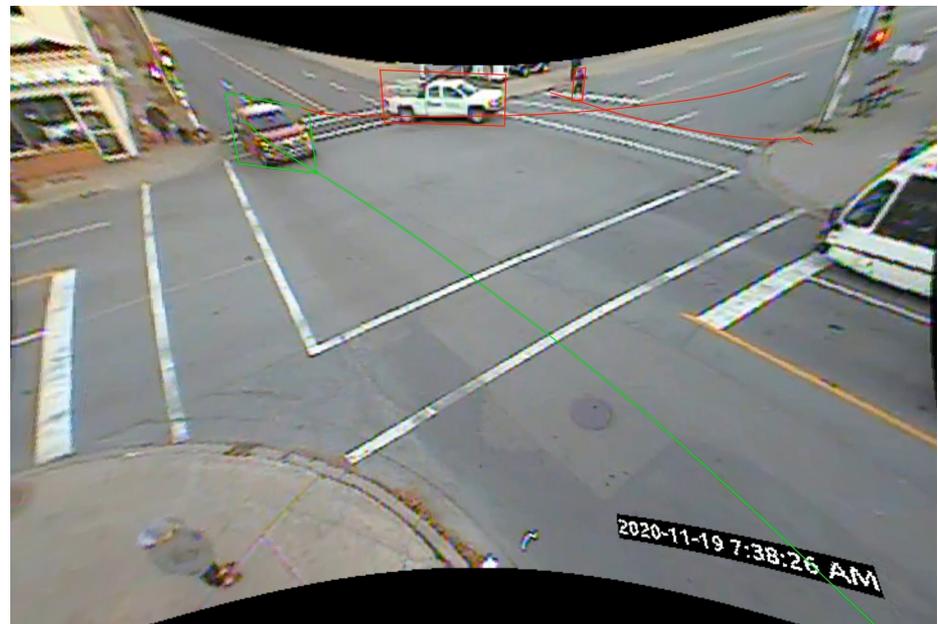
Pedestrian South-Left Hook: $T_2 = 1.9s$, vehicle speed 23 km/h

The SBL driver quickly initiated their permissive left turn to beat the transit bus, coming in close conflict with a pedestrian crossing with the right-of-way. This situation would benefit from a leading pedestrian interval (LPI).

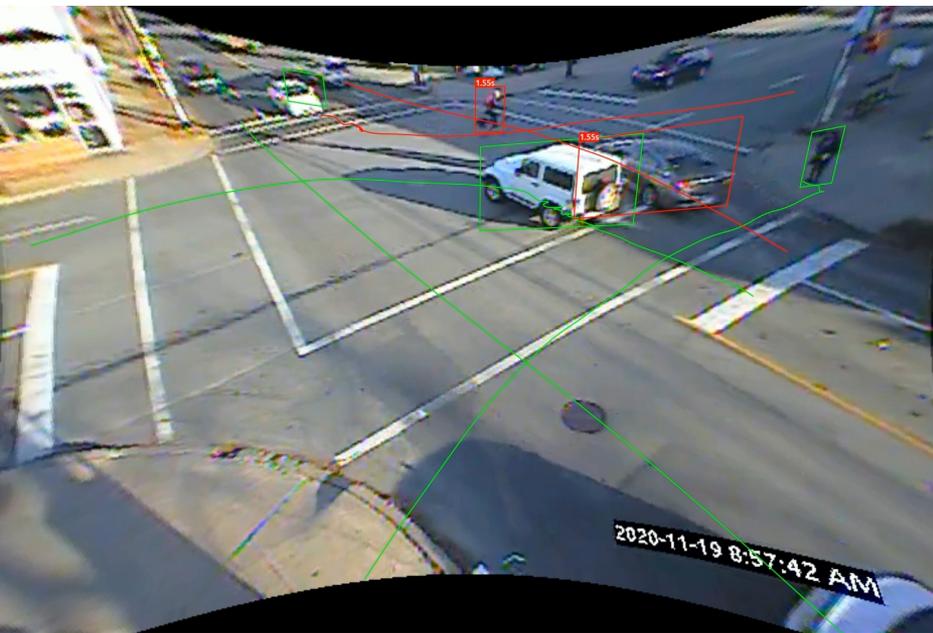
Cyclist Northbound Far-side: T2 = 1.6, vehicle speed 17 km/h

The cyclist maintained a dominant lane position to perform a SBL turn and came in close conflict with a vehicle maneuvering around the NBL vehicle. Due to the negative left turn offset, it is more difficult to detect oncoming road users.

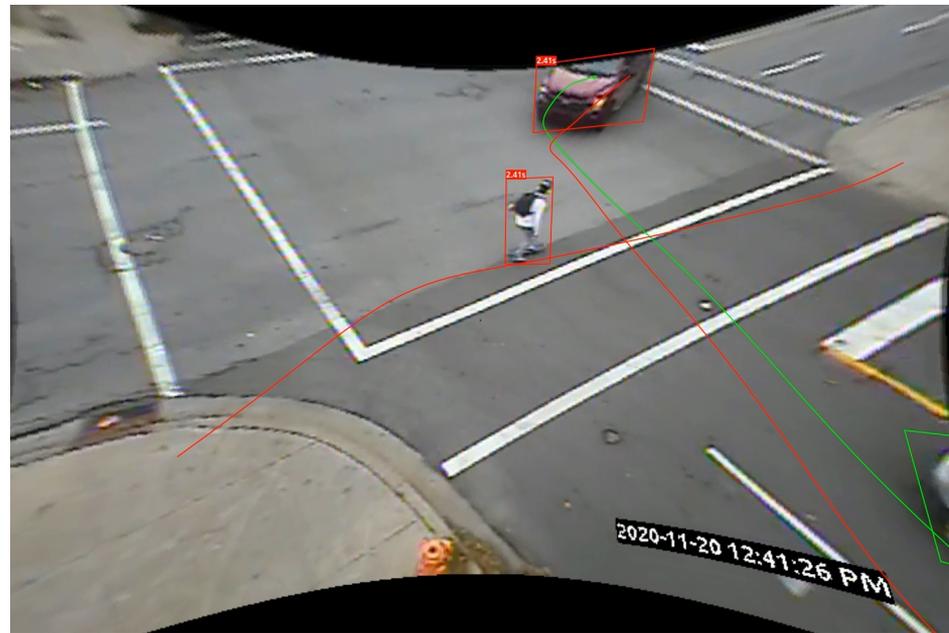
Pedestrian(Skateboarder) East-Left Hook:
T2 = 2.4s, vehicle speed 11 km/h

The EBL driver initiated the left-turn without checking for crossing pedestrians. The driver yielded to the skateboarder and waited in opposing travel lanes, coming in conflict with a westbound oncoming vehicle.

The diagonal curb ramp directed the skateboarder into the intersection.
