Portland St and Eisener Blvd

MicroTraffic Video Diagnostic Findings and Recommendations

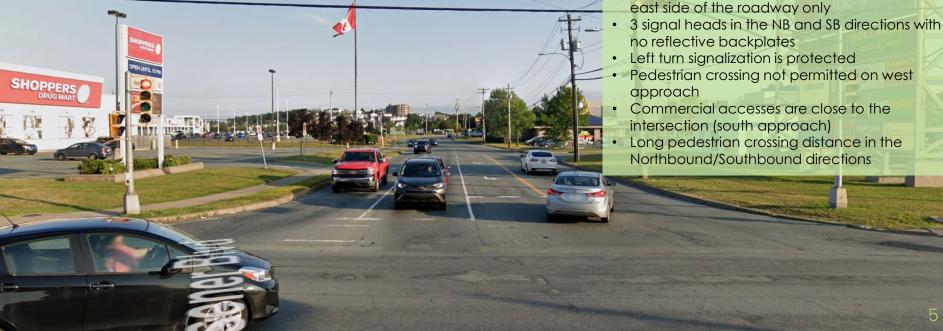
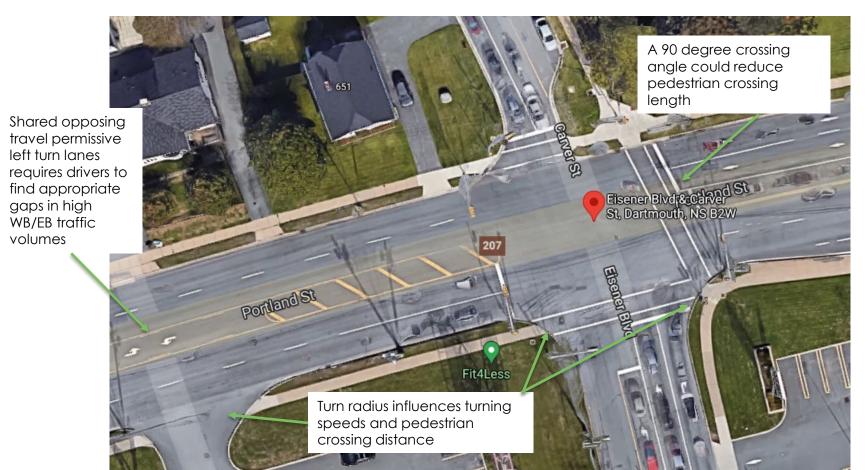
Eisener Blvd. Looking South

- Northbound: through movements are not permitted (one way southbound). Two left turn lanes and one right turn lane
- Southbound: One left turn lane and one shared through and right turn lane
- 50 km/h posted speed limit
- Turn radii of approximately 9 m (estimated from Google Earth) for SBR and NBR allow for moderately elevated right turn speeds.
- Sidewalk with boulevard separation is on the east side of the roadway only

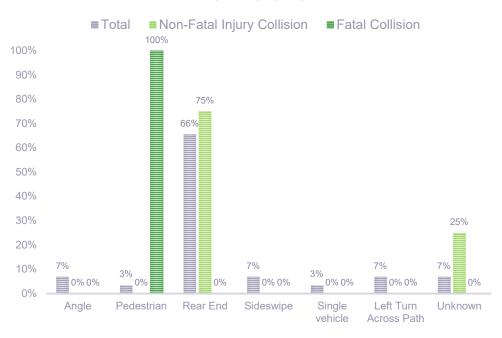
CONFIGURATION DISTRIBUTION OF COLLISIONS

- The provided collision data included 29 collision records from January 1, 2018 to April 12, 2021. Of the 29 records, 14% (4) were classified as non-fatal injury collisions, 3% (1) as a fatal collision, and 83% (24) as property damage only collisions.
- The collisions were classified into the general descriptions shown in the adjacent figure based on the initial impact type and provided directional information.

- The fatal collision involved a northbound-right vehicle and a pedestrian travelling from east to west on the south crossing (Eisener Blvd). The driver failed to yield to the pedestrian with the right-of-way.
- Rear End collisions represent 66% of total collisions and 75% of the non-fatal injury collisions. Of the known directions, the distribution was 60%, 13%, and 27% for Eastbound, Westbound and Northbound respectively.

Rear ends: The primary collision type was Rear End collisions (66% of total and 75% of non-fatal injury collisions). These were primarily in the Eastbound and Westbound directions. High EB/WB speeds and traffic queues are likely contributors to these collision trends. 	 Corridor level speed management strategy for Portland. High friction surface treatments may be considered on a systemic basis for HRM where rear-end crashes are elevated.

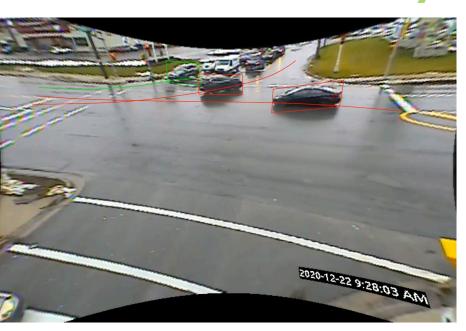
West-left vs East-through data shows a high frequency of detected conflicts over a 50-hour period.

Several conflicts occurred with through vehicle speeds exceeding the 50 km/h posted speed limit (up to 75 km/h).

At impact speeds of 50 km/h, opposing drivers have a 40% chance of a severe injury (MAIS 3+), which increases to >90% at 75 km/h.

West-Left vs East-Through: PET= 1.6s, vehicle speed 56 km/h

Key Issue	Recommendation
 Left Turn Across Path: A high volume of vehicles use Portland (>13,000 veh/day in each direction) Frequent high-risk conflicts were detected for WBL vs EBT. These events show the high speed of oncoming EB drivers and the potential difficulty in finding appropriate gaps in traffic to complete permissive WBL turns. This high level of driver workload and focus on gap acceptance may result in drivers neglecting to check for VRUs using the south crossing prior to initiating their left turn. Frequent uncontrolled commercial accesses along Portland present the same exposure to LTAP collisions. Several low-risk NBL vs SBT conflicts were observed at the end of the protected NB left turn phase. In most cases these were due to queues of WB vehicles preventing left-turning vehicles from clearing the intersection. It is unknown what the cause of congestion is and how far the WB congestion extends along Portland. 	Convert WBL to protected only or extend protected portion of protected permissive phase. Consider corridor level strategies for access management that limit uncontrolled cross median movements Check and potentially extend all red clearance interval for NBL and SBT.

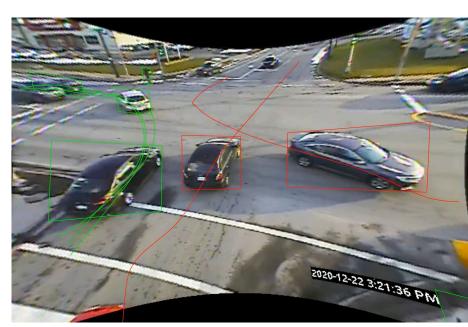
North-Left vs South-Through: PET= 2.8s, vehicle speed 20 km/h

Multiple NBL vs SBT conflict clips show a queue of WB vehicles that prevent the NBL vehicles from clearing the intersection during the protected left turn phase.

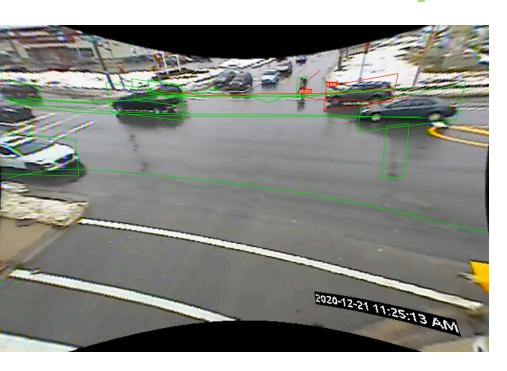
Pedestrian East-Right Hook conflict data show conflicts occurring with through vehicle speeds of nearly 20km/h.

At impact speeds of 20 km/h, pedestrians have a ~10% chance of a severe injury (MAIS 3+).

Due to high right turn radius, vehicles can complete turns at higher speeds, exposing crossing vulnerable road users to increased risk when crossing

Key Issue	Recommendation
 Pedestrian safety: The fatal collision involved a northbound-right vehicle and a pedestrian. 5 east-right hook conflicts were detected during the 50-hour analysis period. Pedestrians are exposed to longer crossing distances due to skewed crossings. The right turn influence vehicle turning speed and risk level to pedestrian in a collision. General improvements to pedestrian safety and visibility would be valuable at this location given its collision history and the desire lines from residential homes north of the intersection to access commercial establishments south of the intersection. 	 Curb radius reductions No right turn on red (to go with radius reduction especially if this pushes turn into 2nd receiving lane) Zebra markings Tactile surfaces on directional curb cuts 90 degree crossing alignments Leading pedestrian intervals
 Speeds: 93 high-risk conflicts (impact vehicle speed >50 km/h) were detected during the 50-hour analysis period. The open cross section and arterial environment along Portland may contribute to high-speed trends. 	Speed moderation techniques should be considered along this corridor (corridor-level speed management strategy), especially given the surrounding land use (residential driveway accesses, etc.).
