Portland St and Pleasant St

MicroTraffic Video Diagnostic Findings and Recommendations

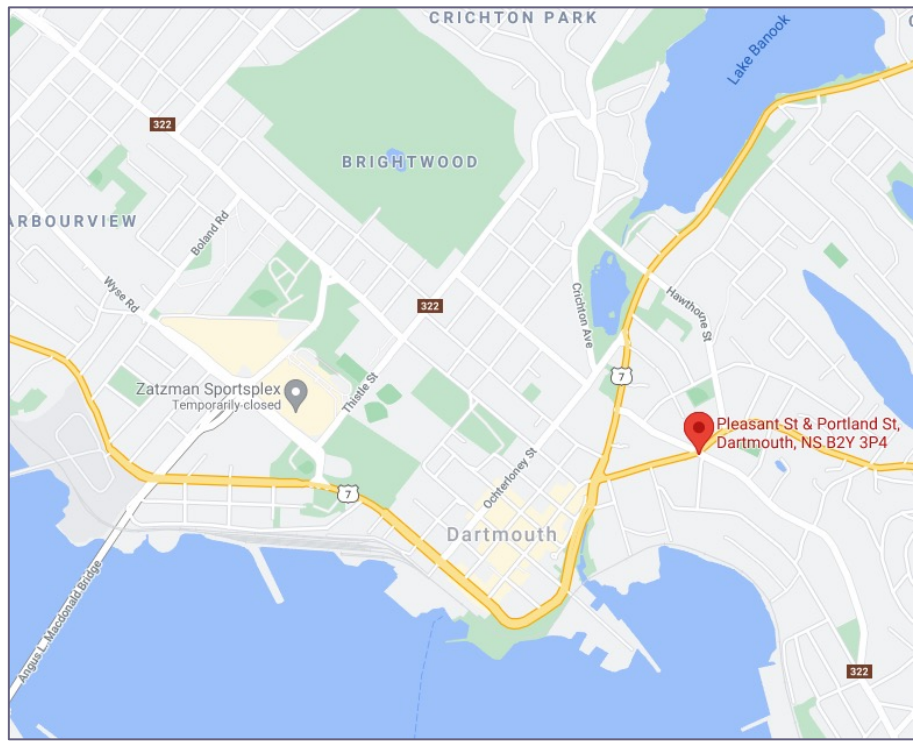
Portland St. Looking North

- Southbound: One through lane and a left turn auxiliary lane
- Northbound: One through lane and a right turn auxiliary lane
- 50 km/h posted speed limit (assumed)
- Northbound left turn not permitted
- Southbound left permissive only
- Four signal heads NB and SB (one nearside each)
- Right turn on red is not restricted
- No reflective back plates on signals
- Sidewalks on both sides of the road with boulevard separation
- Skewed intersection and large right turn radii exposes VRUs to vehicles turning at higher speeds
- Hydro poles and trees located <0.5m away from the roadway
- Several driveway accesses close to the intersection

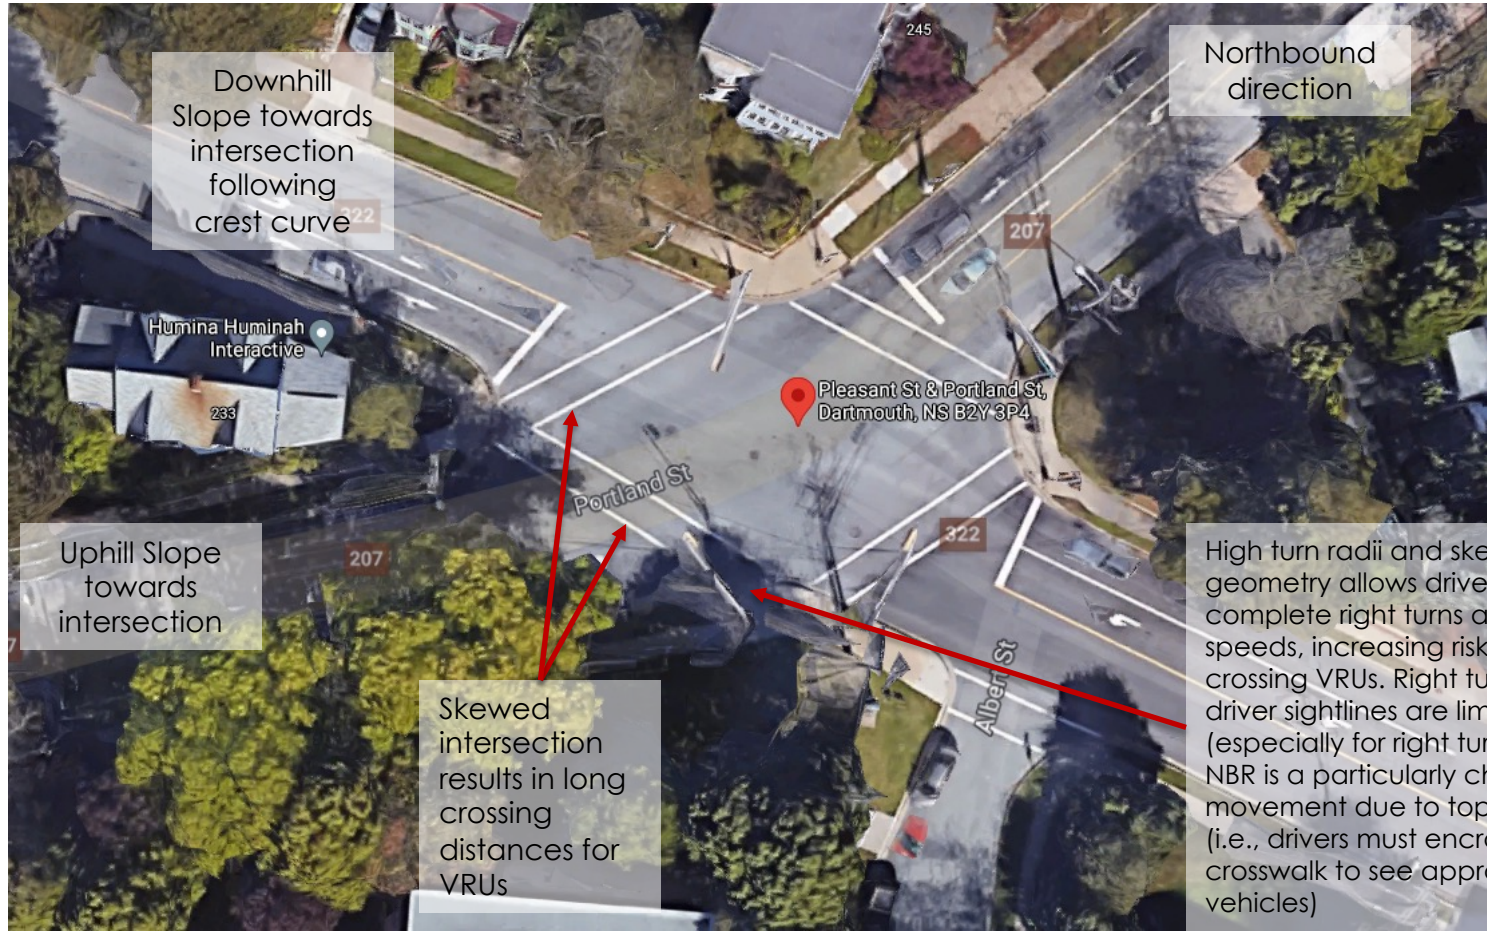
Pleasant St. Looking East

- One through lane and a left turn auxiliary lane
- 50 km/h posted speed limit
- Eastbound and westbound left turn signalization protected/permissive
- Two signal heads EB and three signal heads WB (one nearside)
- Right turn on red is not restricted
- No reflective back plates on signals
- Sidewalks on both sides of the road with boulevard separation
- Hydro poles and trees located <0.5m away from the roadway
- Several driveway accesses close to the intersection

<p>Angle collisions:</p> <ul style="list-style-type: none">• Two angle collisions were recorded in the collision data, both included a westbound vehicle running a red light.• Signal perception improvements would be valuable, especially in the EB/WB directions when sun glare may contribute to signal perception failure.	<p>Add reflective backplates to signals.</p>
