10 Kirk Road Heritage Impact Statement

Heritage Impact Statement
Re Finntigh Mara/Mathers Estate
10 Kirk Road, Halifax, Nova Scotia, B3P 1A6
Aug 31 2022

Prepared by
MacKay-Lyons Sweetapple Architects
2188 Gottingen Street, Halifax, NS, B3K 3B4
902 429 1867
mlsarchitects.ca

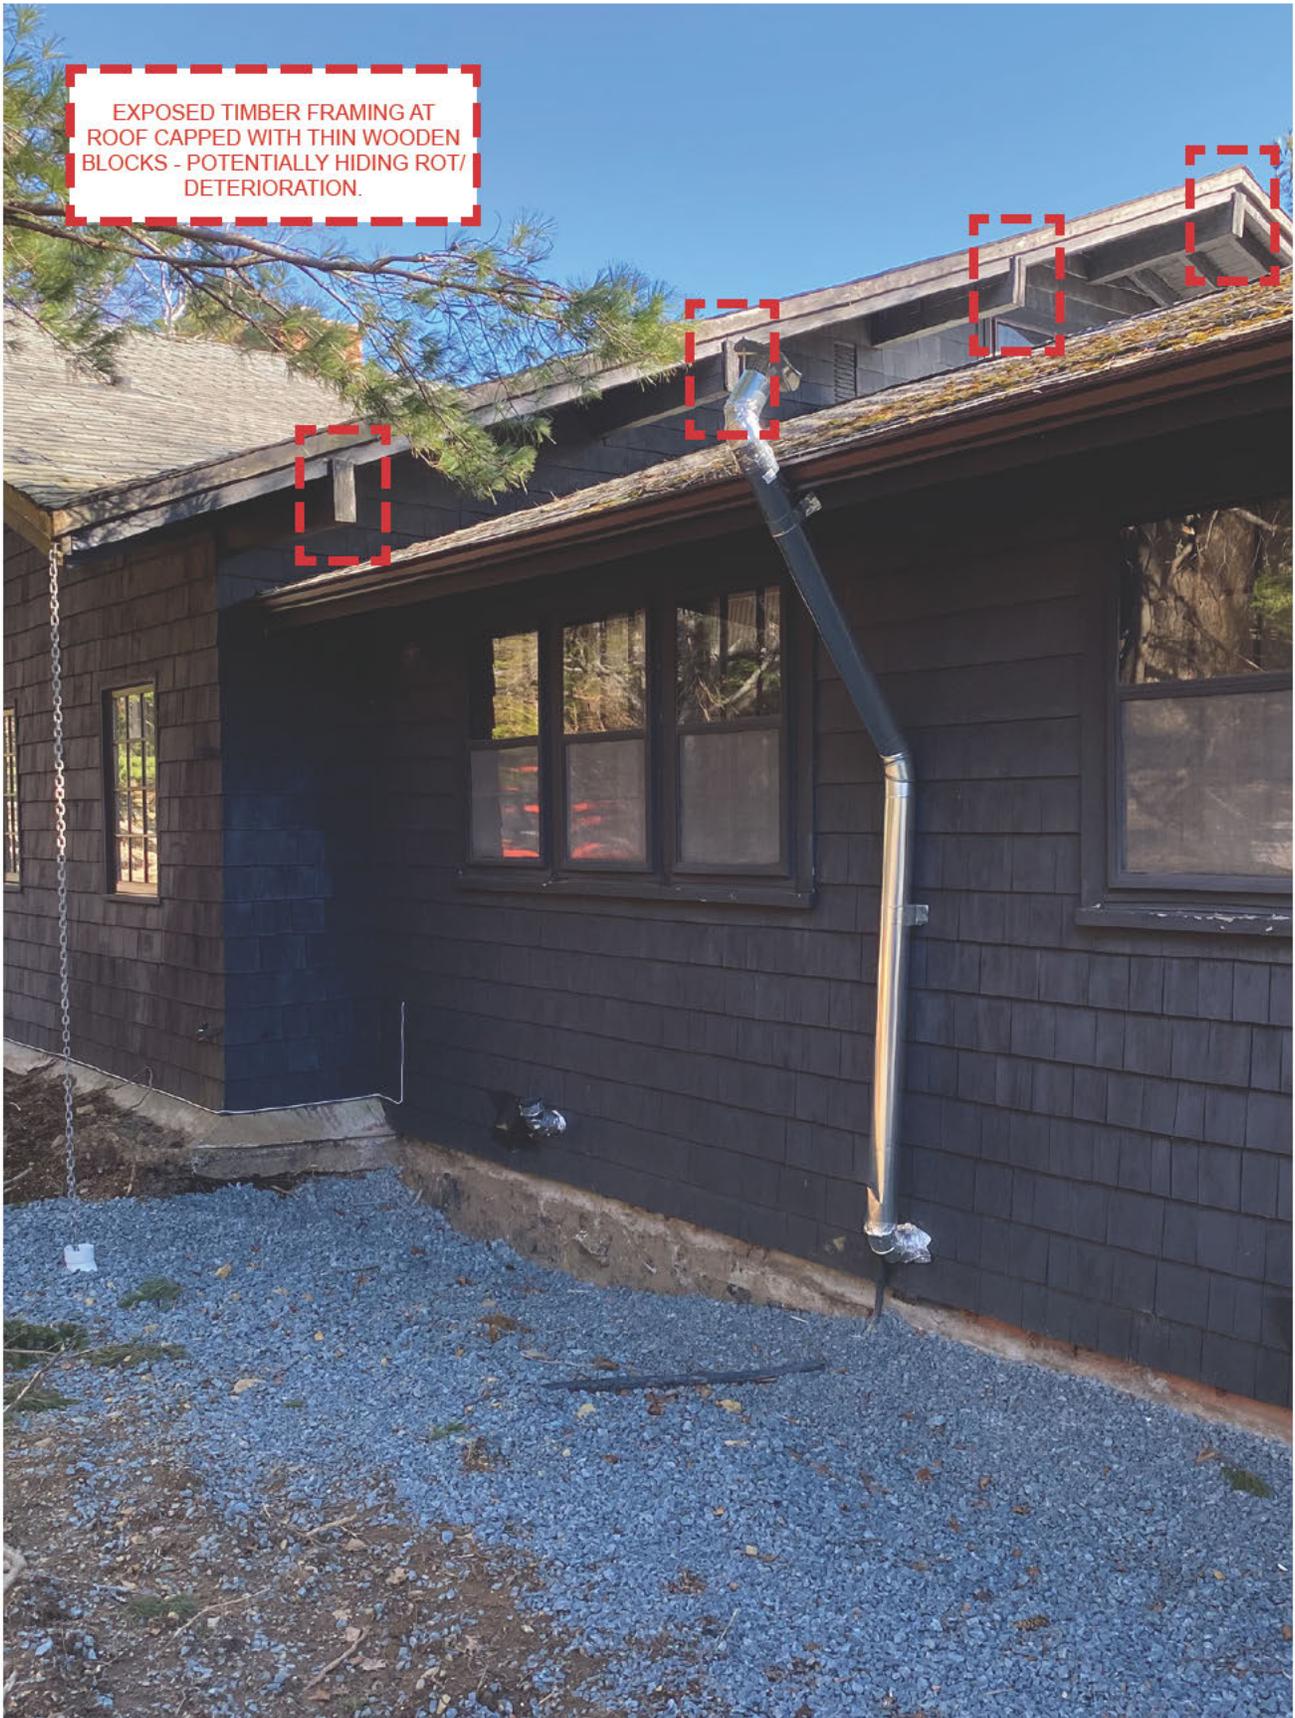
2.1 INTERSECTION OF ANNEX & MAIN HOUSE (SOUTH SIDE).

Additionally, the exposed timber framing members projecting out from the building on the north and south sides were found to be capped (at the ends) with thin wooden blocks, potentially hiding rot or deterioration (refer to AFRR image 2.1).

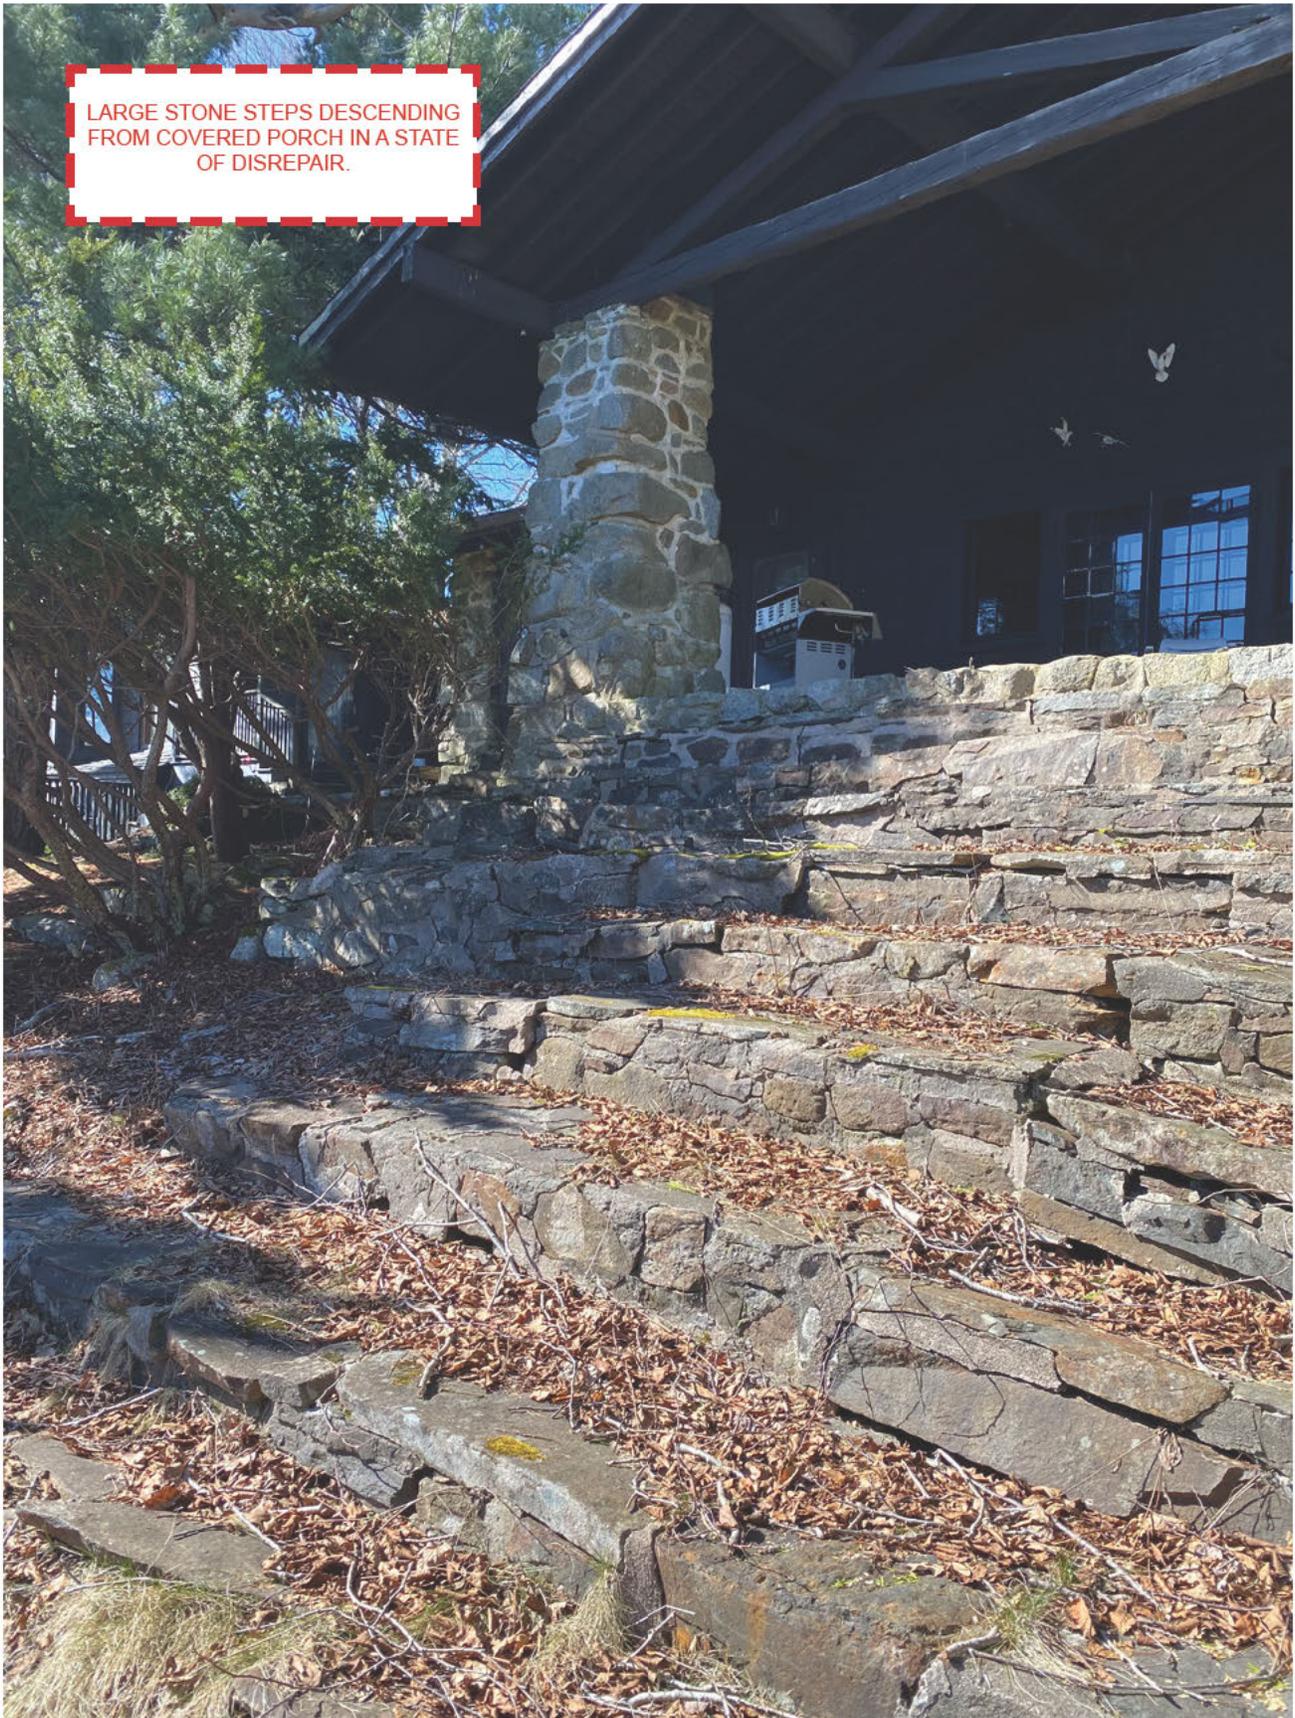
2.3 LARGE STONE STEPS AT COVERED PORCH (EAST SIDE).

The large stone steps (full width between columns) descending from the covered porch (east side), appear in poor condition. The stones (treads and risers) are uneven with cracked mortar - likely caused by frost heave (refer to AFRR image 2.3). The stones appear fully intact and likely could be reset and repaired. The small stone steps descending from the covered porch (north side) also appear in poor condition (refer to AFRR image 2.10). Again, the stones appear fully intact and likely could be reset and repaired.

LARGE STONE STEPS DESCENDING FROM COVERED PORCH IN A STATE OF DISREPAIR.

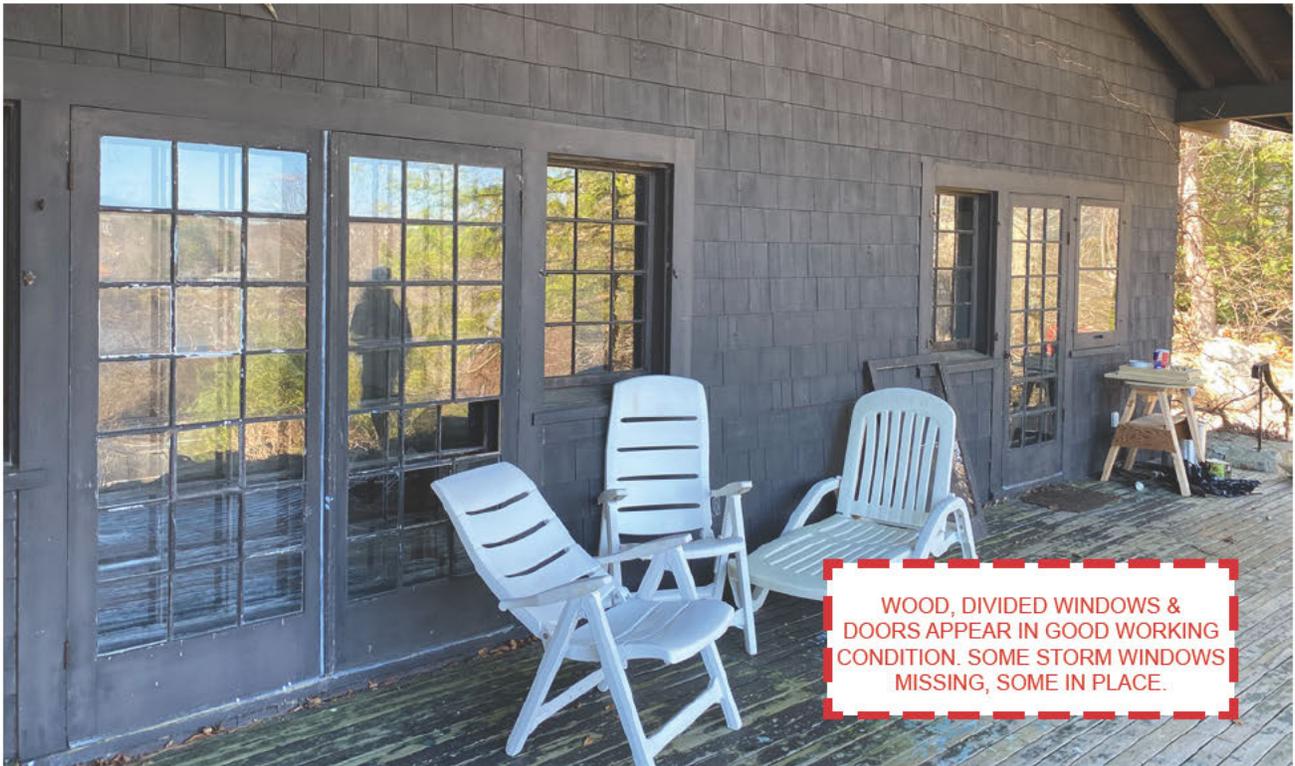
2.5 EXTERIOR WINDOWS & DOORS AT COVERED PORCH (EAST SIDE).

The exterior wood windows and doors (true divided, six over six windows and true divided, 21 pane doors) found at the covered porch appear largely intact and in good condition (refer to AFRR images 2.5 and 2.6). These windows and doors should be further examined to determine the extent of maintenance and repair work required. Some storm windows are missing, and some muntins and panes are missing. Sills, jambs, and casings should also be further examined for any maintenance and repair work required.

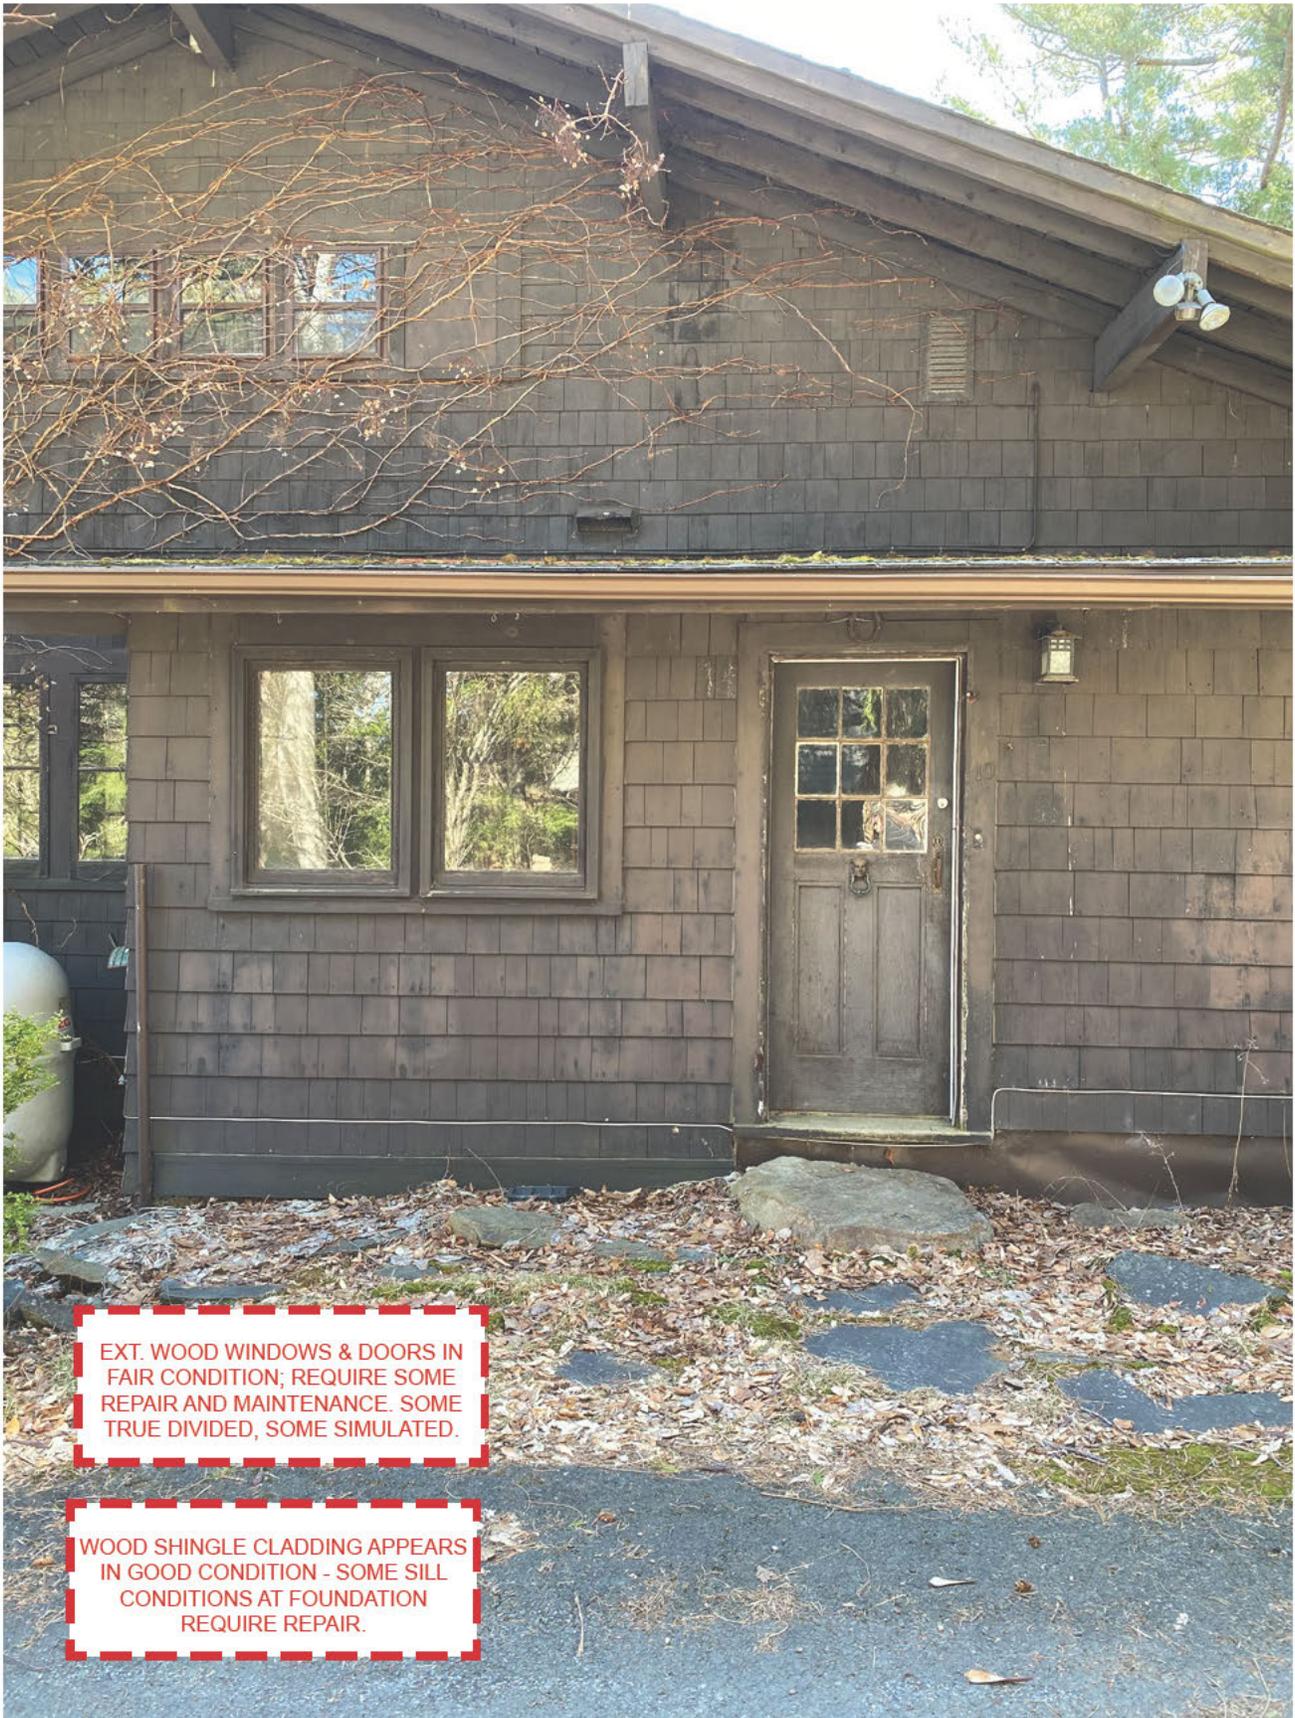
2.9 EXTERIOR WALL AT NORTH SIDE.

EXT. WOOD WINDOWS & DOORS IN FAIR CONDITION; REQUIRE SOME REPAIR AND MAINTENANCE. SOME TRUE DIVIDED, SOME SIMULATED.

WOOD SHINGLE CLADDING APPEARS IN GOOD CONDITION - SOME SILL CONDITIONS AT FOUNDATION REQUIRE REPAIR.

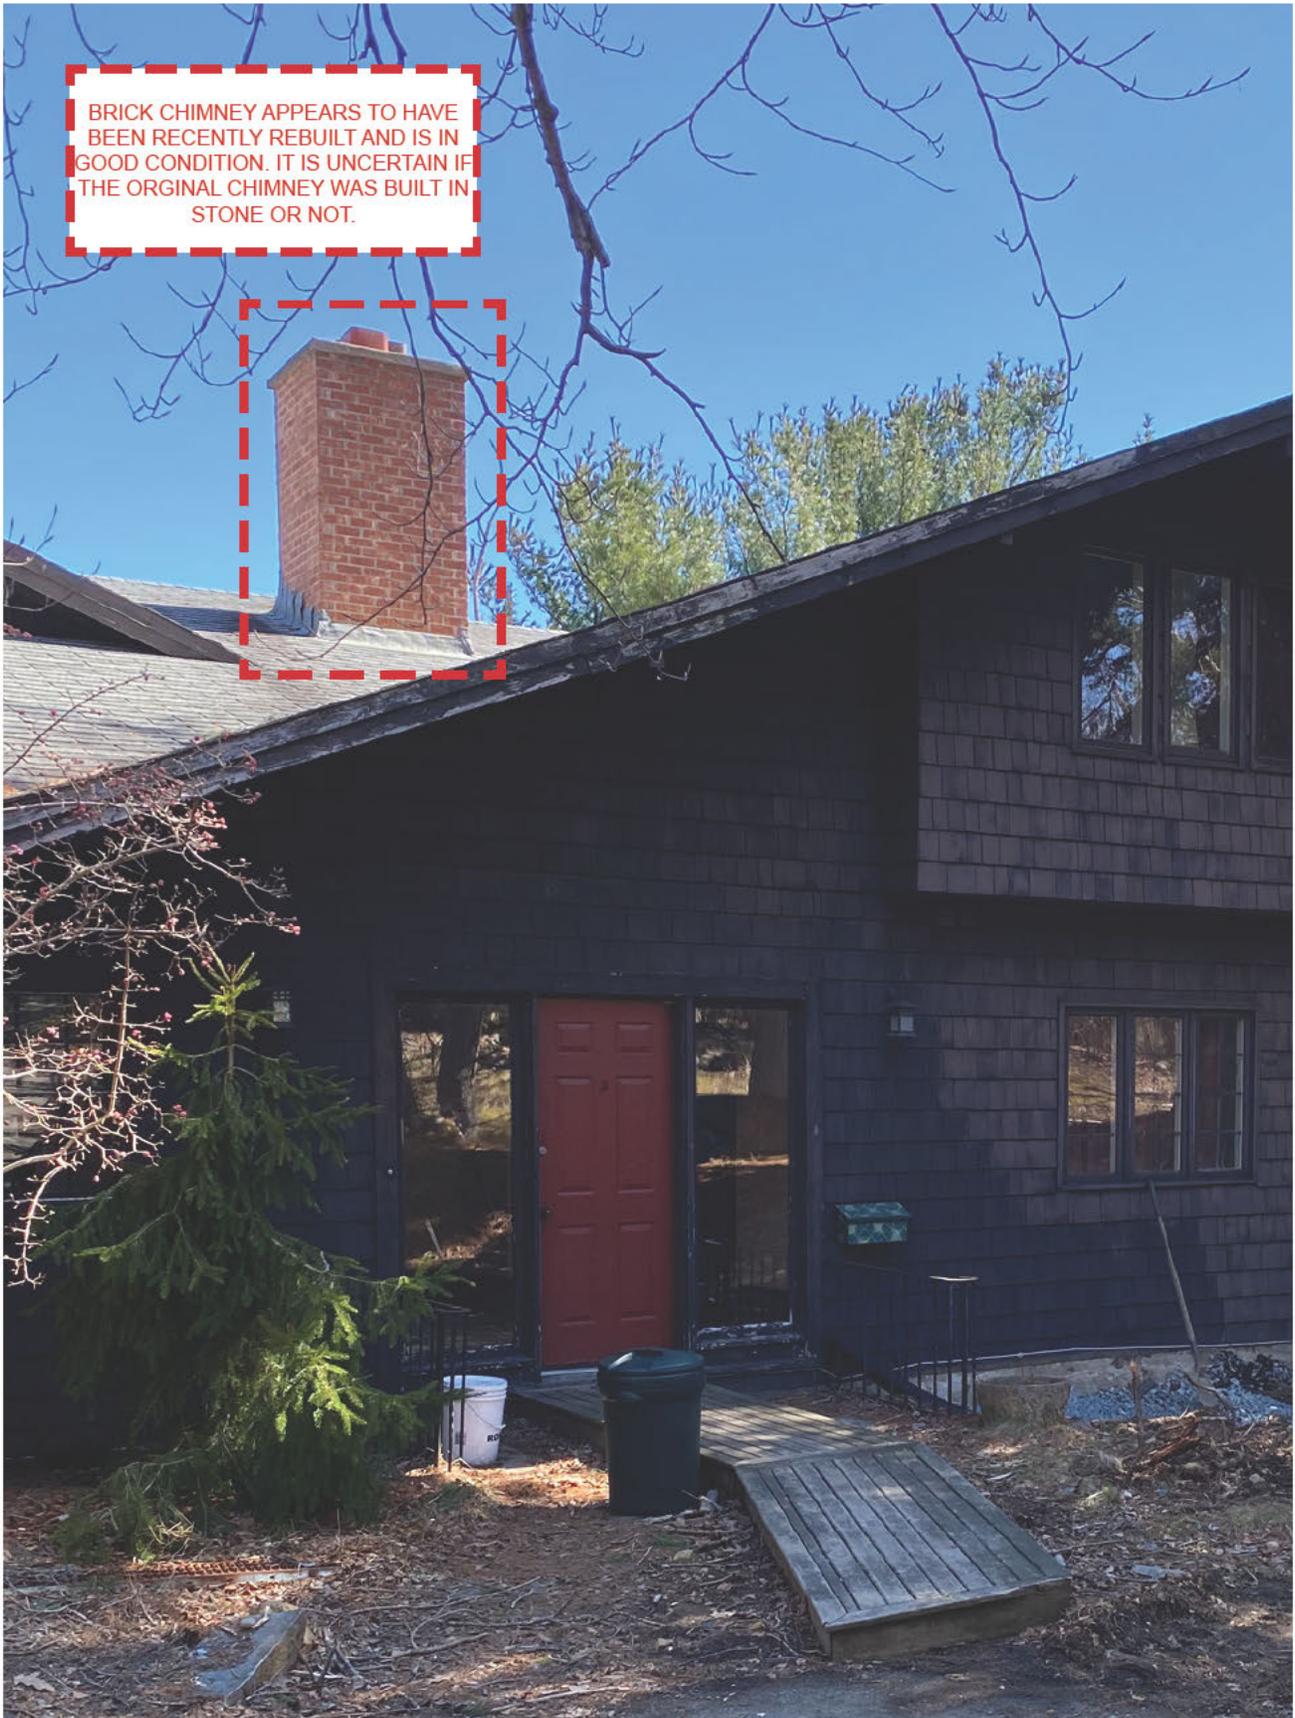
2.11 MAIN ENTRY AT WEST SIDE.

Some simulated divided wood windows were observed on the west side of the house, main and upper floors (refer to AFRR image 2.12). The layout and arrangement of these windows differs from the original drawings by Brown (refer to West Elevation sheet No 2). The main entry door and sidelites are not original to the house (refer to AFRR image 2.11).

BRICK CHIMNEY APPEARS TO HAVE BEEN RECENTLY REBUILT AND IS IN GOOD CONDITION. IT IS UNCERTAIN IF THE ORIGINAL CHIMNEY WAS BUILT IN STONE OR NOT.

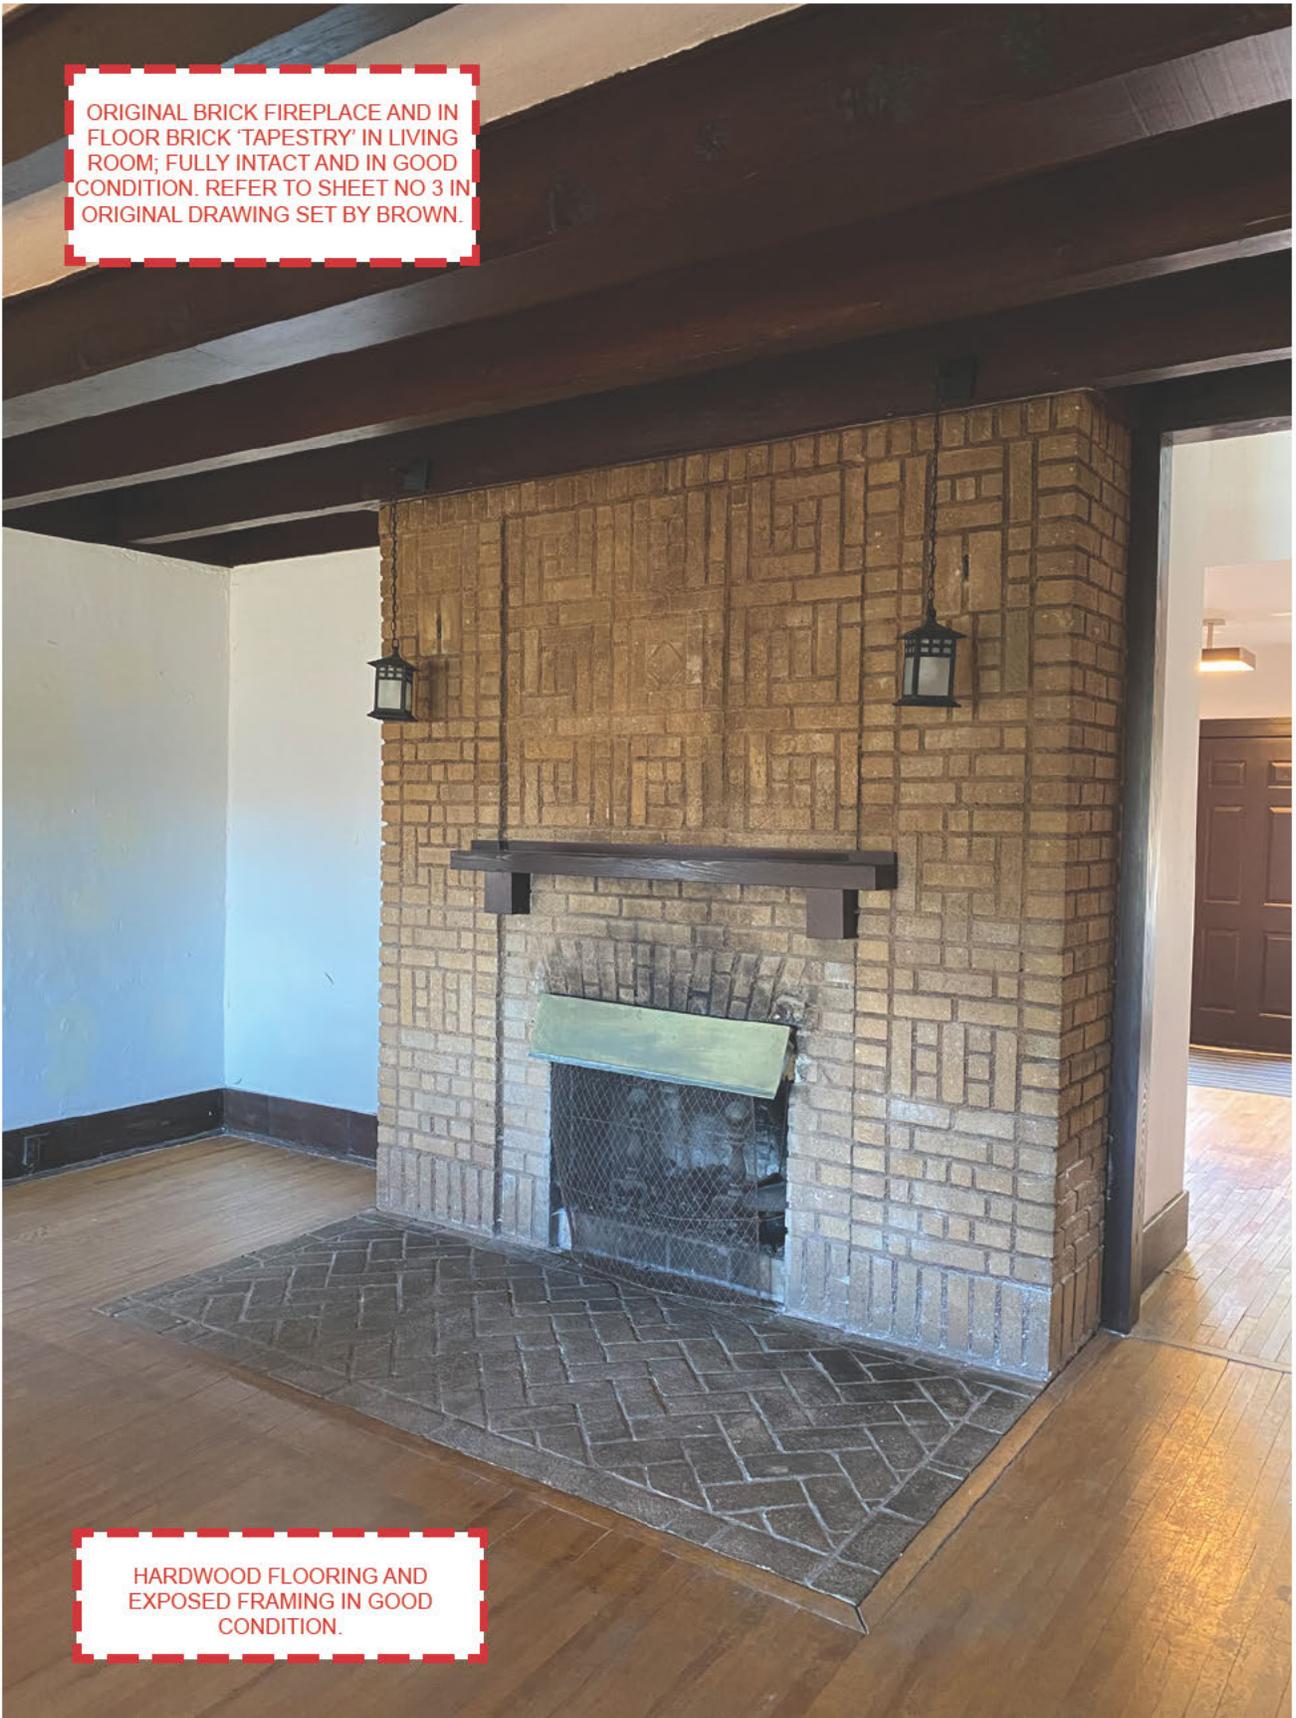
2.14 MAIN FLOOR LIVING AREA.

HARDWOOD FLOORING AND EXPOSED FRAMING IN GOOD CONDITION.

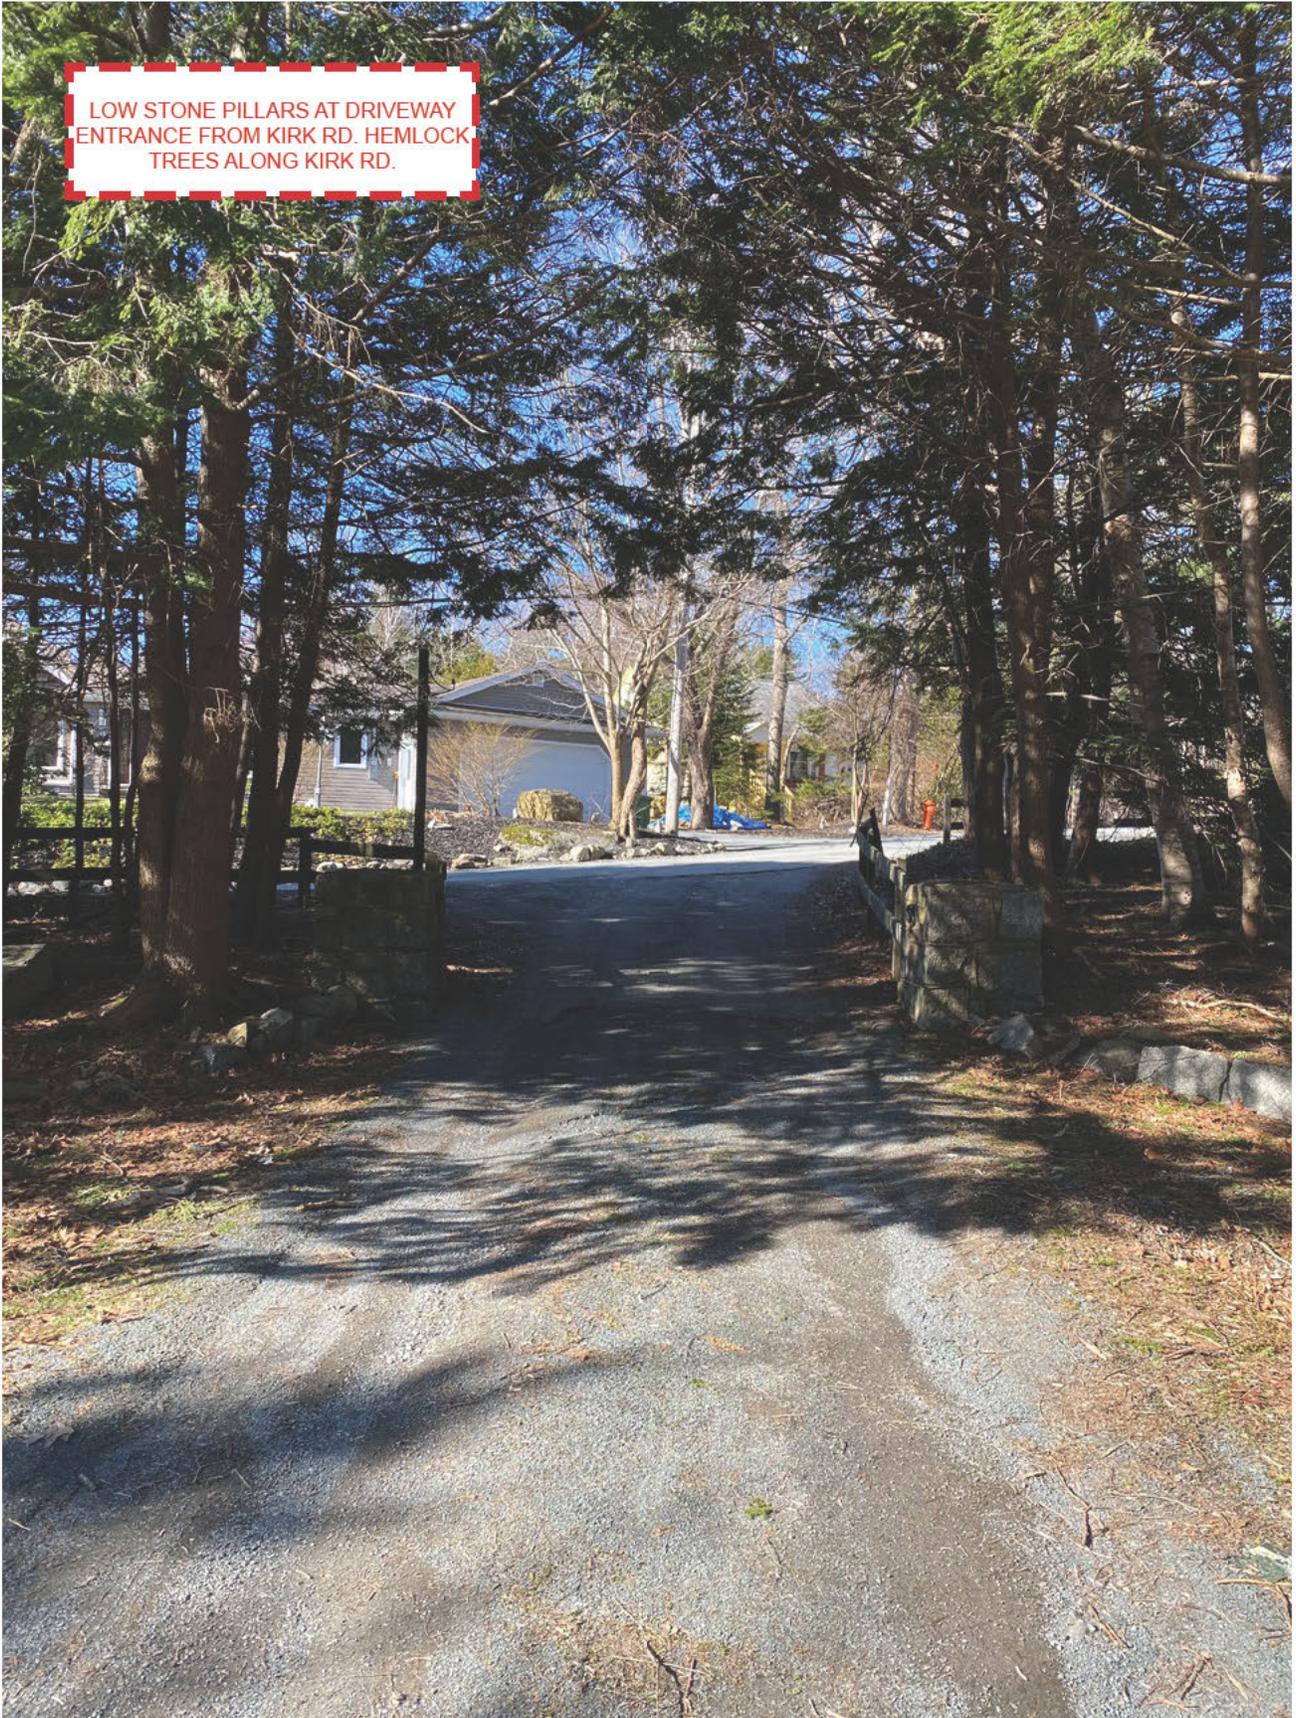
2.24 DRIVEWAY ENTRANCE OFF KIRK RD (WEST VIEW).

LOW STONE PILLARS AT DRIVEWAY
ENTRANCE FROM KIRK RD. HEMLOCK
TREES ALONG KIRK RD.

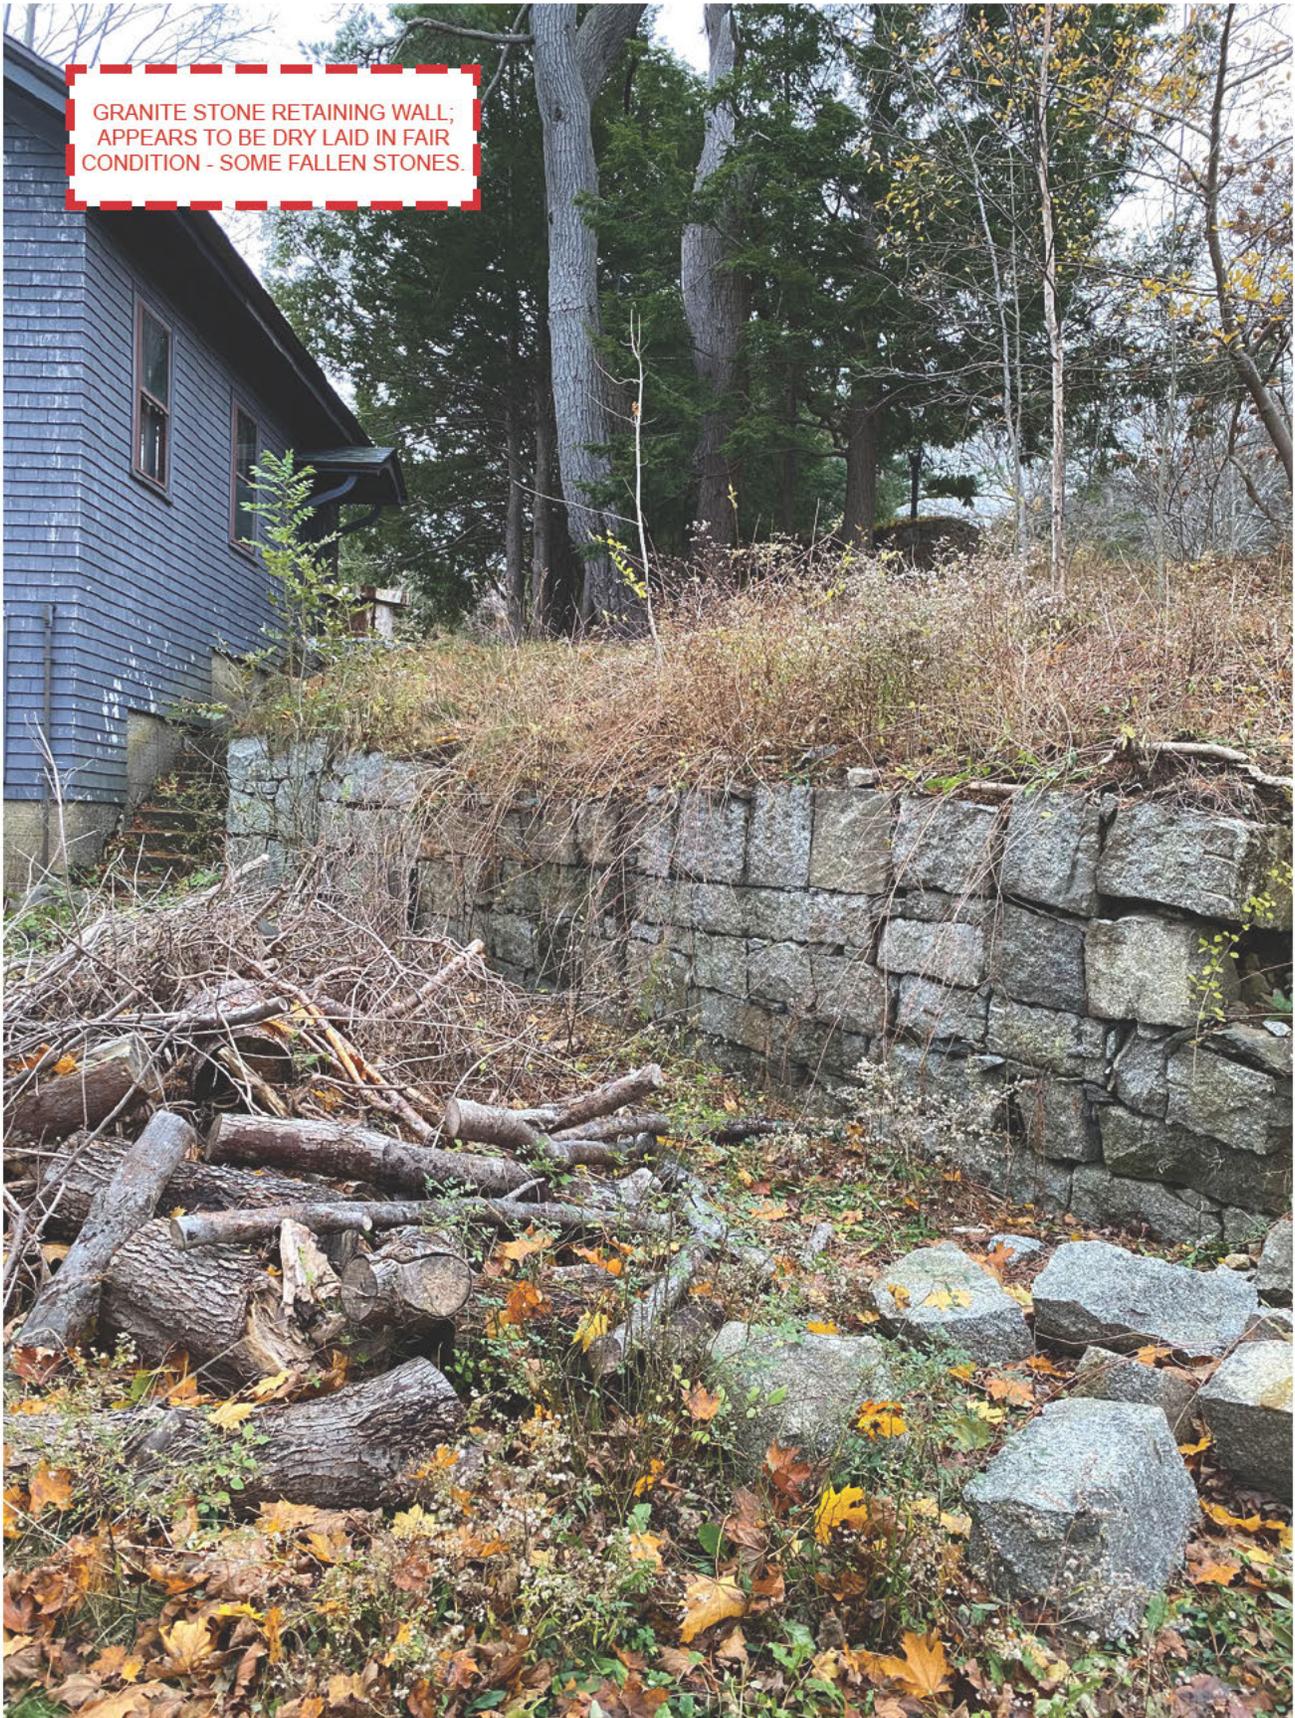
2.27 STONE WALL NEXT TO ROOST (SOUTHWEST VIEW).

GRANITE STONE RETAINING WALL;
APPEARS TO BE DRY LAID IN FAIR
CONDITION - SOME FALLEN STONES.

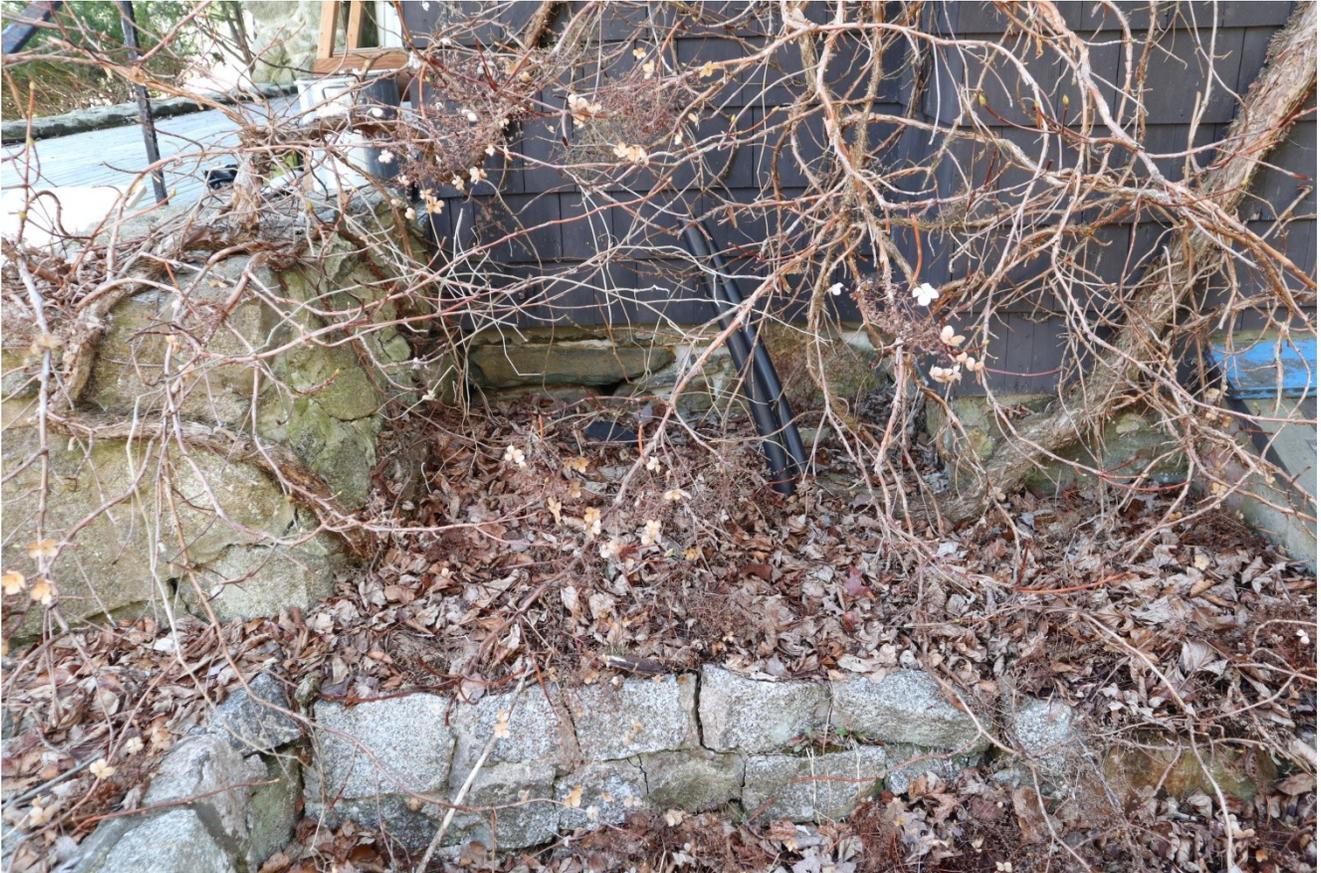
2) Also notices on the exterior of this building was to fact that the foundation itself was constructed as a rock foundation. This was done with little thought to water proofing of the basement. See in the photograph below the visible rock of the foundation wall, and the openings through the rocks. These openings will allow entry of water where ever the grading of the land is not proper. Grading around the building is very bad. Also leaks are common whenever there is snow build up along the wall in which case water will simply run into the building.

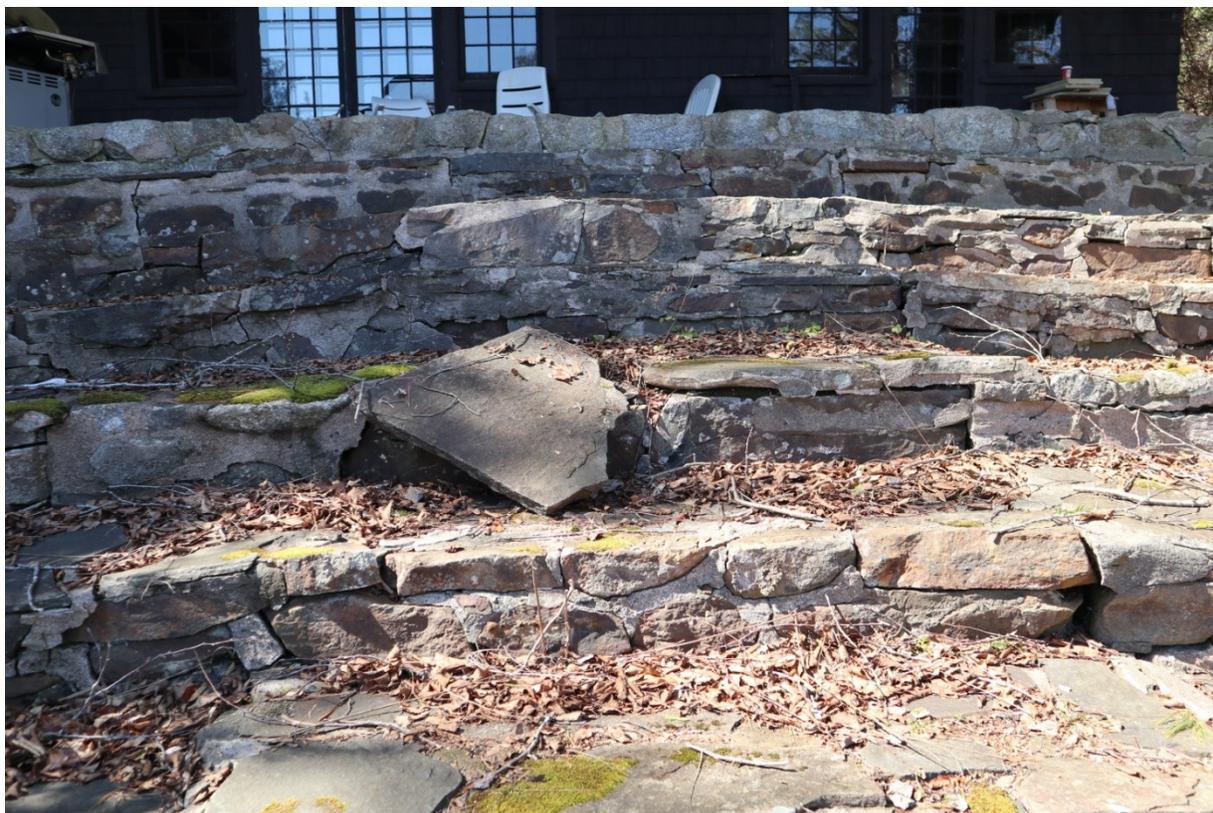
Around the building there are a number of rock walls. Some of these are for the support of rock stairs, others to support deck areas, and others simple as architectural features. In all cases you can clearly pick out the fact that these wall have failed.

In areas where there are rock steps, there are many locations where openings in the rock surface will allow for ones foot to sink through. The rock surface has now become a danger for use. Please see in the photograph below an example of such conditions.

As can be seen not only are the stones separated from each other, some have been totally dislodged. The surface is now up and down as the frost heaving has left it. This is typical all around what once was a well maintained and luxurious property.

These wall have all failed to some degree, with some which can be classified as not structurally sound. These will all require a total rebuild. Others will have to be realigned, and sealed in place with some type of a mortar compound.

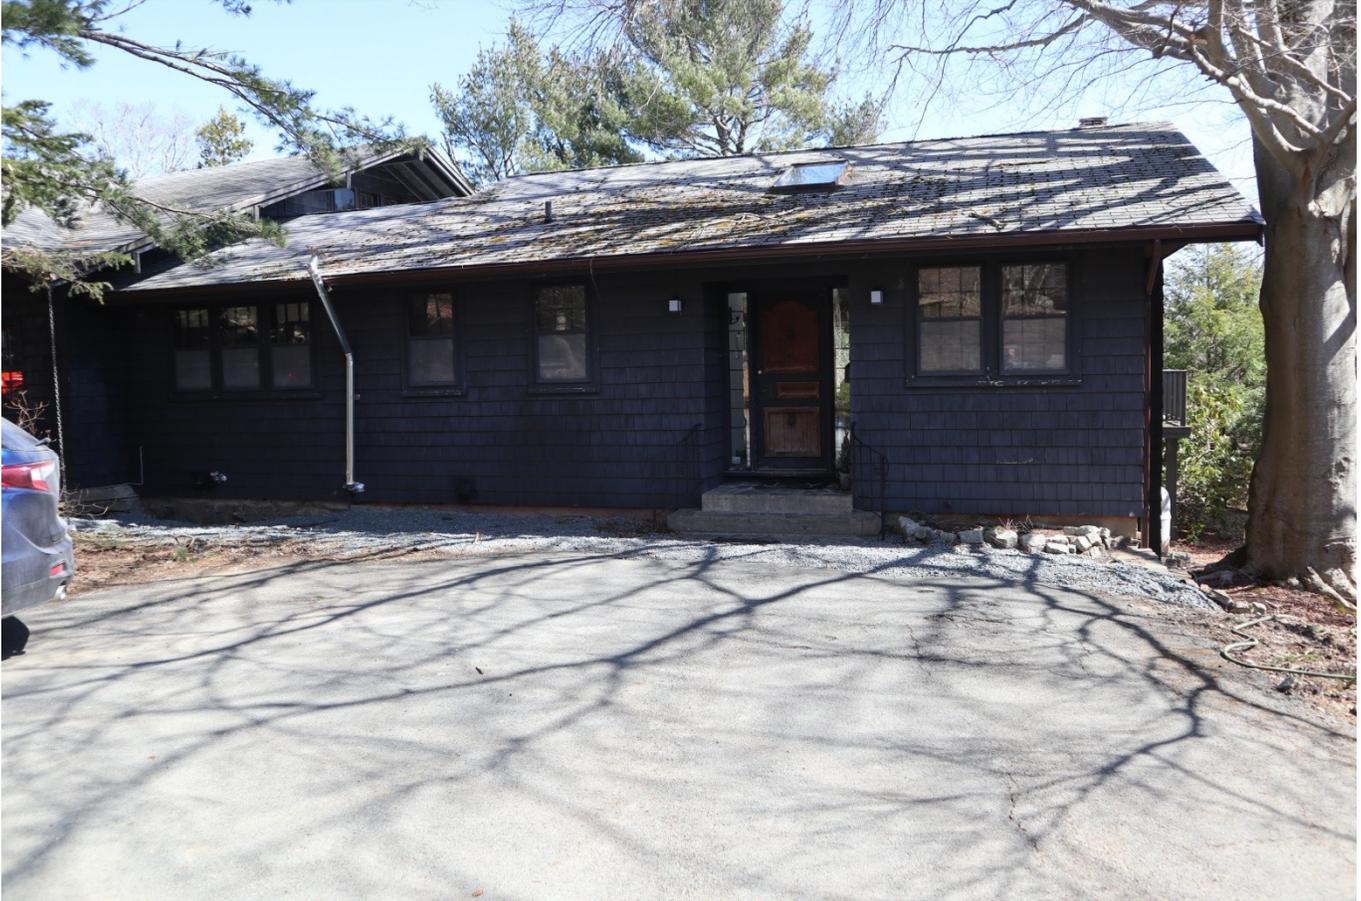
The exterior of the addition was very similar to that of the original house in terms of construction and condition. Please see the front side of this section below.

The roof is covered with debris, leaves and branches. This is caused by overhanging trees.

On the rear side of the roof there is a section which is constructed from cedar shakes. These have a substantial amount of rot.

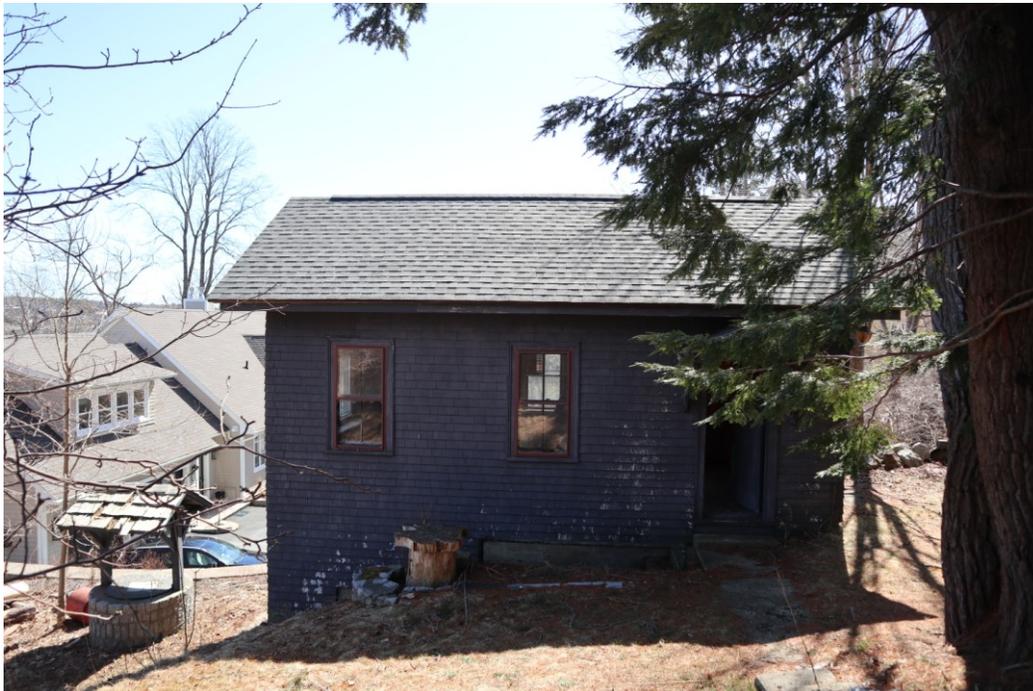
Entrance Face

1) The siding on the exterior of this building is wood shingles. It appears to be in relatively good condition. What it appears to require is chalking around windows and some repair. It could use a good coat of paint as the present paint is starting to dry up and fade.

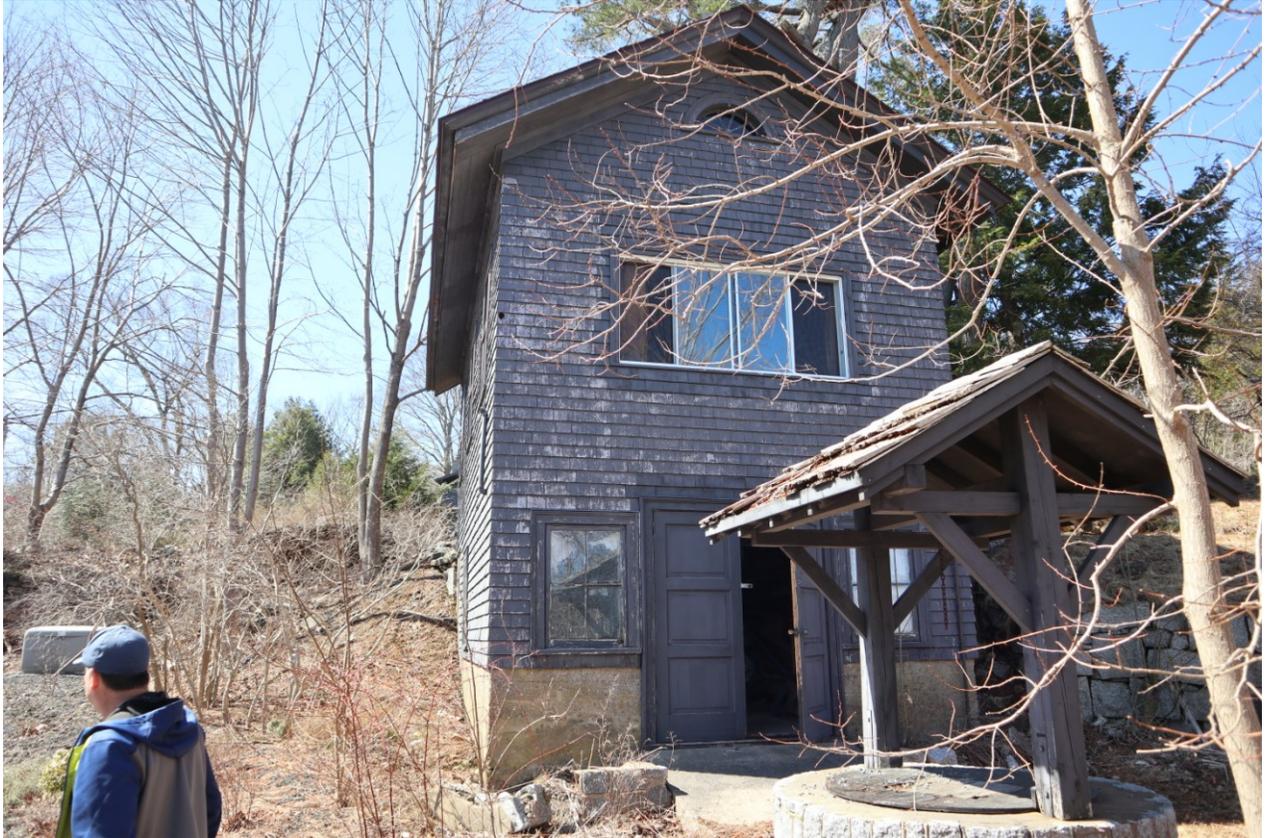
Waterside Face

2) The windows in this building are not in good condition. Most are wood frame single pane glass. These have a significant amount of rot and are in bad need of paint, repair or replacement.

One window is a newer type. This is a vinyl horizontal slider. This window is visible in the photograph above. This window is the best of what is presently there, but it leaks and is visibly aged.
