10 Kirk Road Heritage Impact Statement

Heritage Impact Statement
Re Finntigh Mara/Mathers Estate
10 Kirk Road, Halifax, Nova Scotia, B3P 1A6
Aug 31 2022

Prepared by
MacKay-Lyons Sweetapple Architects
2188 Gottingen Street, Halifax, NS, B3K 3B4
902 429 1867
mlsarchitects.ca

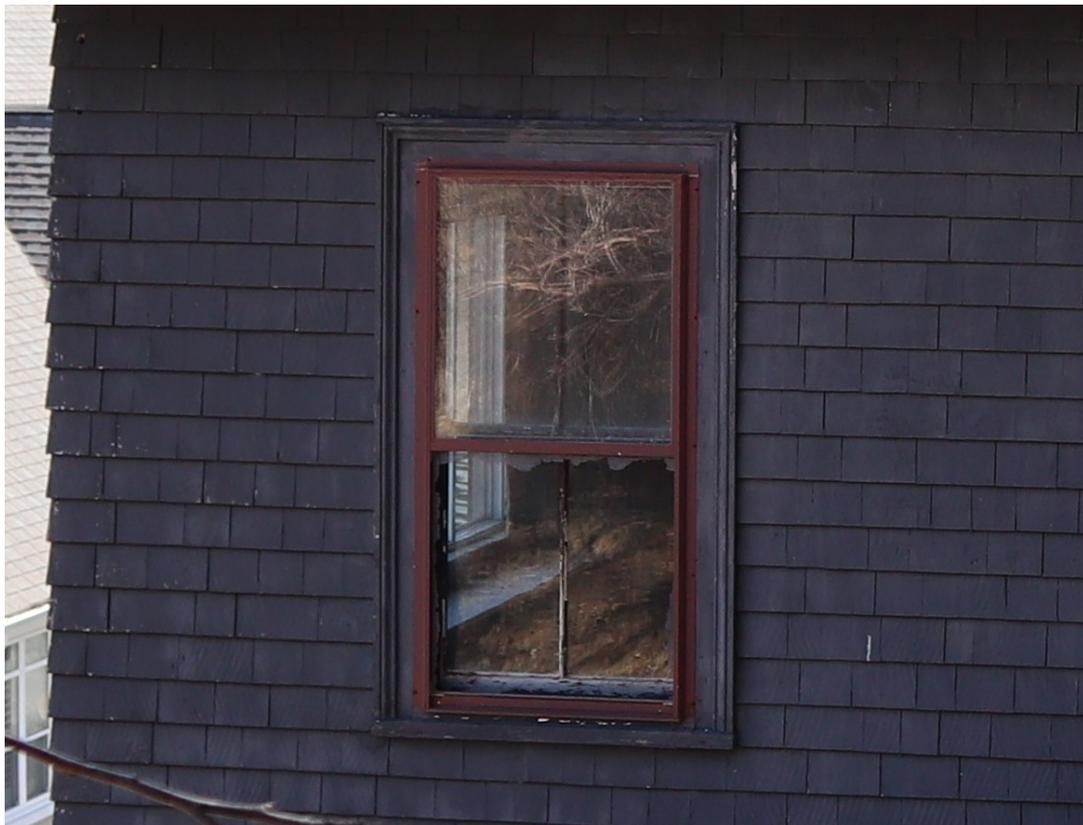
Some of the window frame openings have a storm window on the exterior. These are on the upper level of the building (main). See the second photograph below. As can be seen, this storm window is totally rusted, and the bottom pane of glass is smashed out.

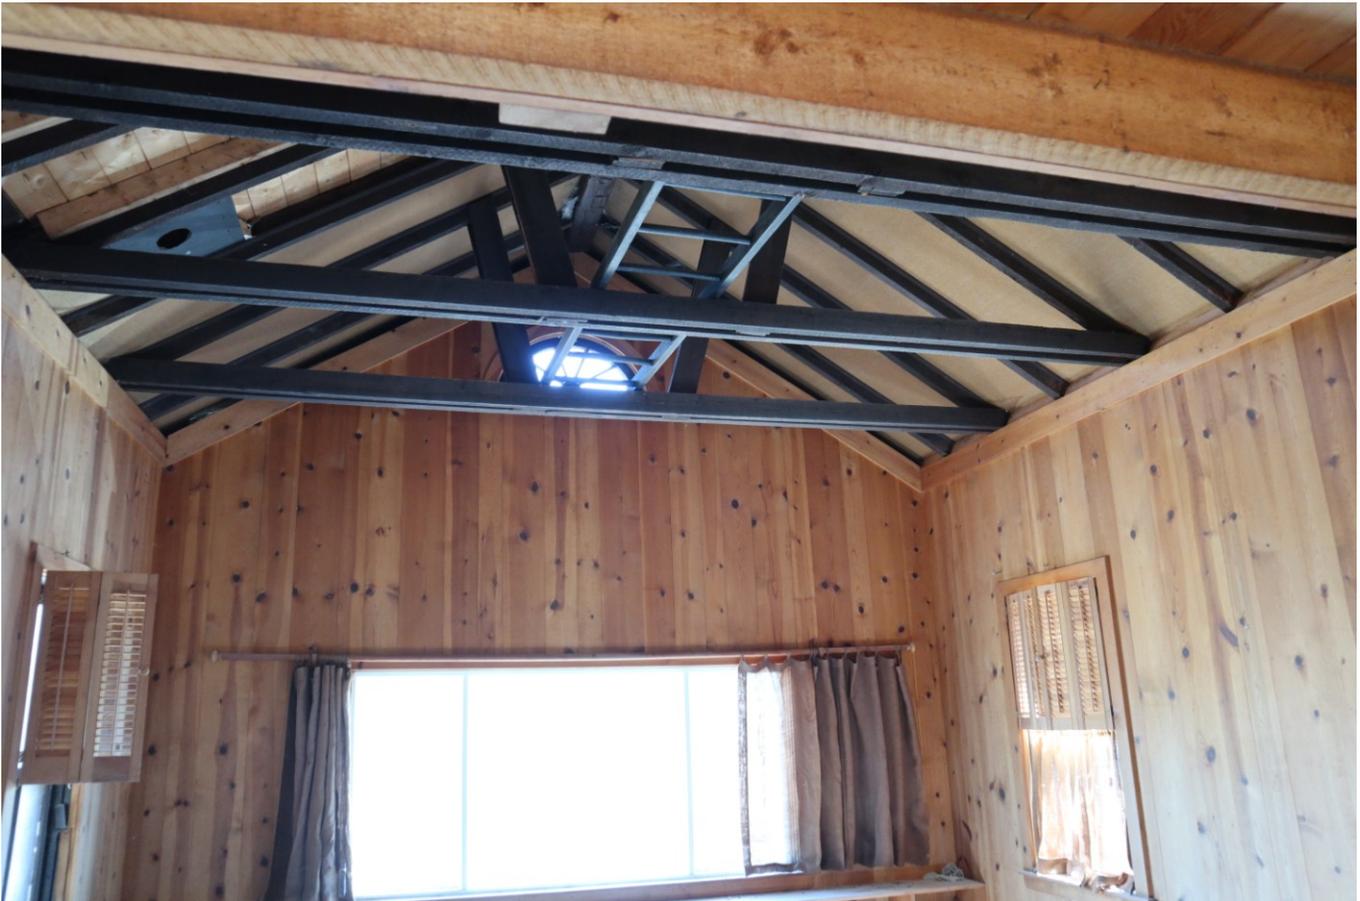
In general, the main floor of this building appears to be in relatively good conditions. See the photograph below.

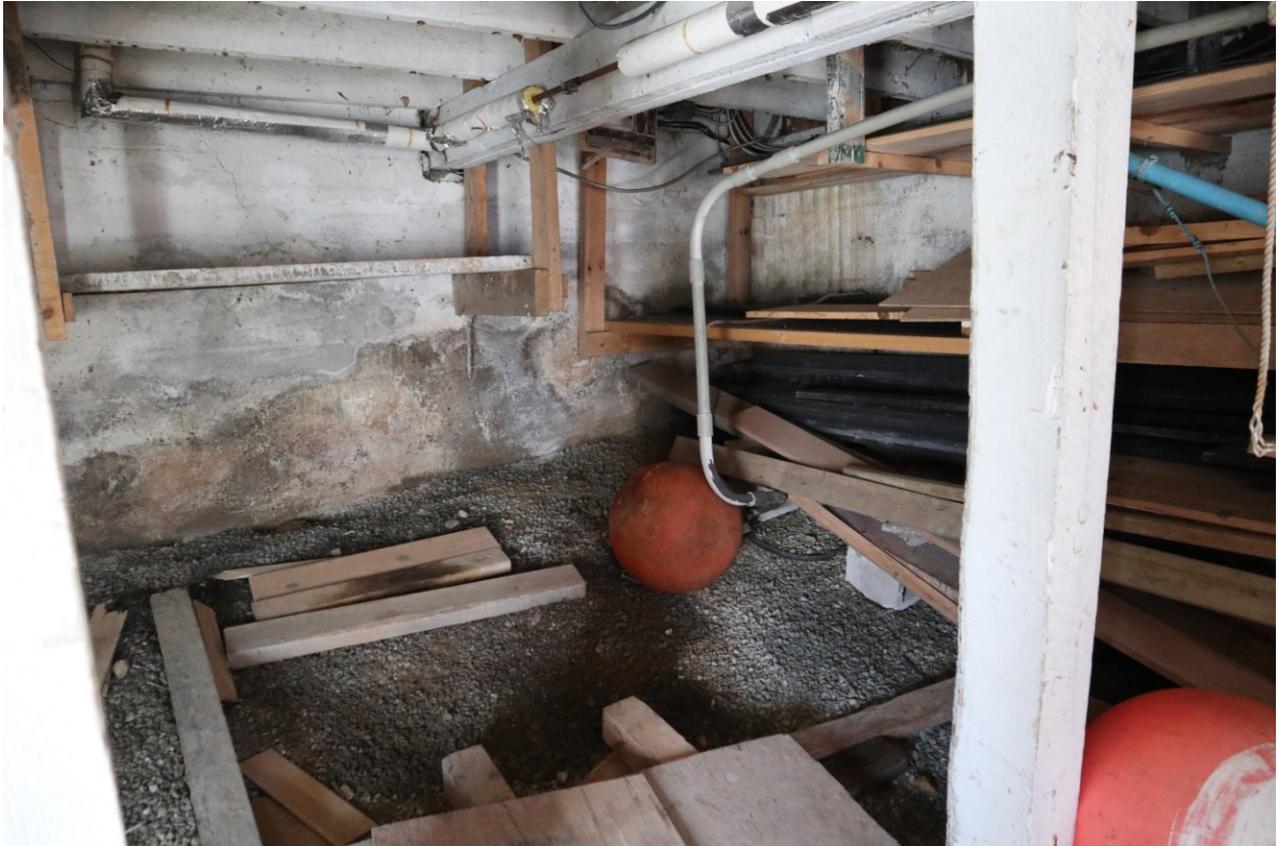
4) There is water flow entering the crawl space. This enters through or under the foundation wall and it travels along a path following the slope of the ground through the crawl space. Evidence of this, and the path of travel is clearly shown by the dark areas of the gravel as shown in the following photograph.

Therefore it is obvious that there presently is water in the crawl space.

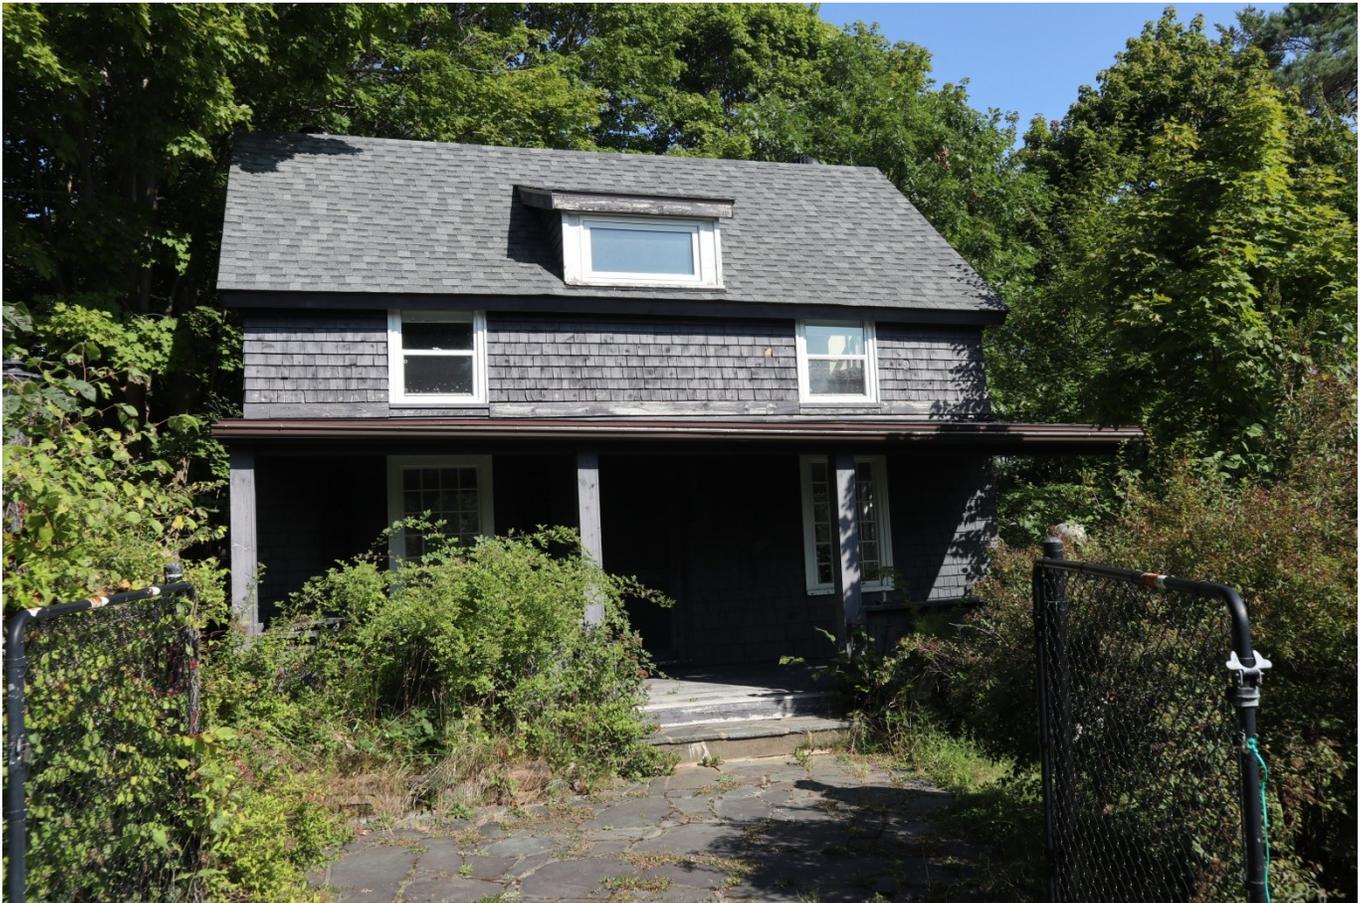
The **Pool House** is a small building on the property which is not set up for use in a residential purpose. The building from a distance looks relatively good but as you get in and around it, this is not the case. Please see the front side of this building below.

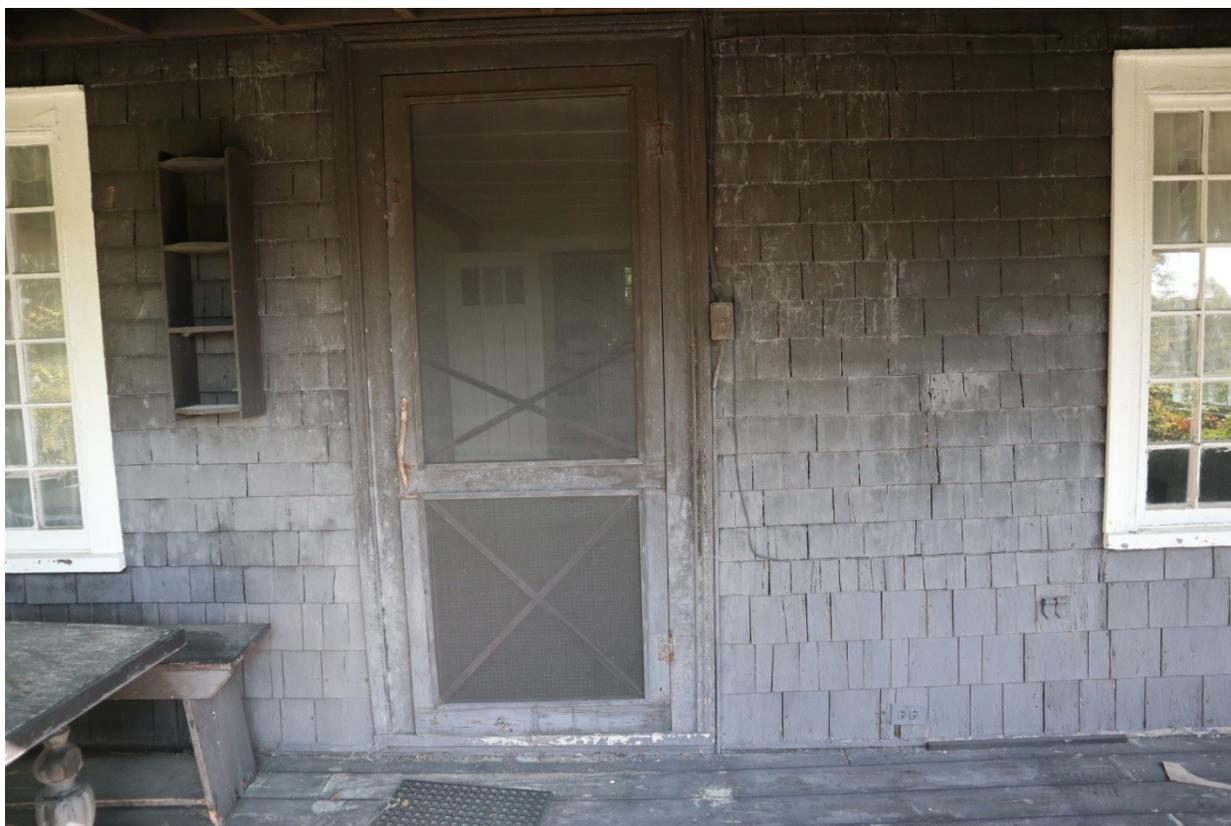
1) The exterior of the building has a substantial amount of rot, especially in and around the deck, or any wall which is near ground level. A close up look at the main front entry of the building reveals the general conditions which are encountered around the perimeter of the building.

Please see in the photograph below the front entry.

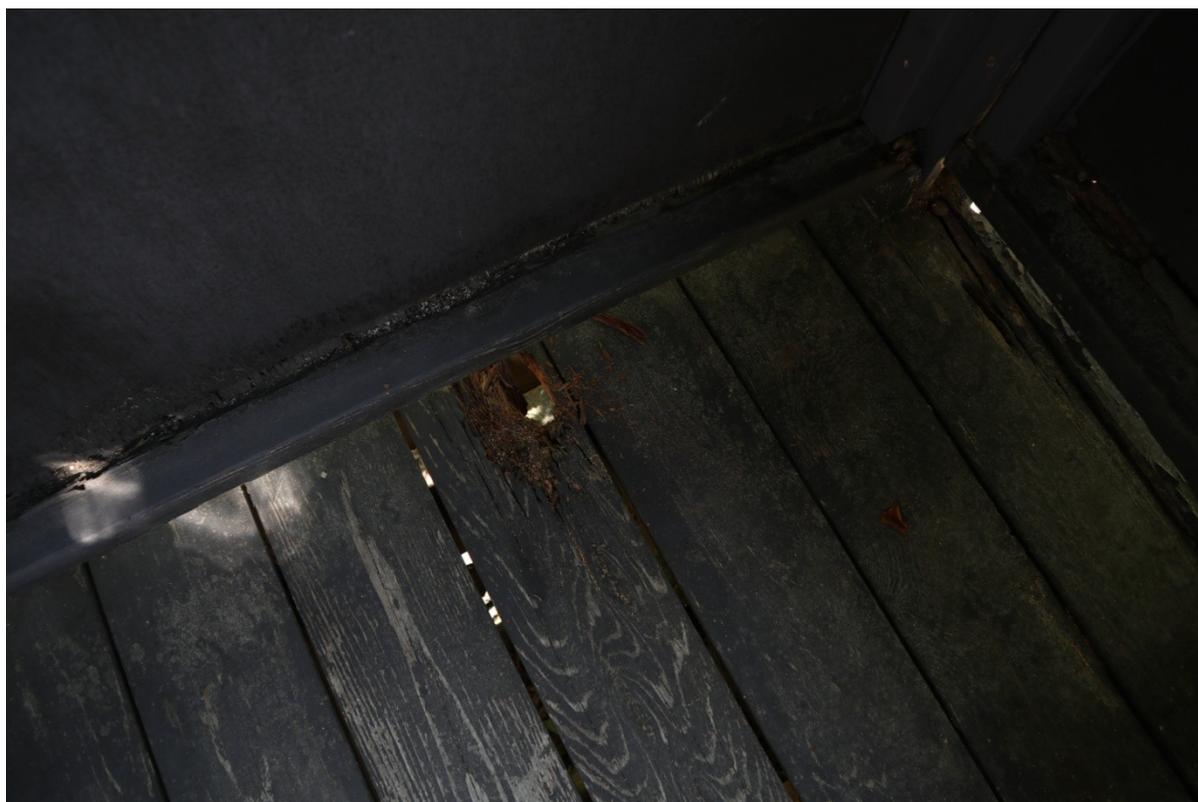
At the time of this inspection, two holes were put into the deck flooring, simply by a kicking motion with one shoe toward the deck. Please see a sample on the photograph below.

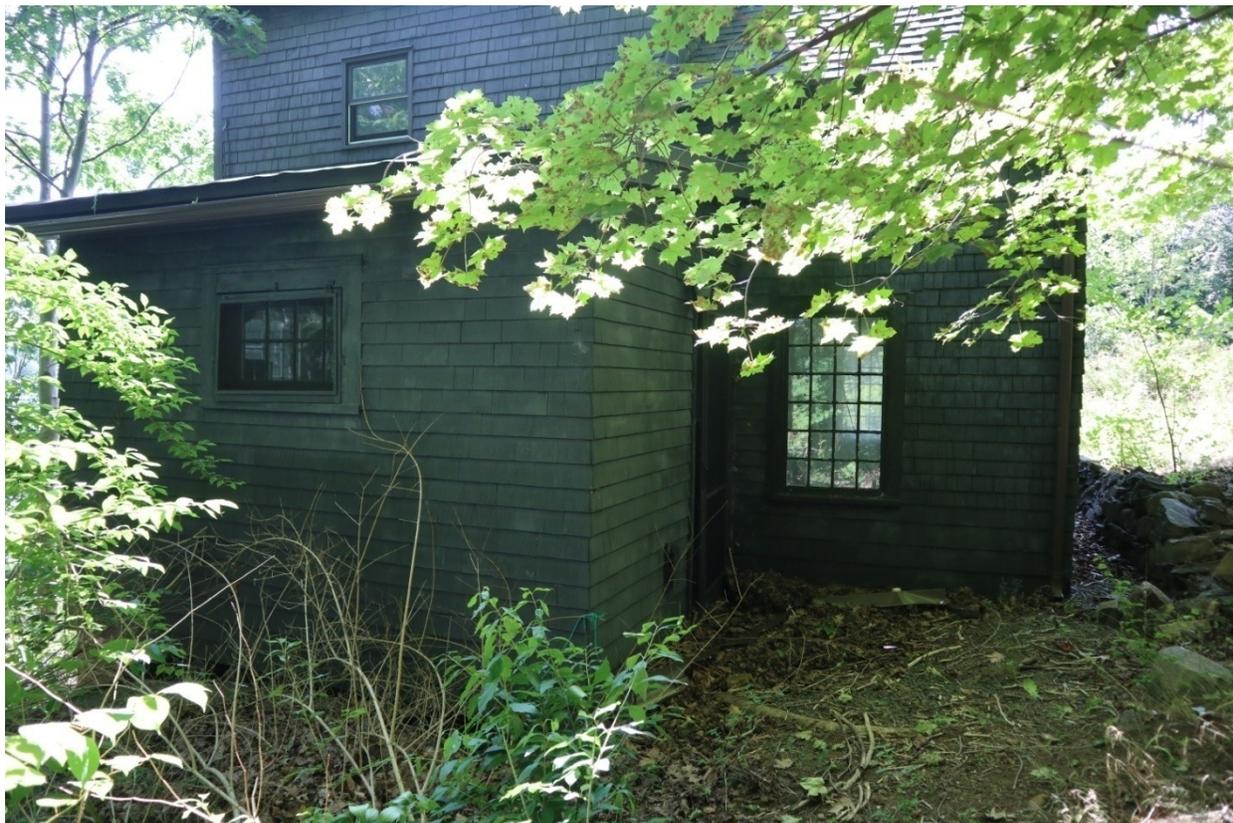
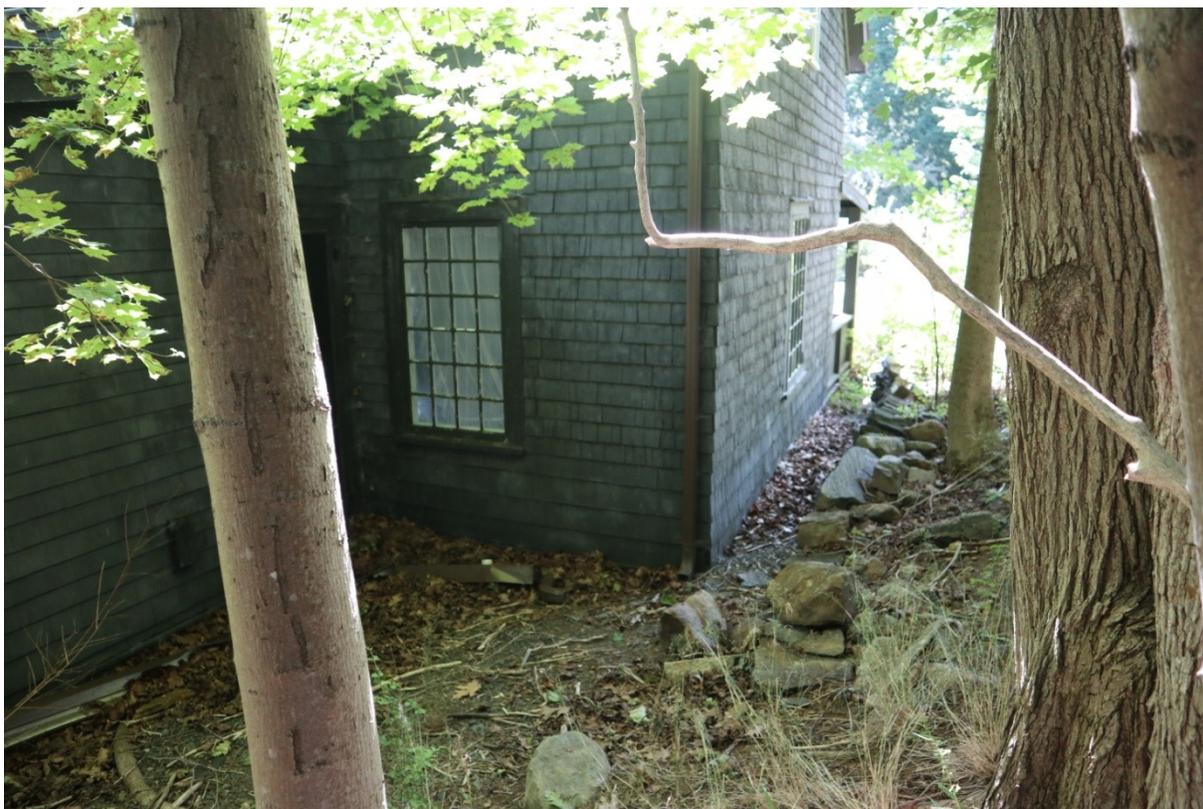
2) The lot grading along two sides of the was totally improper, resulting in water flow towards the building rather than away from the wall. See below.

Compounding this improper problem, was the fact that a good portion of the building exterior walls have the wood siding at or near the grade line. This has led to rot of the siding and the wood wall structure, and water infiltration below building. The space below the building is basically a crawl space.

The National Building Code minimum distance from the exterior ground elevation to the top of a building foundation wall is 6 inches. This is not the case around two sides of this building. Added onto this problem is that of the water drainage flow direction. By code, the ground around the building is to be graded such that the surface water flows away from the property. In this case, surface water flows towards the building.

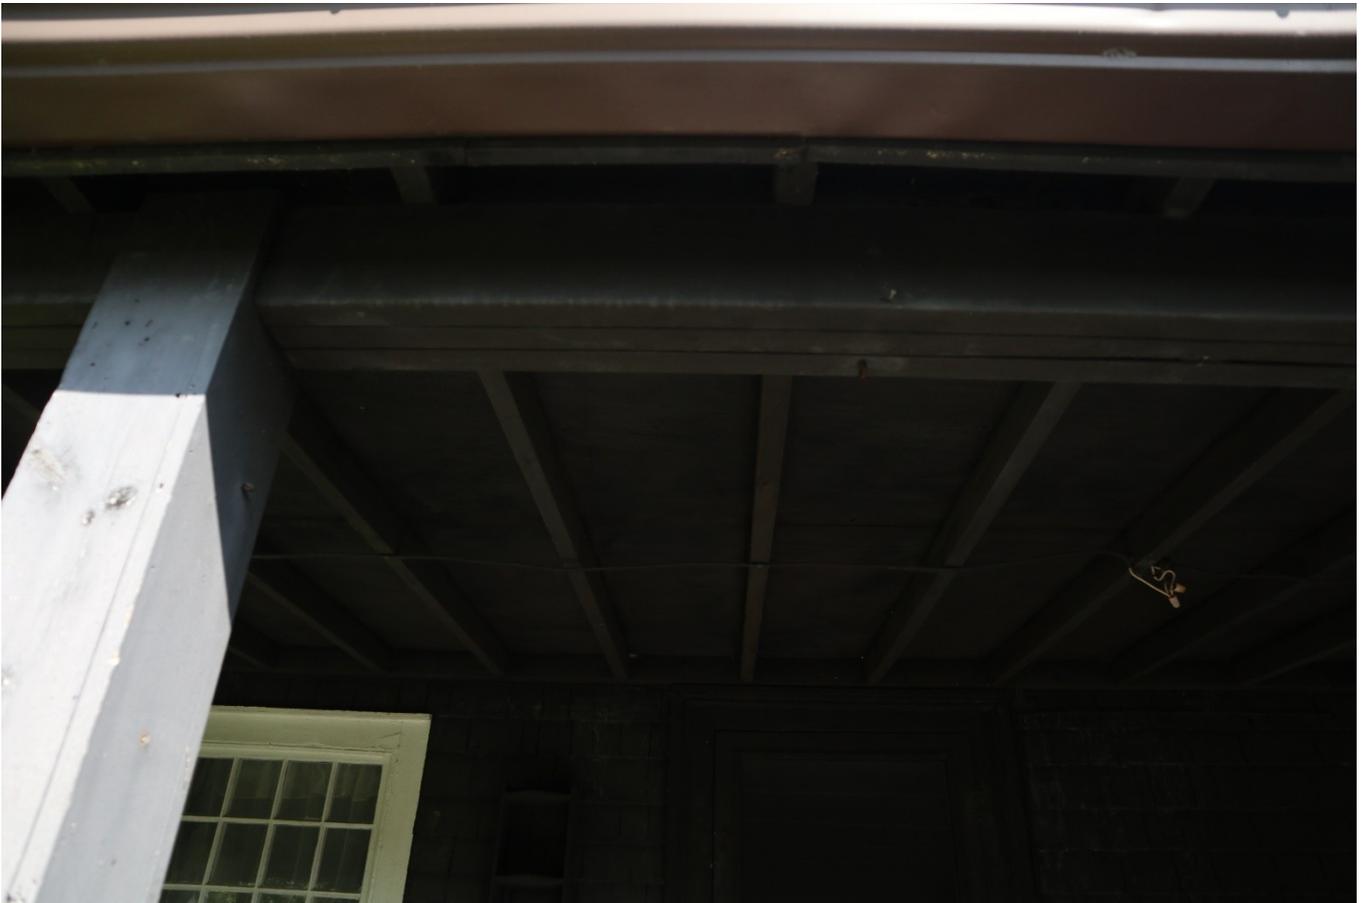
3) The building **Canopy** over front deck is constructed with 2" x 4" wood joists. These are very much undersized considering the length of the joist and the snow loading designation for this area. See photograph below.

This canopy has sections of rot scattered throughout. It is fairly large, and as is, should not pass a structural inspection, thus should fail approved if HRM staff if they were to view it.

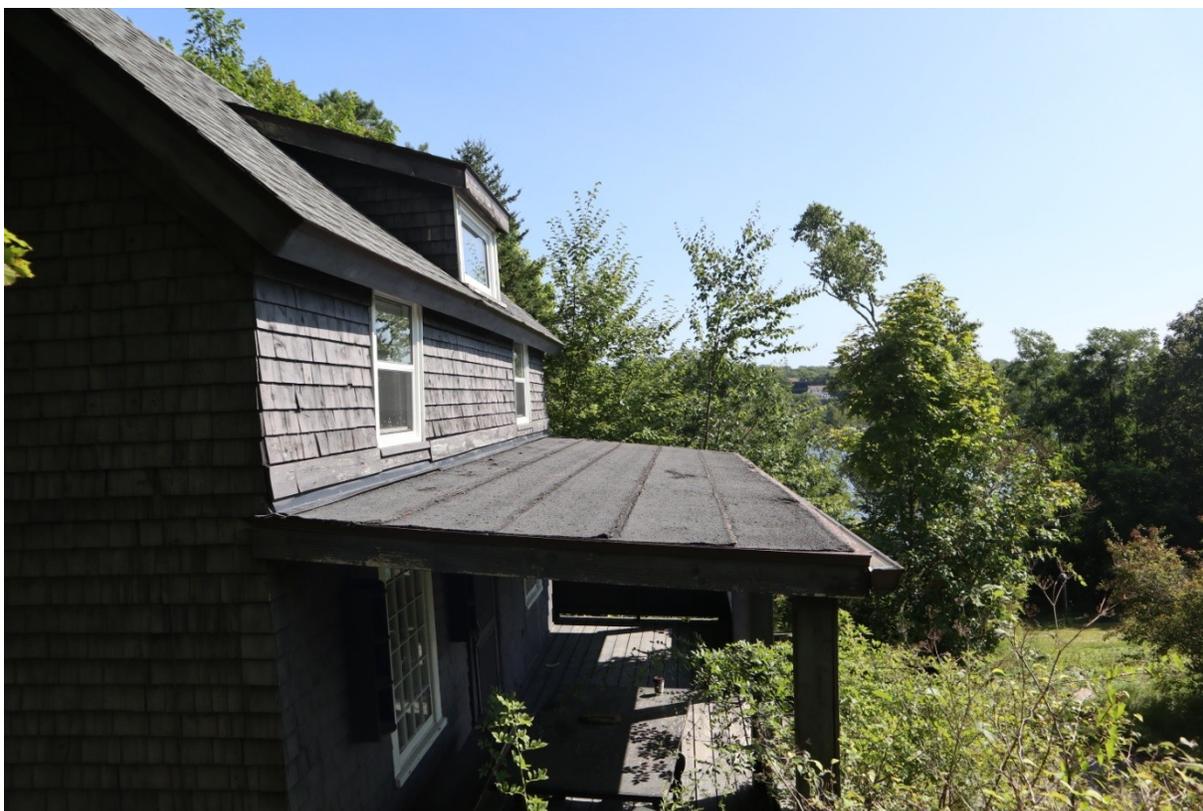
Please see in the photograph below, a side view of the canopy. The torched-on-roof membrane is in very bad condition, and visible is several areas of obvious membrane failure.

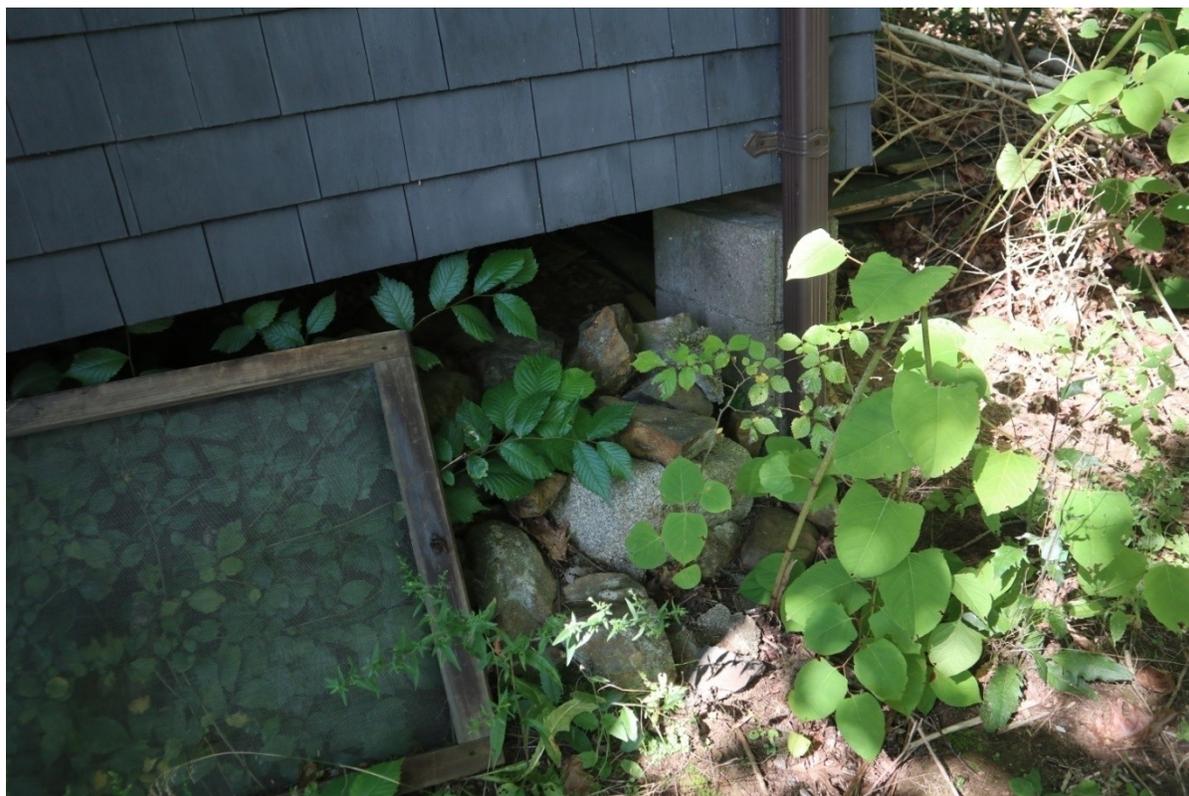
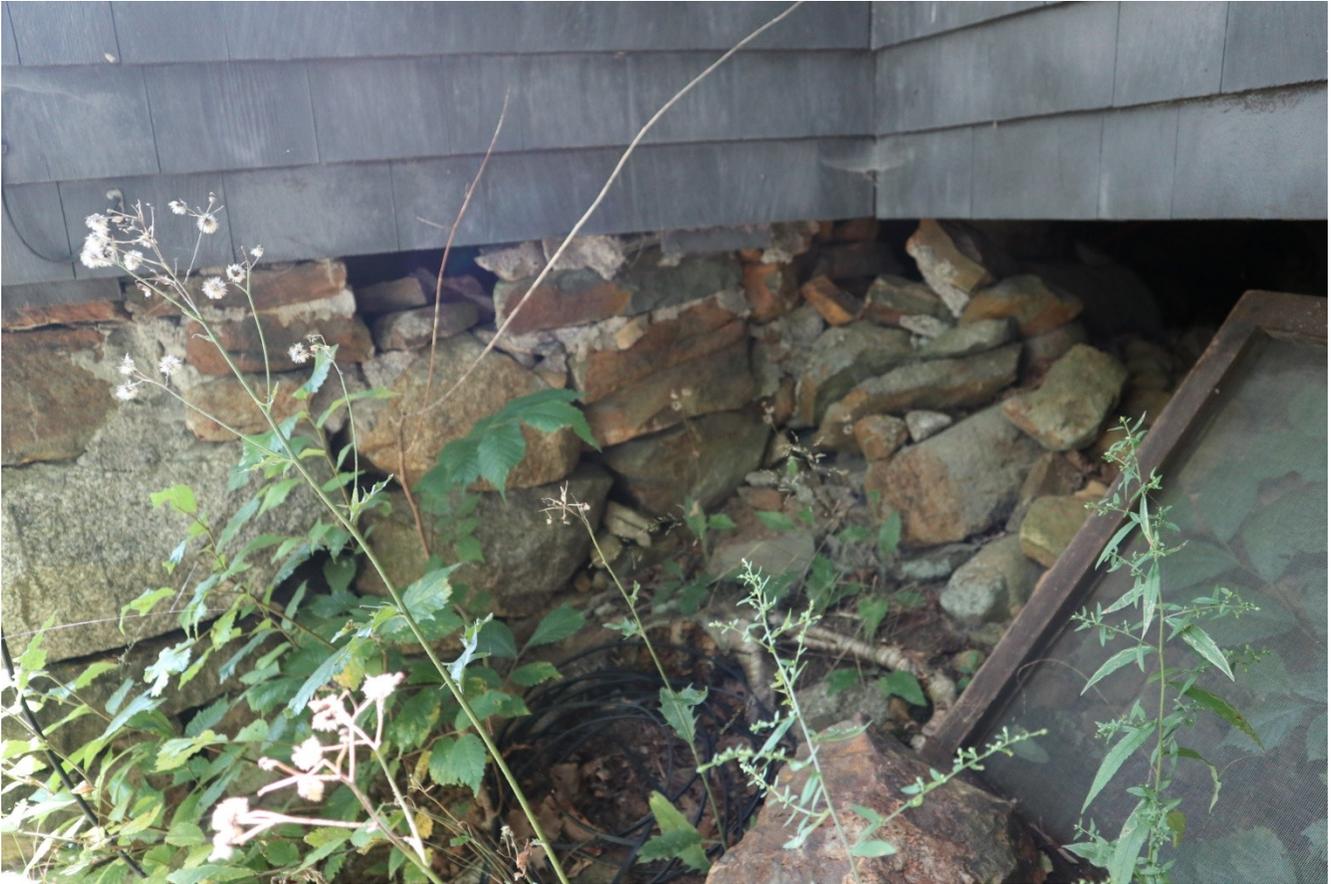
3) **The visible foundation** around the building is virtually non-existent around the exterior. See photographs below.

As is obvious in these photographs, what is there would no longer qualify as a secure foundation. It is now more along the line of a building being supported by piles of rock. There is one corner of the building which is actually supported by a few stacked concrete blocks. This is clearly shown in the photograph on the previous page.

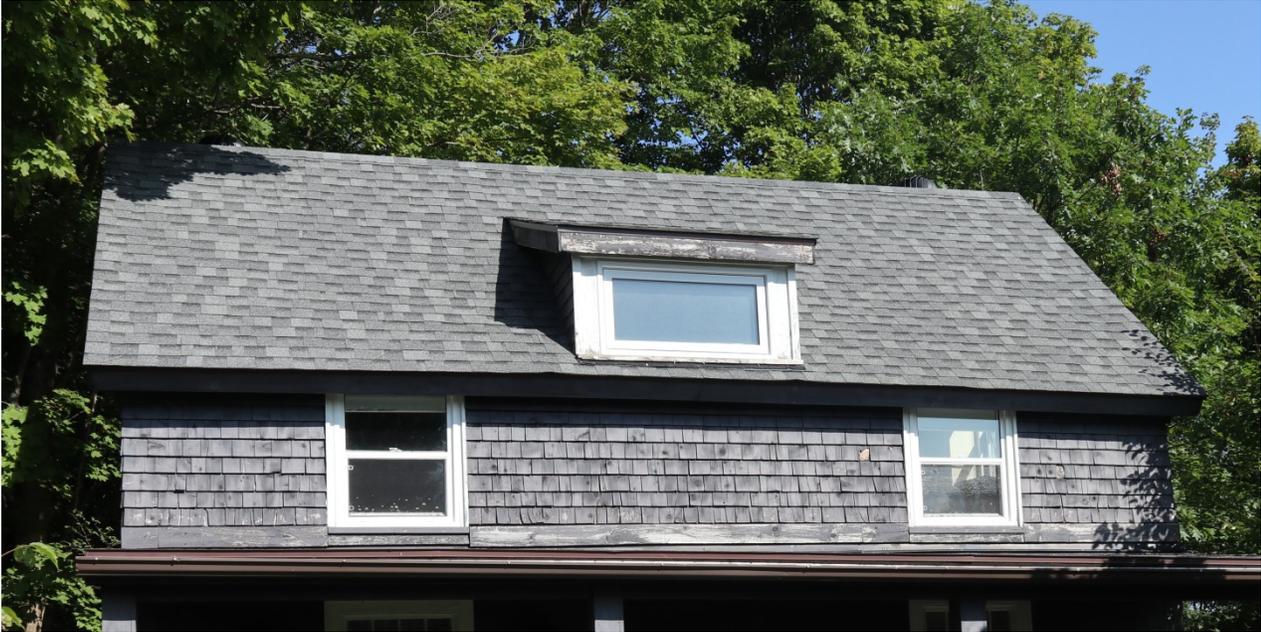
4) The **Building Roof Structure** generally showed well. It asphalt shingles appear to have been replaced recently. The exact age is unknown. However there are no gutters or down spouts. See photograph below.

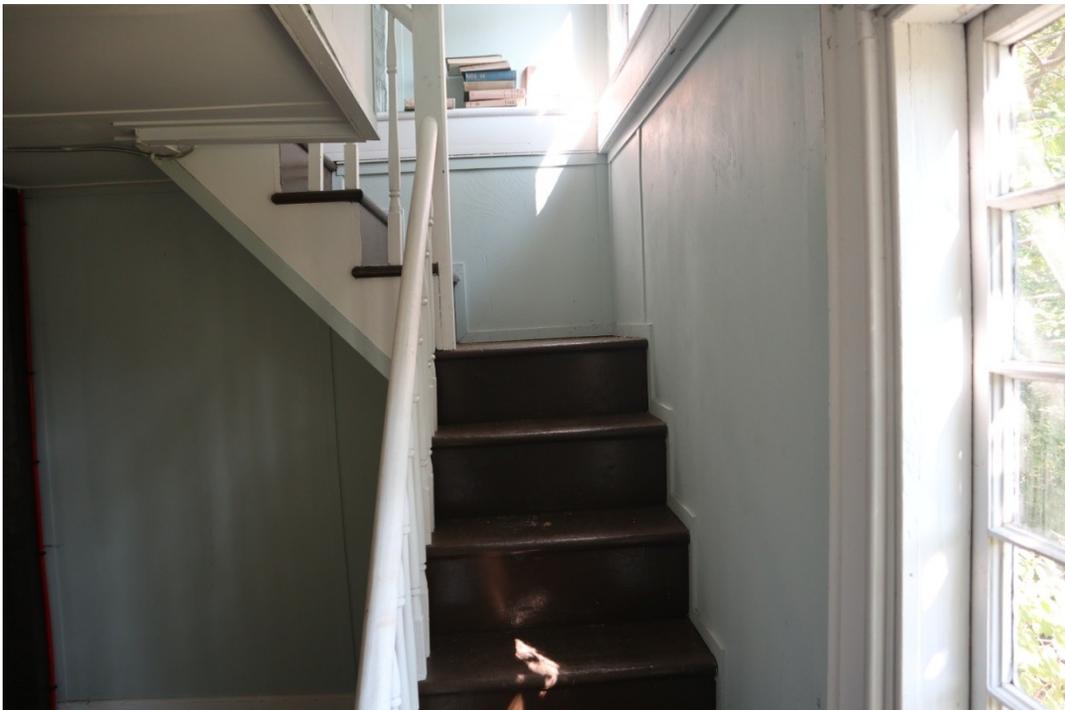
Top floor of this building was inspected next. What stood out the most was the fact that it had little accessibility. The stairway leading up to the top floor was approximately 24 inches wide. See photograph below.

This width of a stairway, makes it very difficult to load furniture or any large item to the top floor.

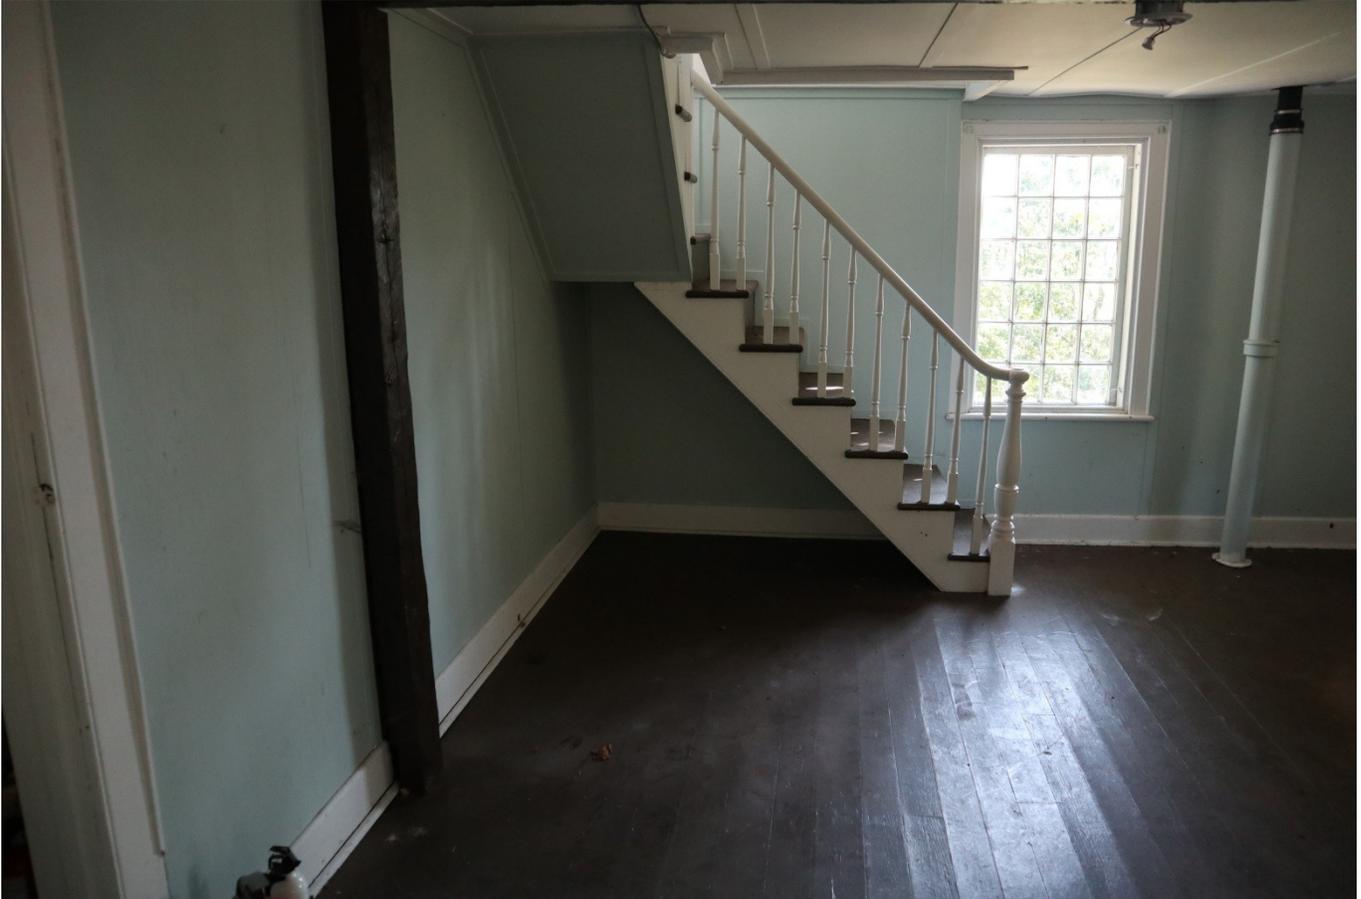
The landing on this stairway was viewed, and considered as structurally unsound. As can be seen in the photograph below, there are no bearing supports below the landing at the corner. The landing is supported only by the end walls on either side. See the photograph below.

Any heavy loading on the landing will immediately result in downward deflection, and if heavy enough, would cause instant failure of the landing.

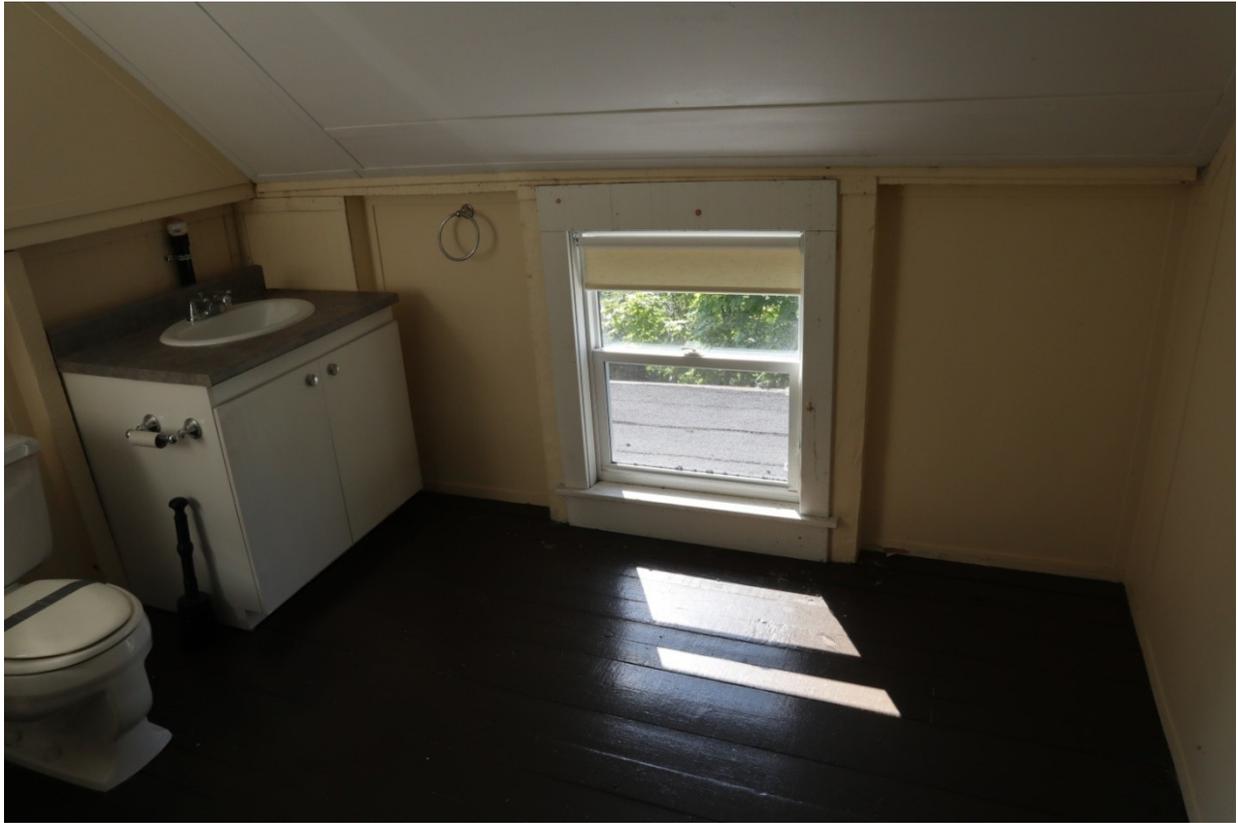
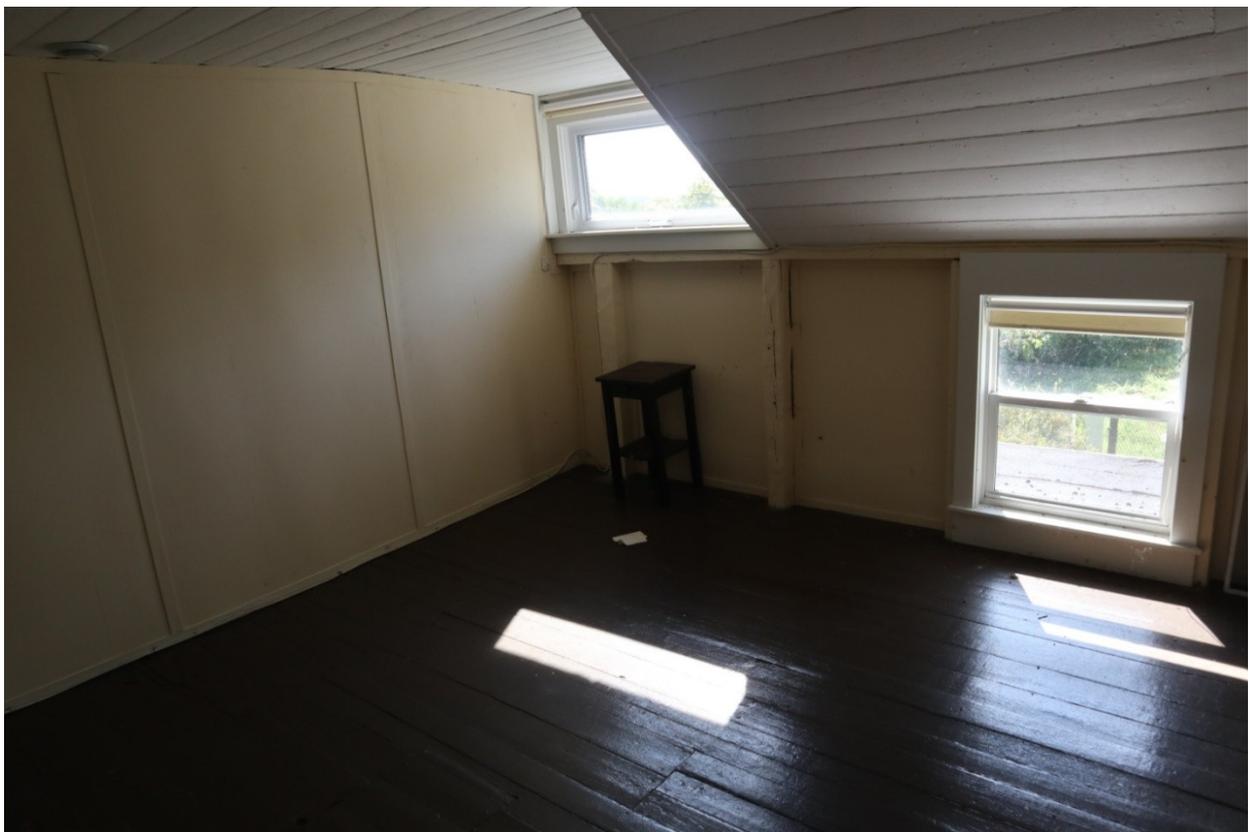
- : A windows in the bathroom and "bedroom" were 5 inches above the floor level. This is not within the acceptable height based on the National Building Code.
- : There was minimal electrical service only on the hallway and bathroom. Not enough plugs or lighting.
- : The available electrical service did not meet code and ran exposed on the wall surface.
- : There was no heating at all on this level
- : There was no insulation in the walls or ceiling
- : There was no finish surface on the wall, as the framing member were visible. These were painted.

Please see photographs below of the top floor.

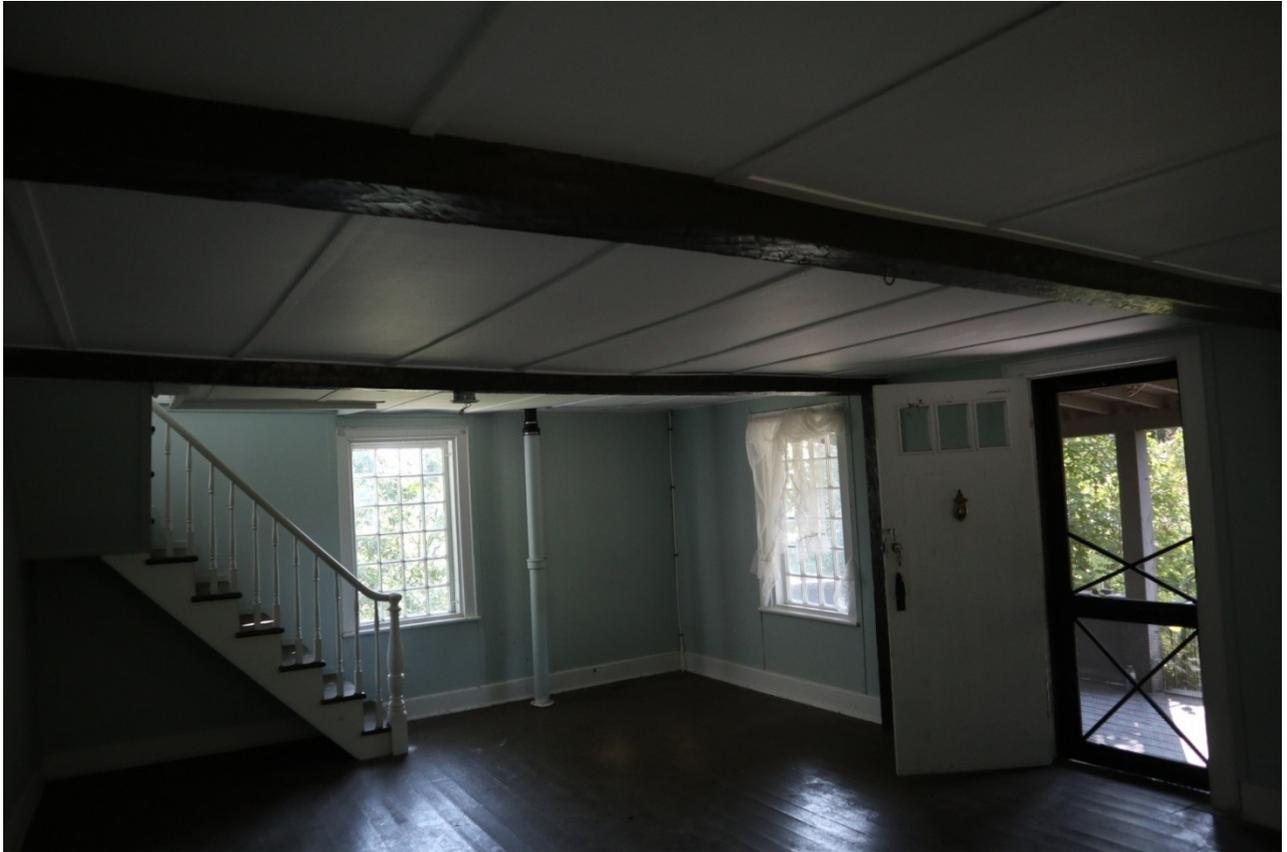
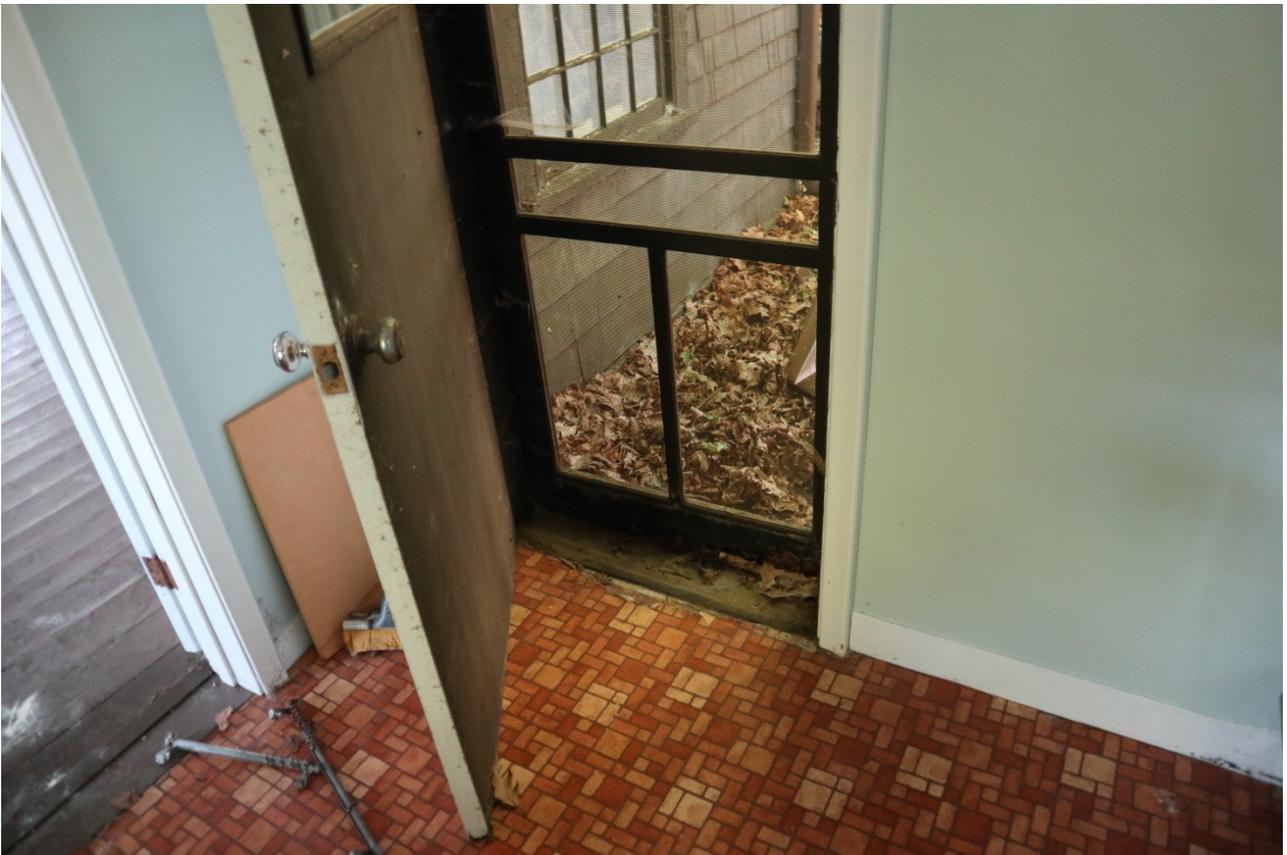
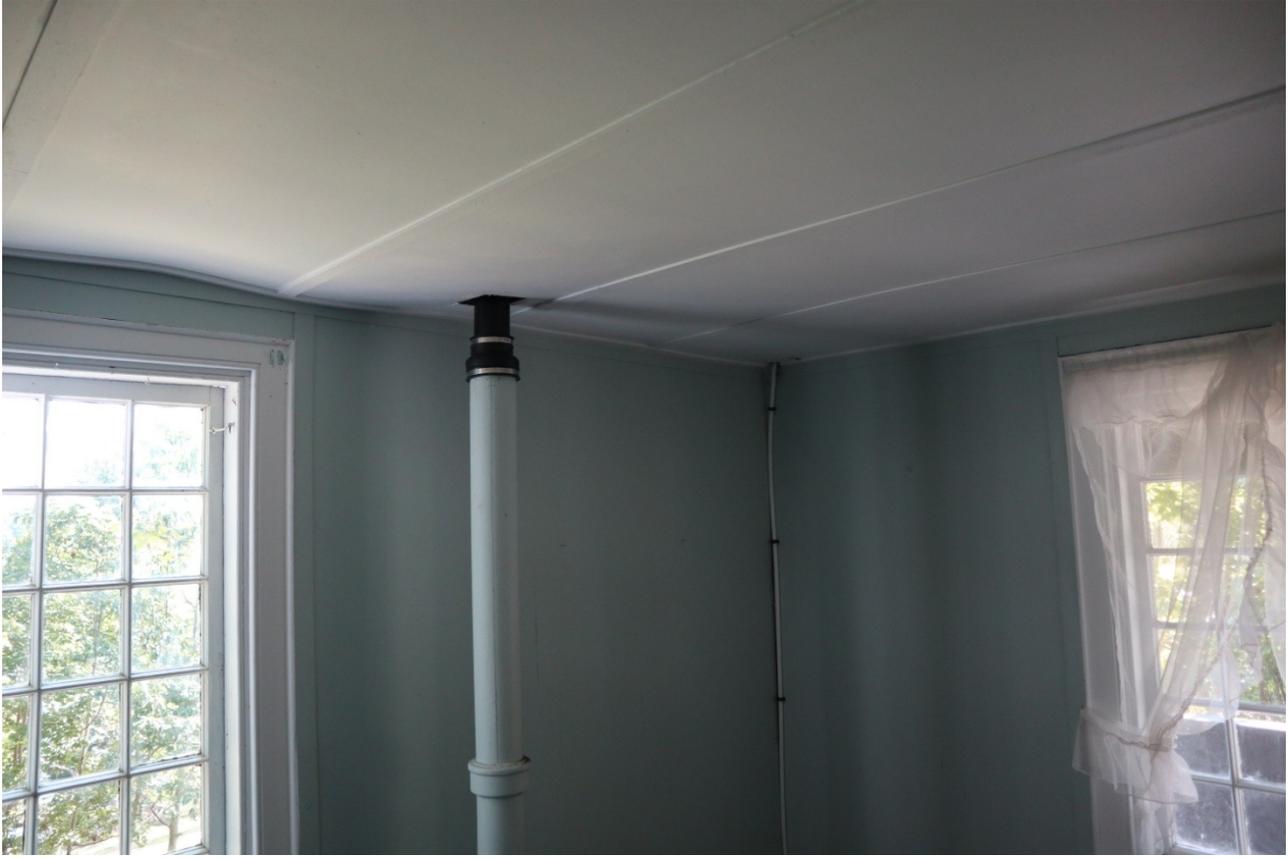
What stood out on the main floor was the way the floor bounced due to lack of structural support. The floor joists are clearly undersized for the span.

- : The drainage line for the upstairs bathroom ran down exposed through the living room area.
- : There was no electrical service at all in the living room area
- : There was minimal electrical service in the kitchen, which also appears to be an addition onto the main structure.
- : The back door was at ground level and susceptible to rot, insects, mice and water infiltration
- : There was not source of heating on this level. Thus there is no heating in the building at all.

Please see below, 3 photographs taken of the main floor space.
