10 Kirk Road Heritage Impact Statement

Heritage Impact Statement
Re Finntigh Mara/Mathers Estate
10 Kirk Road, Halifax, Nova Scotia, B3P 1A6
Aug 31 2022

Prepared by
MacKay-Lyons Sweetapple Architects
2188 Gottingen Street, Halifax, NS, B3K 3B4
902 429 1867
mlsarchitects.ca

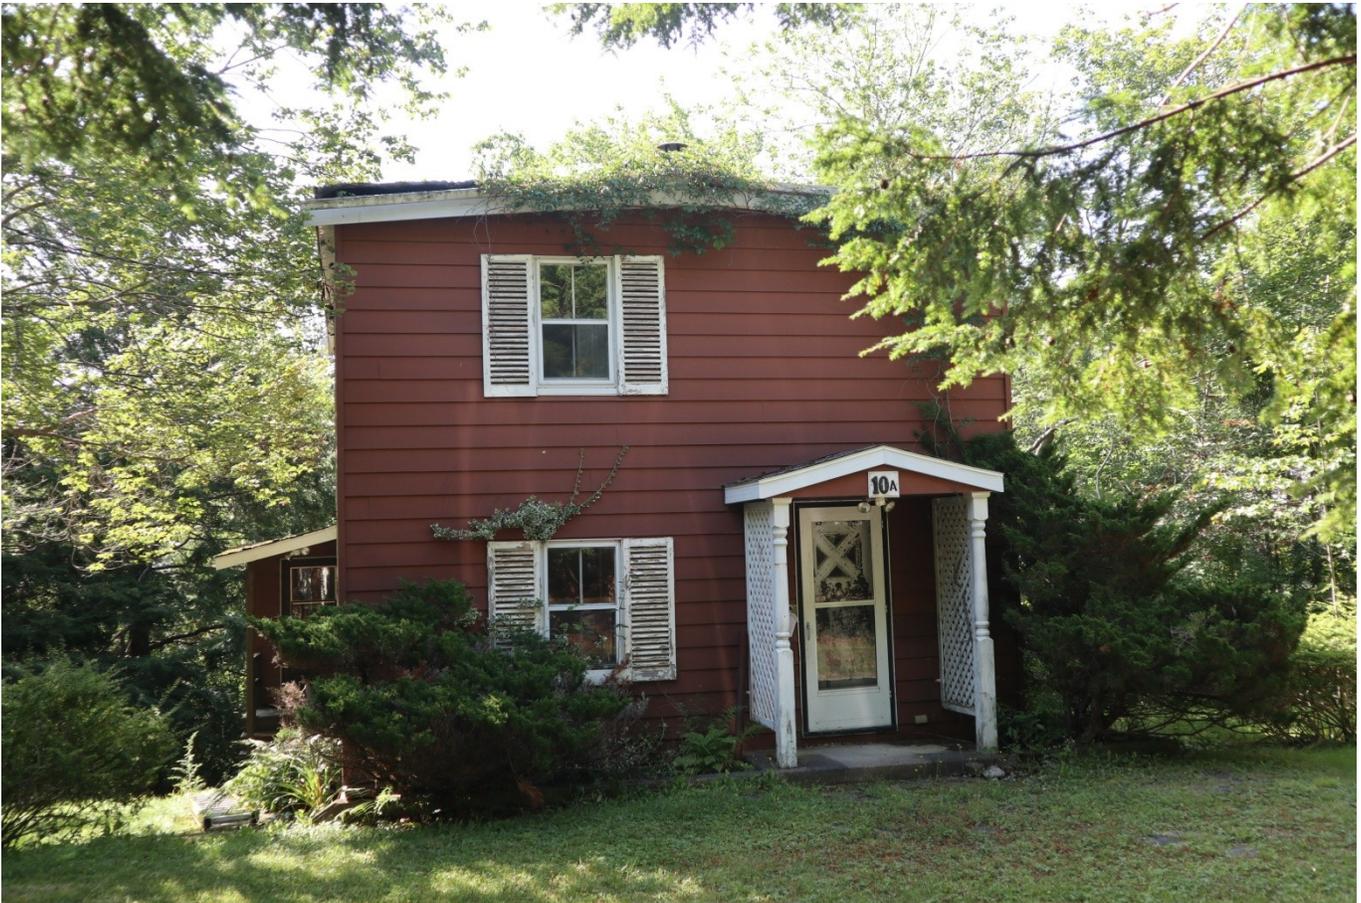
1) The overall condition of the building is quickly pointed as you approach the building. The main front entry is the first visible element of note. It is obvious as to the total lack of maintenance over the years. Visible is a totally rotted front entrance in particular the front door.

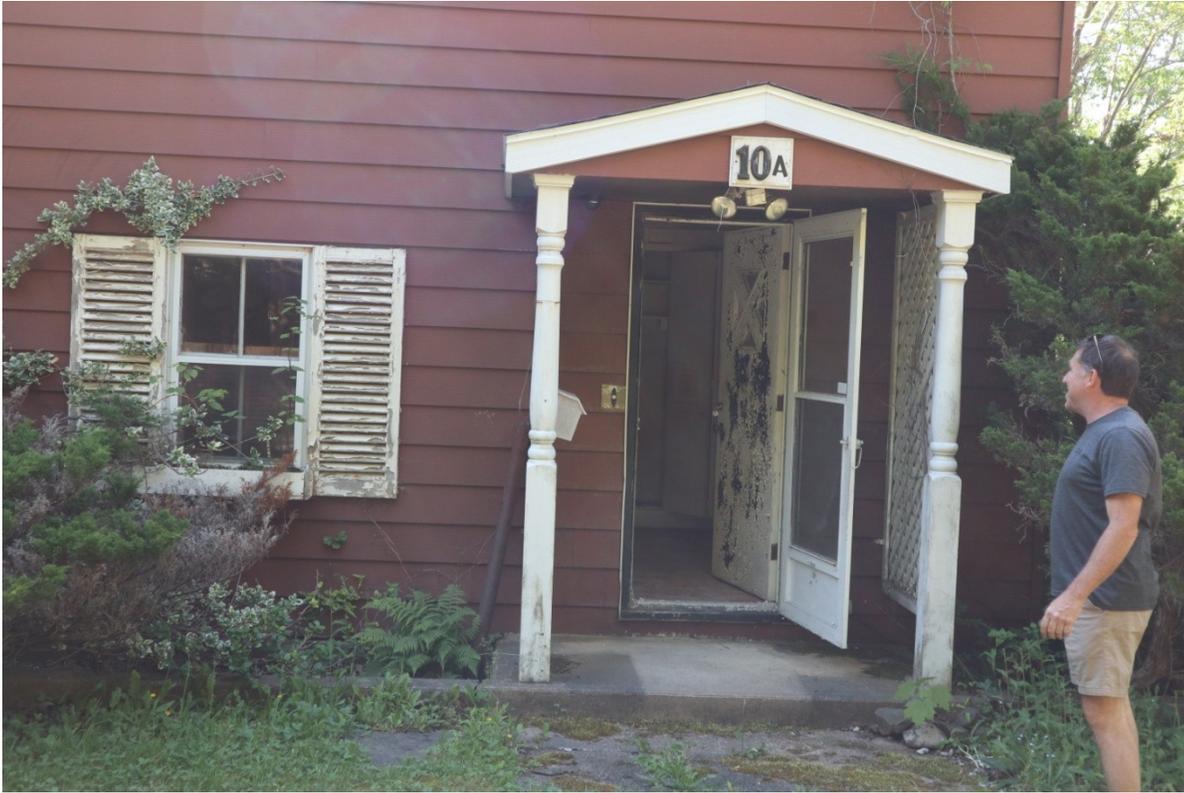
This rot is also evident on the window and window shutters. The windows, which are of both wood and vinyl construction are in generally very bad condition. The wood windows mostly show rot, and the vinyl show a significant build-up of mold.

The shutters are very deteriorated with paint damages and significant mold.

Please see in the photograph below this section of the building exterior.

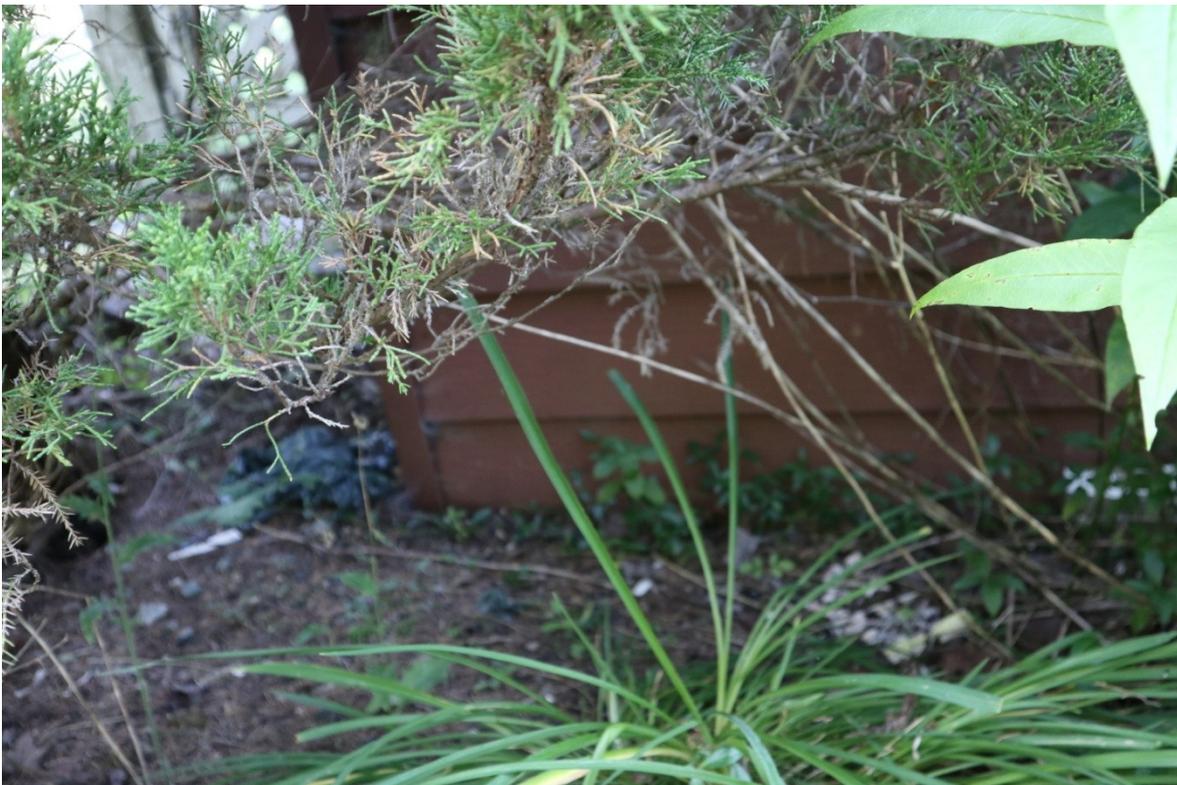
2) The lot grading along to front and side elevations, and a section of the back is totally improper, resulting in water flow towards the building rather than away from the wall. See below.

Compounding this improper condition, there is a good portion of the building exterior wall in which the wood siding is at or near the grade line. This can and probably has led to water infiltration into the building. Visible evidence of this is in the rot and possible mold along the lower coursed of wood siding.

The National Building Code minimum distance from the exterior ground elevation to the top of a building foundation wall is 6 inches. There is great doubt as to whether this distance is maintained around the perimeter of the building. Added onto this problem is that of the water drainage. By code, the ground around the building is to be graded such that the surface water flows away from the property. In this case, surface water flows towards the building.

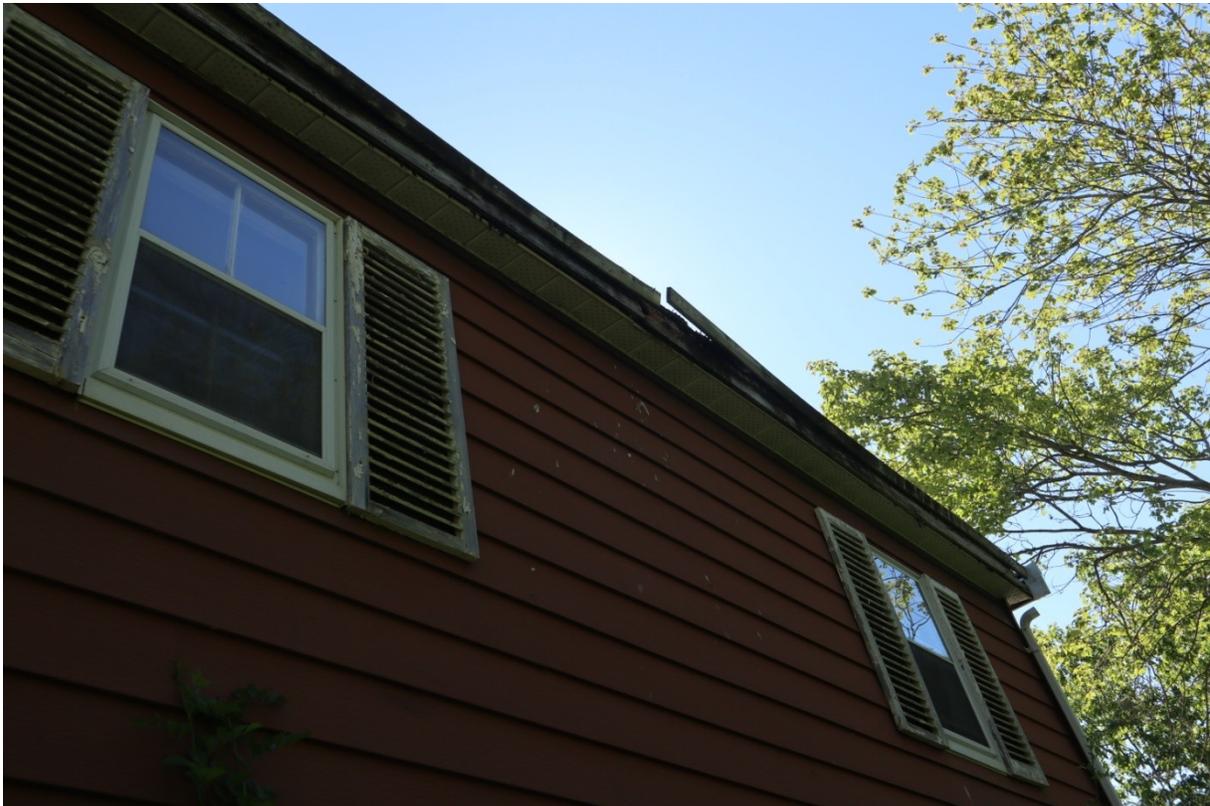
3) The building soffit and fascia were clearly visible as being in very bad condition. See photograph below.

This item is actually in a worse state than is evident in this photograph. The structural components have severe rot. There is even a section where the roof is rotted out clear through to the soffit face allowing water to pour through.

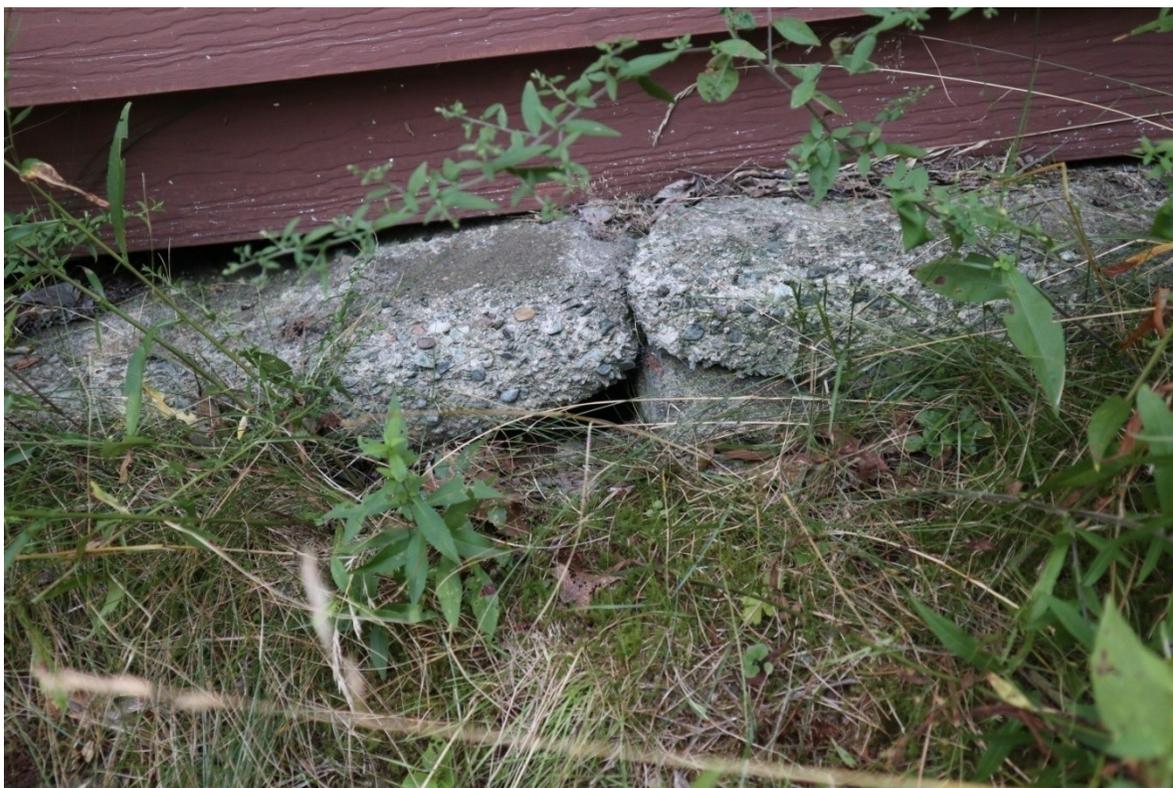
As is evident in the above photograph, the building is resting directly on the footing. Being on the surface of the ground, this footing has visible cracking.

The footing is also not continuous. There are sections where the building appears to be resting on the ground.

Items of note from this photograph are:

- a) There is no frost protection on the foundation leading to up and down movement of the building during the freeze-thaw cycles.
- b) There is major settlement of the building on this face and surrounding area of the building.
- c) Prime location for the infiltration of water, bugs, mice, etc.
- d) Prime location for wood rot and resulting mold formation.

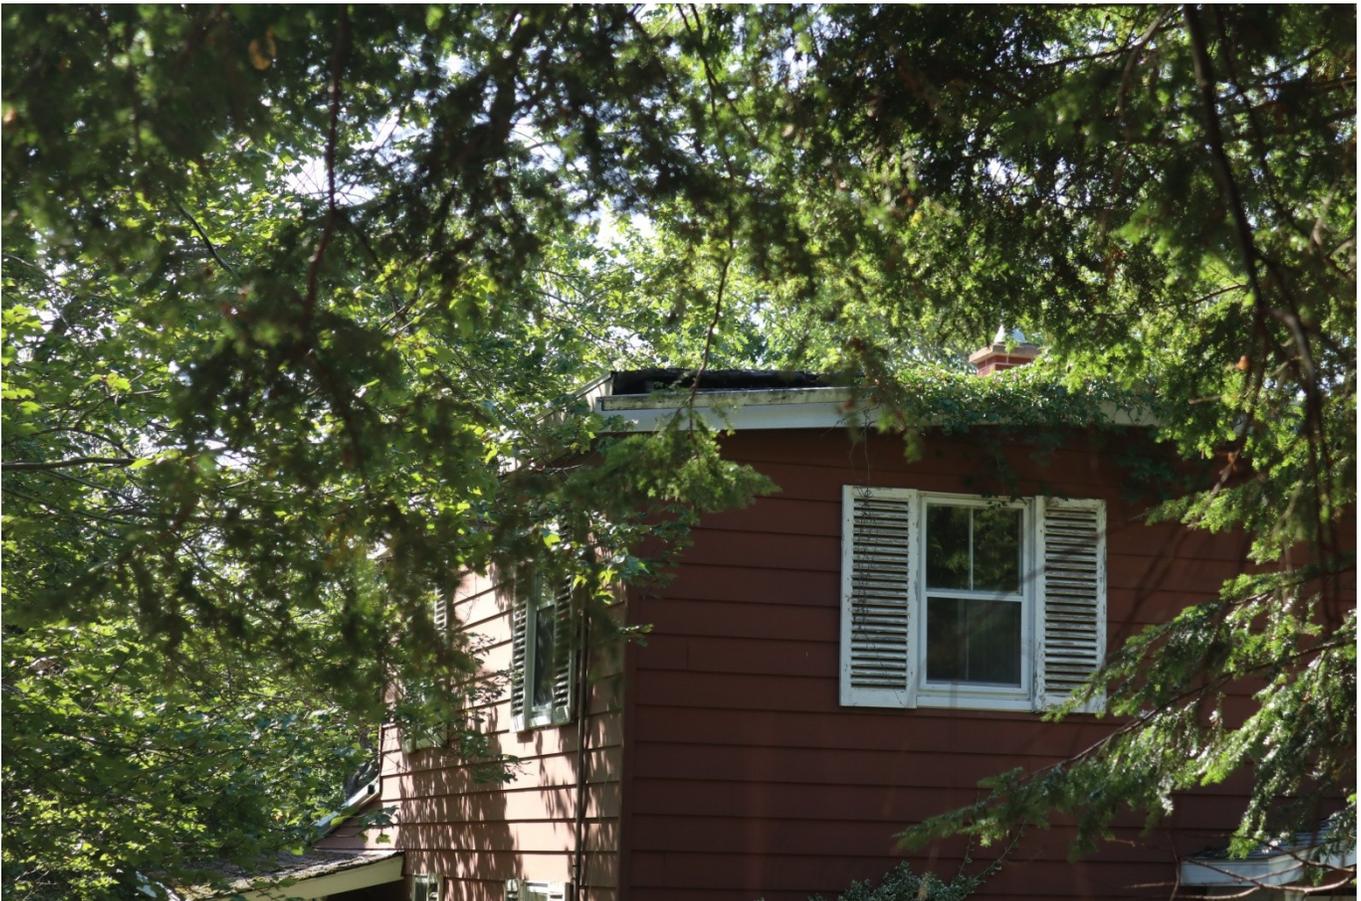
Please see in the photograph below the front face of the building at the roof line. The roof is wide open. It appears that the section of the roof over the soffit has collapsed.

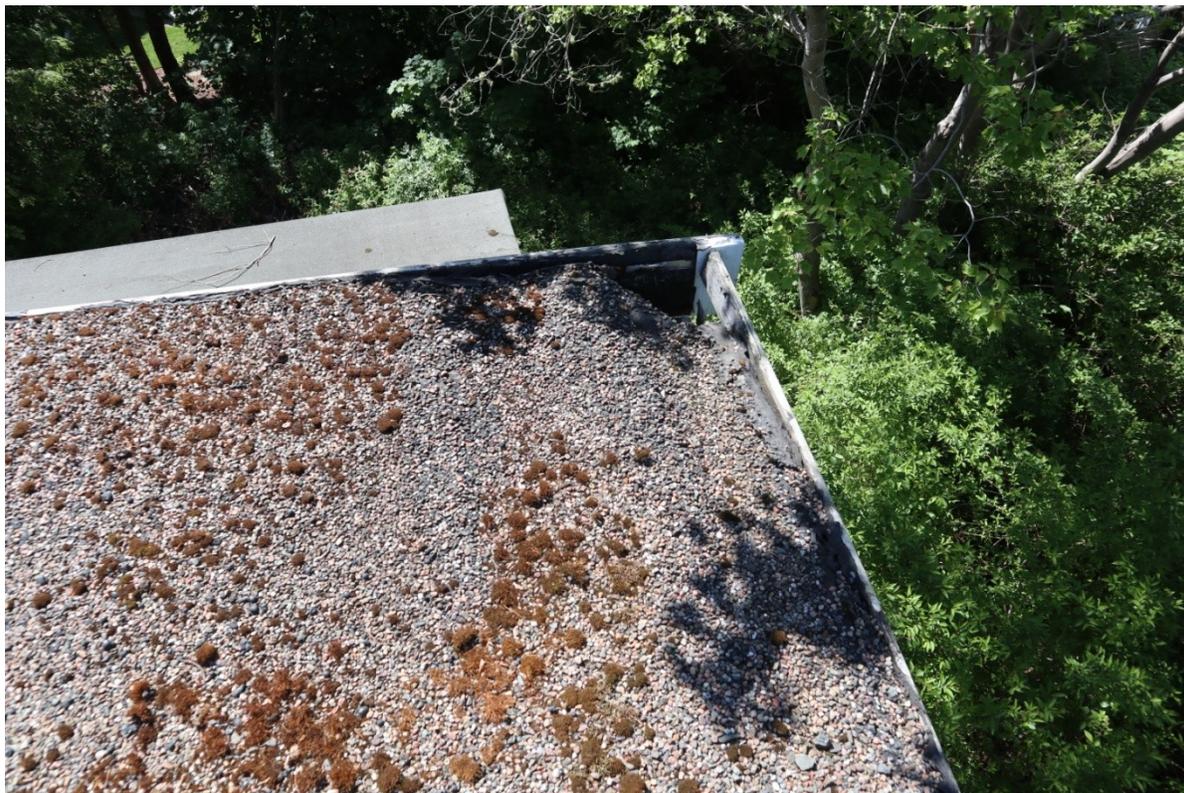
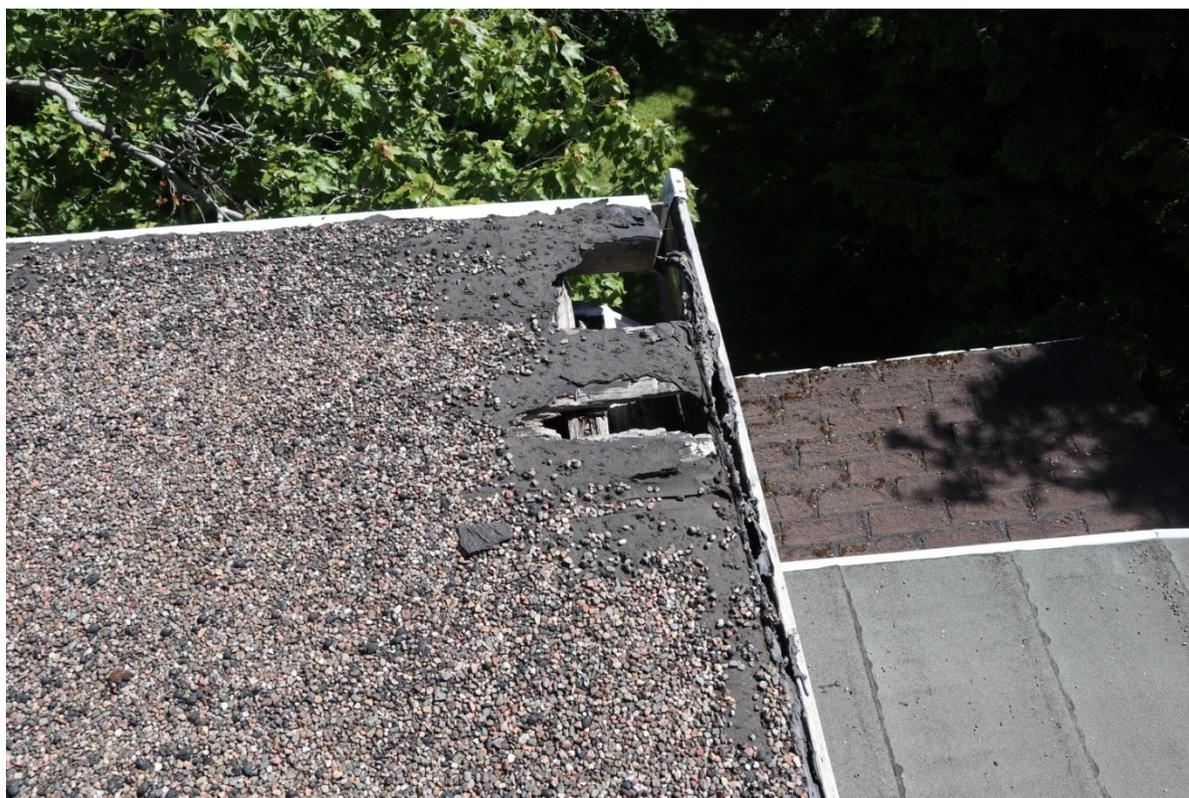
From the top of the roof, on the rear side, there is visible another sections of the roof which have totally collapsed. The first photograph is on the right side, and the second photograph is on the left.

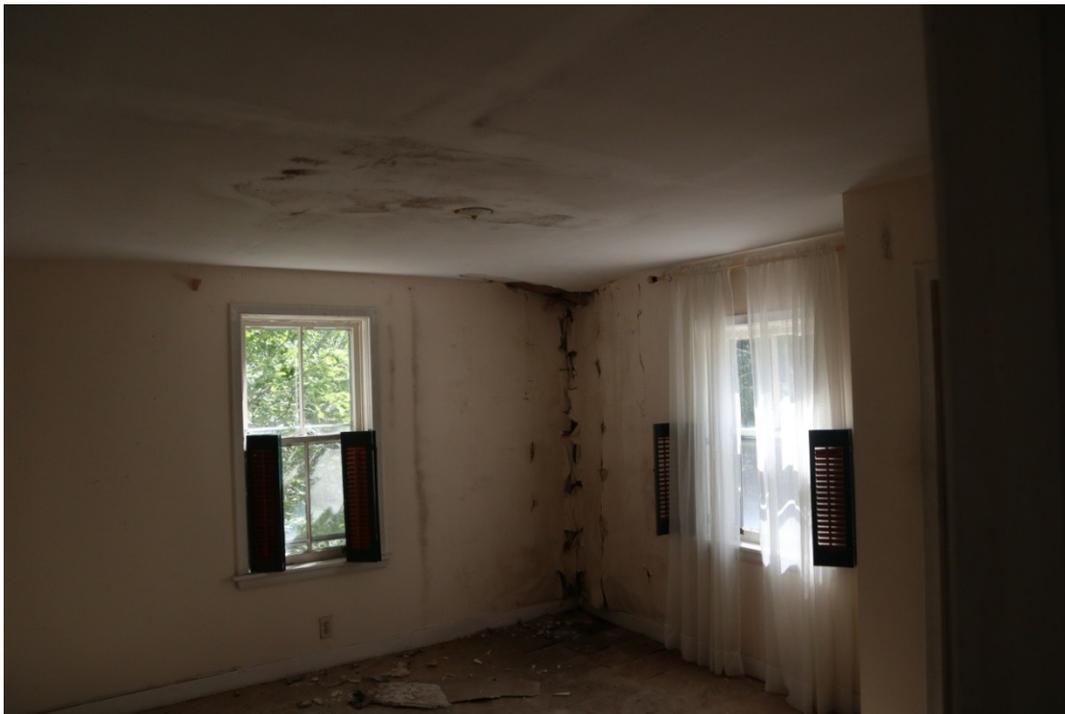
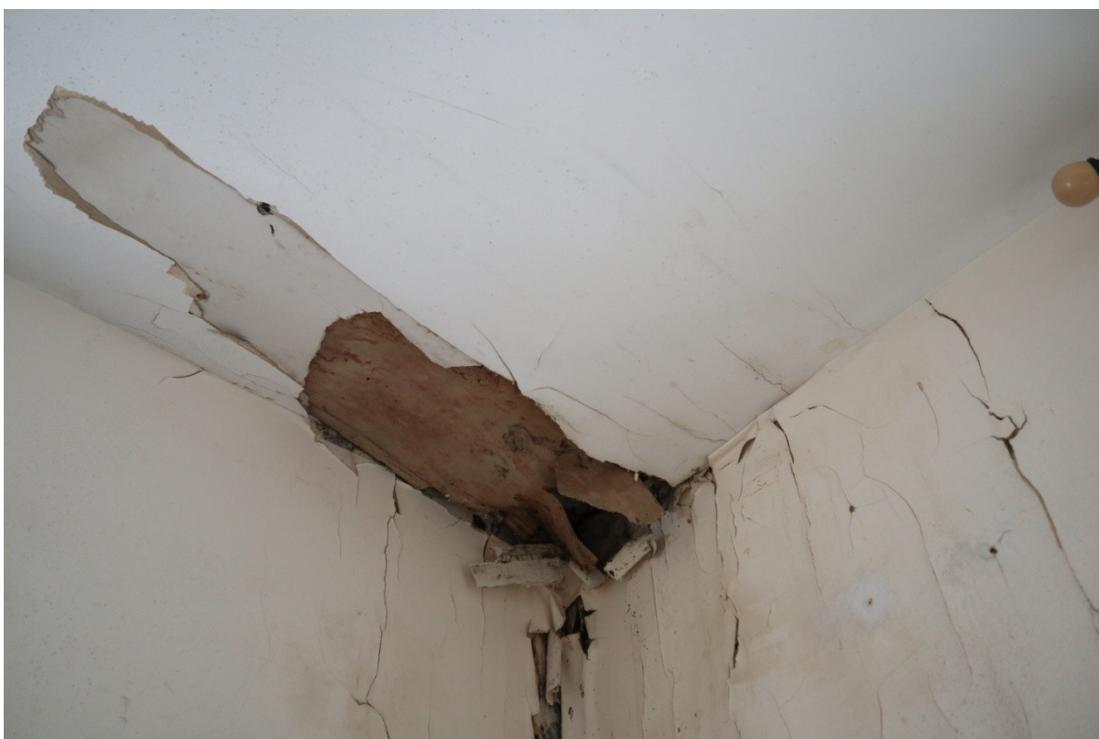
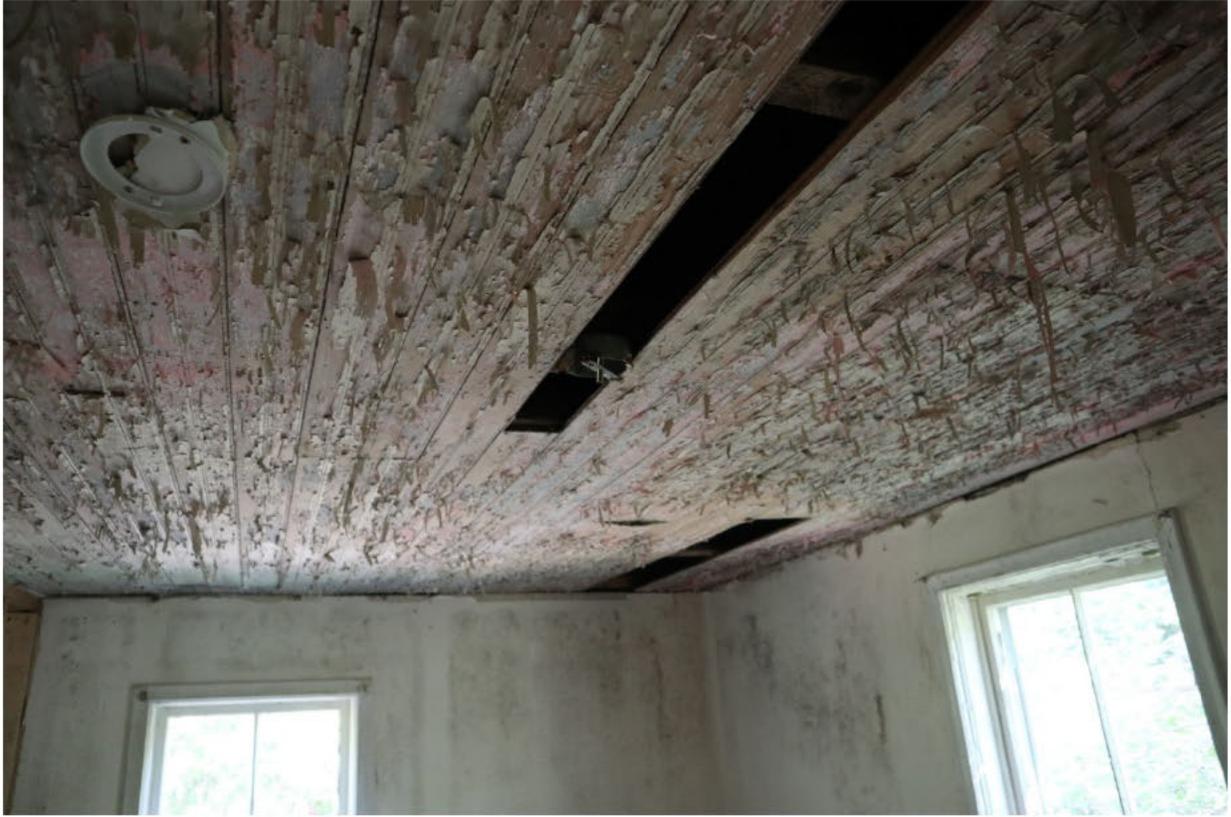
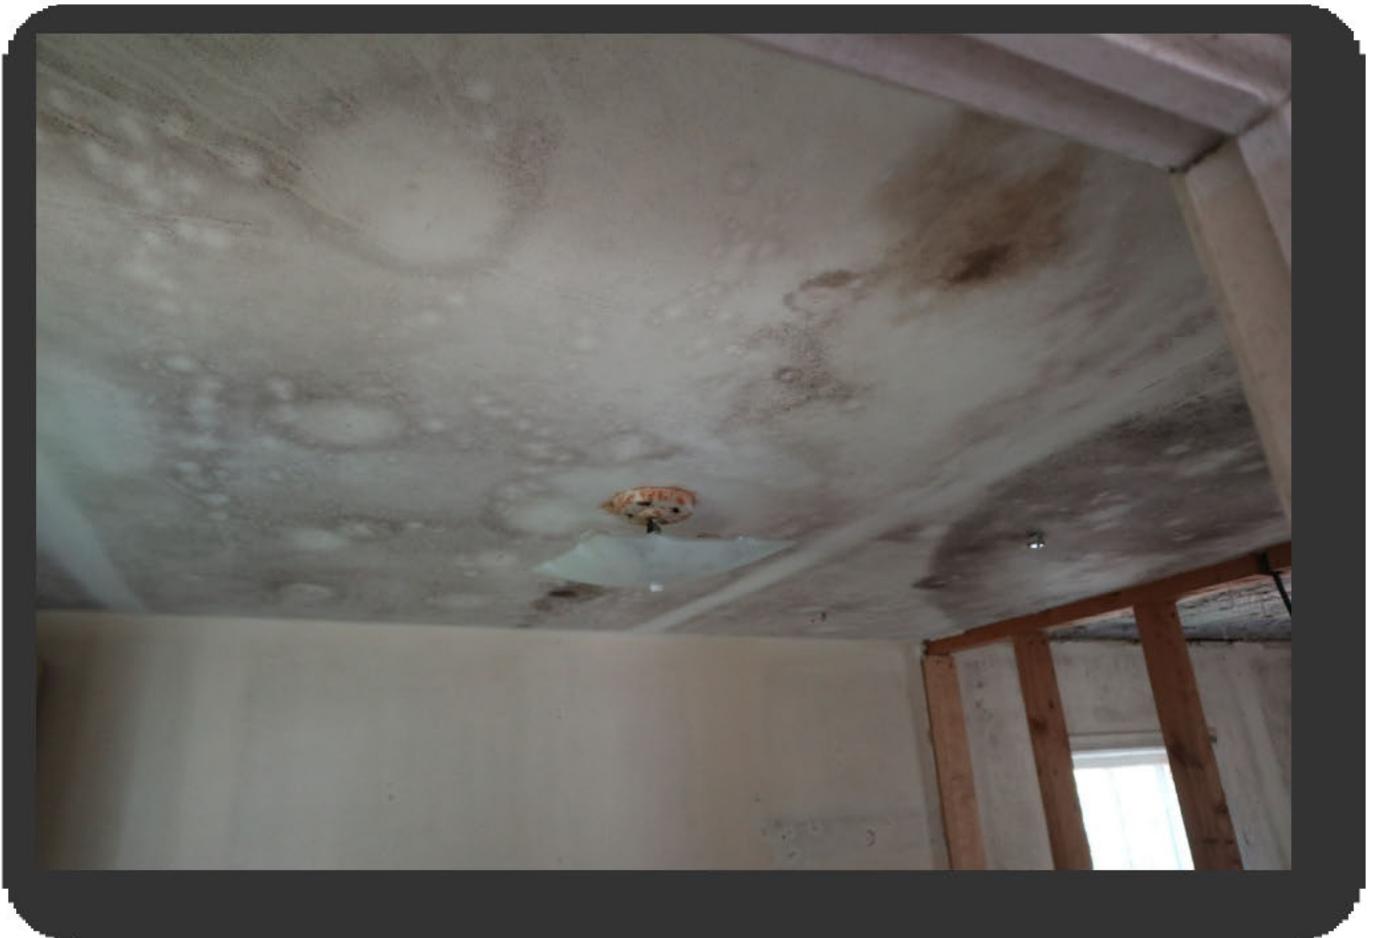
In the building interior, the upper level was viewed, and it basically was in worse state than that which the exterior of the building might have revealed. The conditions in general are quite evident in the following photographs.

As is evident in the previous four photographs there is little of the upper floor level which is considered as worth salvaging. Amongst the defects were:

- a) Numerous punctures of the ceiling drywall caused by what appears to be water infiltration
- b) Rusted out light fixtures and other electrical components, including electrical wiring
- c) Soft drywall or plaster is evident in most locations
- d) Mold all over the surface of the ceilings and the walls
- e) All the flooring is viewed as requiring replacement
- f) Railing on stairs show evidence of rot
- g) Windows and their trim are rotted and are substantially covered in mold

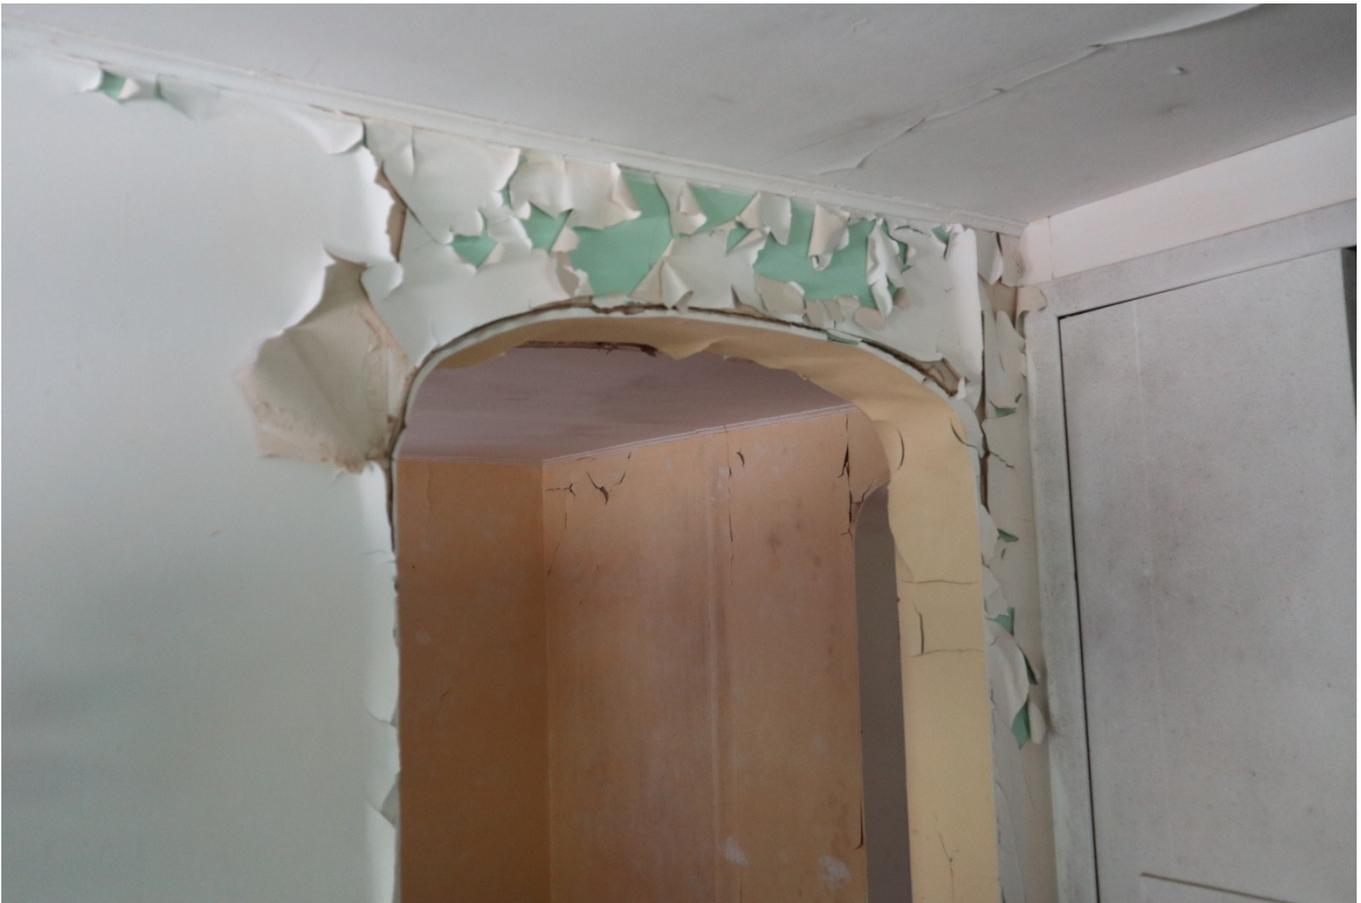
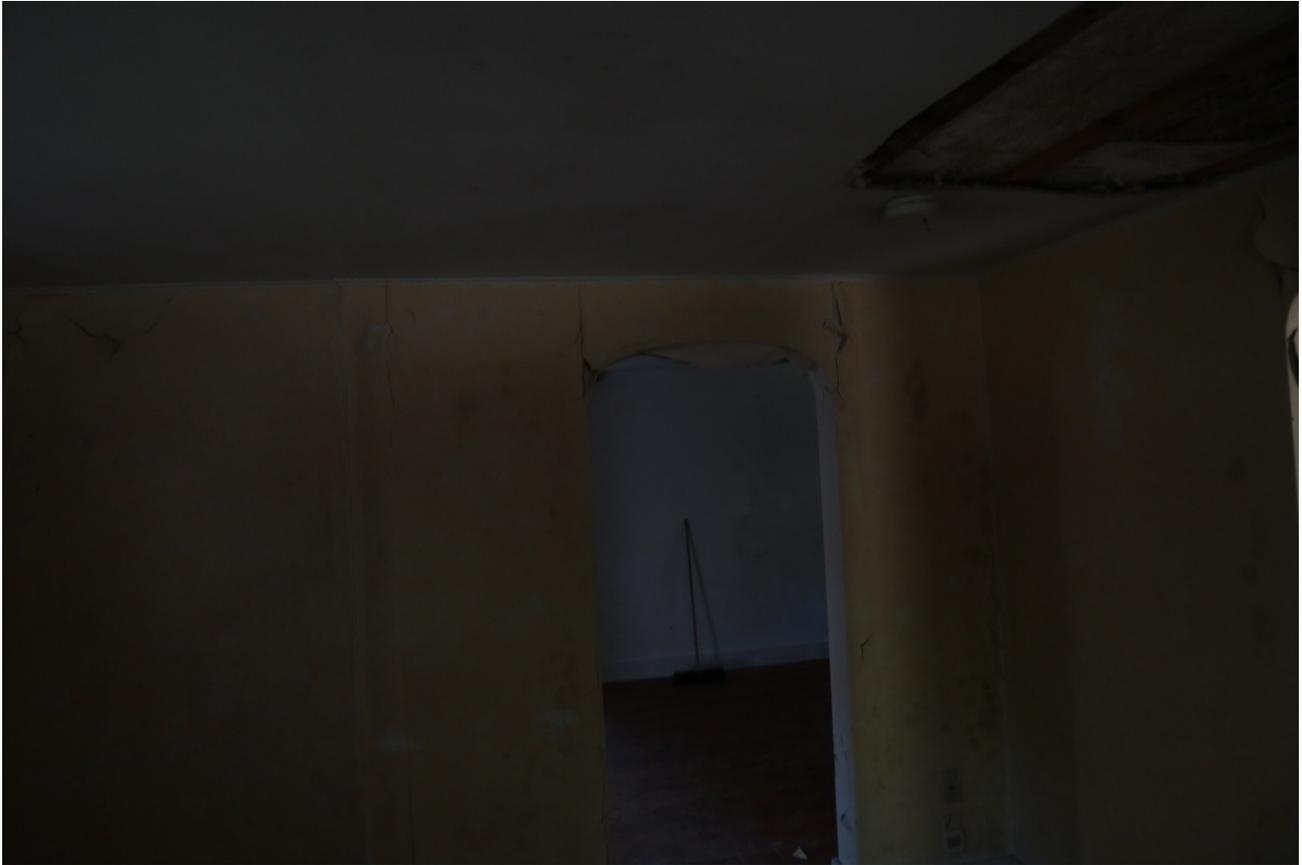
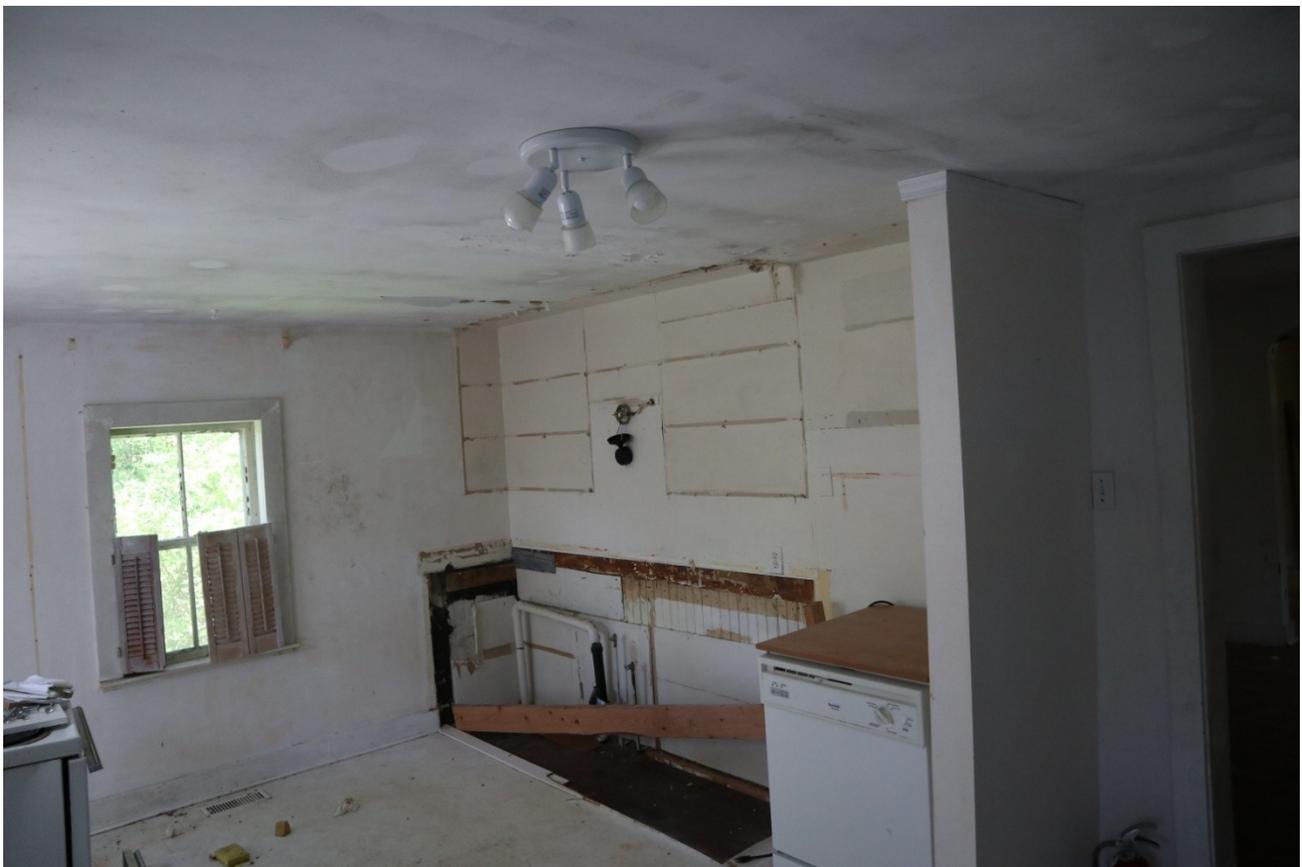
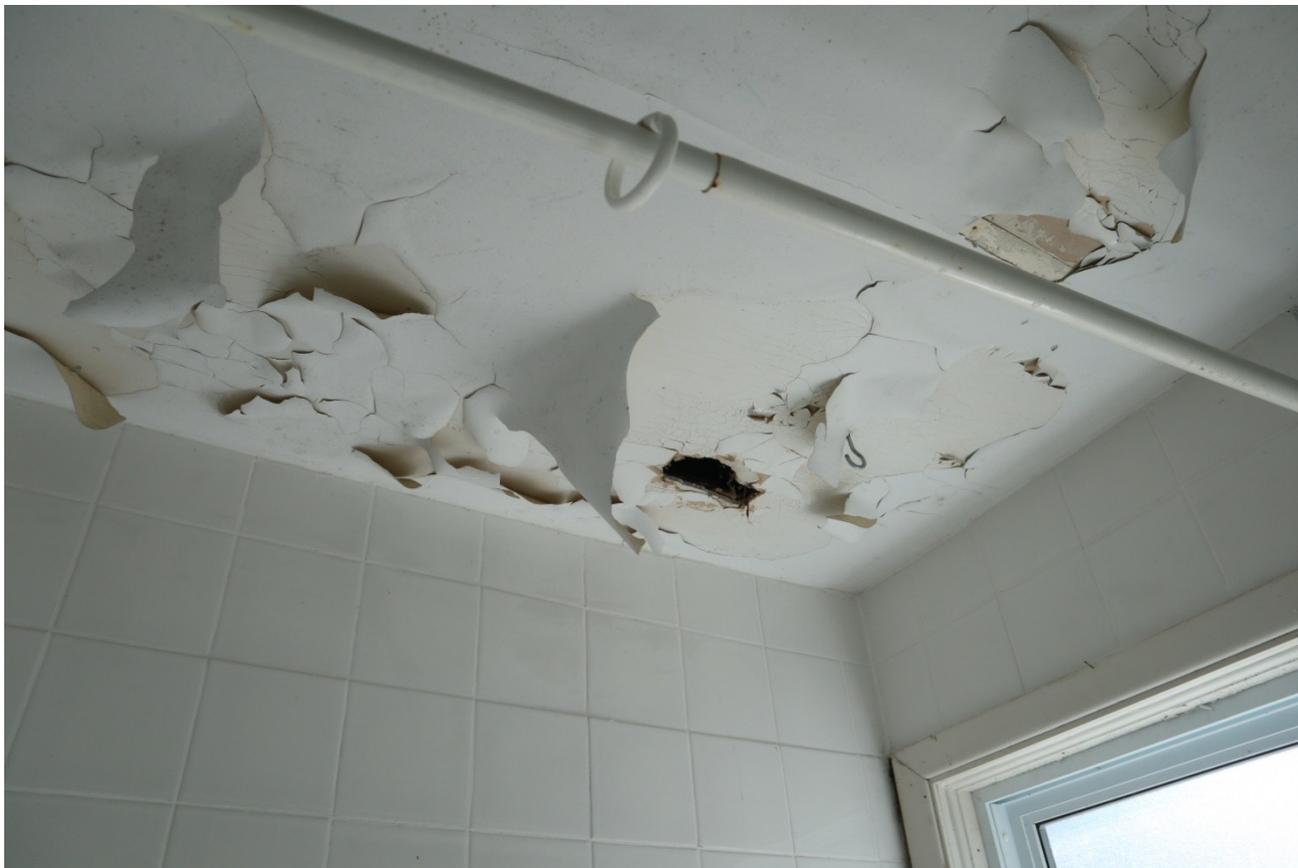
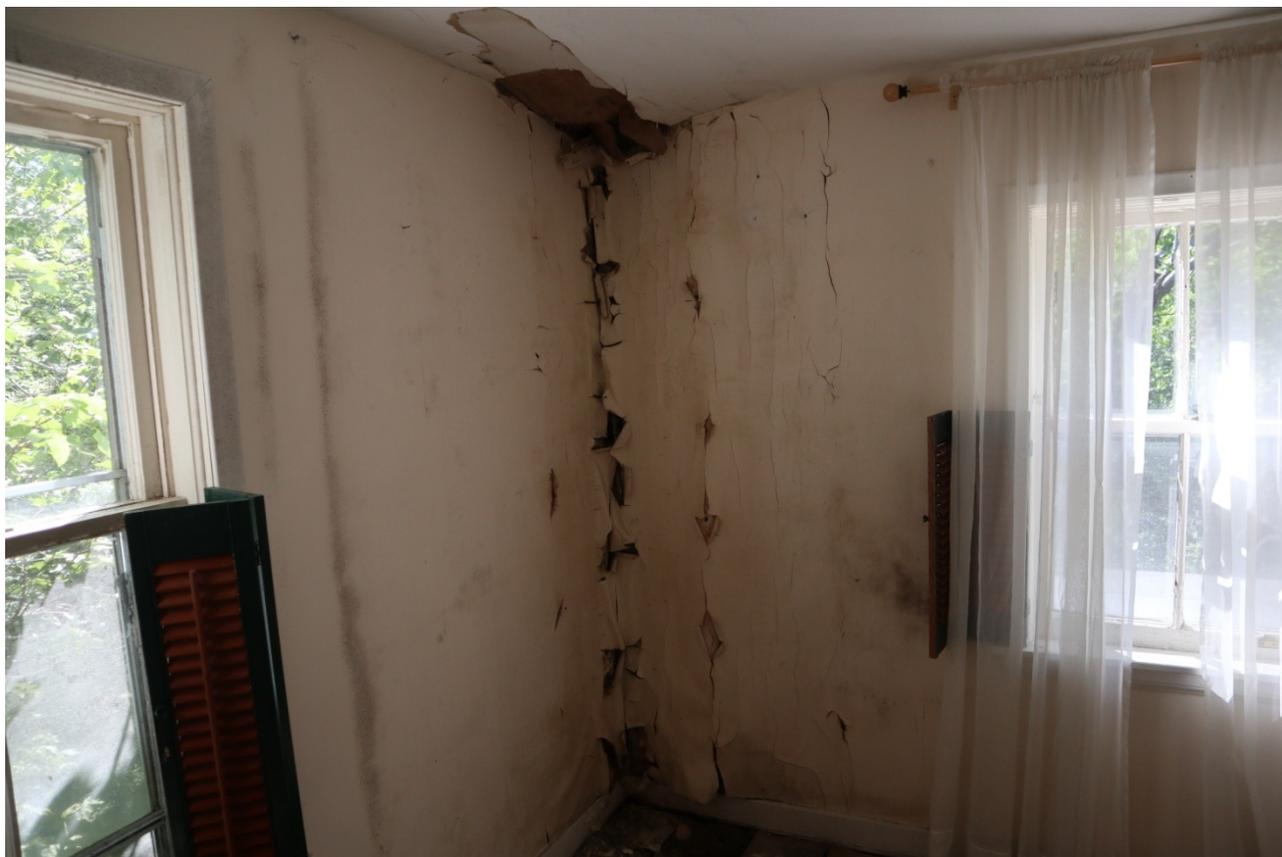
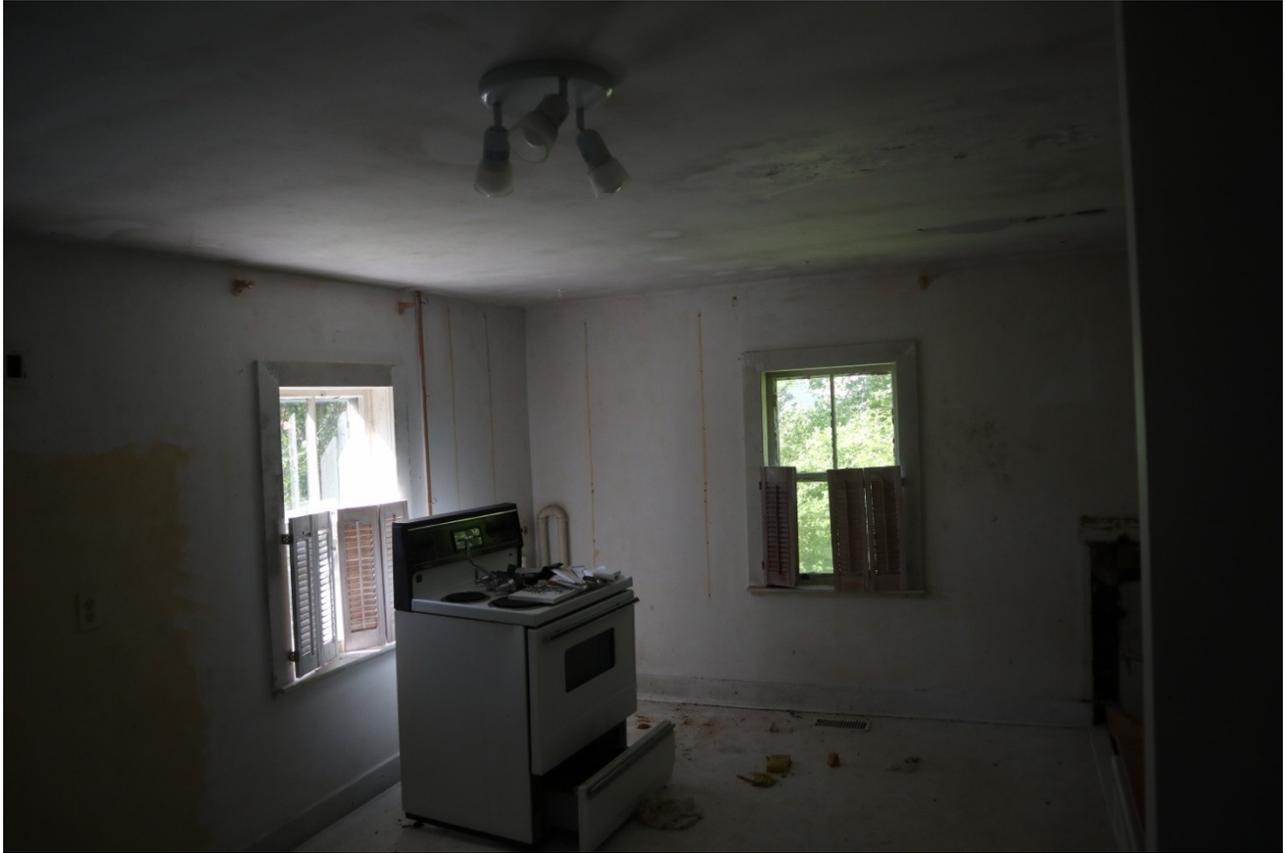
The conditions on the main floor are similar to that in the floor above. See photographs below.

As was evident in the floor above, this level showed little improvement. Amongst the defects were:

- a) Settled floor system, falling from the front to the back of the house
- b) Rusted out light fixtures and other electrical components, including electrical wiring
- c) Soft drywall or plaster is evident in most locations
- d) Mold all over the surface of the ceilings and the walls
- e) All the flooring is viewed as requiring replacement
- f) Windows and their trim are rotted and are substantially covered in mold

The electrical outlets, switches and fixtures were all deteriorated. The complete new wiring of the house is clearly evident. There is little chance that Nova Scotia Power would pass any aspect of the electrical system in the building.

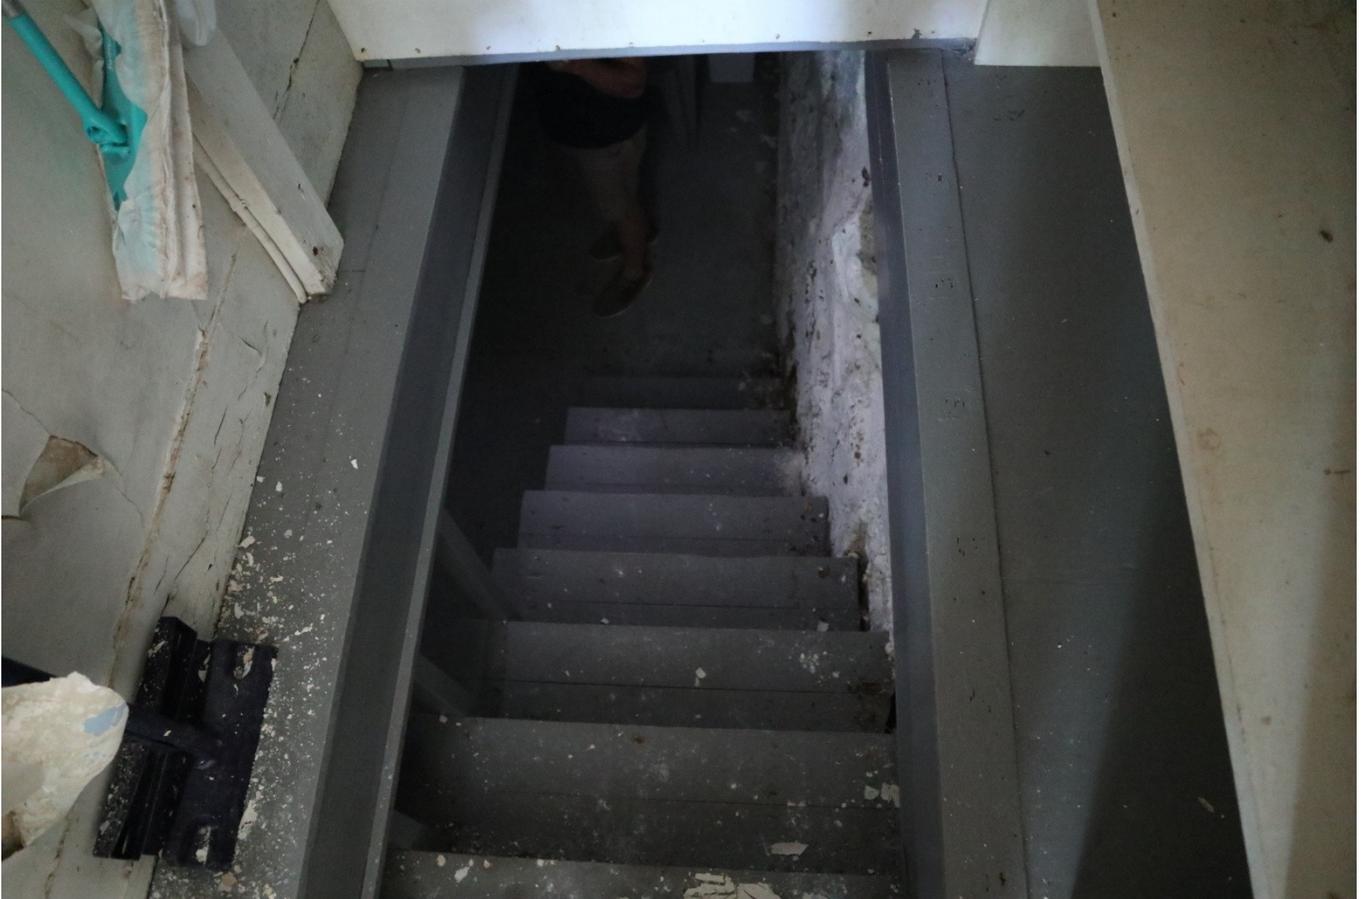
Going down into the basement was a challenge in itself. The stairway was rotted out. It was relatively dark, and a flashlight had to be used in order to get a good idea of the conditions. Please see below some of the photographs taken.

These stairs actually showed better than the upper level stairway, at least in terms of deterioration. However the walls around them were all deteriorated and would require significant upgrade.

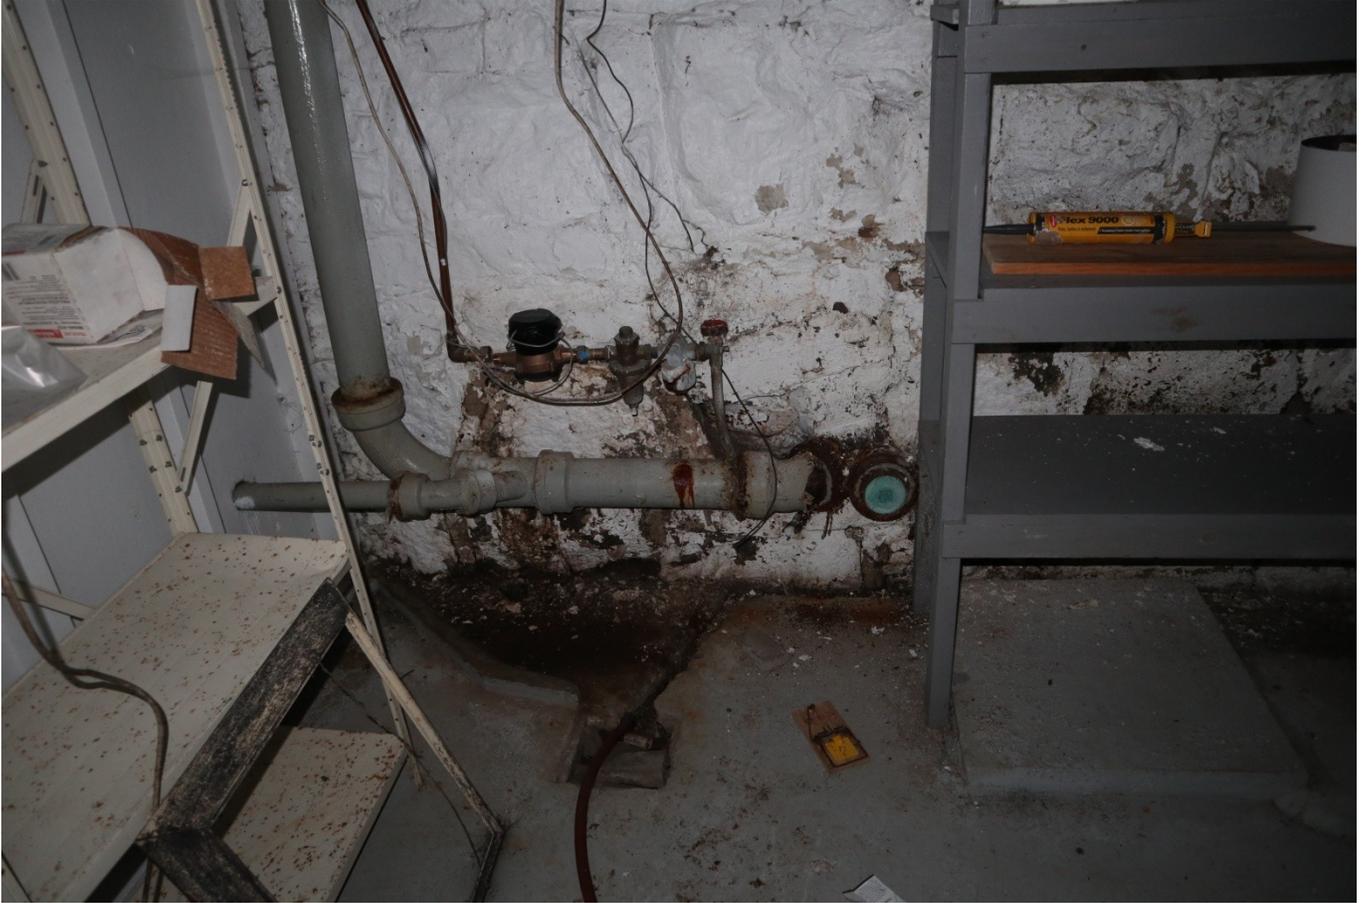
In the two photographs below, is shown the point of sewer and water entry into the building. You can see the rust and mildew on the piping caused by the infiltration of water.

You can also see the area for pooling of water underneath the service lines. This is one of many points of water entry into the basement. The foundation walls are of rock construction, and easily allow water to enter through cavities between the rock.

Amongst the defects on this level were:

- a) Rusted out light fixtures and other electrical components, including electrical wiring
- b) Ponding of water in various locations
- c) Water entry through the foundation walls
