Item No. 9.1.1
Heritage Advisory Committee
July 26, 2023

SUBJECT: **Case H00528: Substantial Alteration to the municipally registered heritage property at 10 Kirk Road, Halifax**

4.0 - Assessment of Existing Conditions

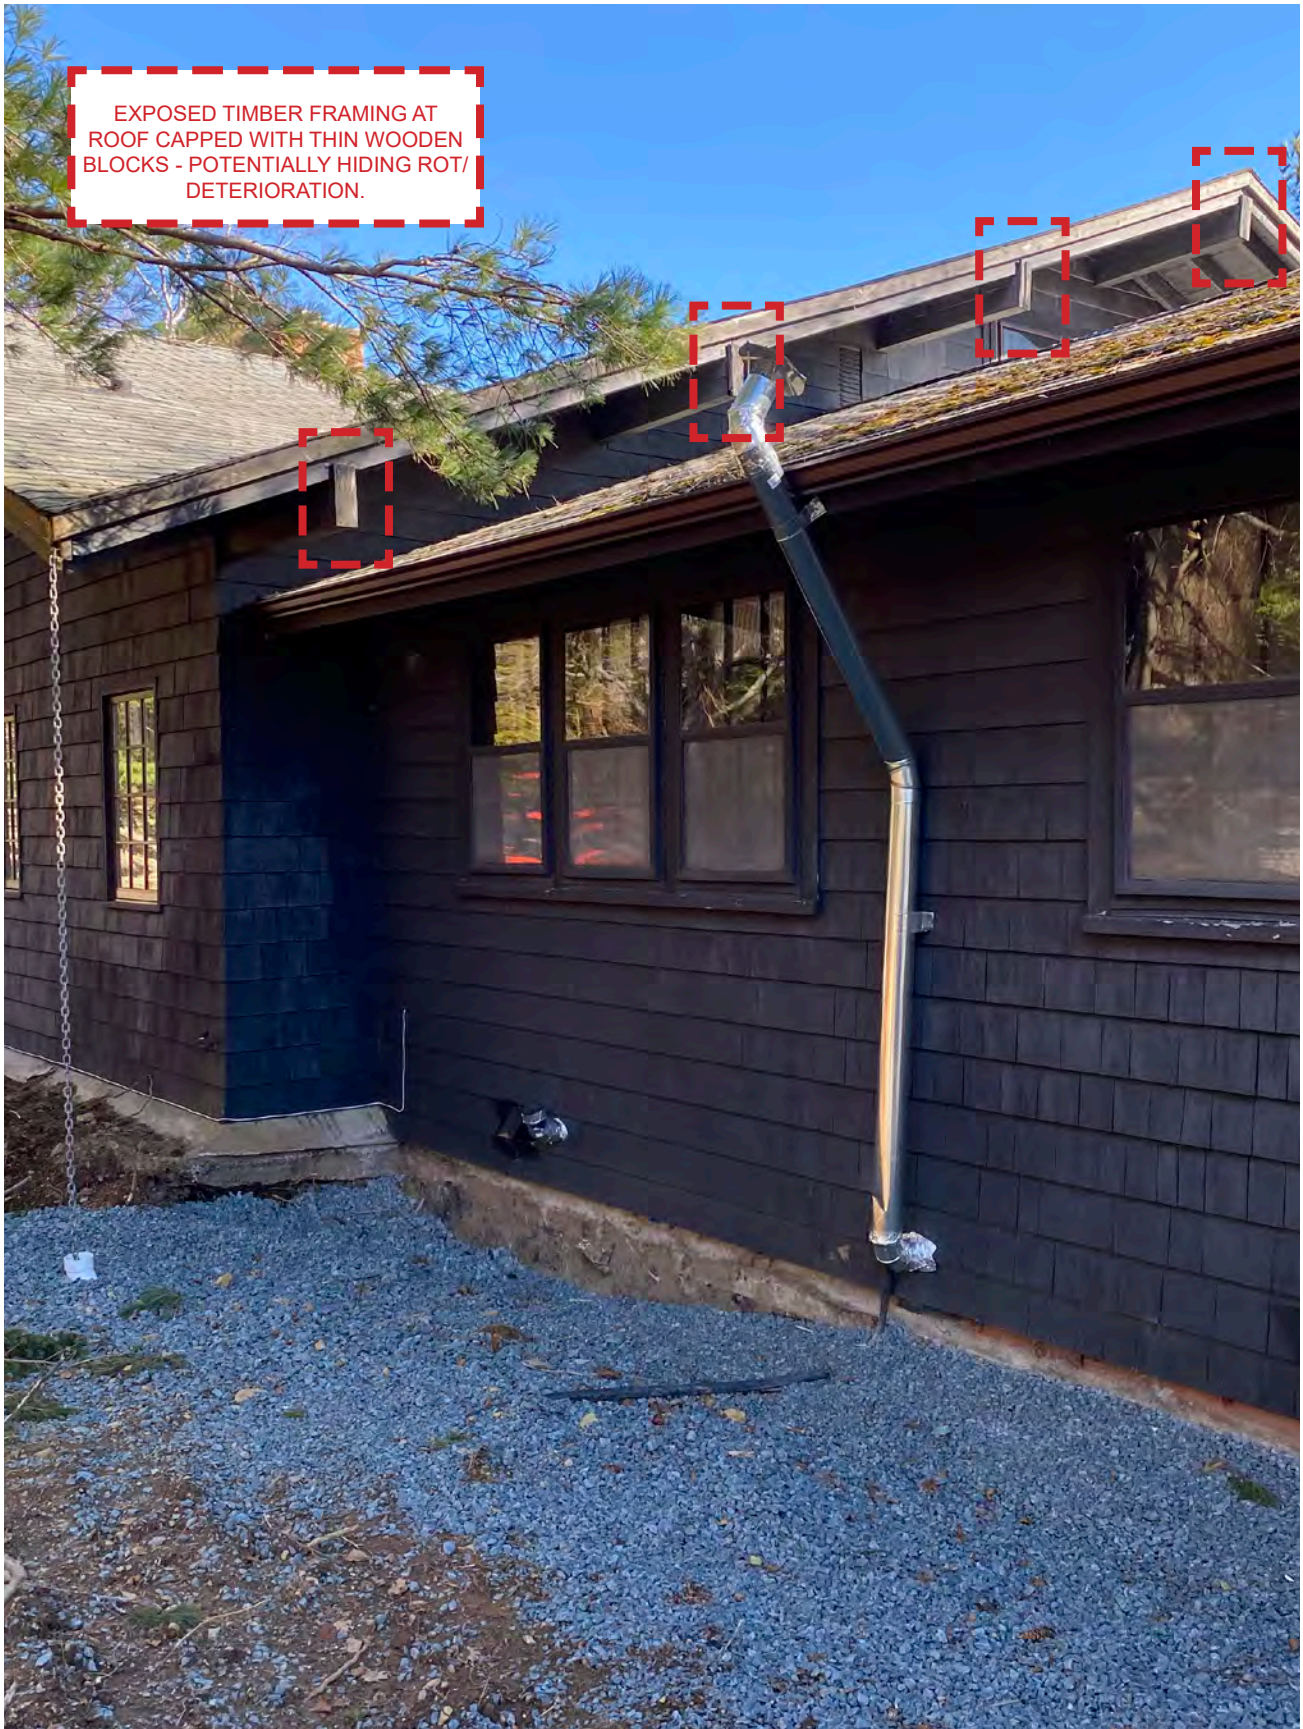
2.1 INTERSECTION OF ANNEX & MAIN HOUSE (SOUTH SIDE).

Additionally, the exposed timber framing members projecting out from the building on the north and south sides were found to be capped (at the ends) with thin wooden blocks, potentially hiding rot or deterioration (refer to AFRR image 2.1).

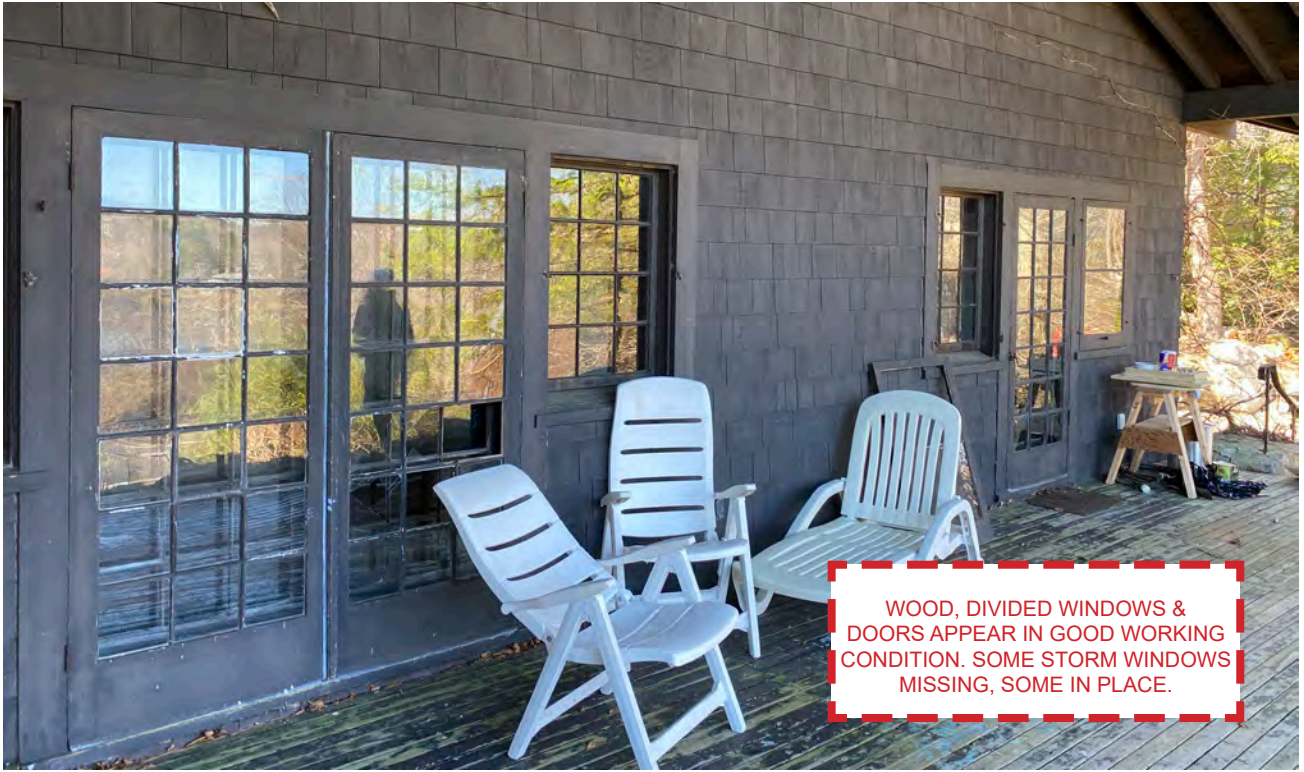
2.5 EXTERIOR WINDOWS & DOORS AT COVERED PORCH (EAST SIDE).

The exterior wood windows and doors (true divided, six over six windows and true divided, 21 pane doors) found at the covered porch appear largely intact and in good condition (refer to AFRR images 2.5 and 2.6). These windows and doors should be further examined to determine the extent of maintenance and repair work required. Some storm windows are missing, and some muntins and panes are missing. Sills, jambs, and casings should also be further examined for any maintenance and repair work required.

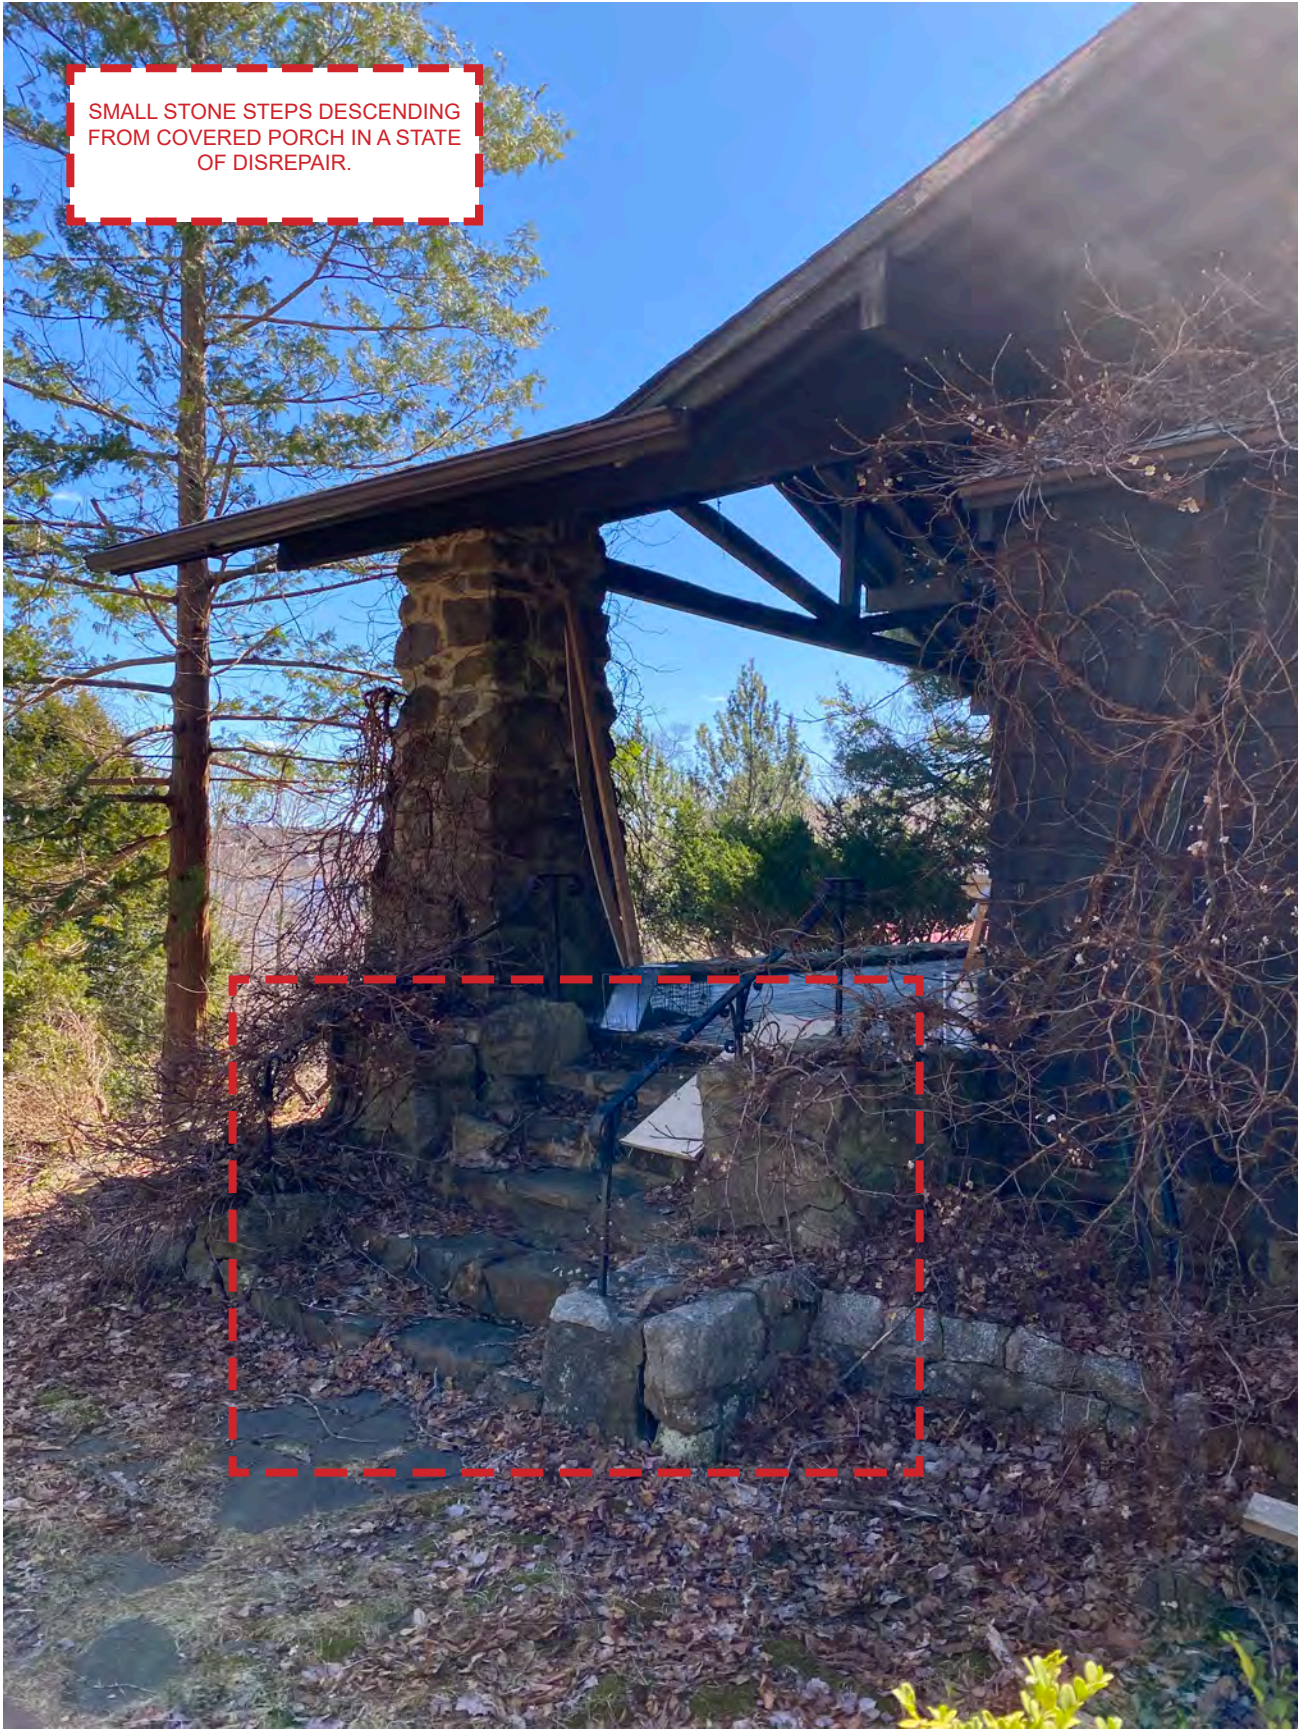
2.10 SMALL STONE STEPS LEADING TO COVERED PORCH (NORTH SIDE).

SMALL STONE STEPS DESCENDING FROM COVERED PORCH IN A STATE OF DISREPAIR.

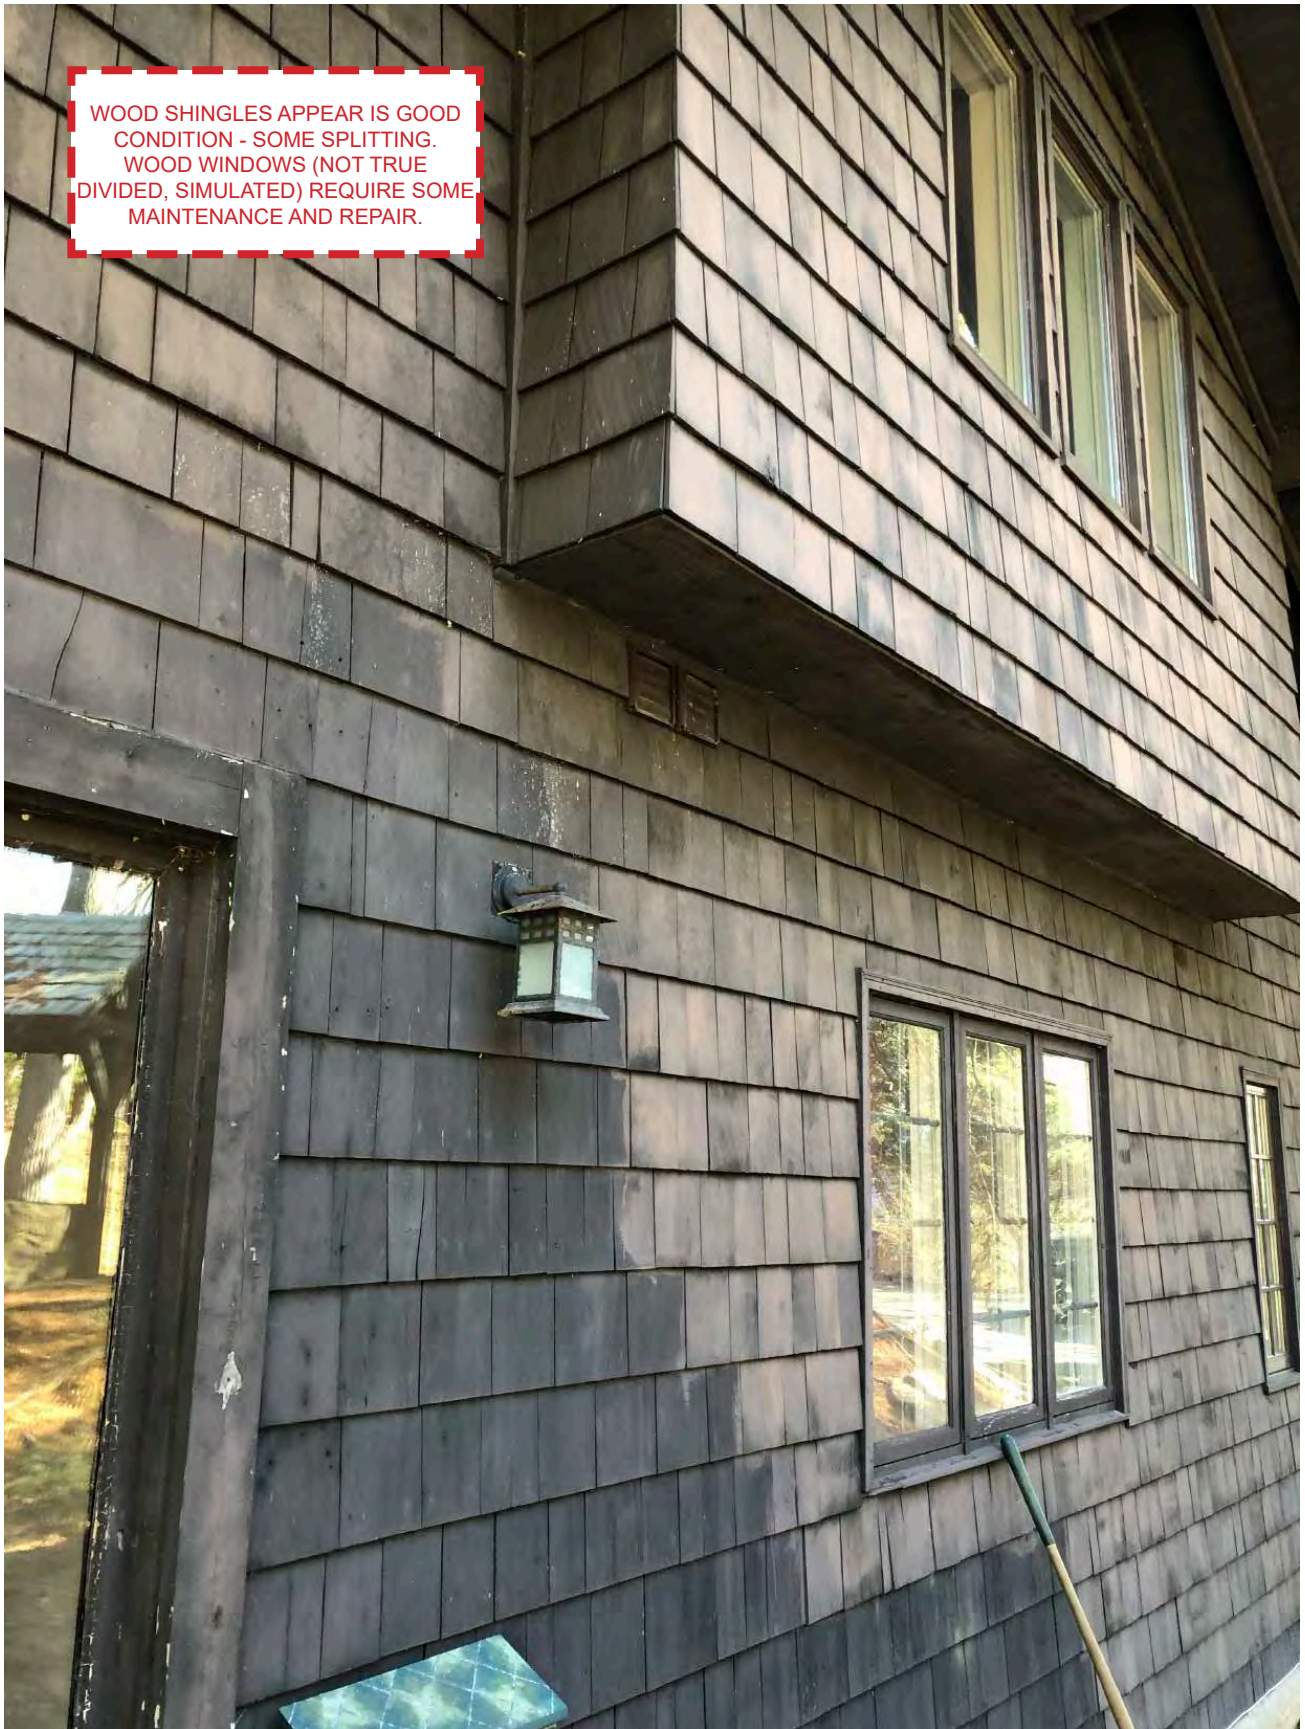
2.12 BUMP OUT AT UPPER LEVEL (WEST SIDE).

Some simulated divided wood windows were observed on the west side of the house, main and upper floors (refer to AFRR image 2.12). The layout and arrangement of these windows differs from the original drawings by Brown (refer to West Elevation sheet No 2). The main entry door and sidelites are not original to the house (refer to AFRR image 2.11).

The wood shingle cladding on the sidewalls generally appears in good condition. Some minor splitting was observed (refer to AFRR image 2.12). Shingles appear mostly flat with no major curling, cupping, bowing, or warping. The paint finish is in good condition - some fading but no major cracking or peeling was observed.

WOOD SHINGLES APPEAR IS GOOD
CONDITION - SOME SPLITTING.
WOOD WINDOWS (NOT TRUE
DIVIDED, SIMULATED) REQUIRE SOME
MAINTENANCE AND REPAIR.

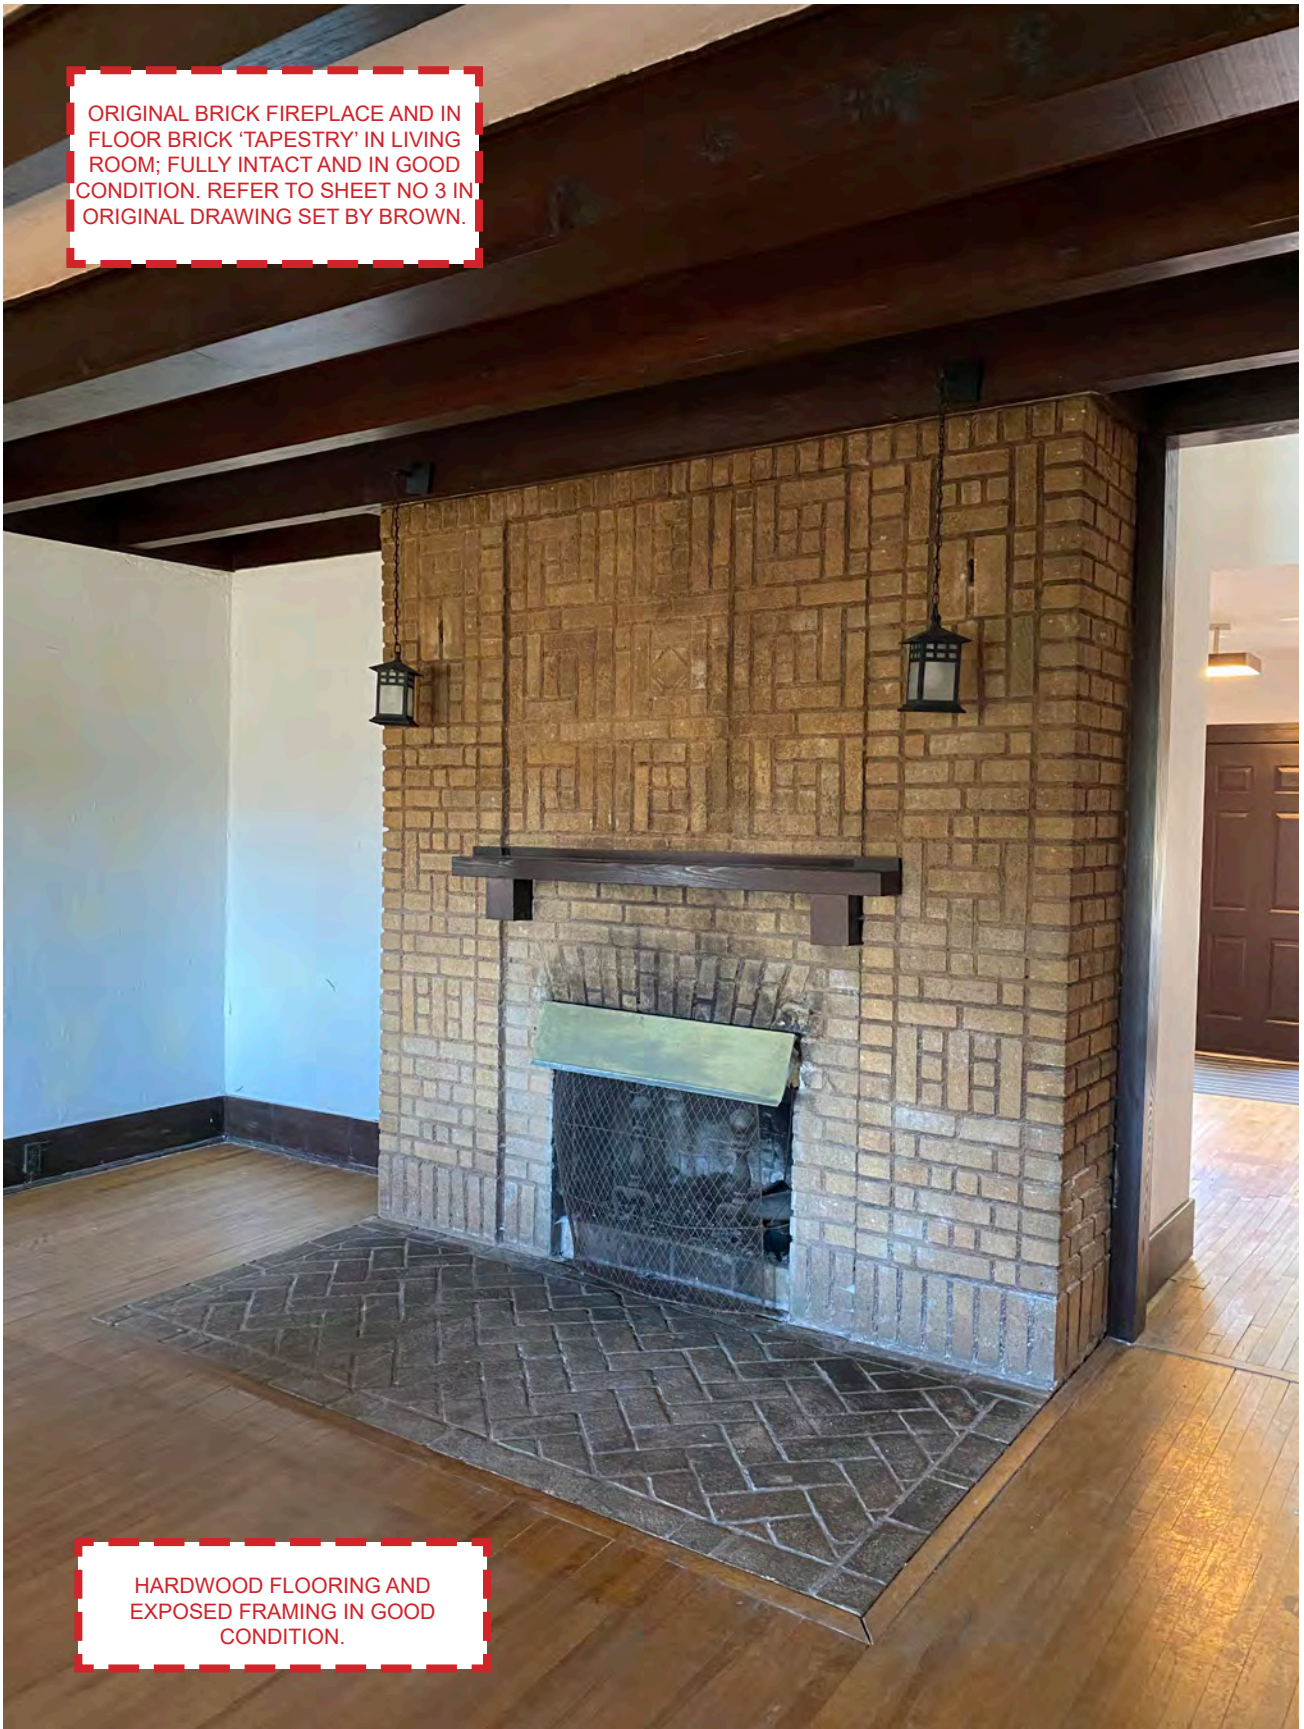
2.14 MAIN FLOOR LIVING AREA.

HARDWOOD FLOORING AND EXPOSED FRAMING IN GOOD CONDITION.

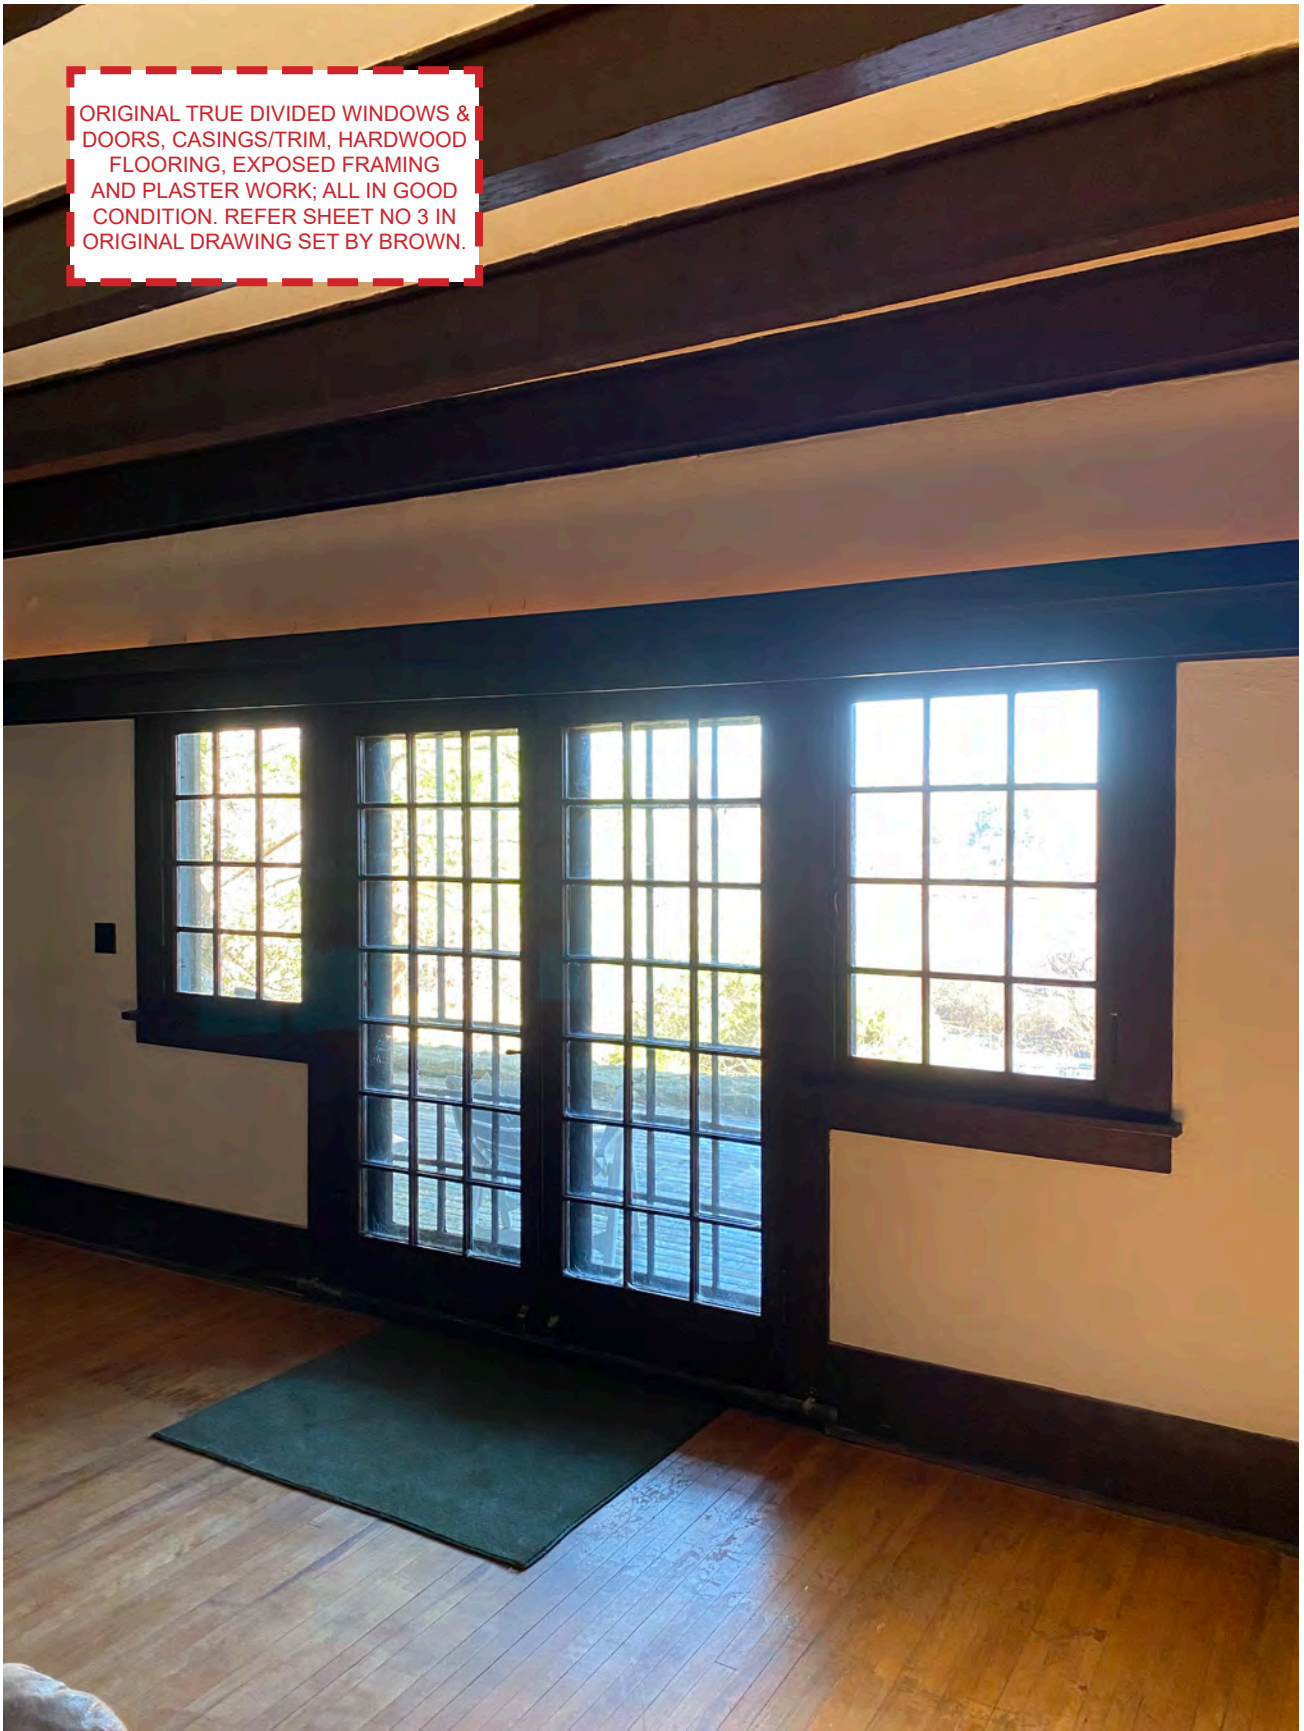
2.16 MAIN FLOOR LIVING ROOM (EAST).

ORIGINAL TRUE DIVIDED WINDOWS & DOORS, CASINGS/TRIM, HARDWOOD FLOORING, EXPOSED FRAMING AND PLASTER WORK; ALL IN GOOD CONDITION. REFER SHEET NO 3 IN ORIGINAL DRAWING SET BY BROWN.

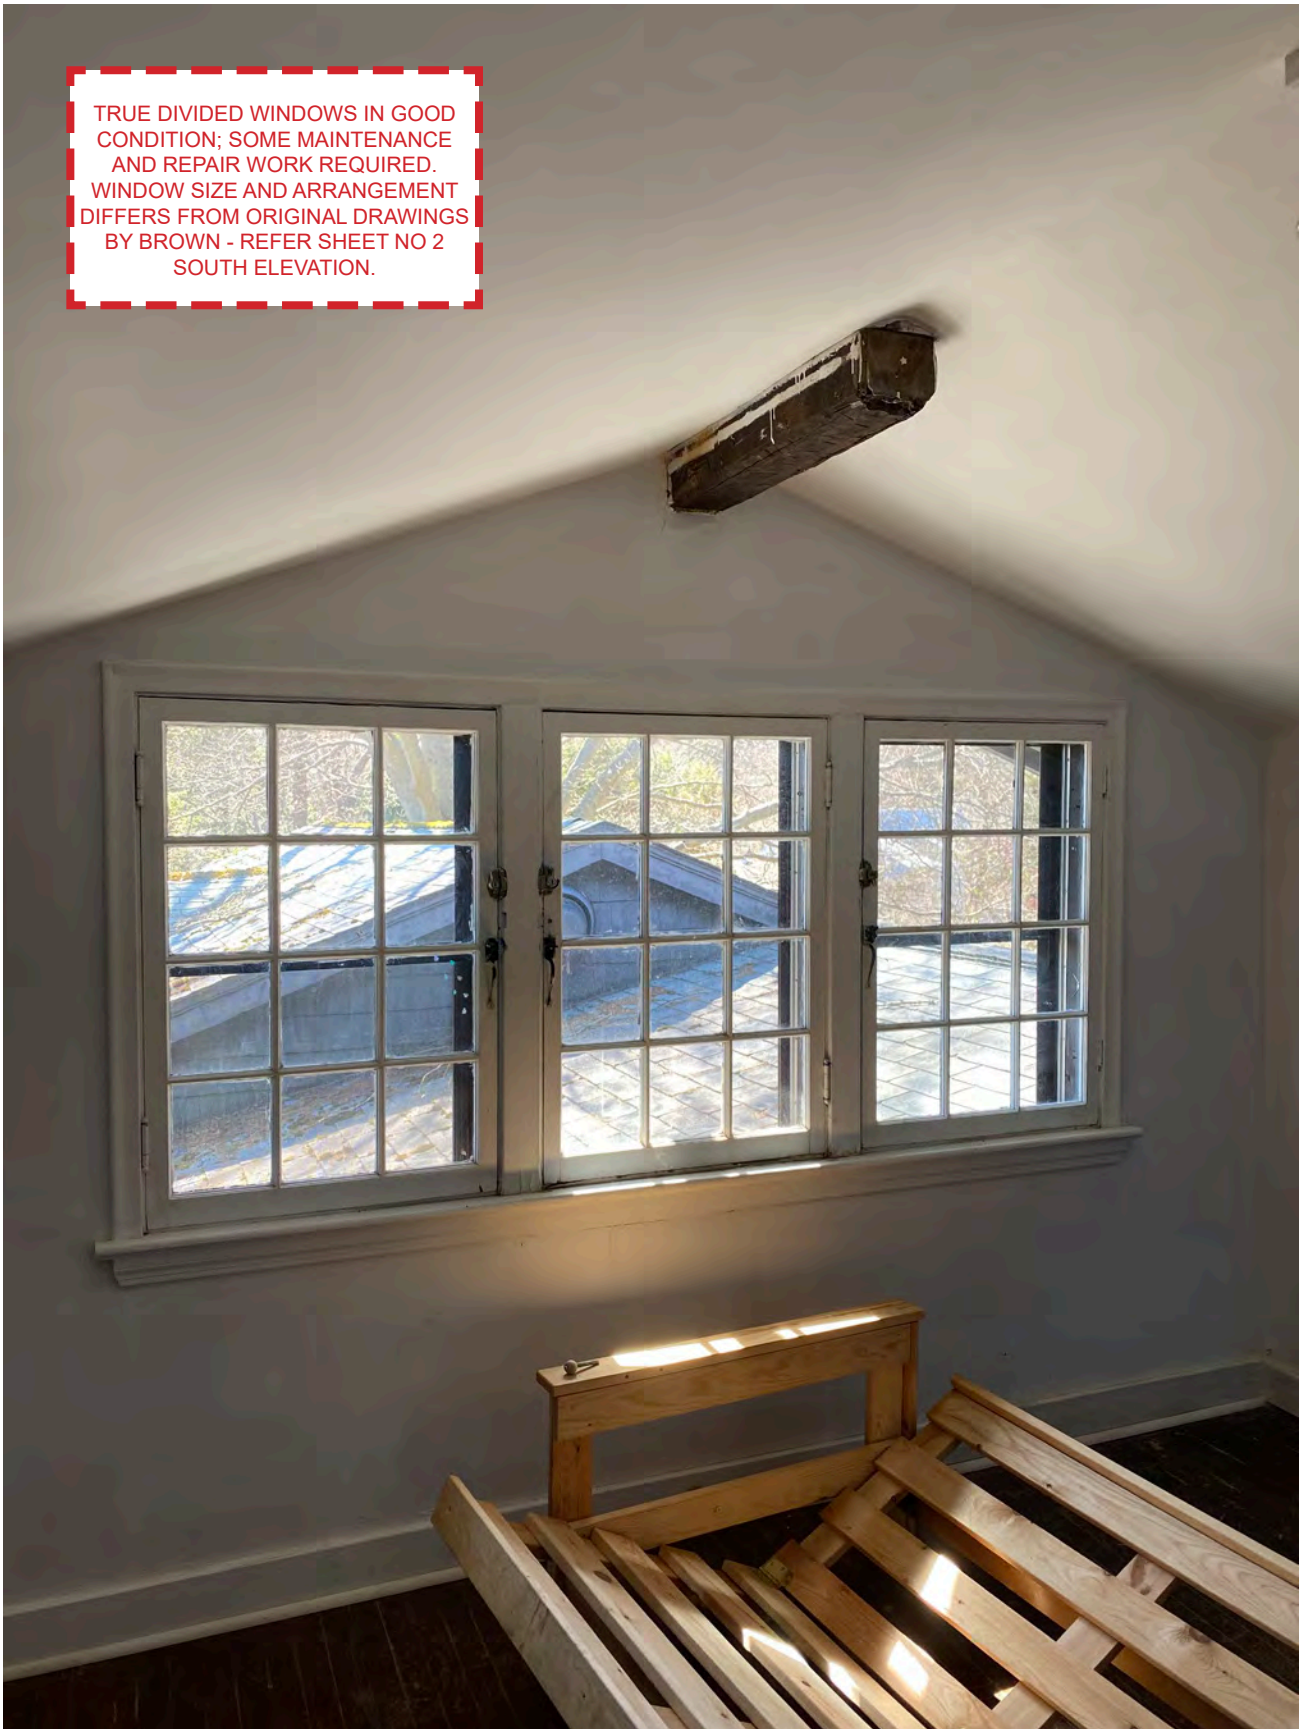
2.19 BEDROOM, UPPER FLOOR (SOUTH SIDE).

TRUE DIVIDED WINDOWS IN GOOD
CONDITION; SOME MAINTENANCE
AND REPAIR WORK REQUIRED.
WINDOW SIZE AND ARRANGEMENT
DIFFERS FROM ORIGINAL DRAWINGS
BY BROWN - REFER SHEET NO 2
SOUTH ELEVATION.

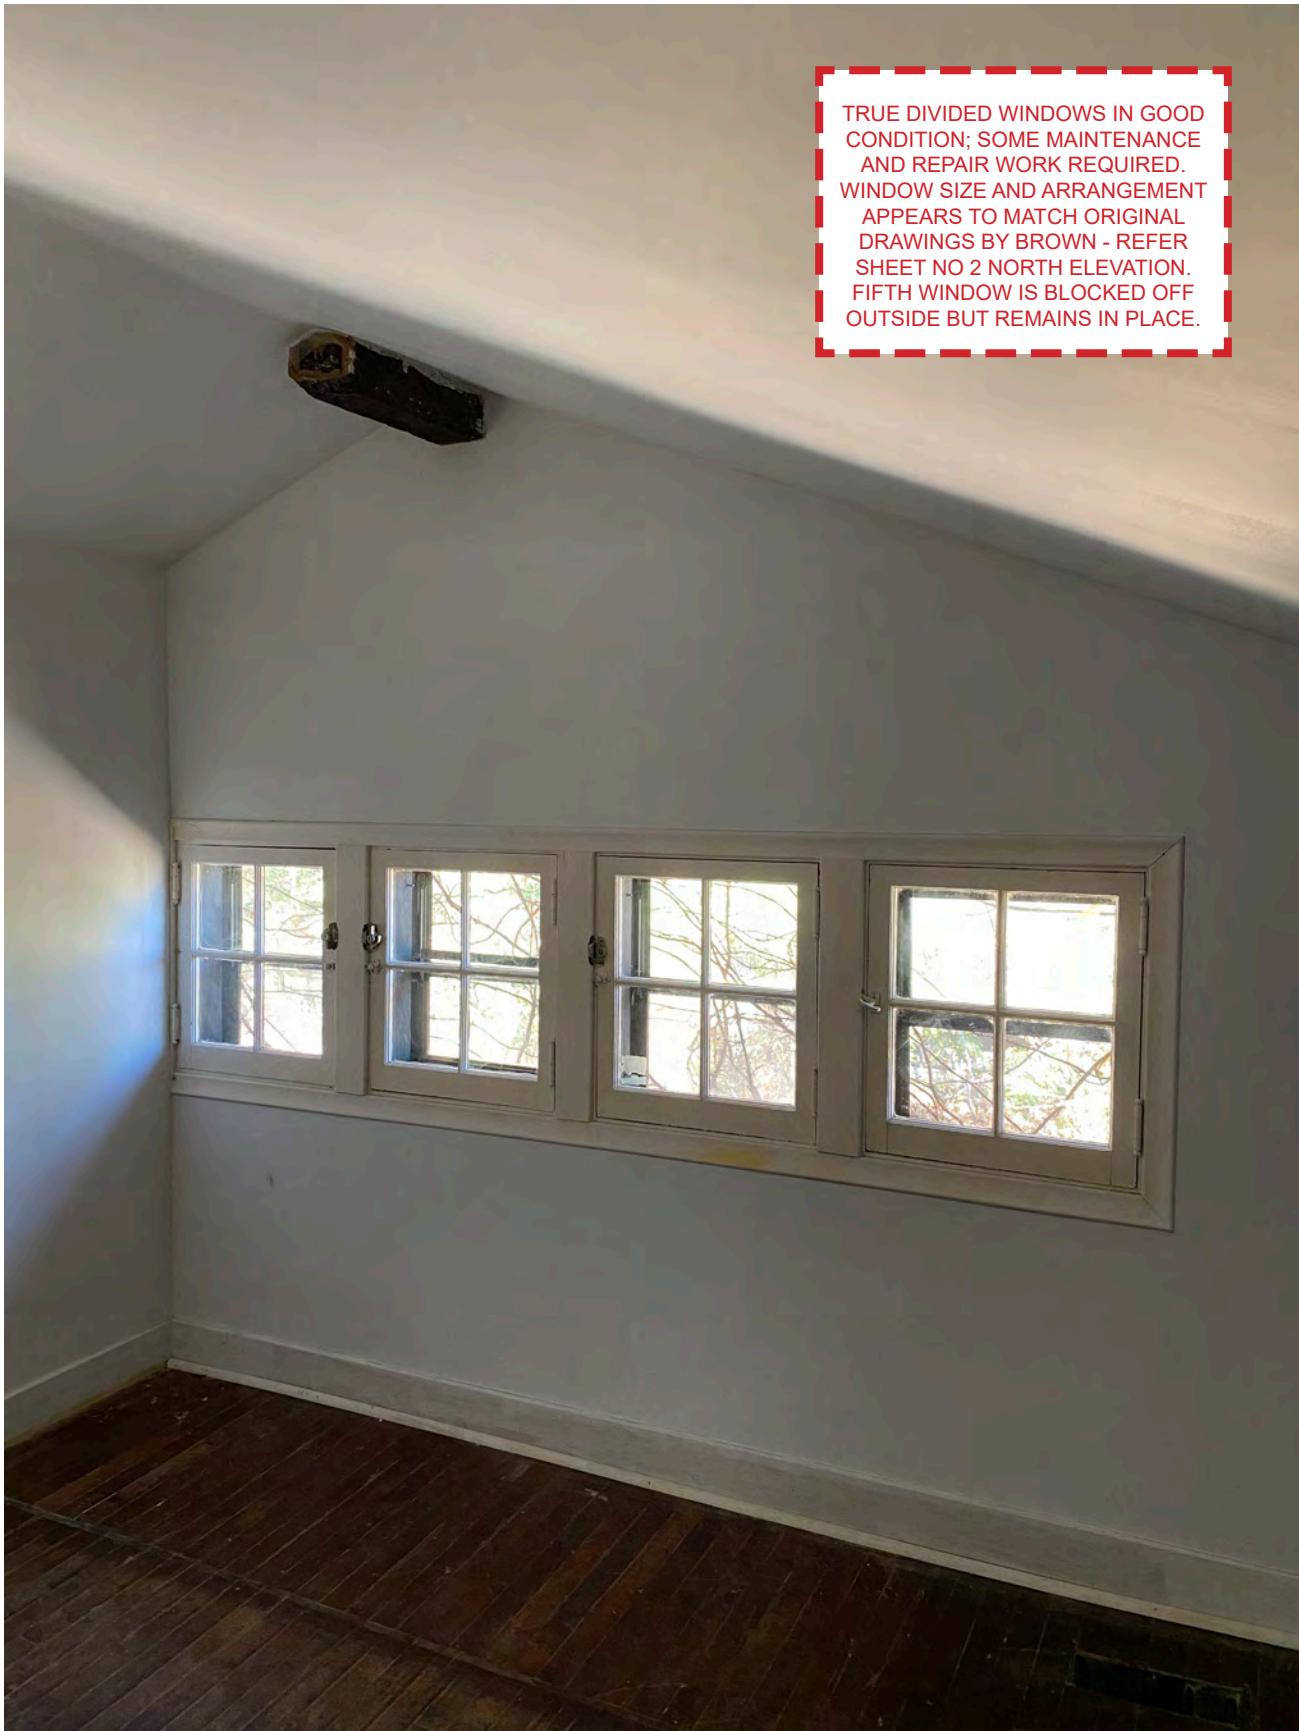
2.20 BEDROOM, UPPER FLOOR (NORTH SIDE).

TRUE DIVIDED WINDOWS IN GOOD
CONDITION; SOME MAINTENANCE
AND REPAIR WORK REQUIRED.
WINDOW SIZE AND ARRANGEMENT
APPEARS TO MATCH ORIGINAL
DRAWINGS BY BROWN - REFER
SHEET NO 2 NORTH ELEVATION.
FIFTH WINDOW IS BLOCKED OFF
OUTSIDE BUT REMAINS IN PLACE.

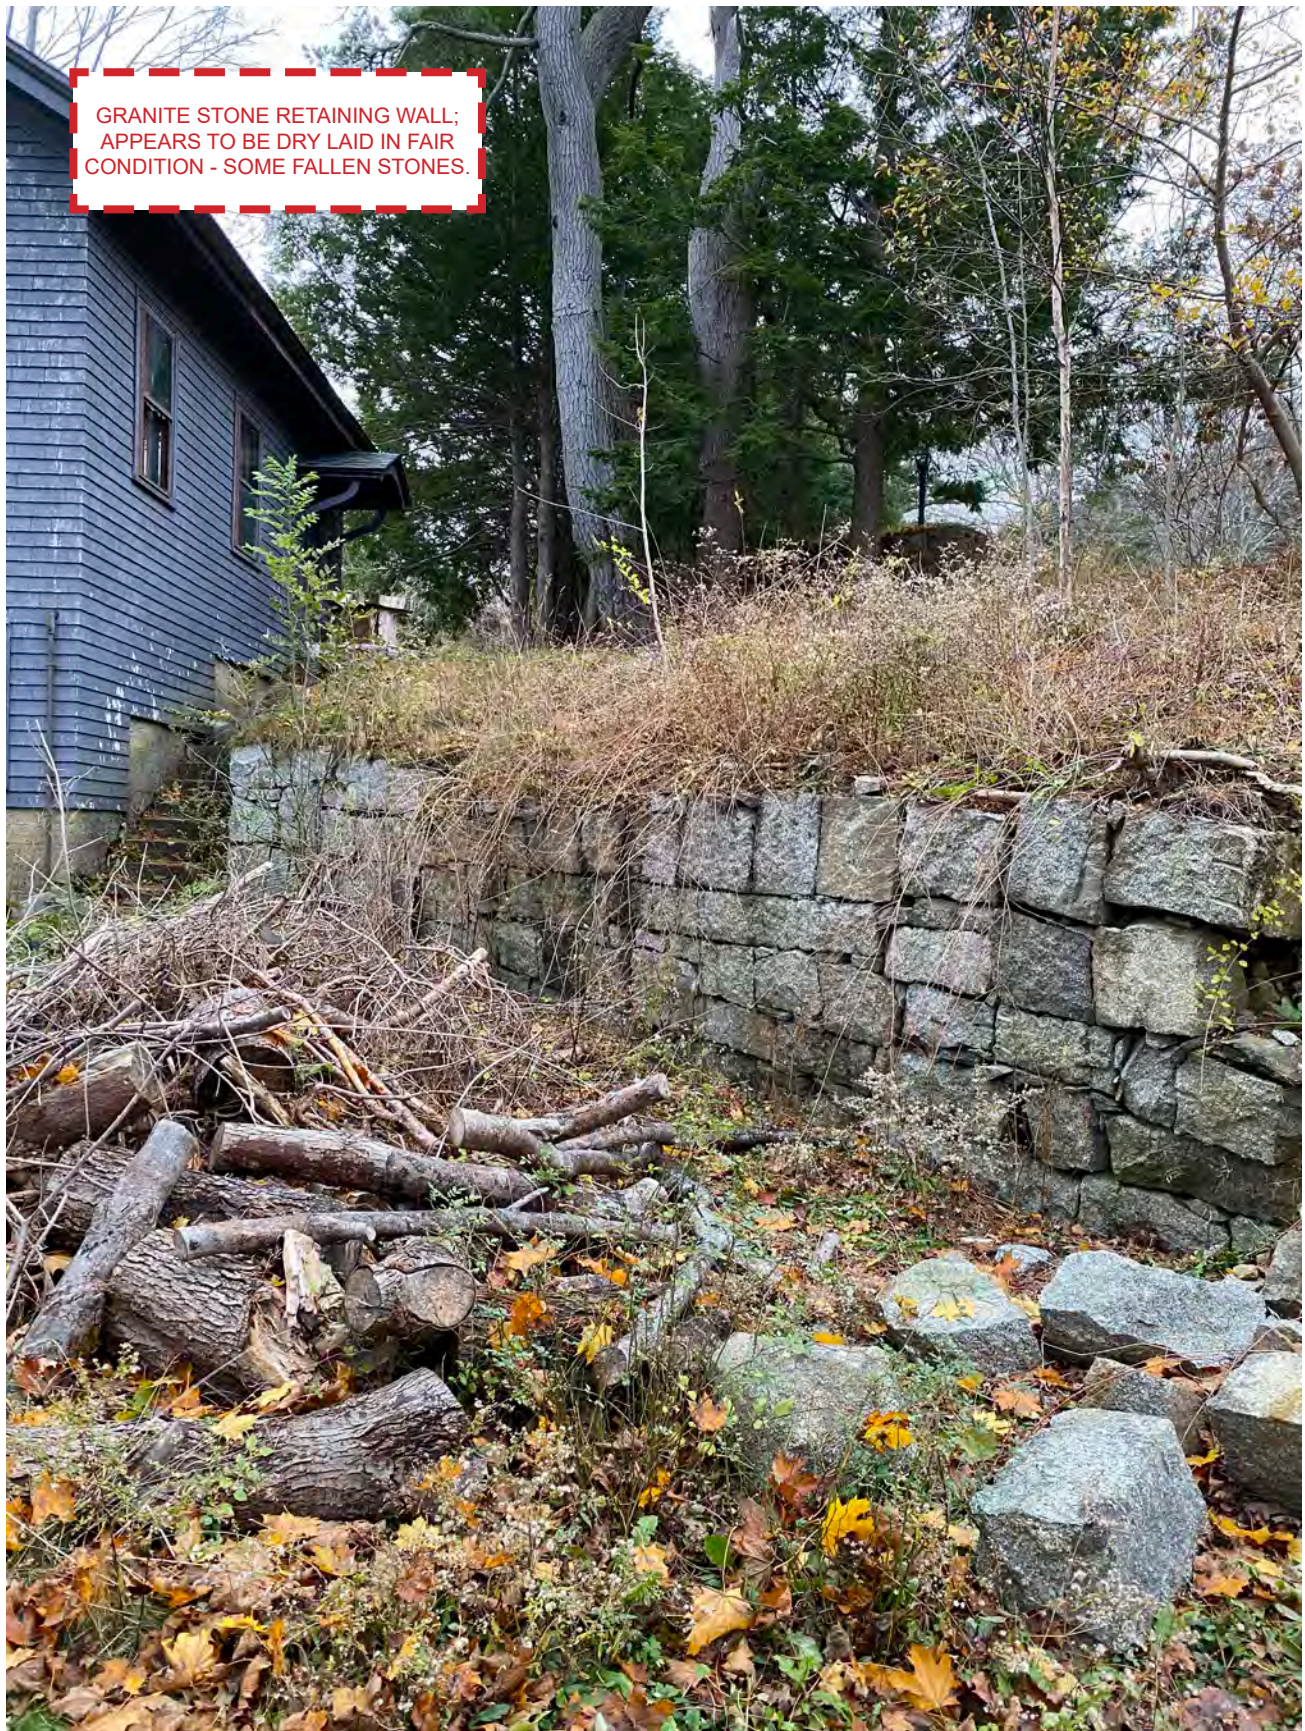
2.27 STONE WALL NEXT TO ROOST (SOUTHWEST VIEW).

GRANITE STONE RETAINING WALL;
APPEARS TO BE DRY LAID IN FAIR
CONDITION - SOME FALLEN STONES.

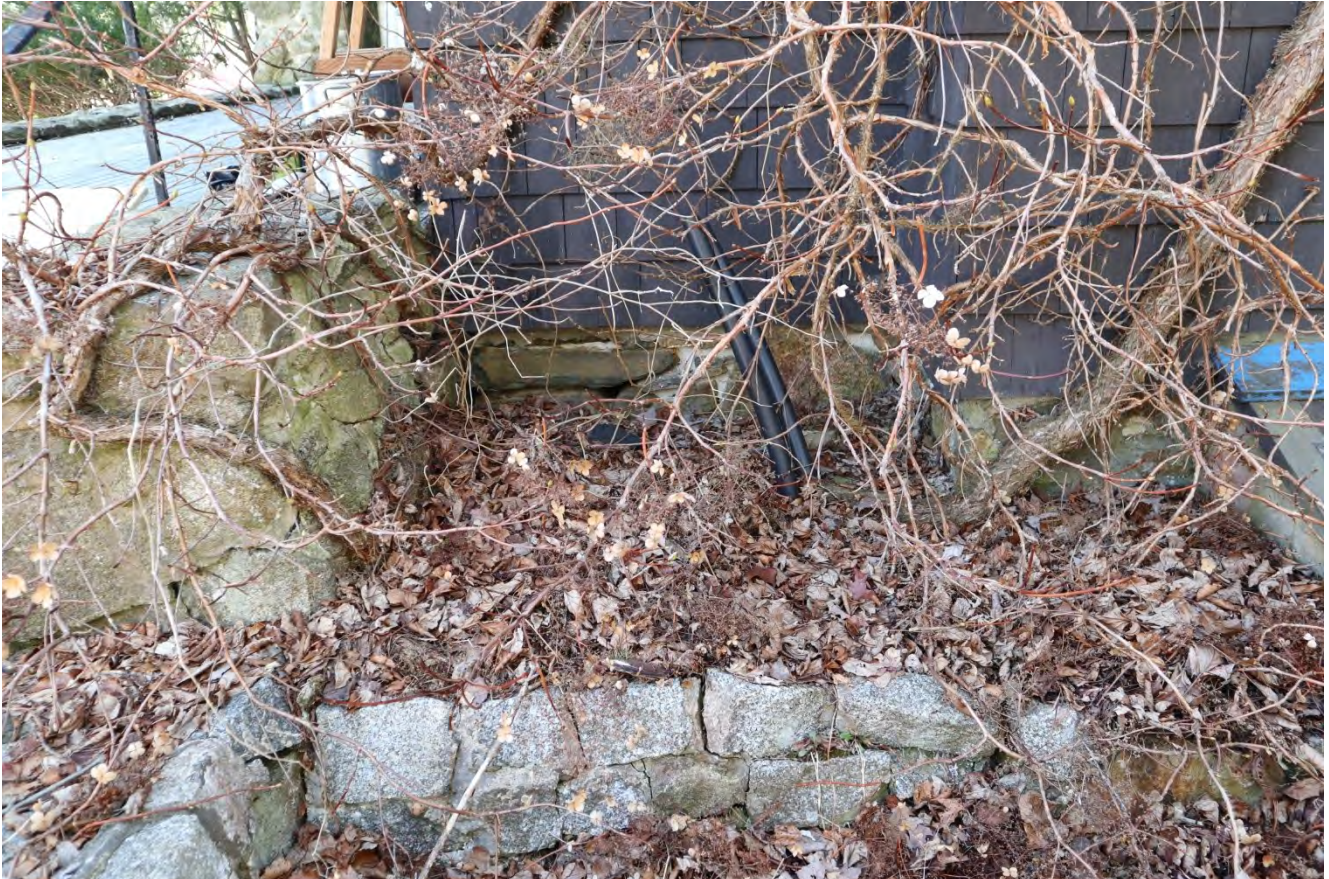
2) Also notices on the exterior of this building was to fact that the foundation itself was constructed as a rock foundation. This was done with little thought to water proofing of the basement. See in the photograph below the visible rock of the foundation wall, and the openings through the rocks. These openings will allow entry of water where ever the grading of the land is not proper. Grading around the building is very bad. Also leaks are common whenever there is snow build up along the wall in which case water will simply run into the building.

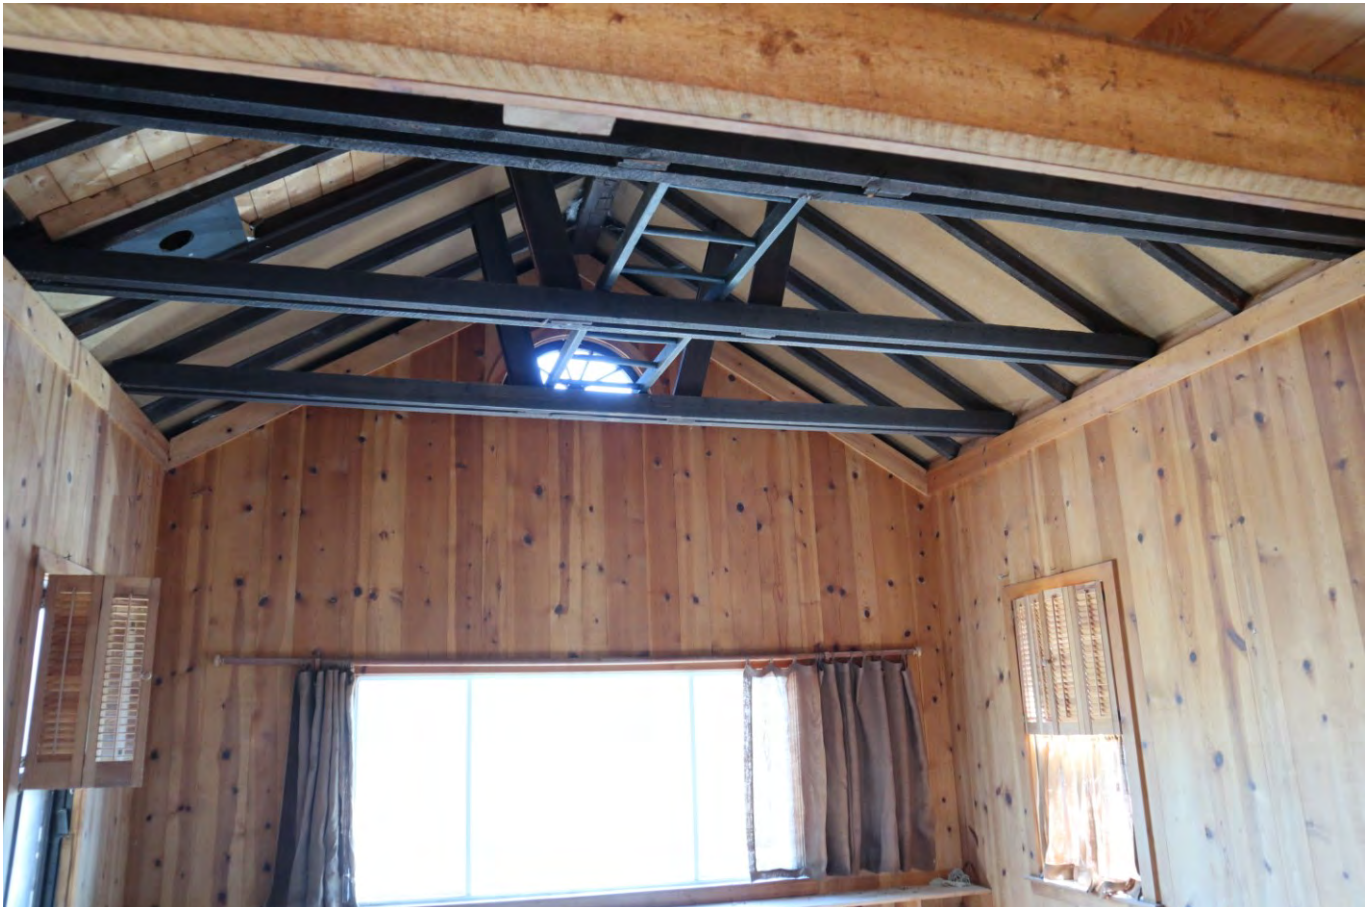
In general, the main floor of this building appears to be in relatively good conditions. See the photograph below.
