Item No. 9.1.1
Heritage Advisory Committee
July 26, 2023

SUBJECT: **Case H00528: Substantial Alteration to the municipally registered heritage property at 10 Kirk Road, Halifax**

4.0 - Assessment of Existing Conditions

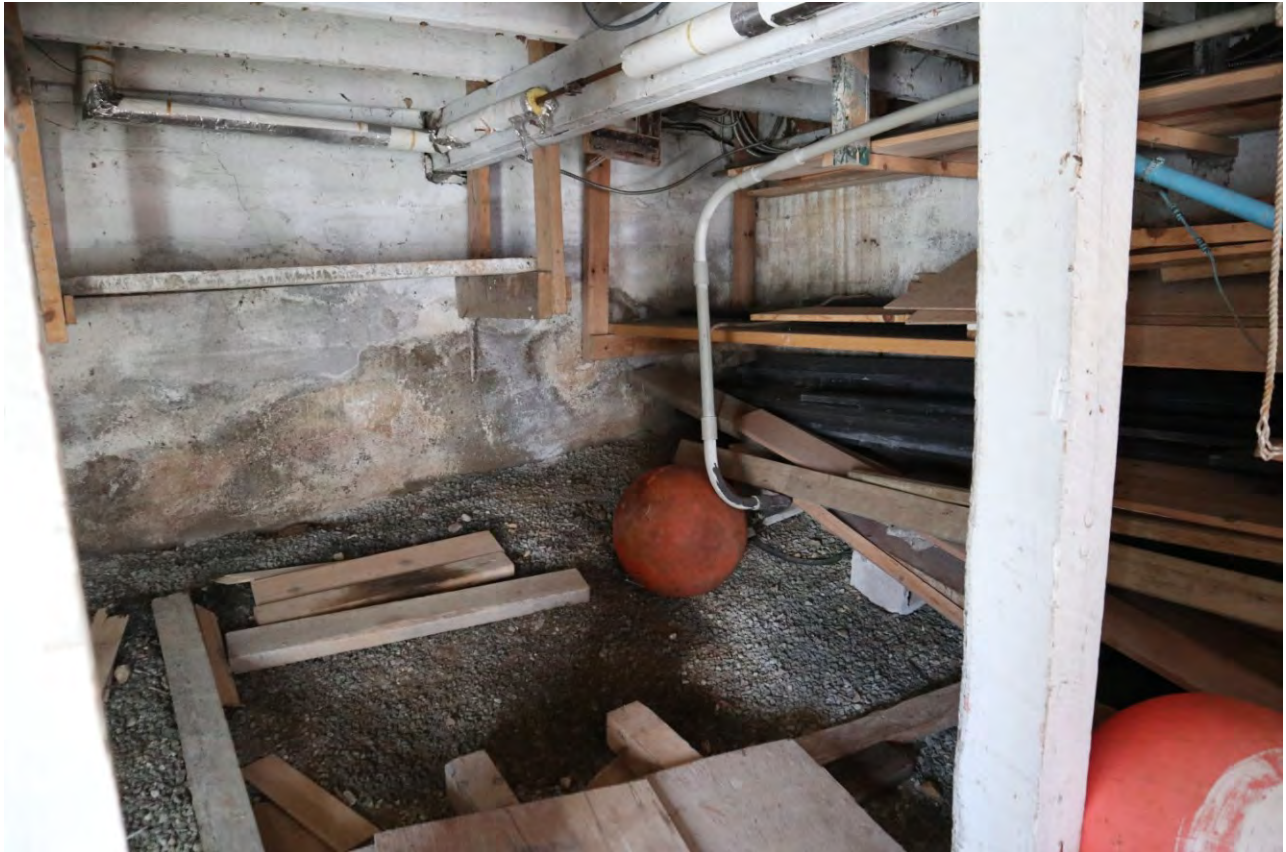
4) There is water flow entering the crawl space. This enters through or under the foundation wall and it travels along a path following the slope of the ground through the crawl space. Evidence of this, and the path of travel is clearly shown by the dark areas of the gravel as shown in the following photograph.

Therefore it is obvious that there presently is water in the crawl space.

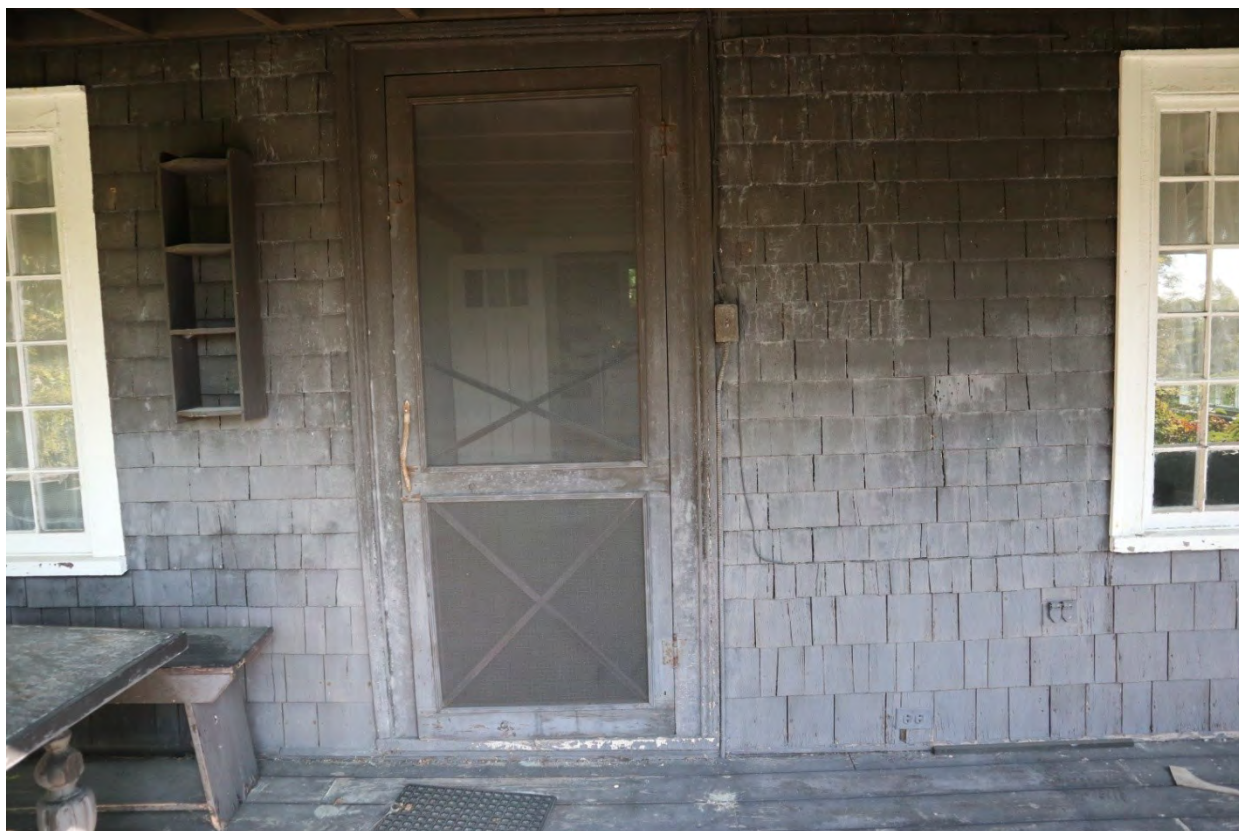
1) The exterior of the building has a substantial amount of rot, especially in and around the deck, or any wall which is near ground level. A close up look at the main front entry of the building reveals the general conditions which are encountered around the perimeter of the building.

Please see in the photograph below the front entry.

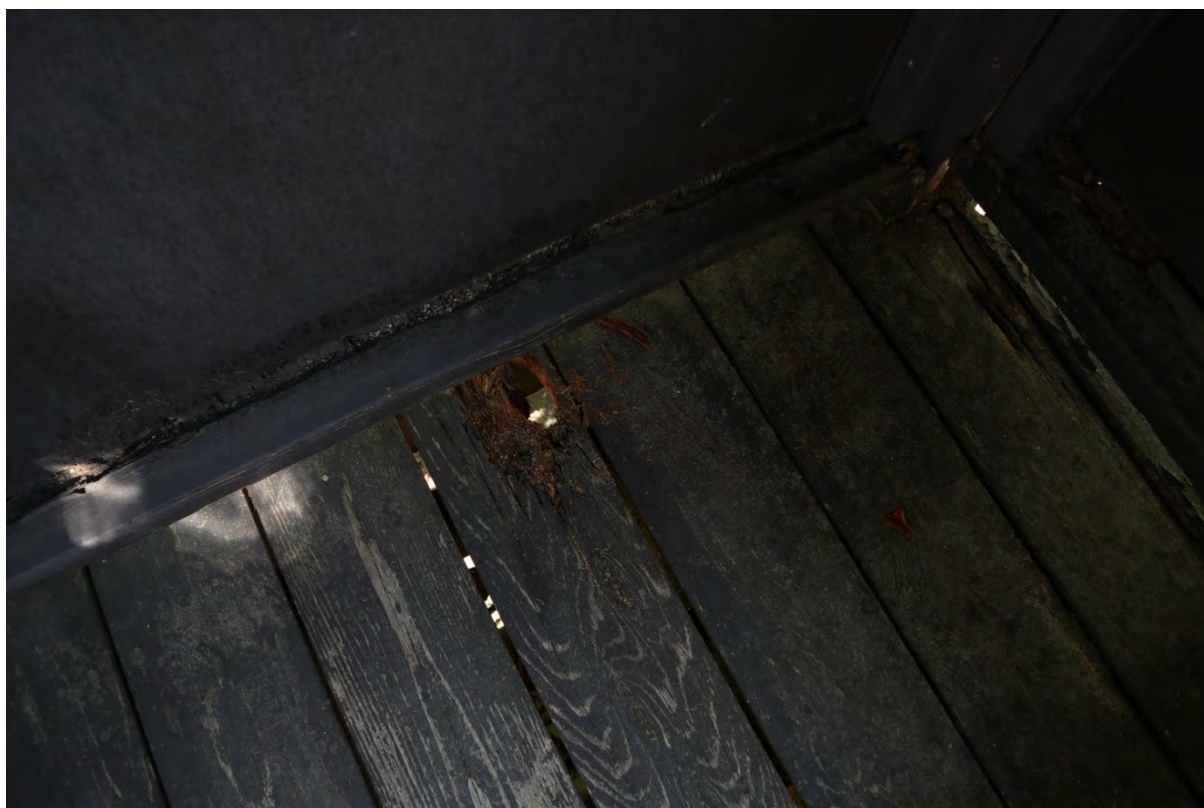
At the time of this inspection, two holes were put into the deck flooring, simply by a kicking motion with one shoe toward the deck. Please see a sample on the photograph below.

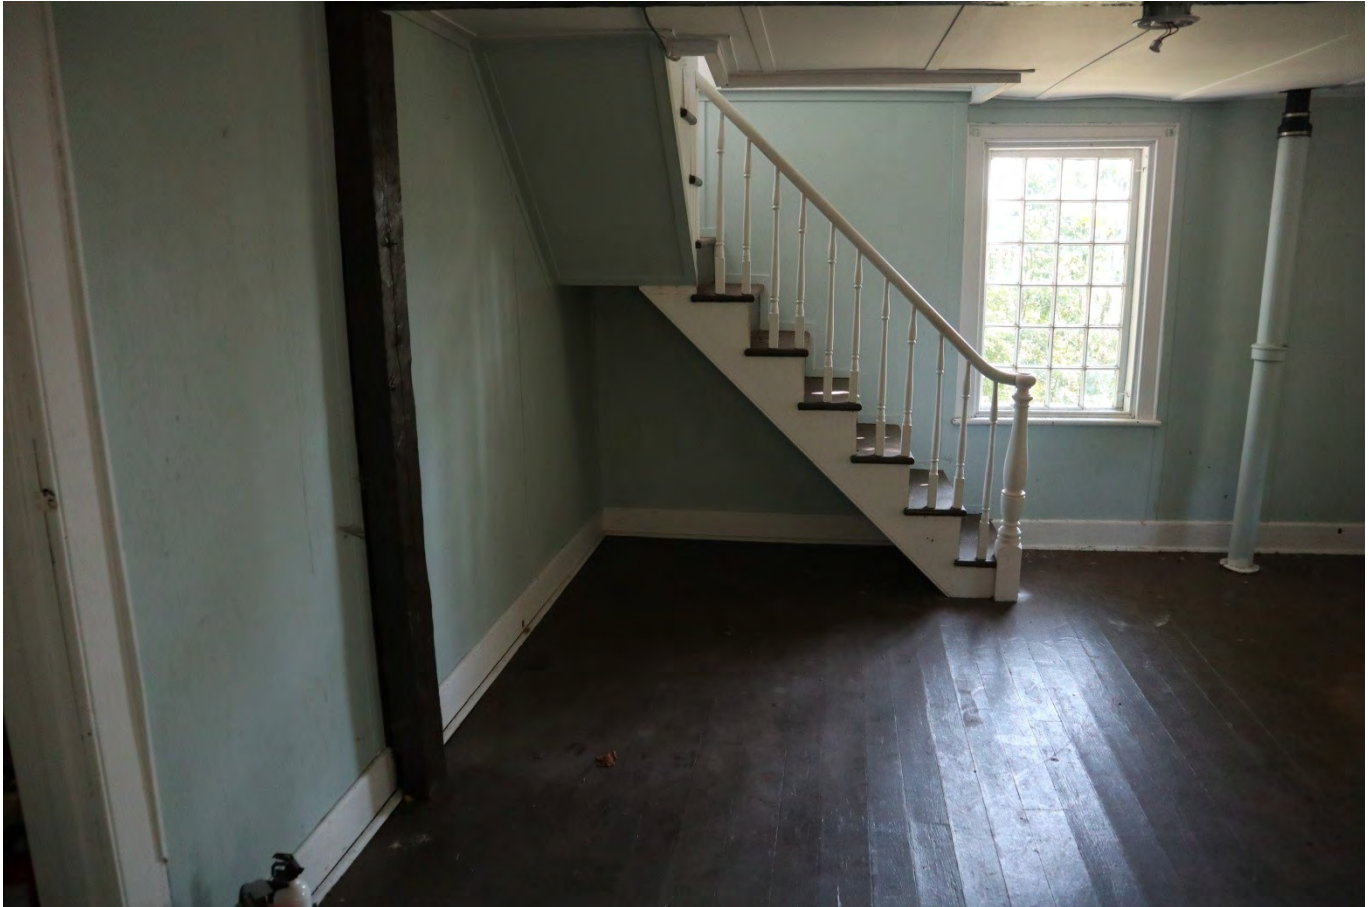
The landing on this stairway was viewed, and considered as structurally unsound. As can be seen in the photograph below, there are no bearing supports below the landing at the corner. The landing is supported only by the end walls on either side. See the photograph below.

Any heavy loading on the landing will immediately result in downward deflection, and if heavy enough, would cause instant failure of the landing.

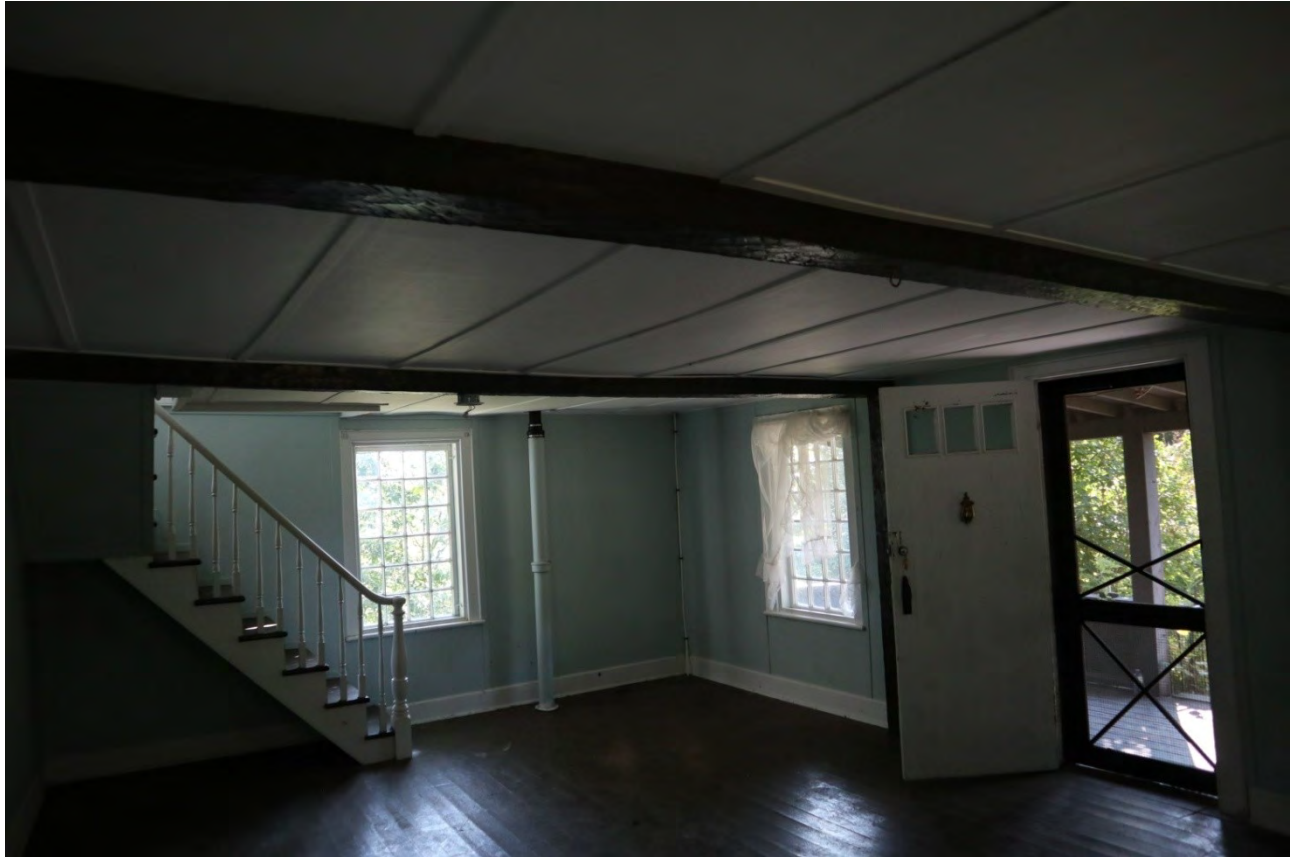
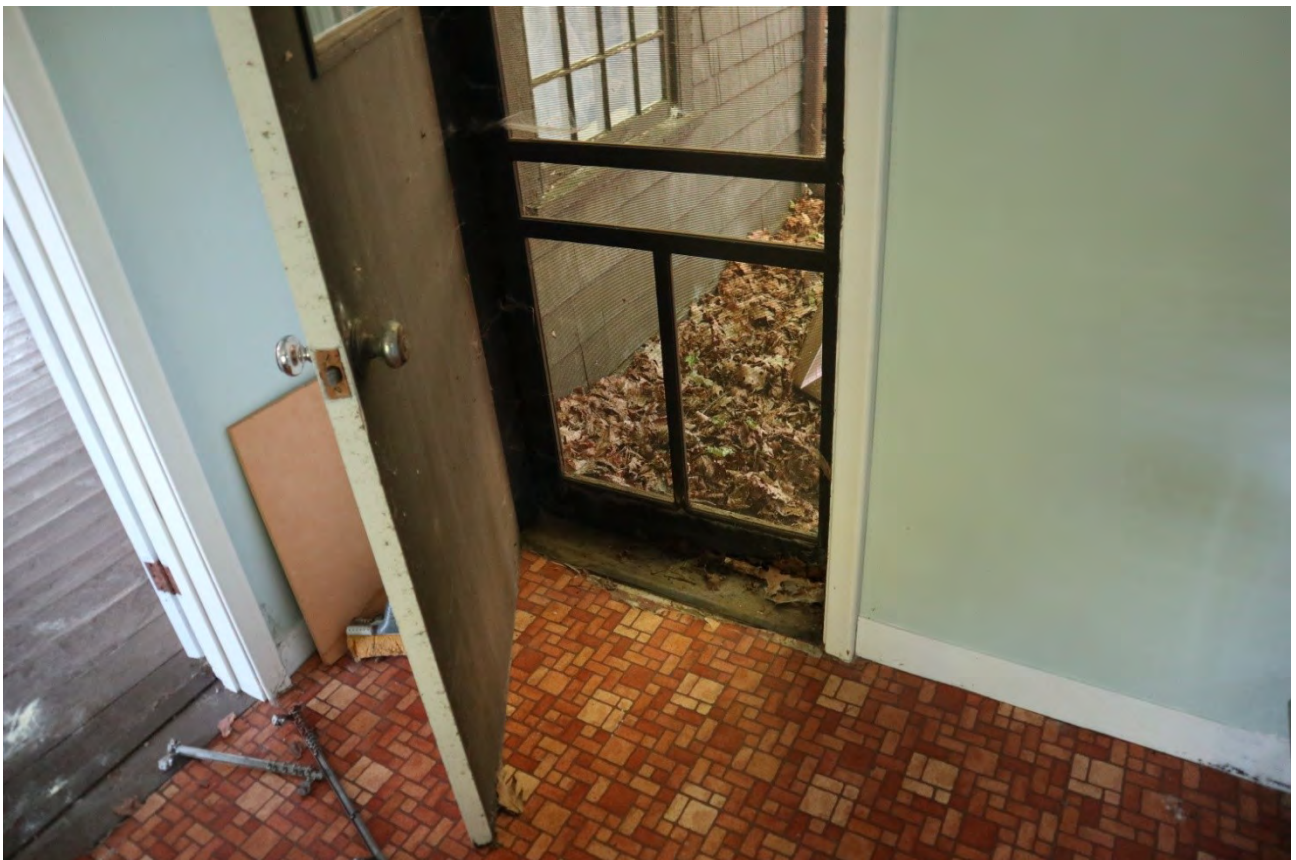
What stood out on the main floor was the way the floor bounced due to lack of structural support. The floor joists are clearly undersized for the span.

- : The drainage line for the upstairs bathroom ran down exposed through the living room area.
- : There was no electrical service at all in the living room area
- : There was minimal electrical service in the kitchen, which also appears to be an addition onto the main structure.
- : The back door was at ground level and susceptible to rot, insects, mice and water infiltration
- : There was not source of heating on this level. Thus there is no heating in the building at all.

Please see below, 3 photographs taken of the main floor space.

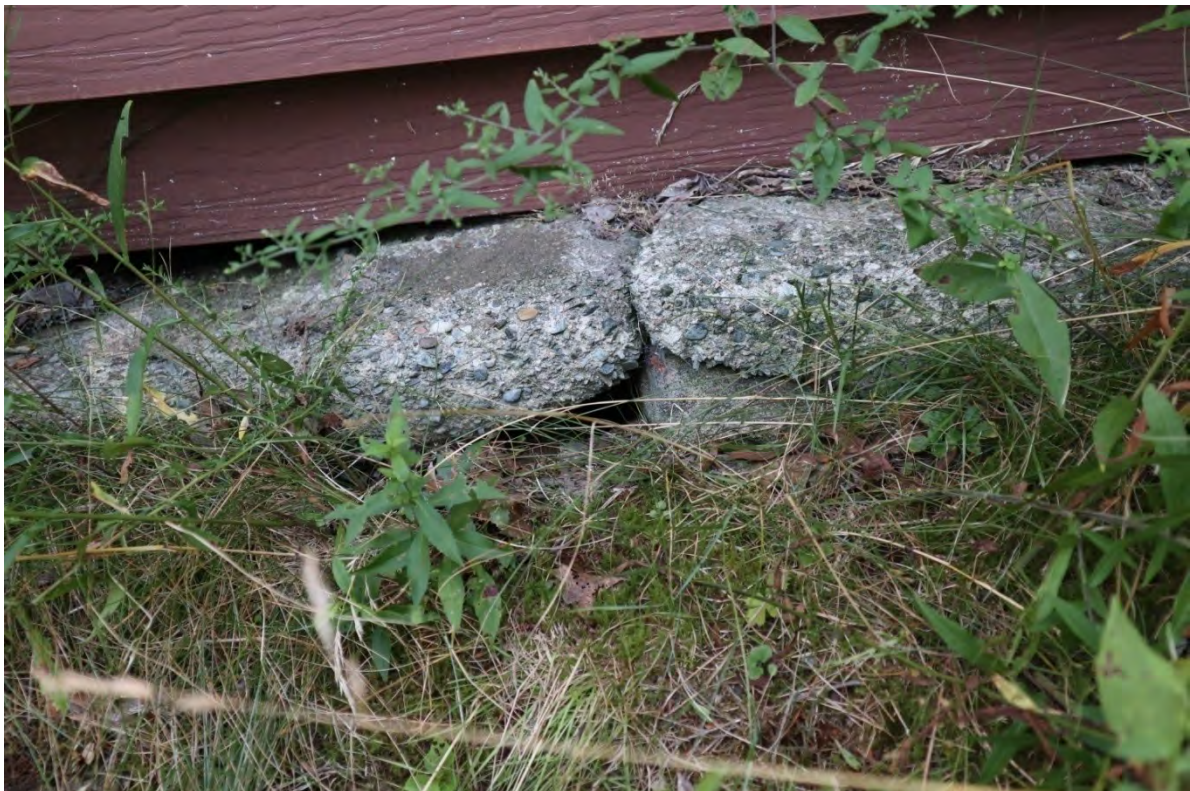
The footing is also not continuous. There are sections where the building appears to be resting on the ground.

Items of note from this photograph are:

- a) There is no frost protection on the foundation leading to up and down movement of the building during the freeze-thaw cycles.
- b) There is major settlement of the building on this face and surrounding area of the building.
- c) Prime location for the infiltration of water, bugs, mice, etc.
- d) Prime location for wood rot and resulting mold formation.

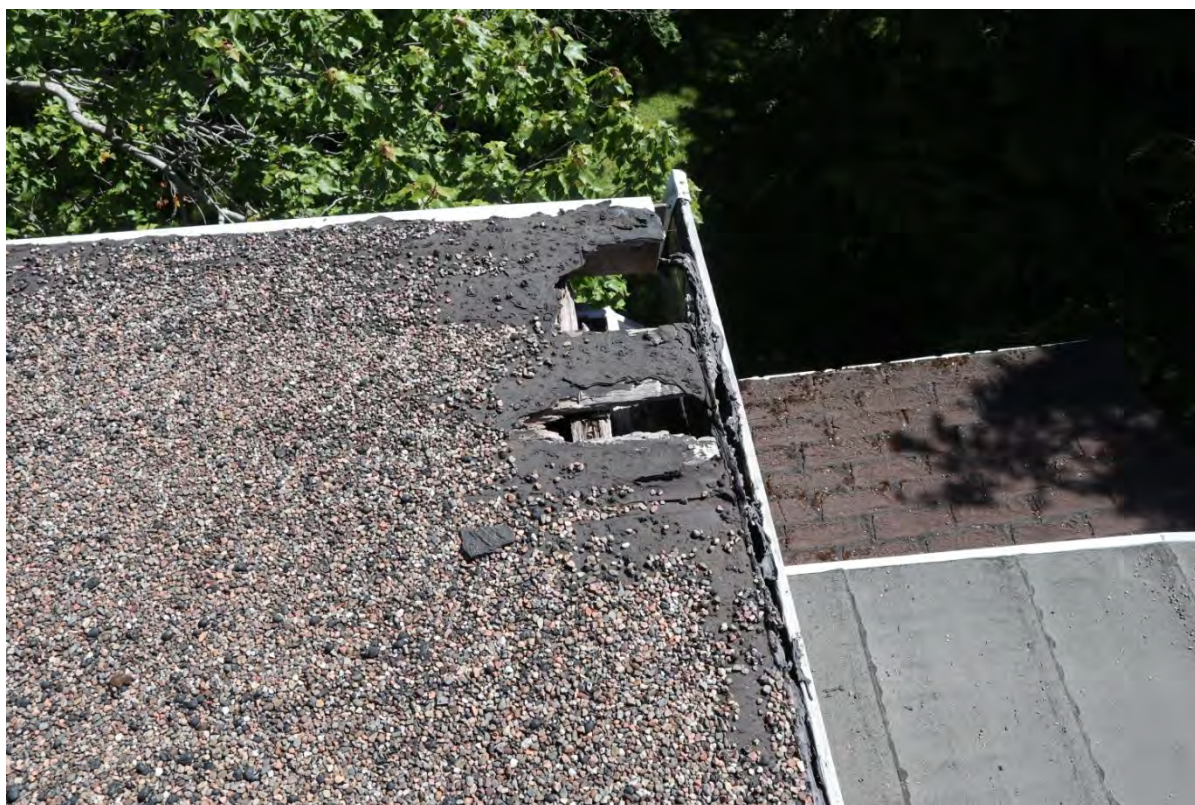
From the top of the roof, on the rear side, there is visible another sections of the roof which have totally collapsed. The first photograph is on the right side, and the second photograph is on the left.

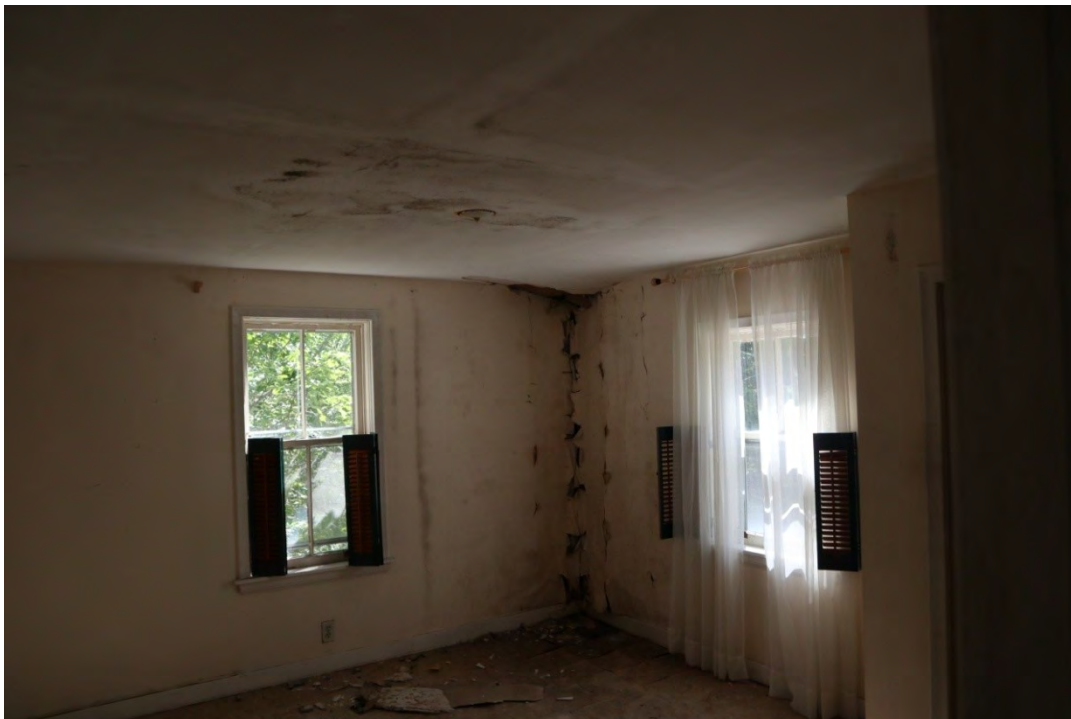
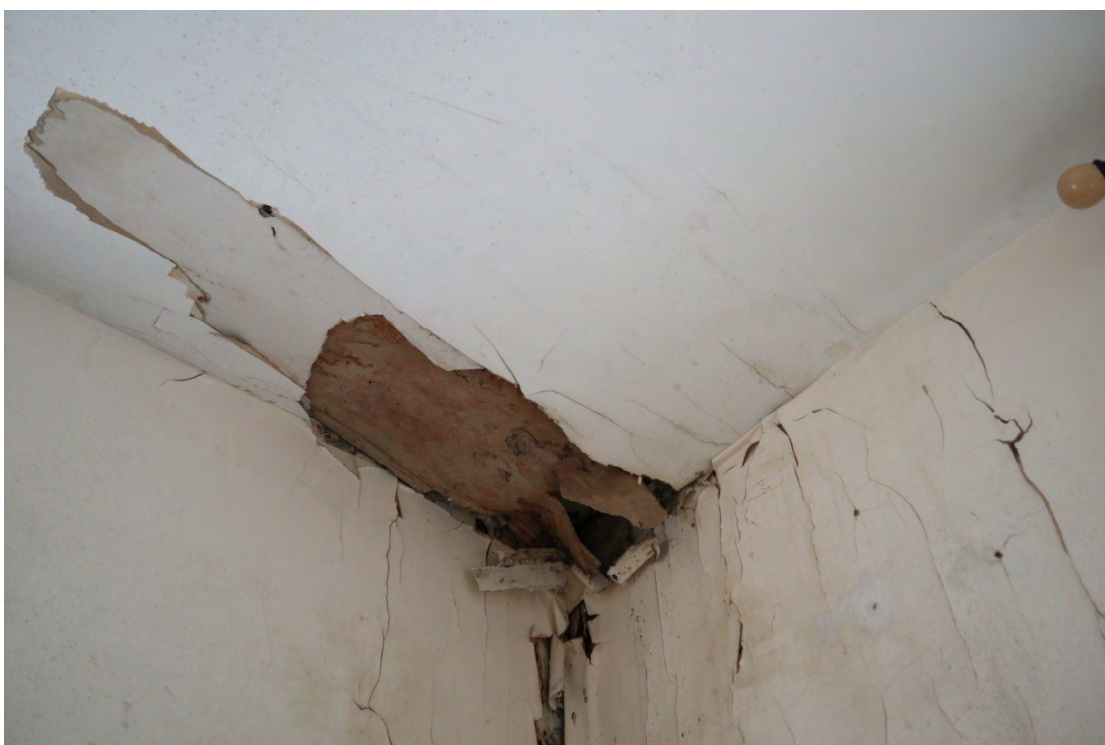
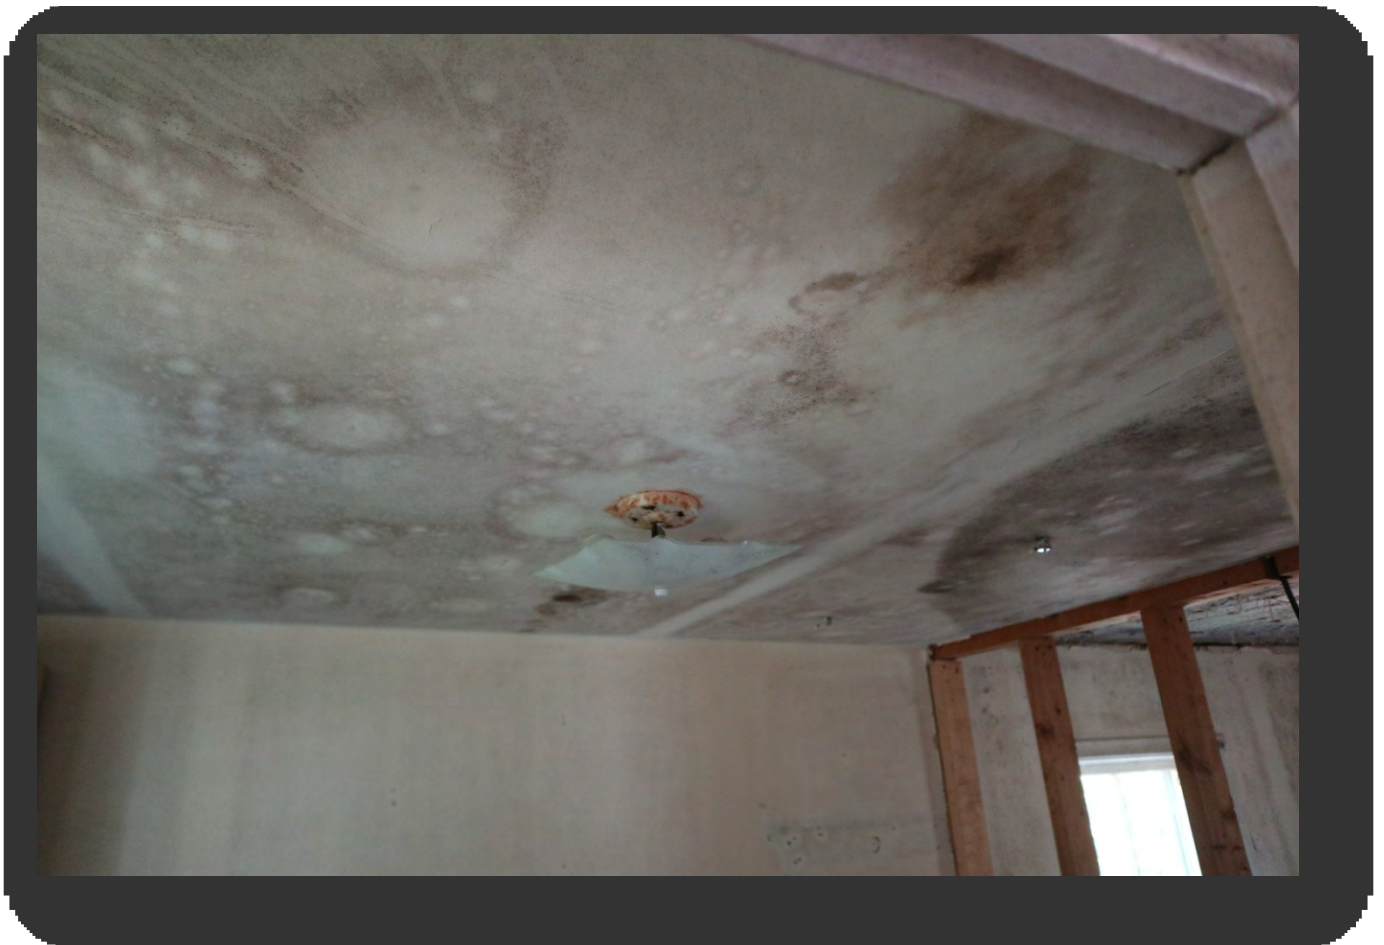
In the building interior, the upper level was viewed, and it basically was in worse state than that which the exterior of the building might have revealed. The conditions in general are quite evident in the following photographs.

As is evident in the previous four photographs there is little of the upper floor level which is considered as worth salvaging. Amongst the defects were:

- a) Numerous punctures of the ceiling drywall caused by what appears to be water infiltration
- b) Rusted out light fixtures and other electrical components, including electrical wiring
- c) Soft drywall or plaster is evident in most locations
- d) Mold all over the surface of the ceilings and the walls
- e) All the flooring is viewed as requiring replacement
- f) Railing on stairs show evidence of rot
- g) Windows and their trim are rotted and are substantially covered in mold

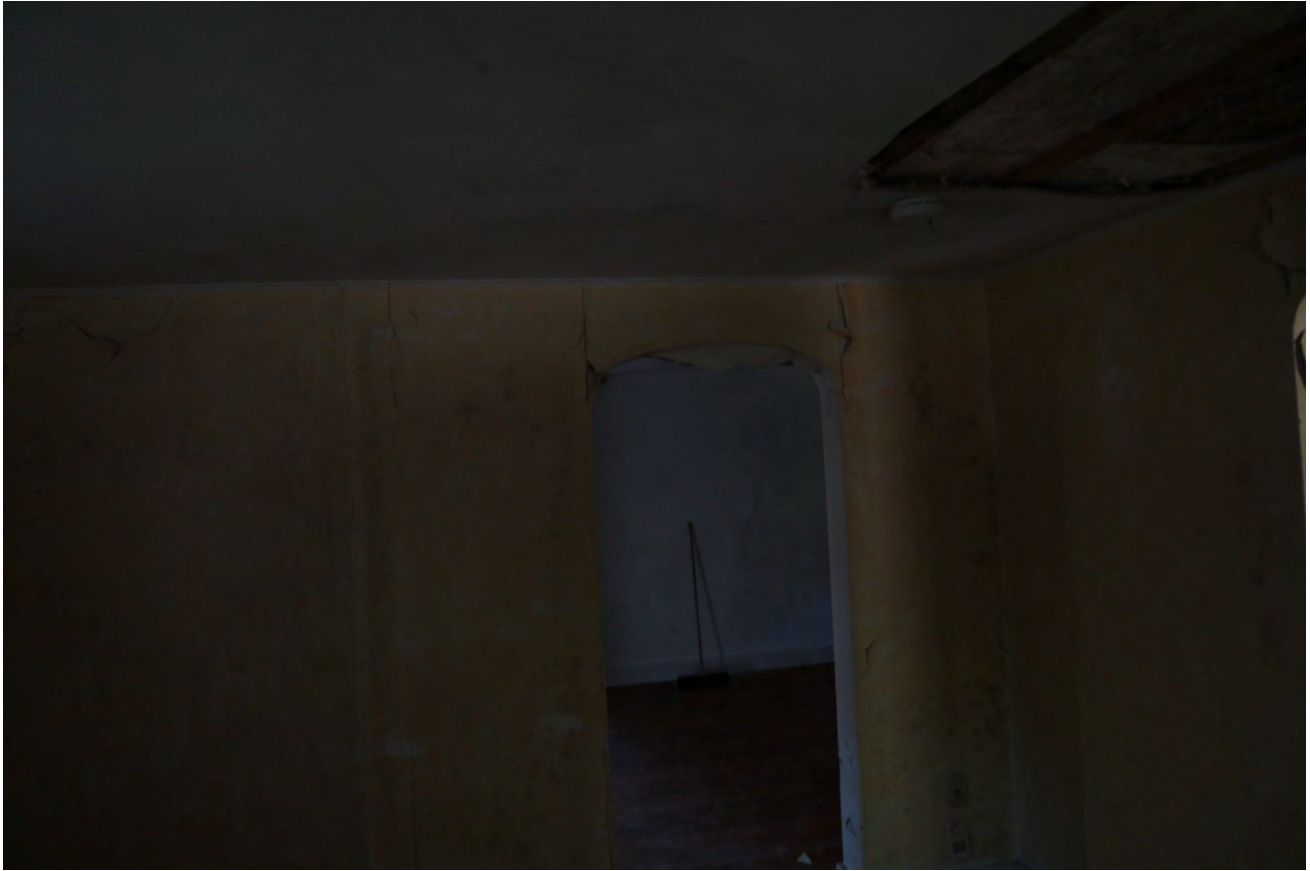
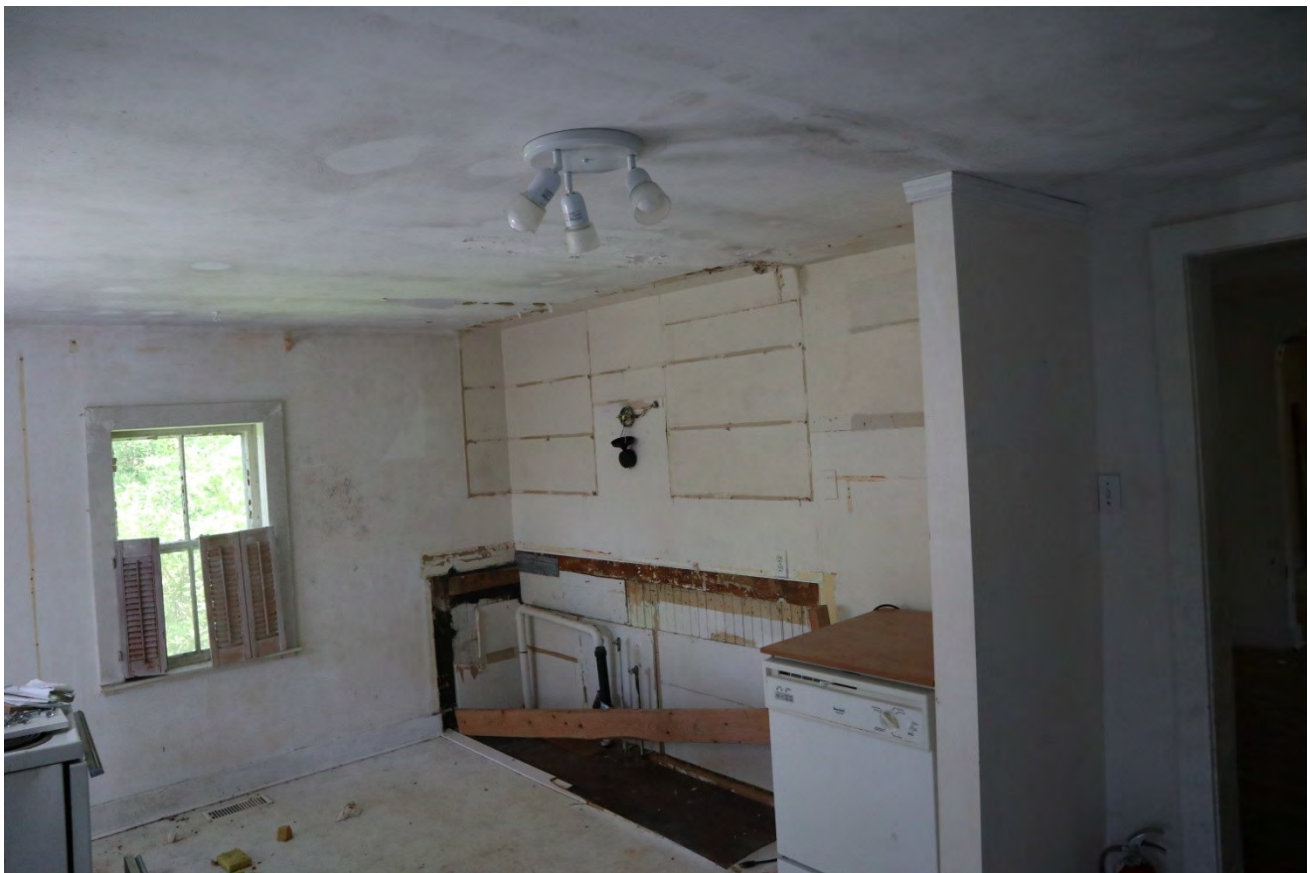
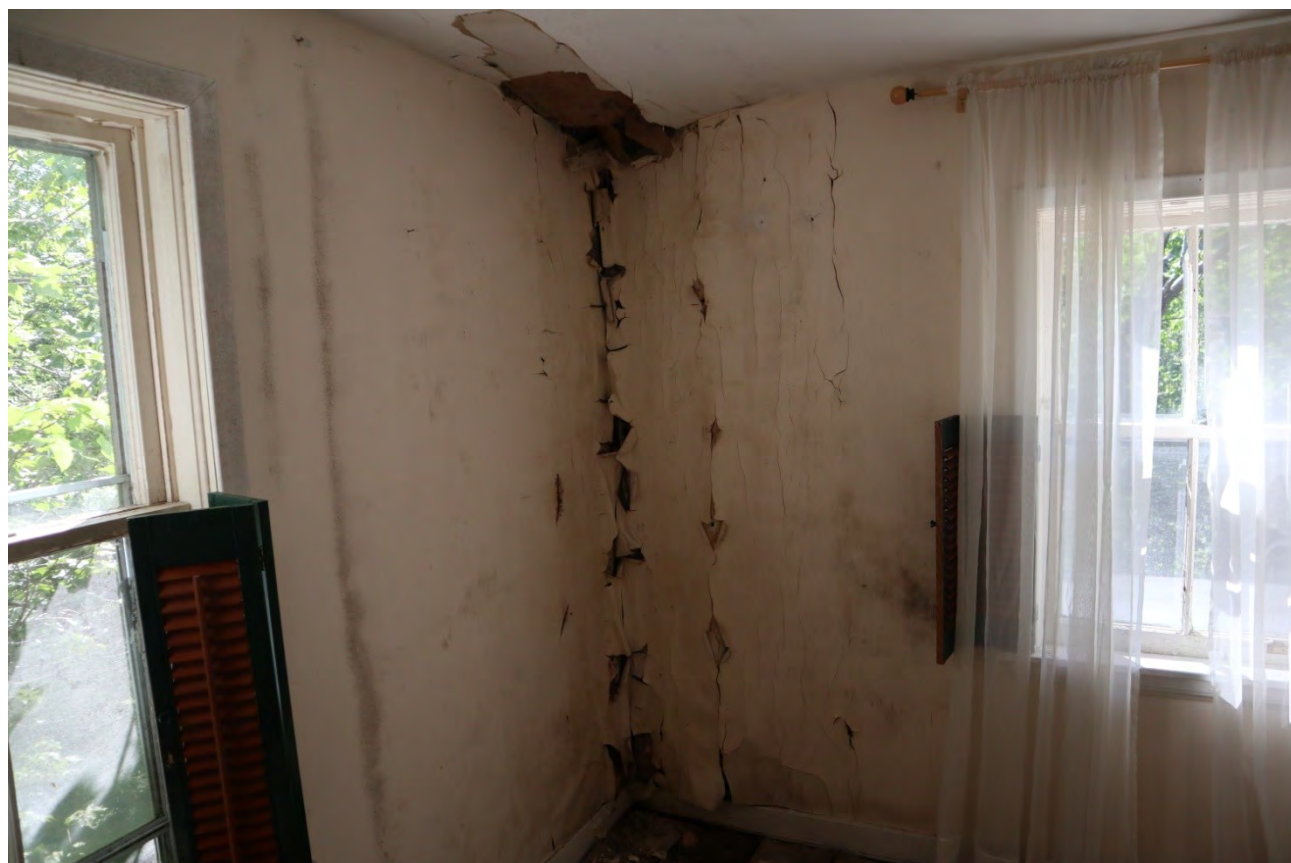
The conditions on the main floor are similar to that in the floor above. See photographs below.

As was evident in the floor above, this level showed little improvement. Amongst the defects were:

- a) Settled floor system, falling from the front to the back of the house
- b) Rusted out light fixtures and other electrical components, including electrical wiring
- c) Soft drywall or plaster is evident in most locations
- d) Mold all over the surface of the ceilings and the walls
- e) All the flooring is viewed as requiring replacement
- f) Windows and their trim are rotted and are substantially covered in mold

The electrical outlets, switches and fixtures were all deteriorated. The complete new wiring of the house is clearly evident. There is little chance that Nova Scotia Power would pass any aspect of the electrical system in the building.

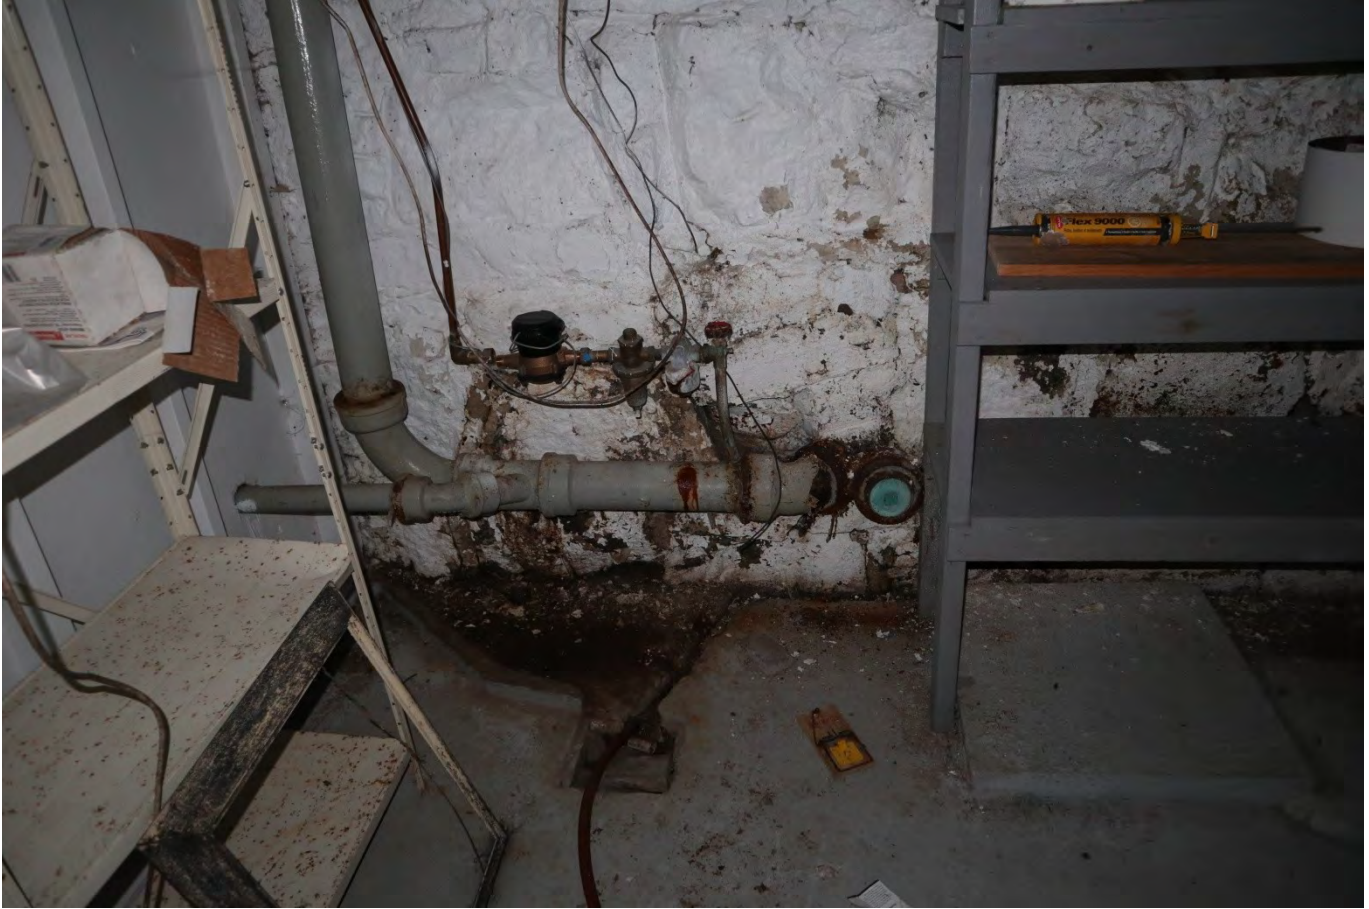
In the two photographs below, is shown the point of sewer and water entry into the building. You can see the rust and mildew on the piping caused by the infiltration of water.

You can also see the area for pooling of water underneath the service lines. This is one of many points of water entry into the basement. The foundation walls are of rock construction, and easily allow water to enter through cavities between the rock.

- a) Rusted out light fixtures and other electrical components, including electrical wiring
- b) Ponding of water in various locations
- c) Water entry through the foundation walls
