**Item No. 15.7.1**  
**Halifax Regional Council**  
**August 22, 2023**

**DATE:** July 26, 2023

**SUBJECT:** **Case H00528: Substantial Alteration to the municipally registered heritage property at 10 Kirk Road, Halifax**

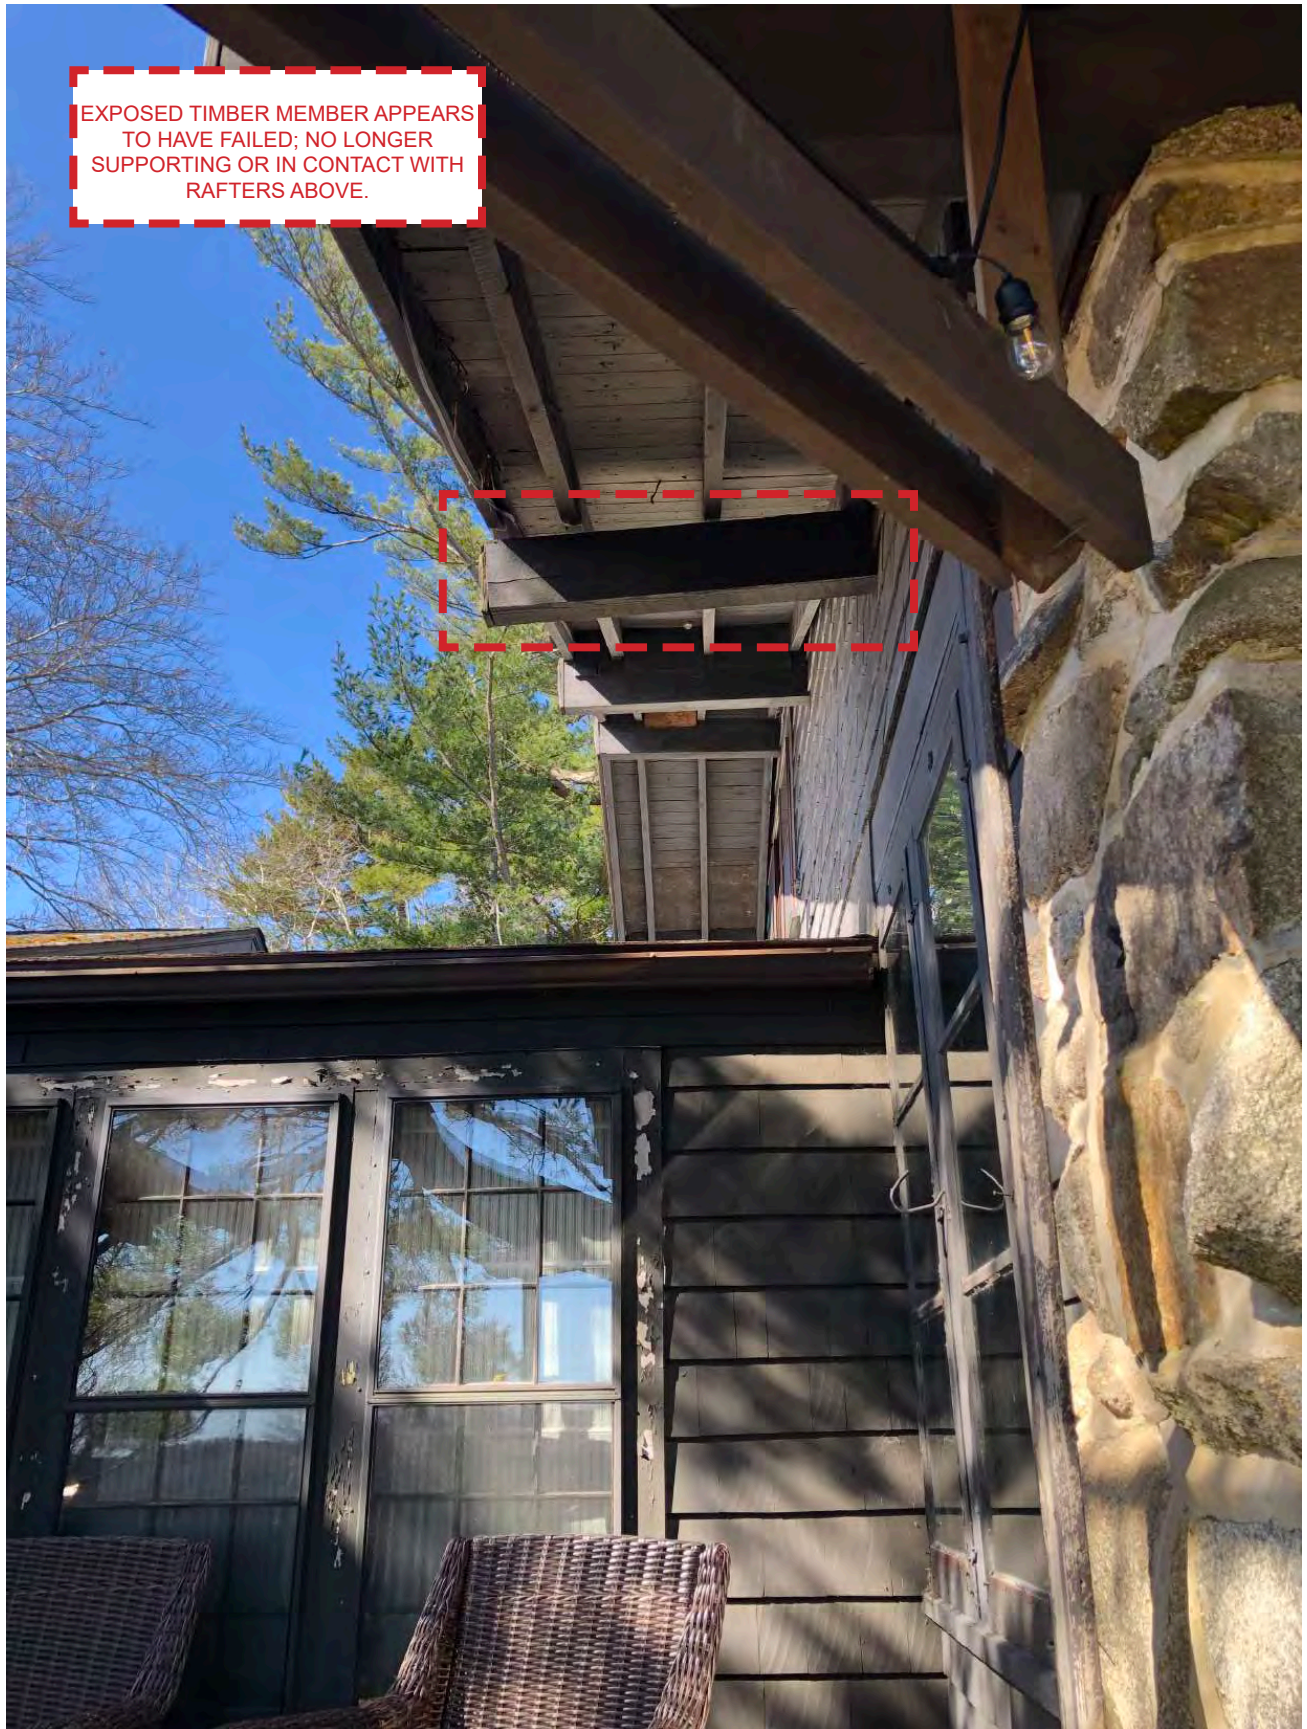
2.7 EXPOSED TIMBER FRAMING ABOVE ANNEX (SOUTH SIDE).

The exposed timber framing, which supports the overhanging eaves and covered porch, requires further examination. One framing member on the south side of the building appears to have failed and is no longer in contact or supporting the rafters above (refer to Architectural Field Review Report [AFRR] image 2.7 ).

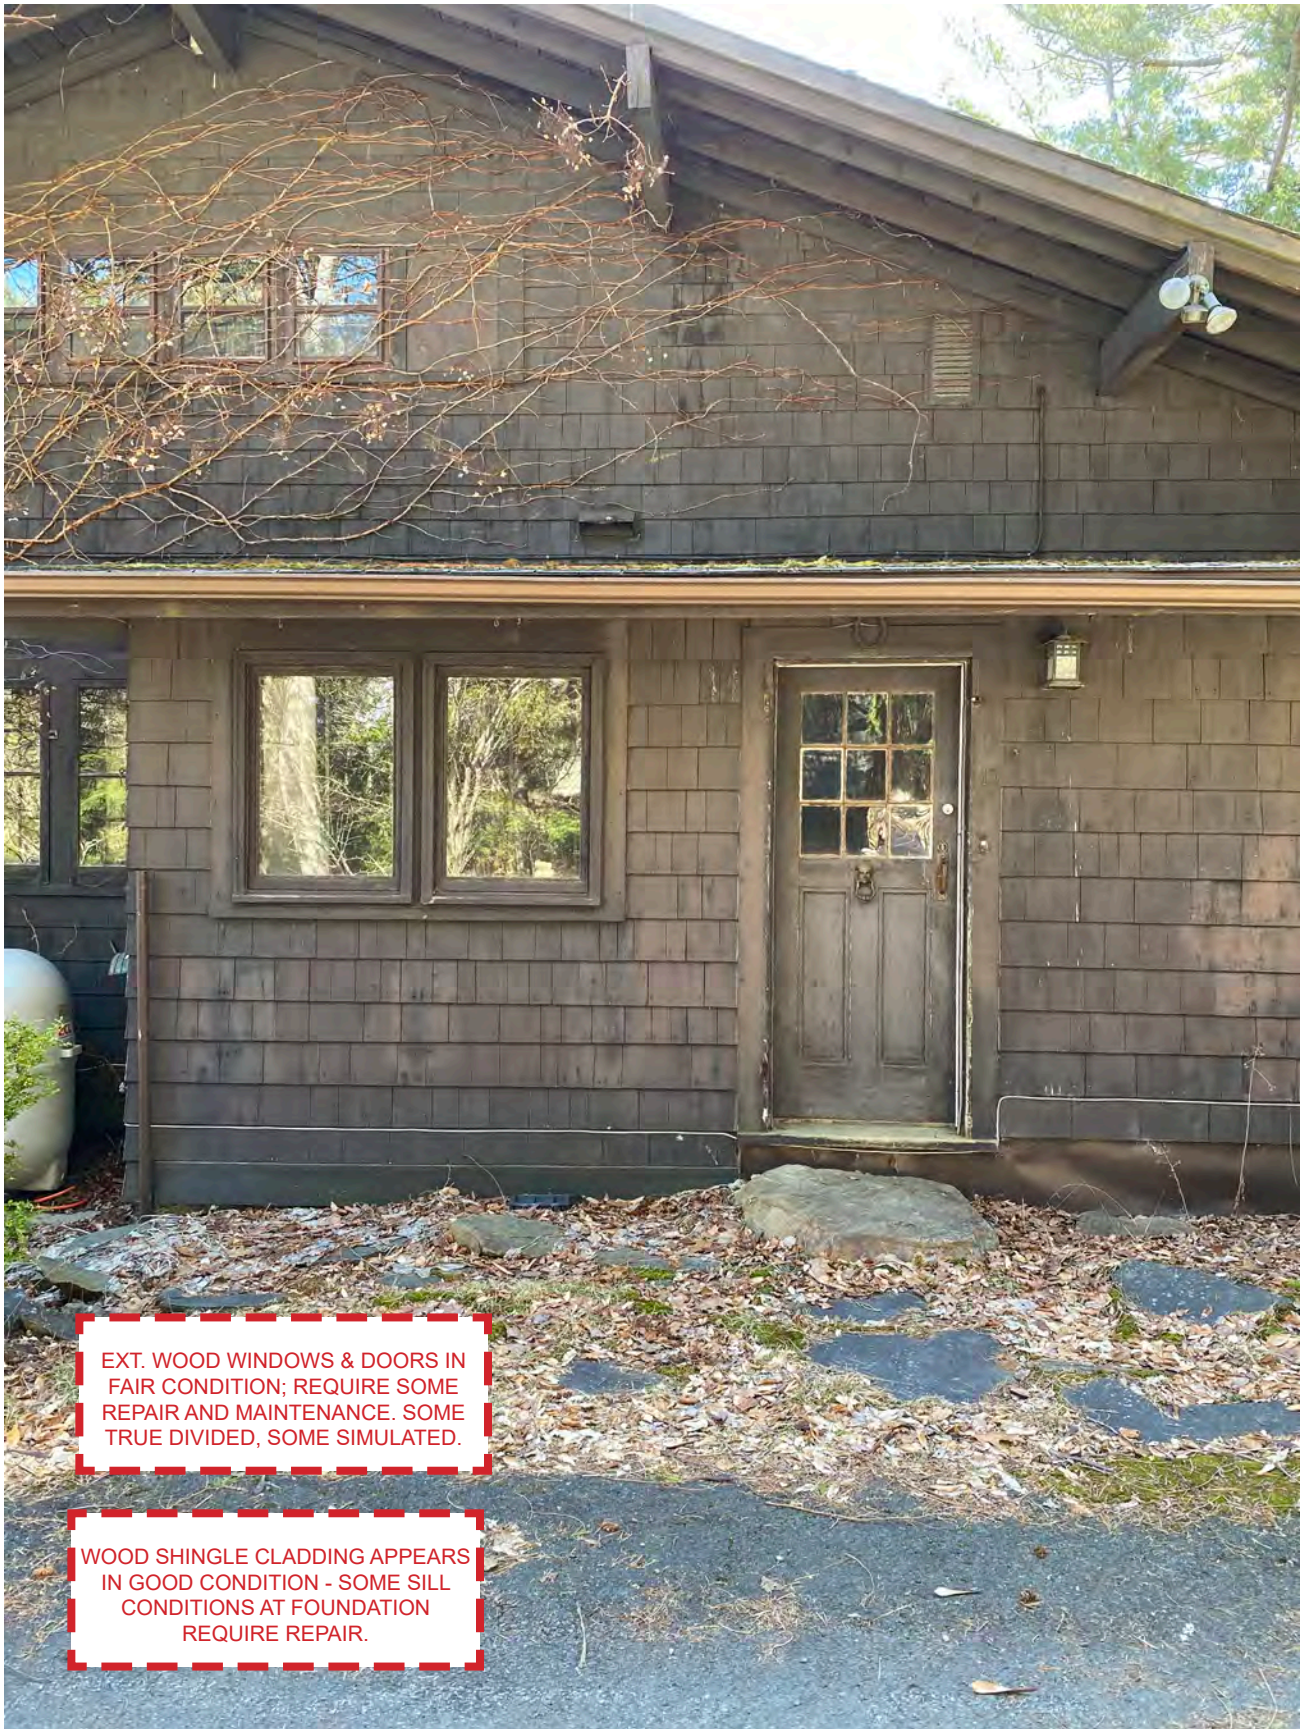
2.9 EXTERIOR WALL AT NORTH SIDE.

EXT. WOOD WINDOWS & DOORS IN FAIR CONDITION; REQUIRE SOME REPAIR AND MAINTENANCE. SOME TRUE DIVIDED, SOME SIMULATED.

WOOD SHINGLE CLADDING APPEARS IN GOOD CONDITION - SOME SILL CONDITIONS AT FOUNDATION REQUIRE REPAIR.

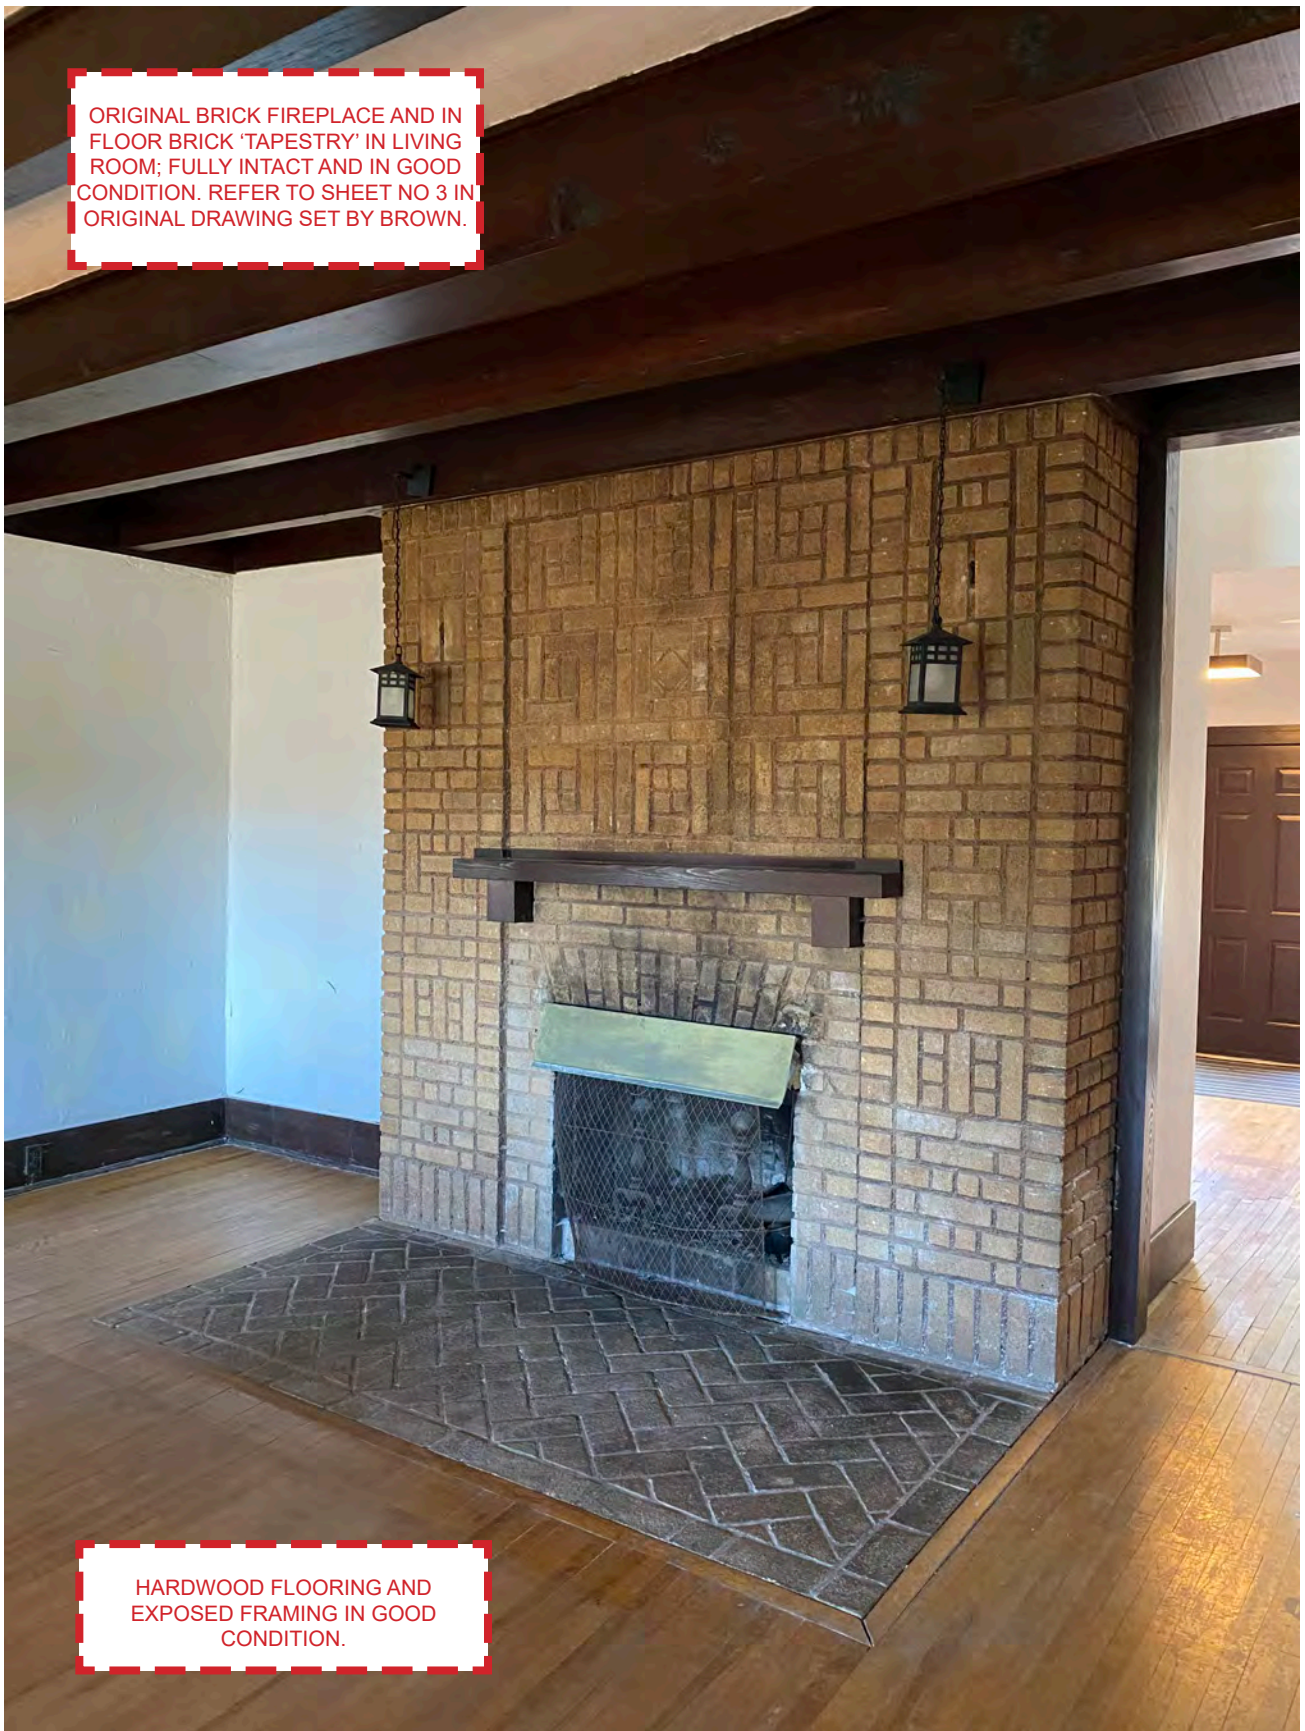
2.14 MAIN FLOOR LIVING AREA.

ORIGINAL BRICK FIREPLACE AND IN FLOOR BRICK 'TAPESTRY' IN LIVING ROOM; FULLY INTACT AND IN GOOD CONDITION. REFER TO SHEET NO 3 IN ORIGINAL DRAWING SET BY BROWN.

HARDWOOD FLOORING AND EXPOSED FRAMING IN GOOD CONDITION.

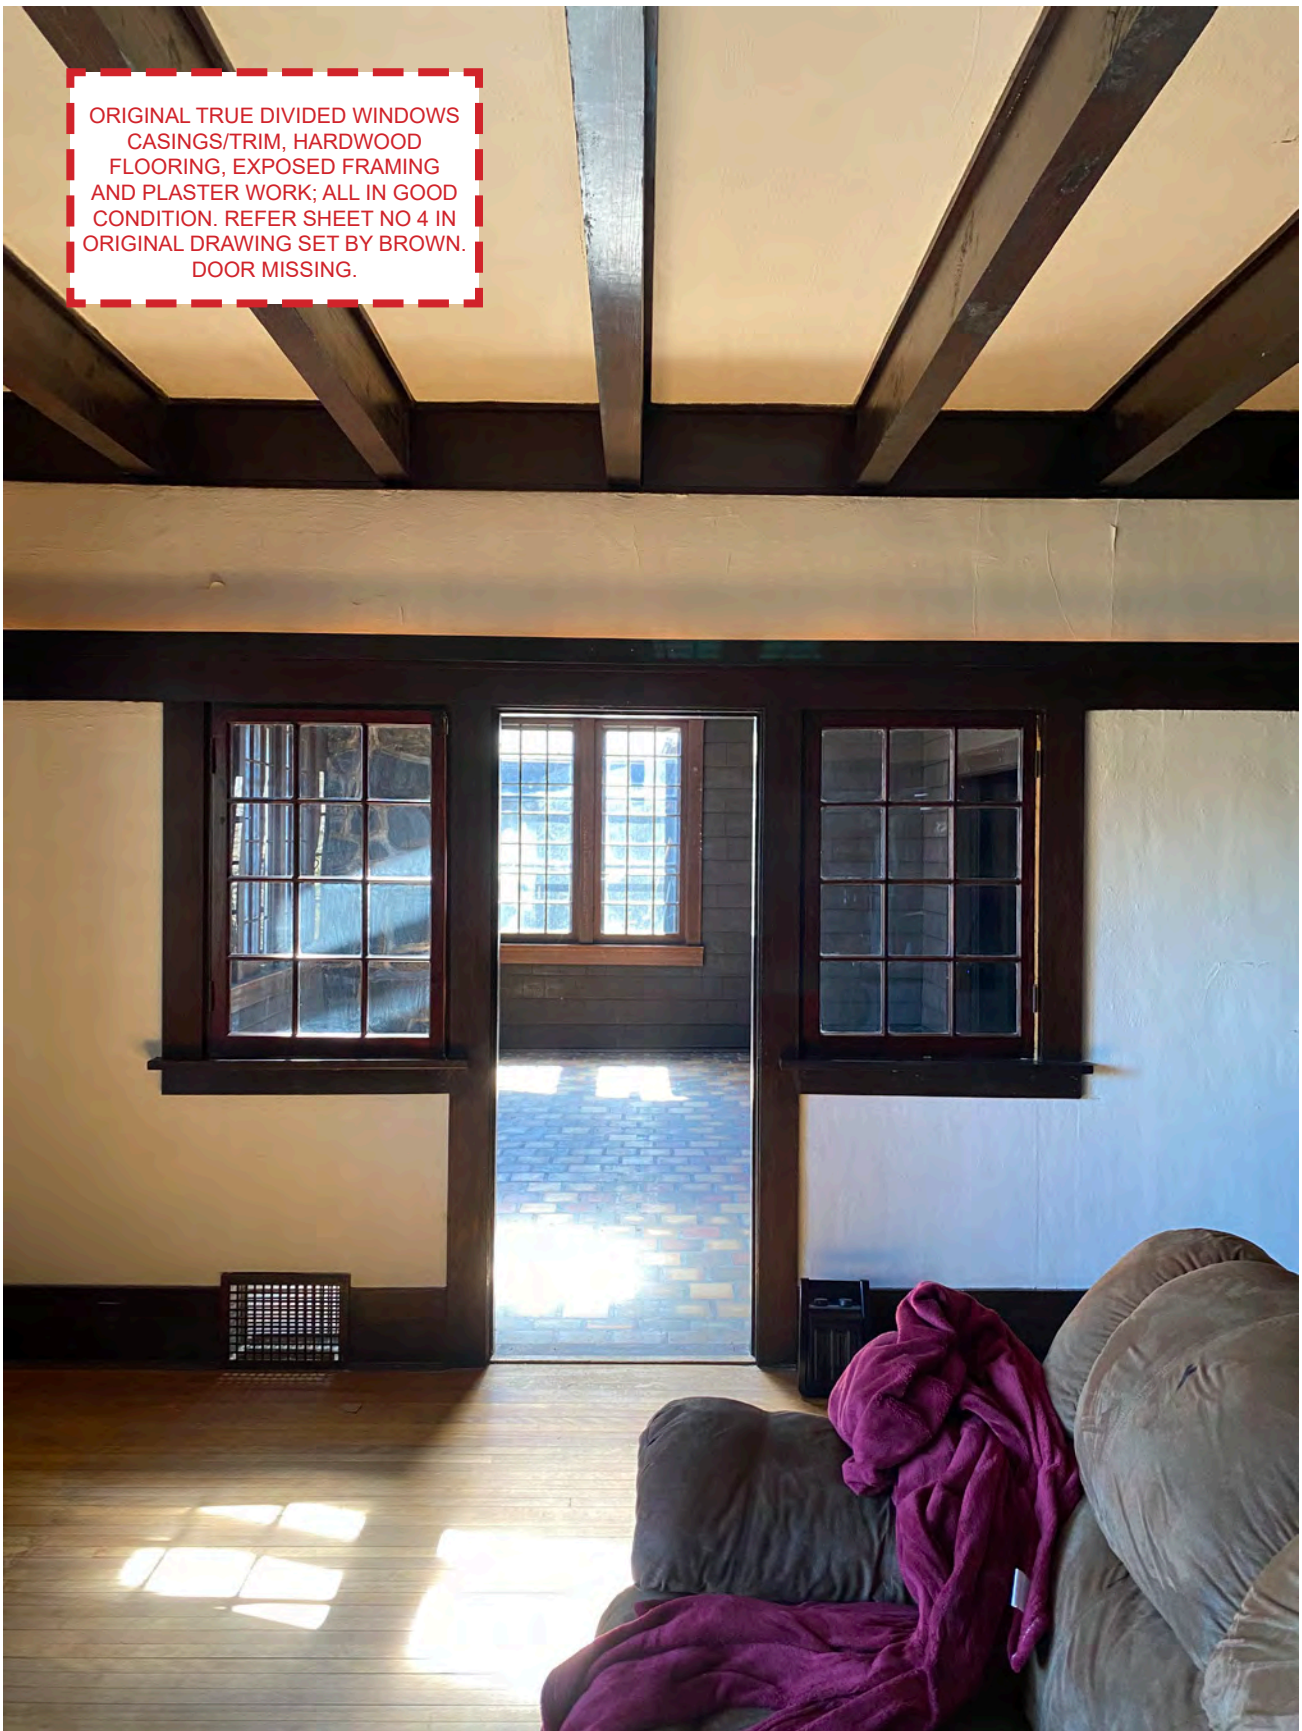
2.17 MAIN FLOOR LIVING ROOM (SOUTH).

ORIGINAL TRUE DIVIDED WINDOWS  
CASINGS/TRIM, HARDWOOD  
FLOORING, EXPOSED FRAMING  
AND PLASTER WORK; ALL IN GOOD  
CONDITION. REFER SHEET NO 4 IN  
ORIGINAL DRAWING SET BY BROWN.  
DOOR MISSING.

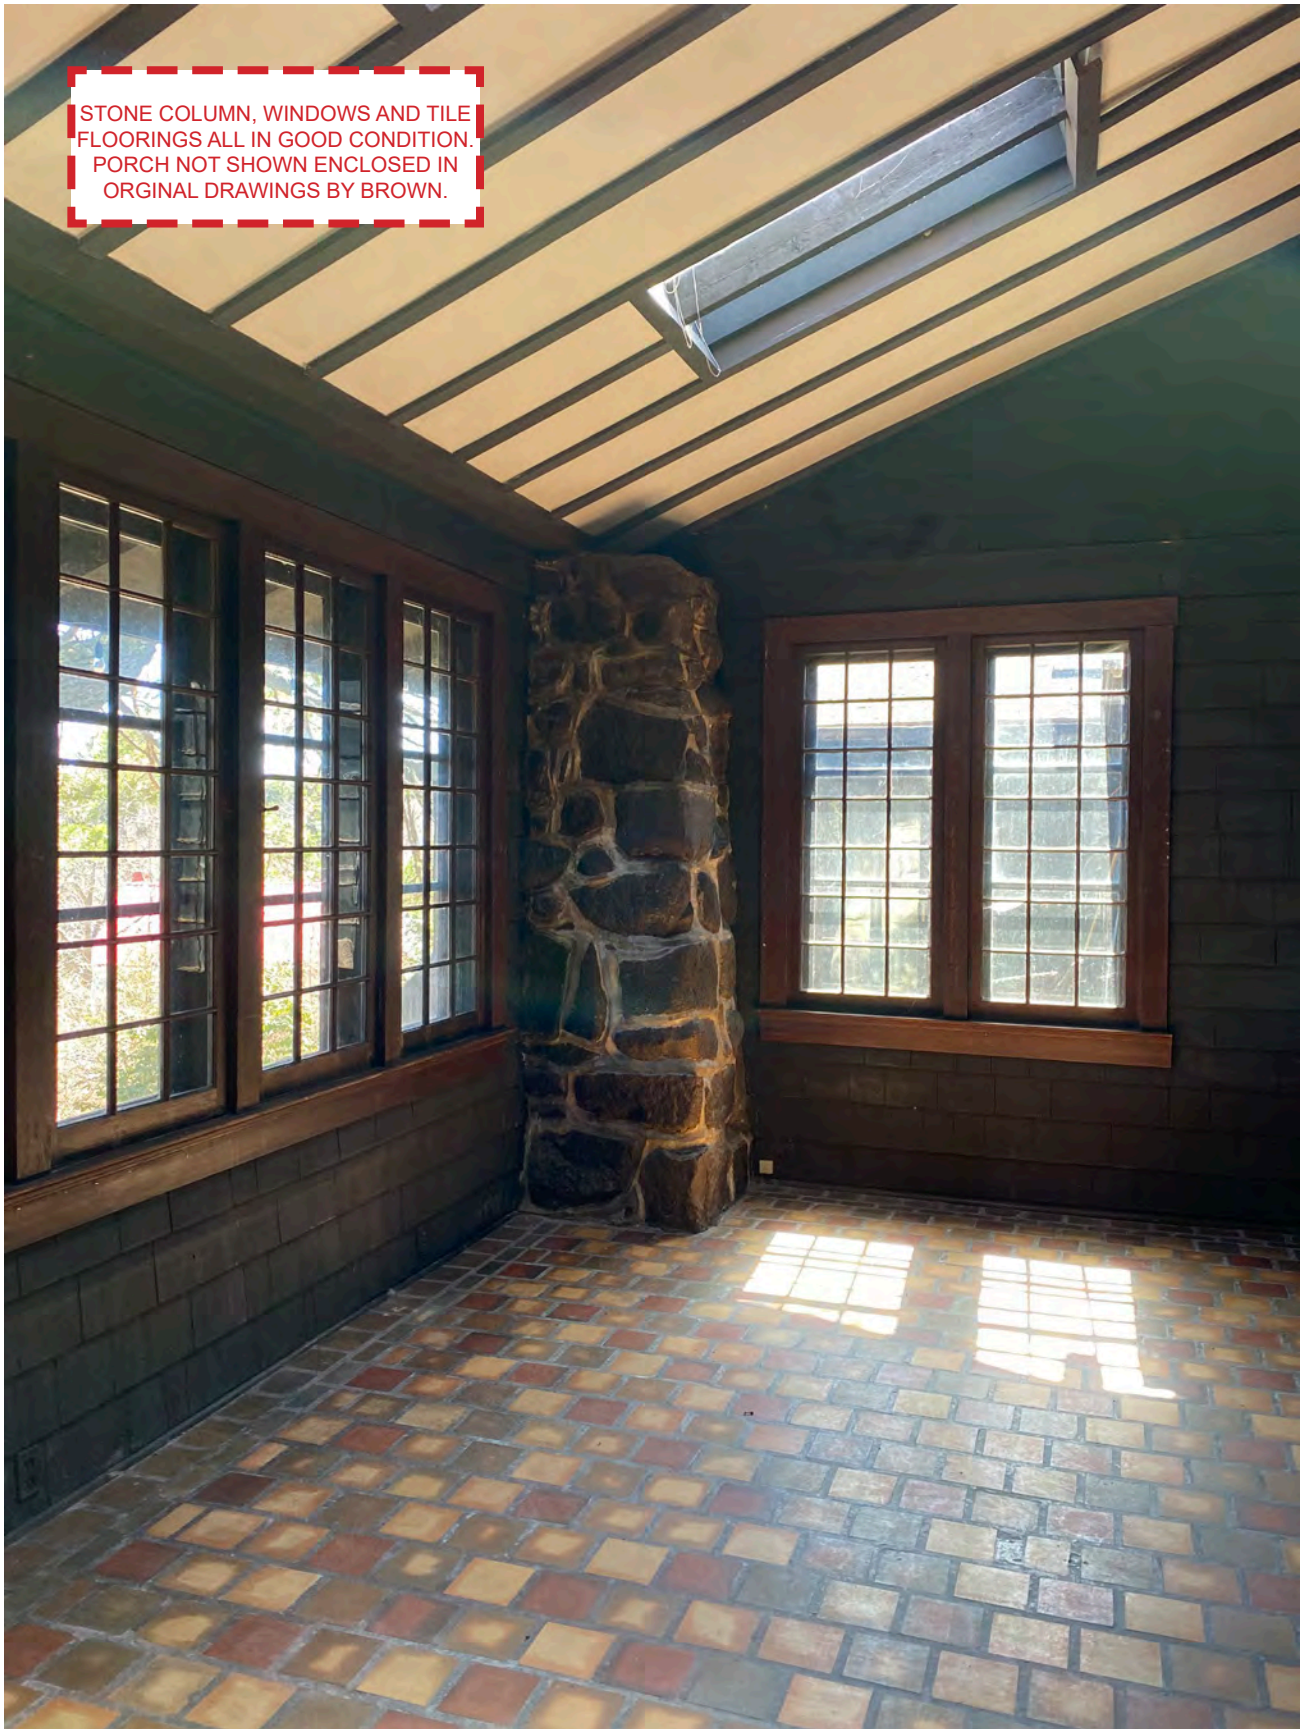
2.18 ENCLOSED PORCH, MAIN FLOOR (SOUTHEAST CORNER).

STONE COLUMN, WINDOWS AND TILE FLOORINGS ALL IN GOOD CONDITION. PORCH NOT SHOWN ENCLOSED IN ORIGINAL DRAWINGS BY BROWN.

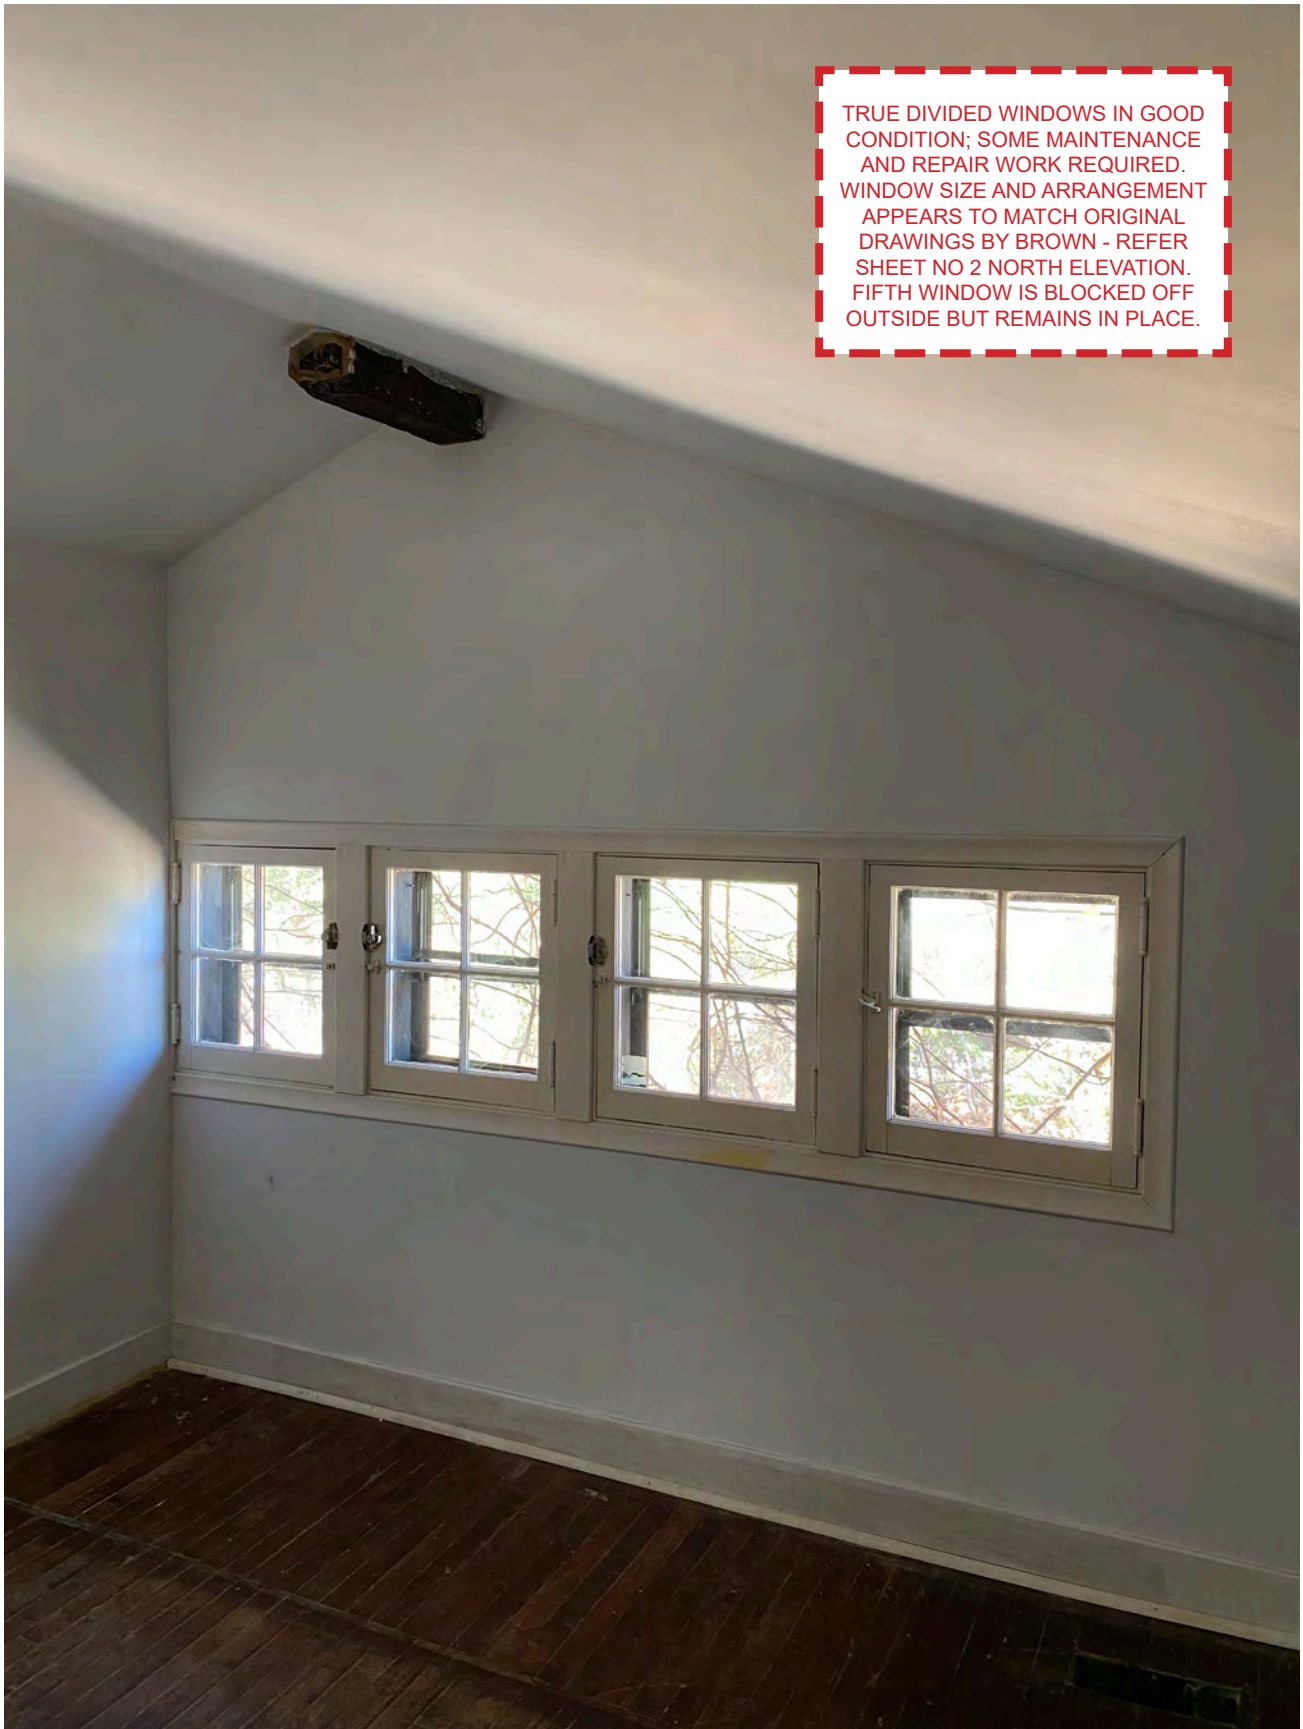
2.19 BEDROOM, UPPER FLOOR (SOUTH SIDE).

TRUE DIVIDED WINDOWS IN GOOD  
CONDITION; SOME MAINTENANCE  
AND REPAIR WORK REQUIRED.  
WINDOW SIZE AND ARRANGEMENT  
APPEARS TO MATCH ORIGINAL  
DRAWINGS BY BROWN - REFER  
SHEET NO 2 NORTH ELEVATION.  
FIFTH WINDOW IS BLOCKED OFF  
OUTSIDE BUT REMAINS IN PLACE.

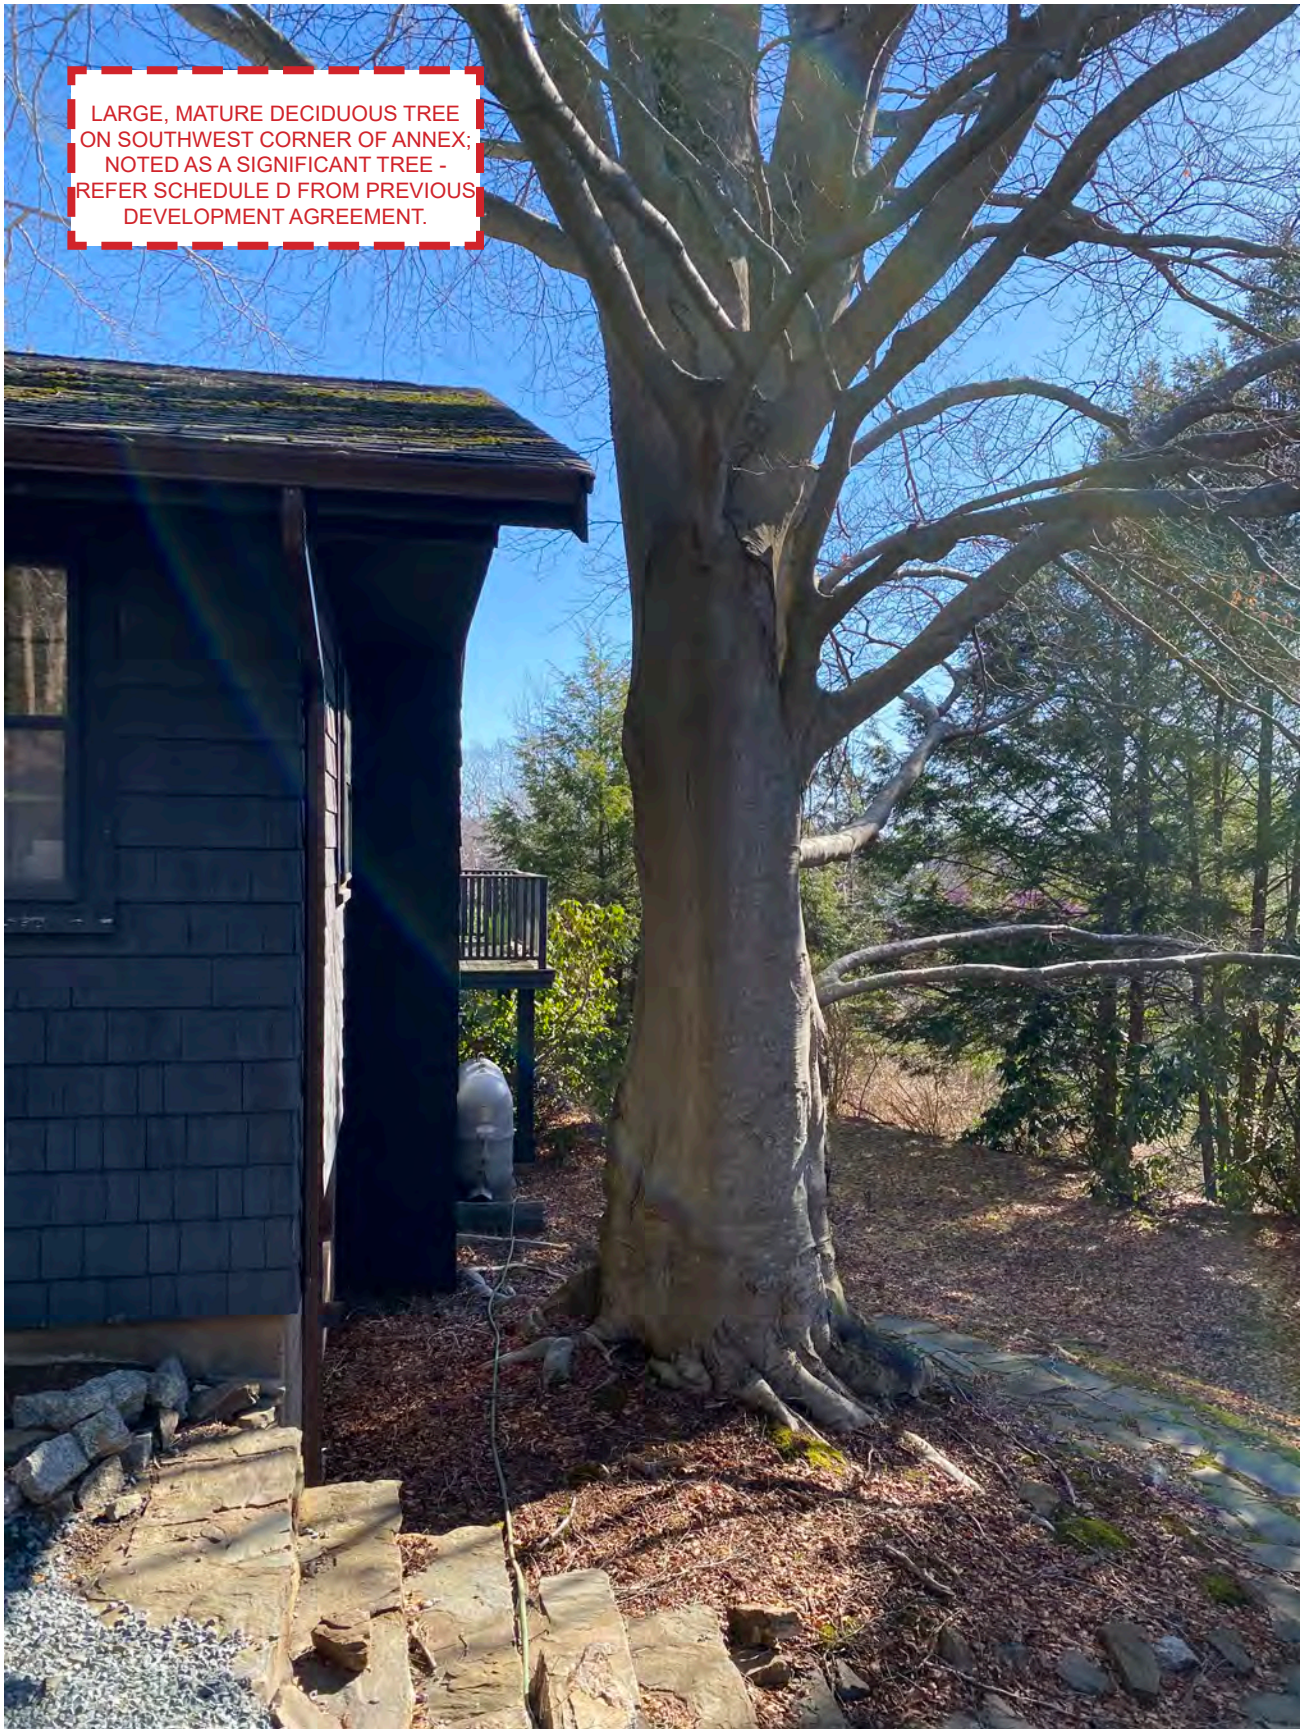
**2.22** TREE AT SOUTHWEST CORNER OF ANNEX.

LARGE, MATURE DECIDUOUS TREE  
ON SOUTHWEST CORNER OF ANNEX;  
NOTED AS A SIGNIFICANT TREE -  
REFER SCHEDULE D FROM PREVIOUS  
DEVELOPMENT AGREEMENT.

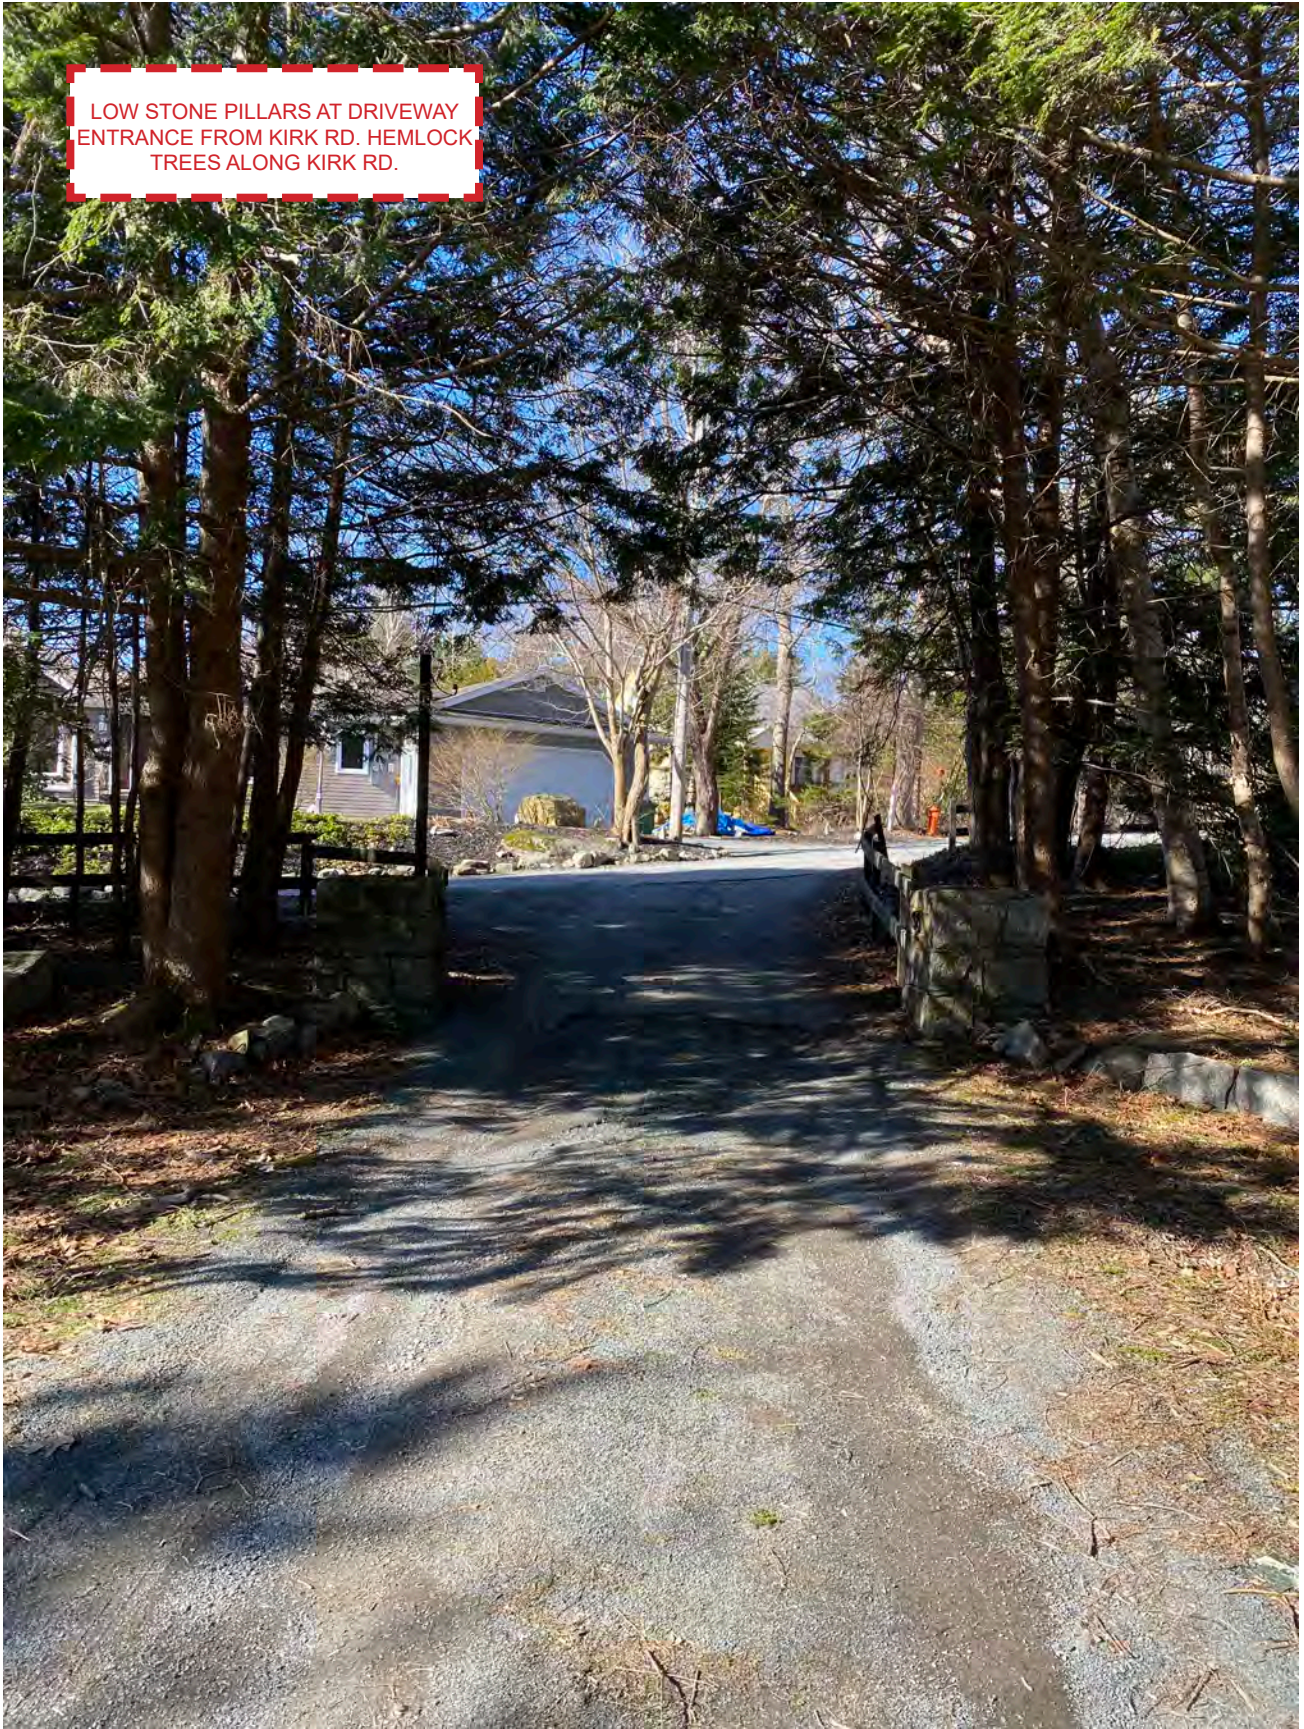
**2.24** DRIVEWAY ENTRANCE OFF KIRK RD (WEST VIEW).

LOW STONE PILLARS AT DRIVEWAY  
ENTRANCE FROM KIRK RD. HEMLOCK  
TREES ALONG KIRK RD.

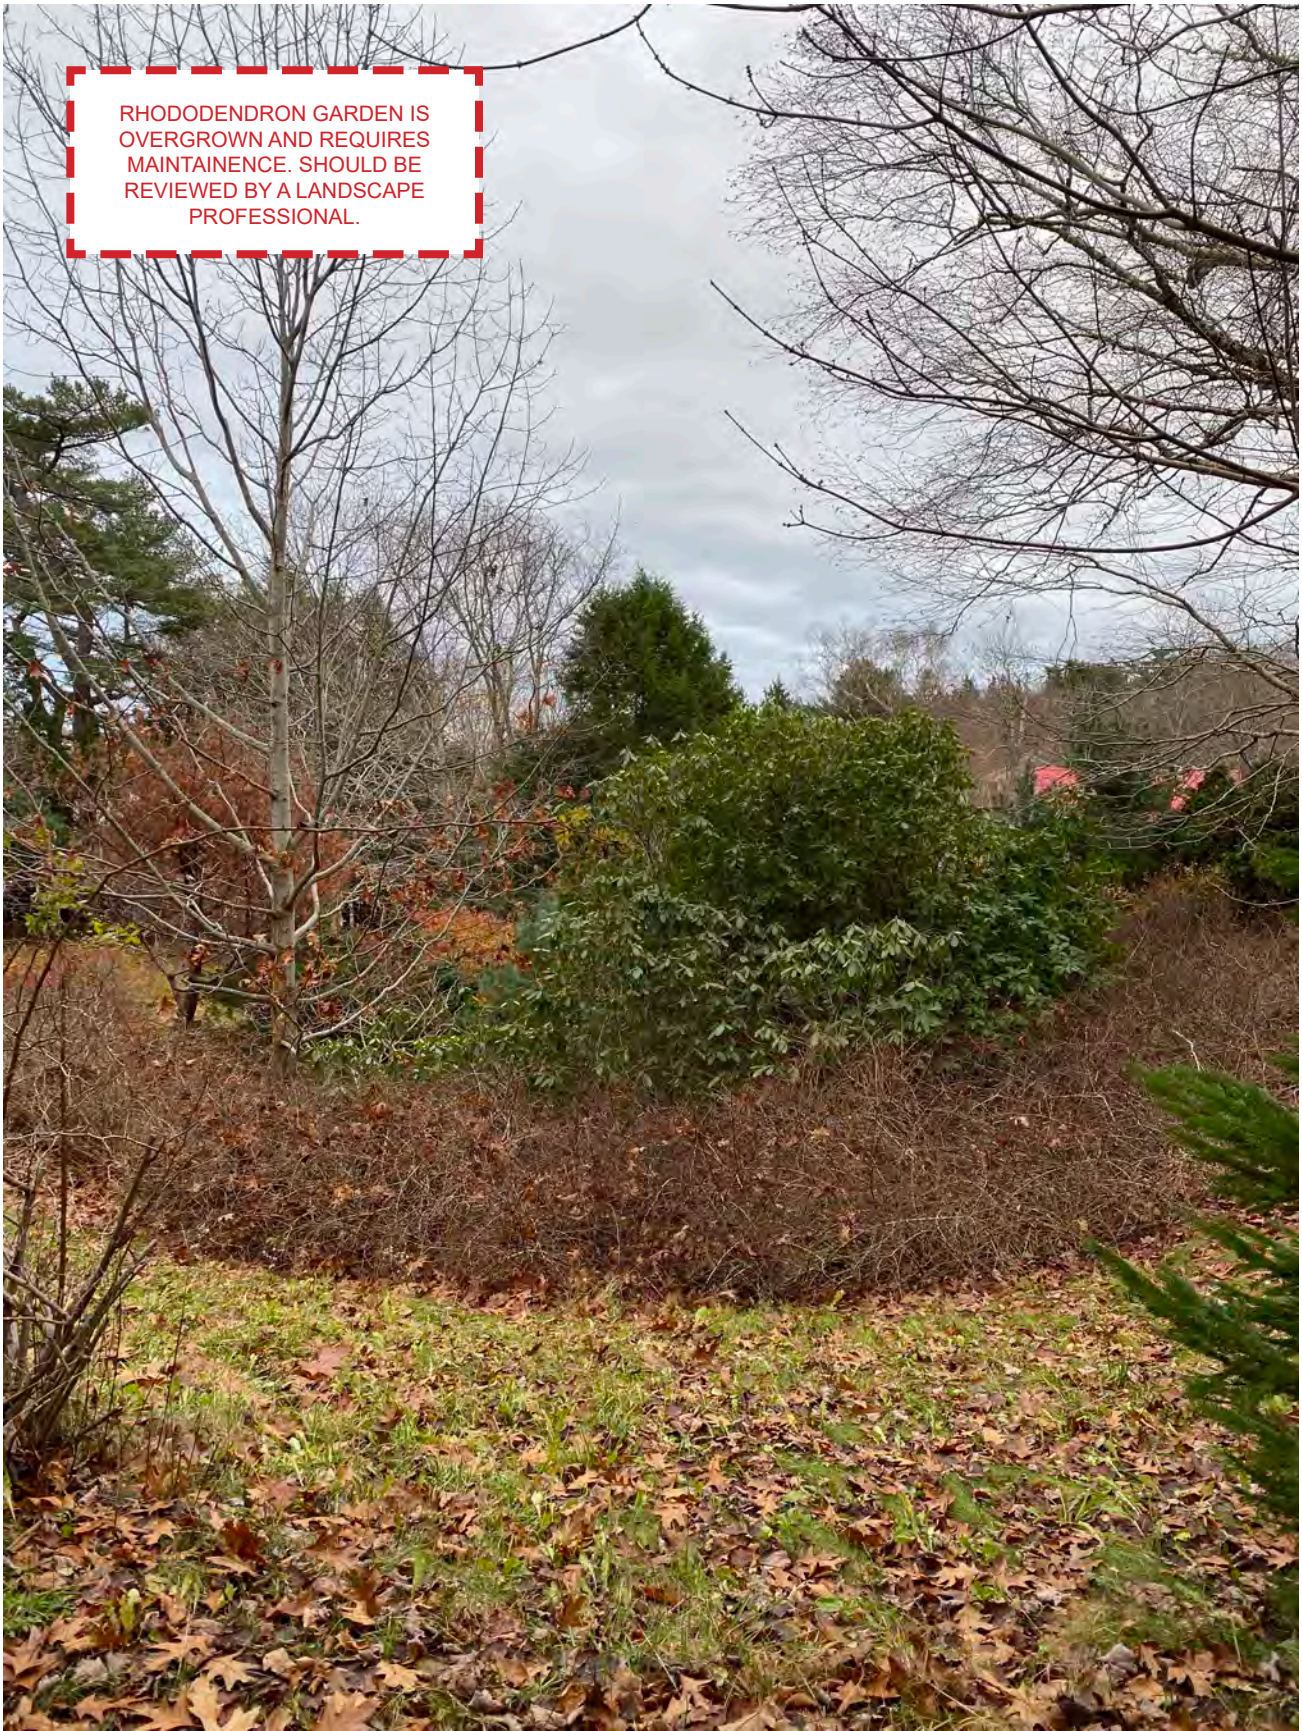
**2.26** RHODODENDRON GARDEN (EAST VIEW).

RHODODENDRON GARDEN IS  
OVERGROWN AND REQUIRES  
MAINTAINENCE. SHOULD BE  
REVIEWED BY A LANDSCAPE  
PROFESSIONAL.

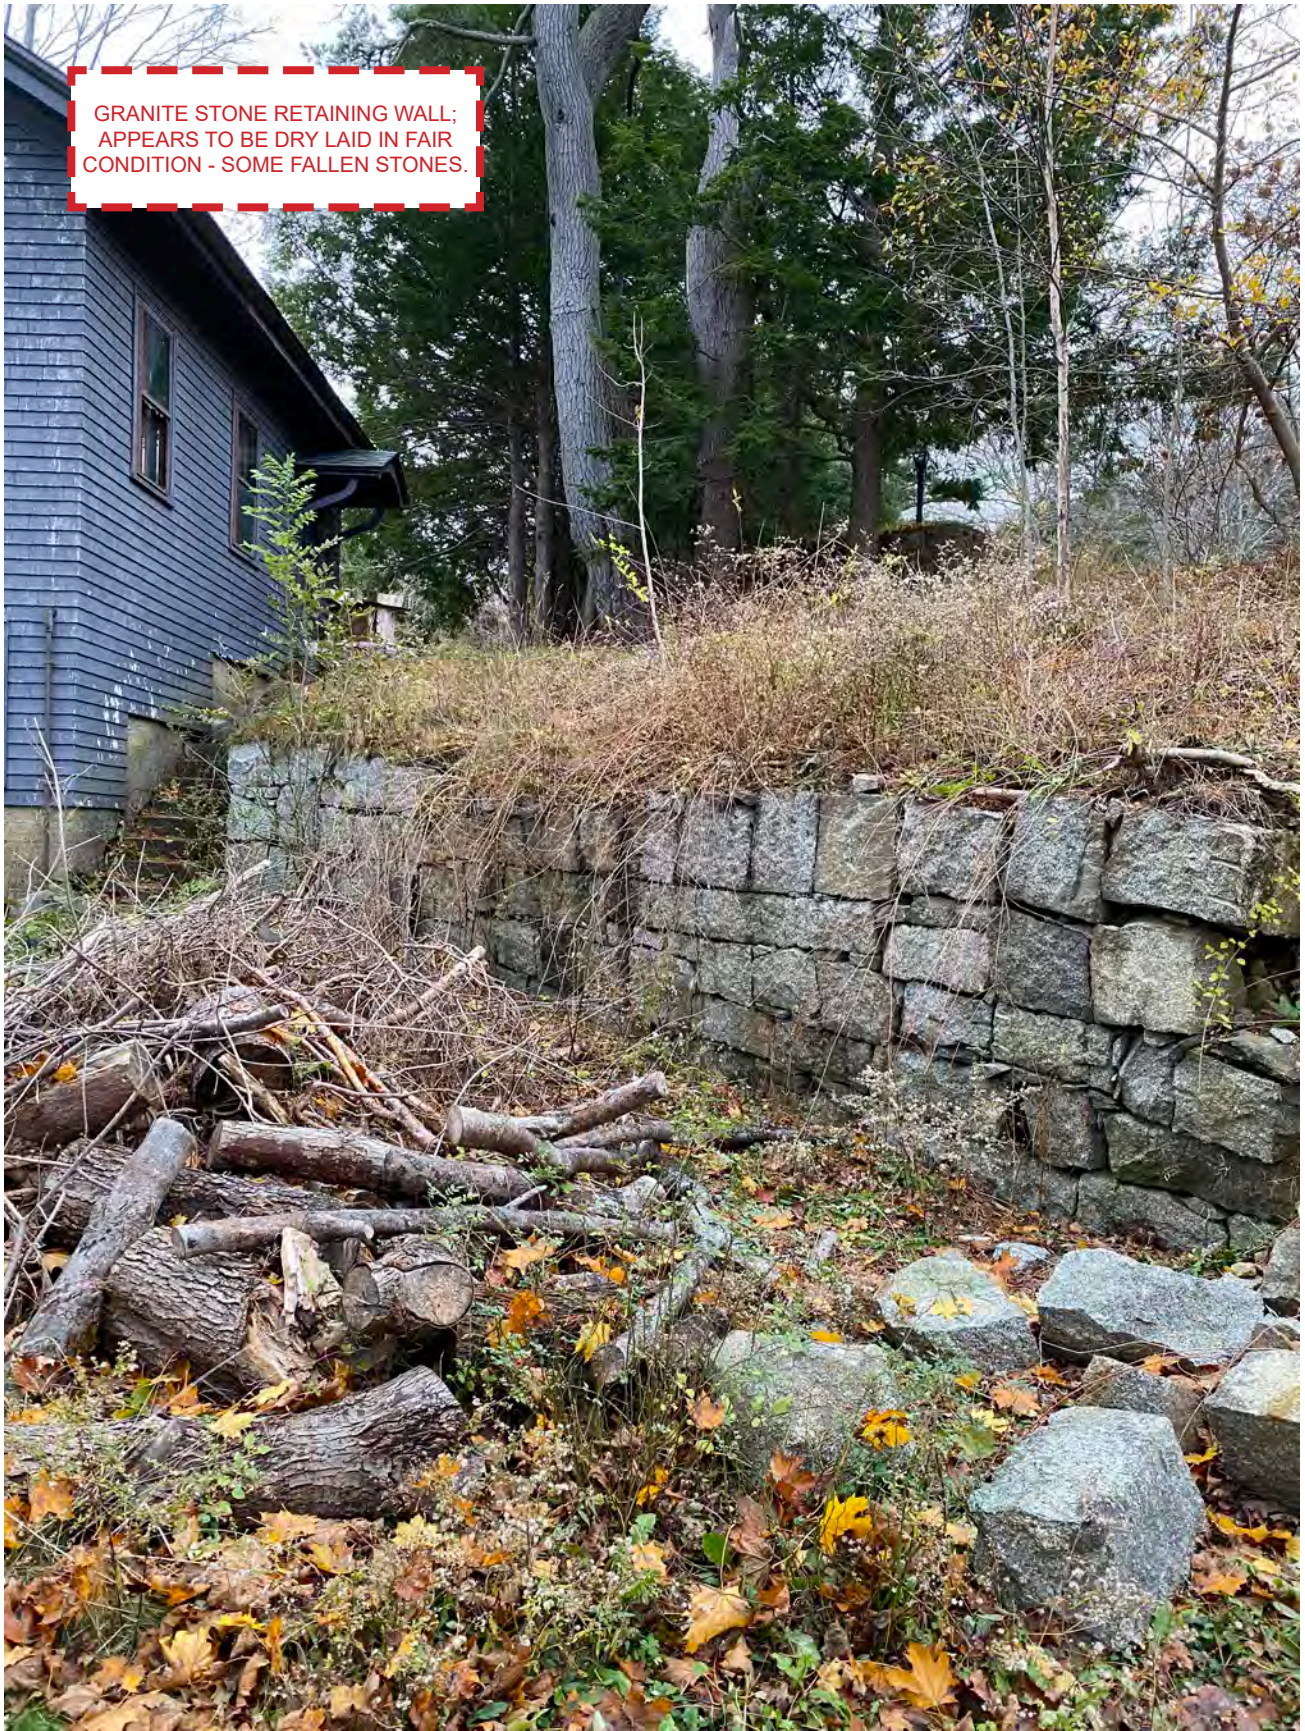
**2.27** STONE WALL NEXT TO ROOST (SOUTHWEST VIEW).

GRANITE STONE RETAINING WALL;  
APPEARS TO BE DRY LAID IN FAIR  
CONDITION - SOME FALLEN STONES.
