**Item No. 15.7.1**  
**Halifax Regional Council**  
**August 22, 2023**

**DATE:** July 26, 2023

**SUBJECT:** **Case H00528: Substantial Alteration to the municipally registered heritage property at 10 Kirk Road, Halifax**

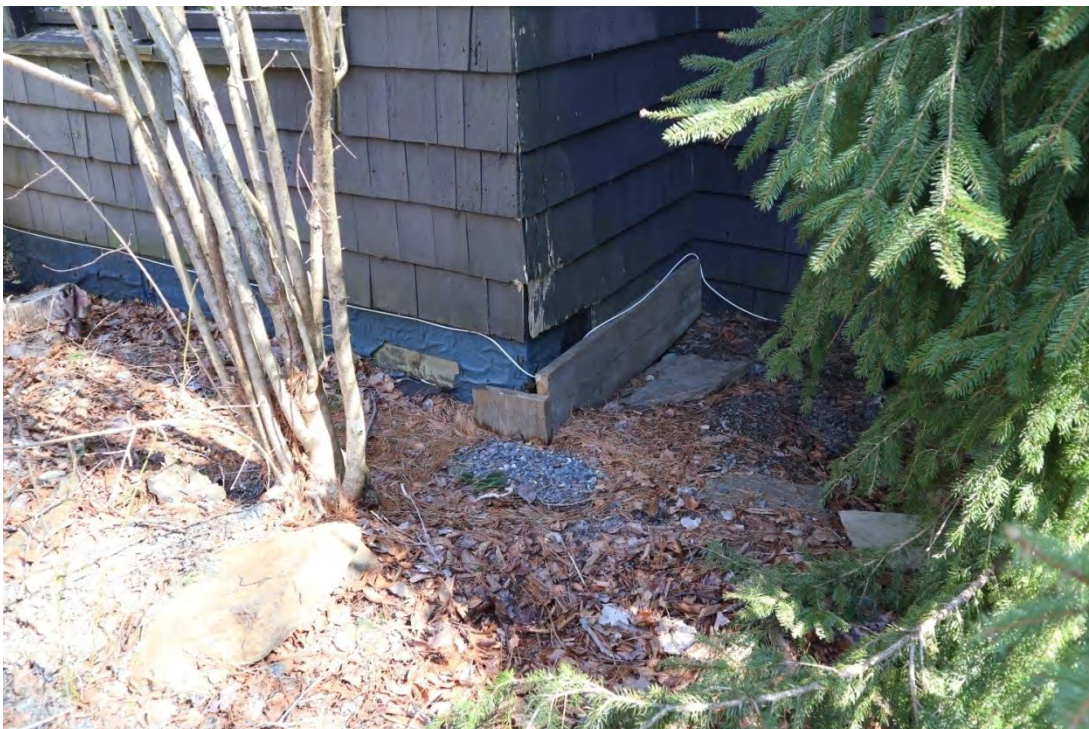
1) The first item of note was the site grading around the building. On the front side, that which faces Kirk Road, the foundation of the house barely comes out of the ground. This has led to a number of water problems due to the fact that water can flow over the foundation and into the basement. This has caused problems such as rotting of the lower wall area, rim and floor joists etc. See below wood wall below ground line.

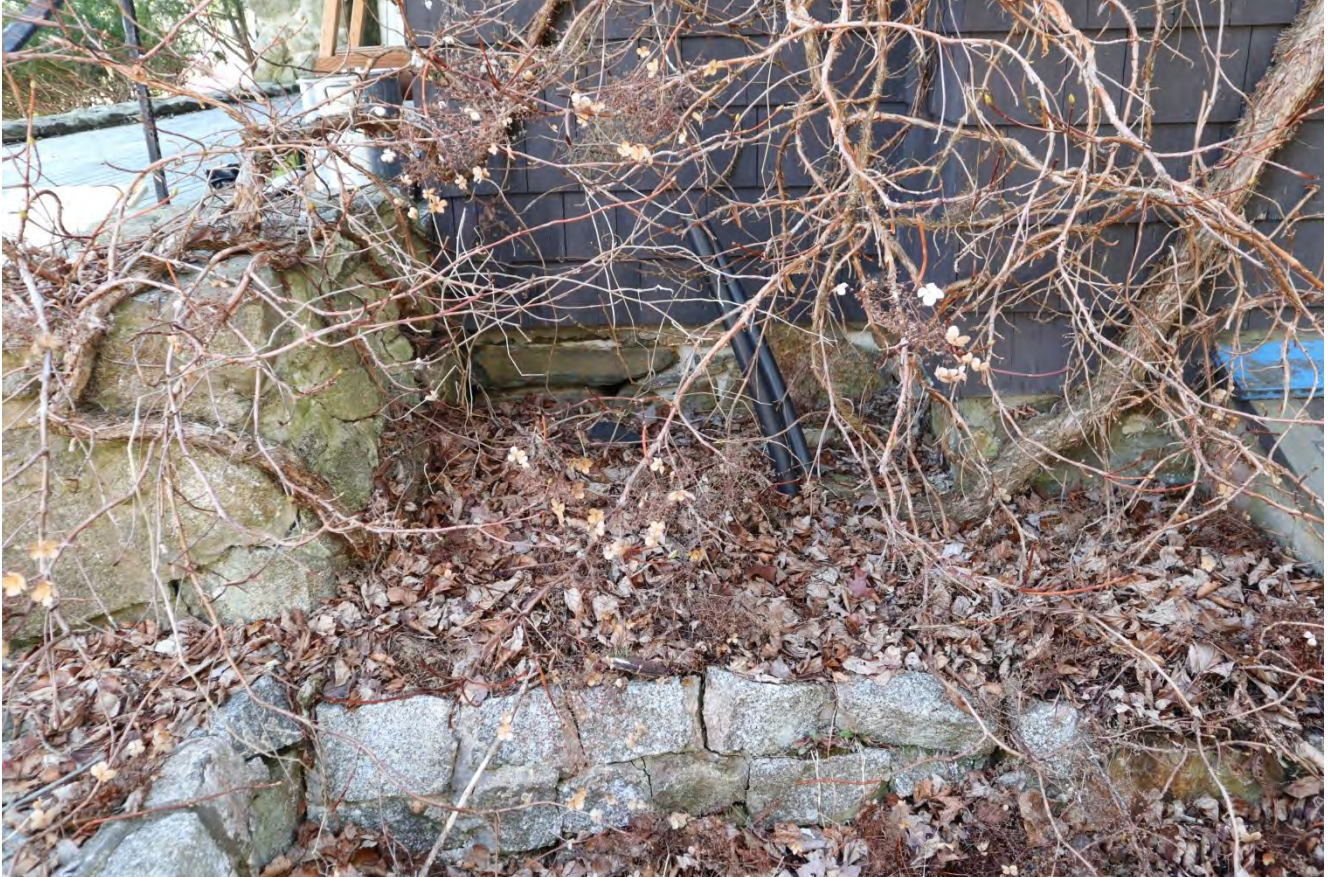
2) Also notices on the exterior of this building was to fact that the foundation itself was constructed as a rock foundation. This was done with little thought to water proofing of the basement. See in the photograph below the visible rock of the foundation wall, and the openings through the rocks. These openings will allow entry of water where ever the grading of the land is not proper. Grading around the building is very bad. Also leaks are common whenever there is snow build up along the wall in which case water will simply run into the building.

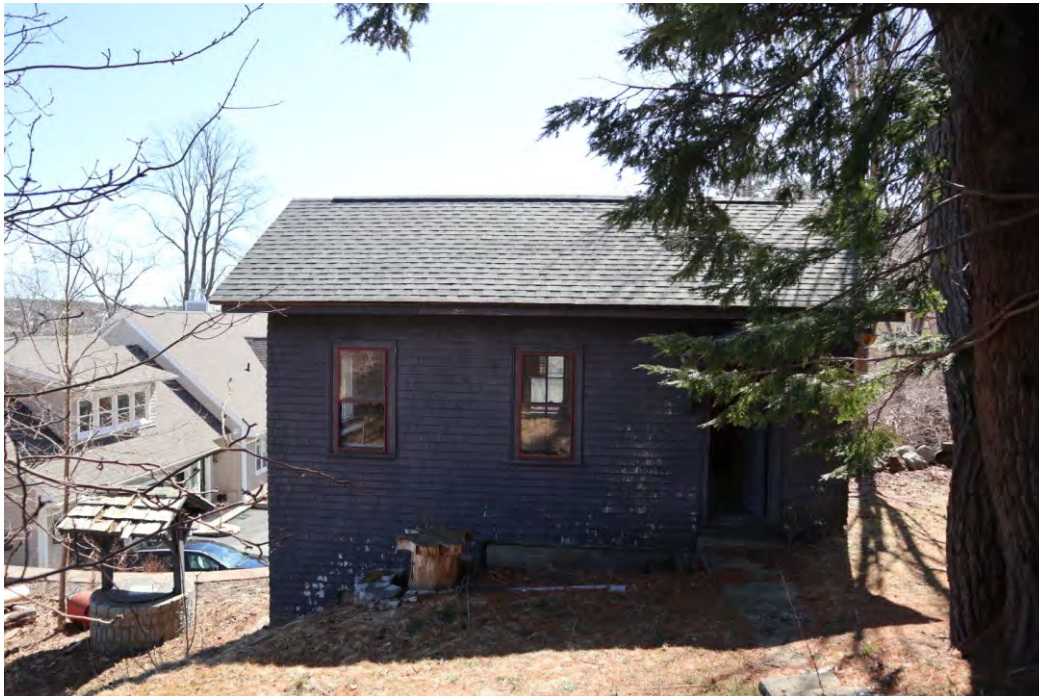
Entrance Face

1) The siding on the exterior of this building is wood shingles. It appears to be in relatively good condition. What it appears to require is chalking around windows and some repair. It could use a good coat of paint as the present paint is starting to dry up and fade.

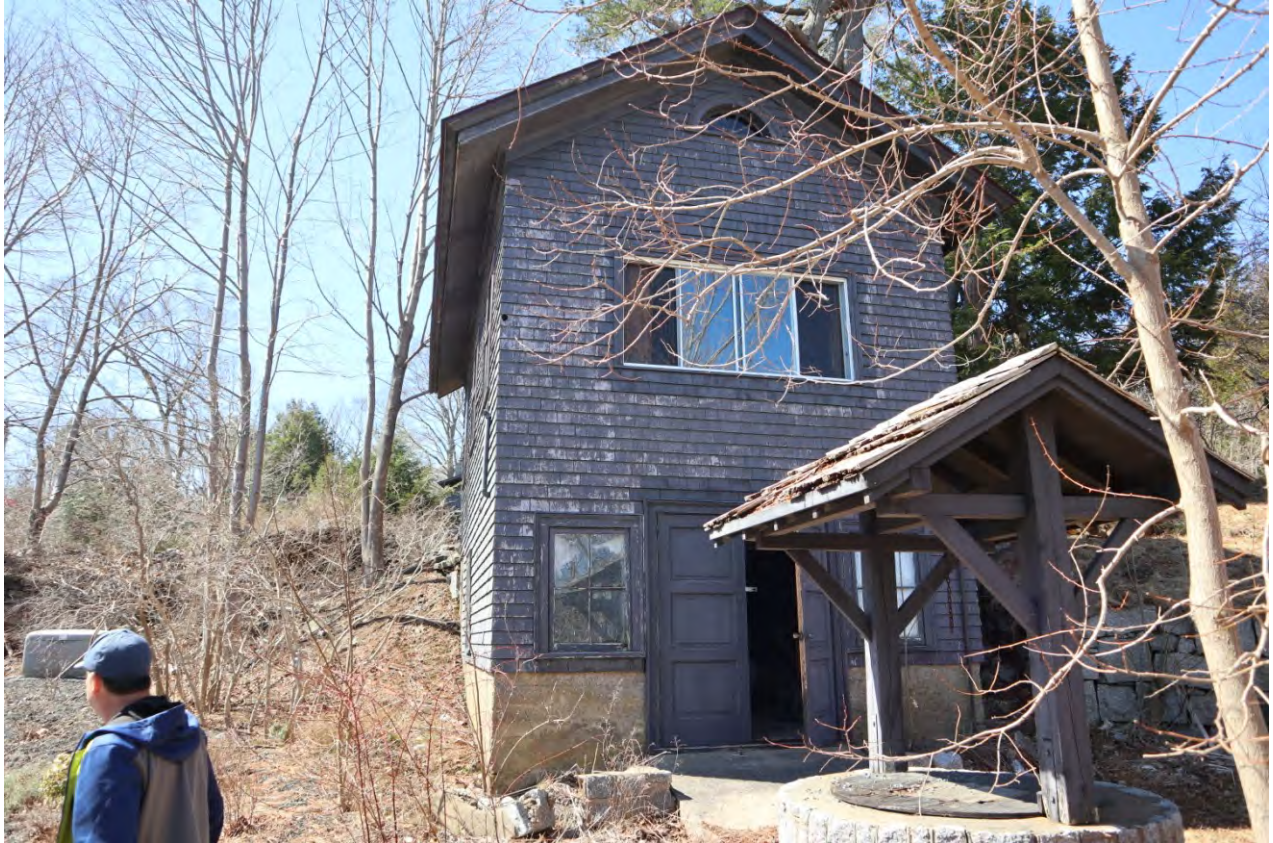
Waterside Face

One window is a newer type. This is a vinyl horizontal slider. This window is visible in the photograph above. This window is the best of what is presently there, but it leaks and is visibly aged.

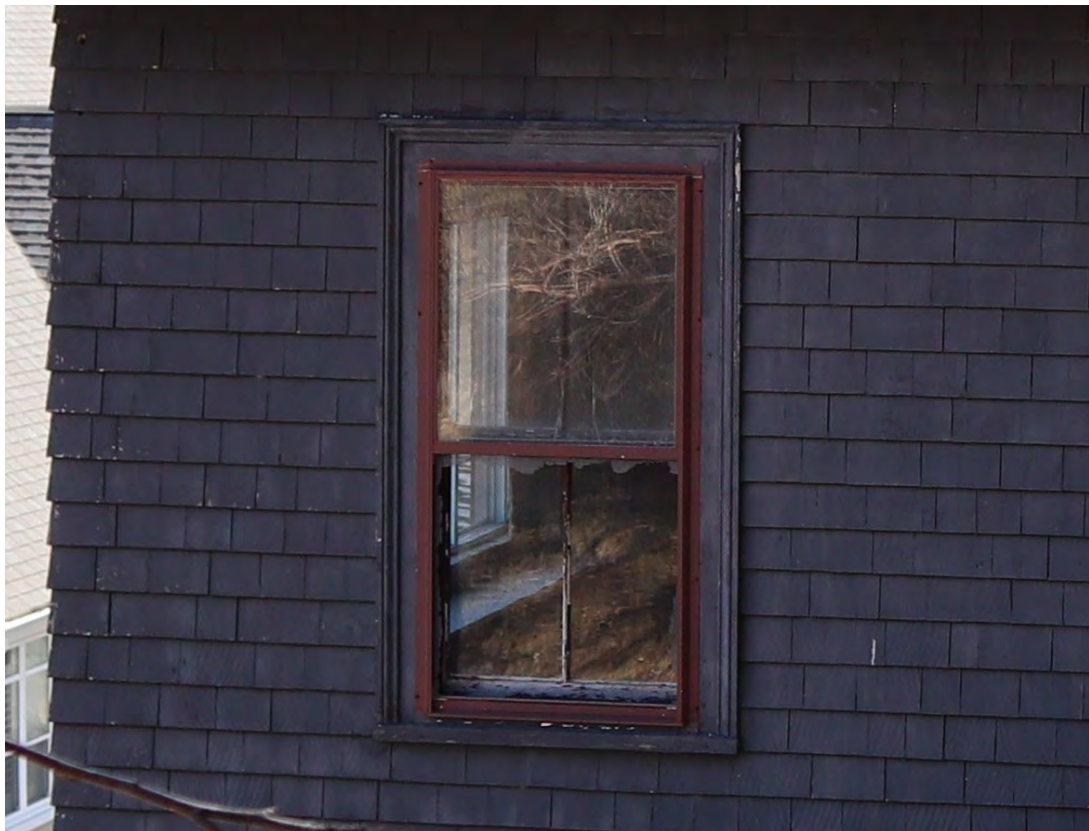
Some of the window frame openings have a storm window on the exterior. These are on the upper level of the building (main). See the second photograph below. As can be seen, this storm window is totally rusted, and the bottom pane of glass is smashed out.

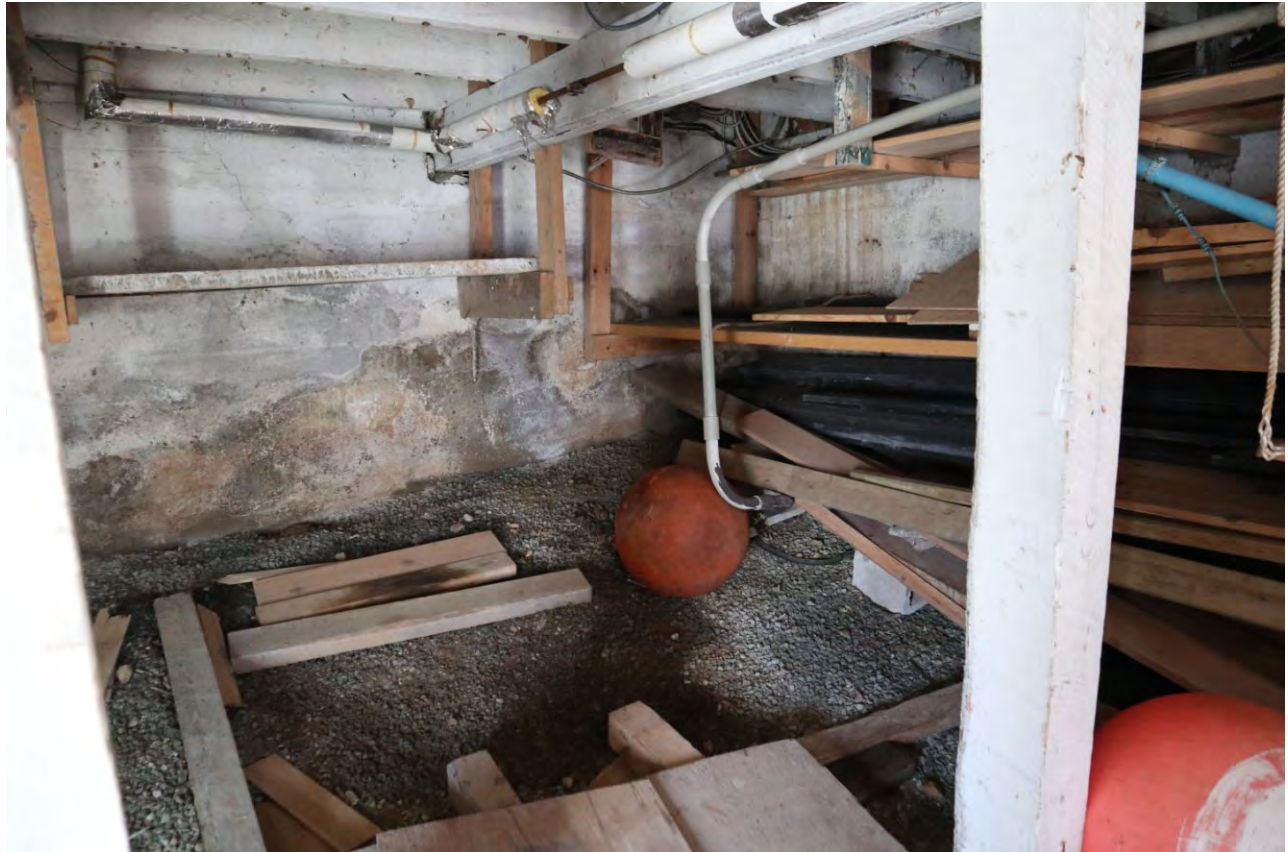
4) There is water flow entering the crawl space. This enters through or under the foundation wall and it travels along a path following the slope of the ground through the crawl space. Evidence of this, and the path of travel is clearly shown by the dark areas of the gravel as shown in the following photograph.

Therefore it is obvious that there presently is water in the crawl space.

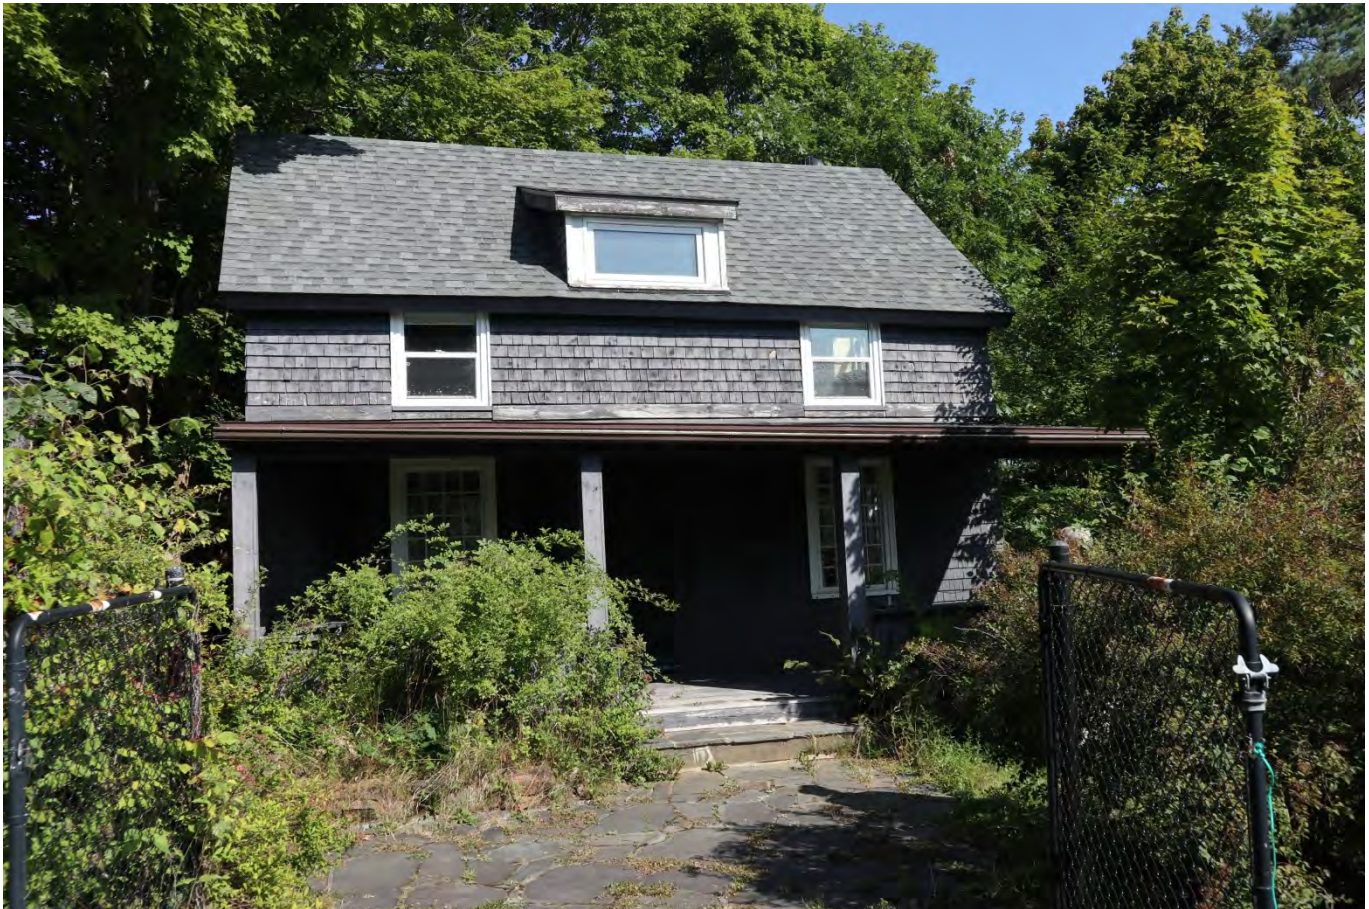
The **Pool House** is a small building on the property which is not set up for use in a residential purpose. The building from a distance looks relatively good but as you get in and around it, this is not the case. Please see the front side of this building below.

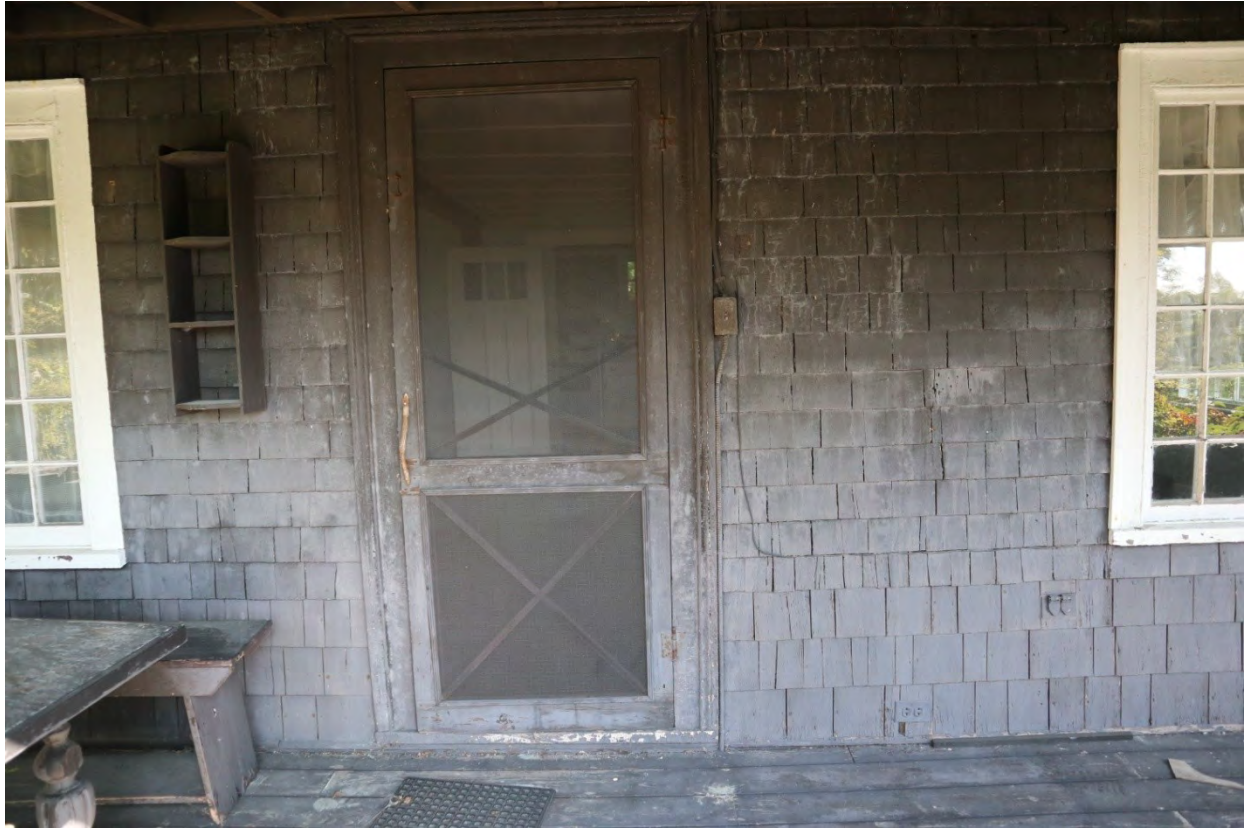
1) The exterior of the building has a substantial amount of rot, especially in and around the deck, or any wall which is near ground level. A close up look at the main front entry of the building reveals the general conditions which are encountered around the perimeter of the building.

Please see in the photograph below the front entry.

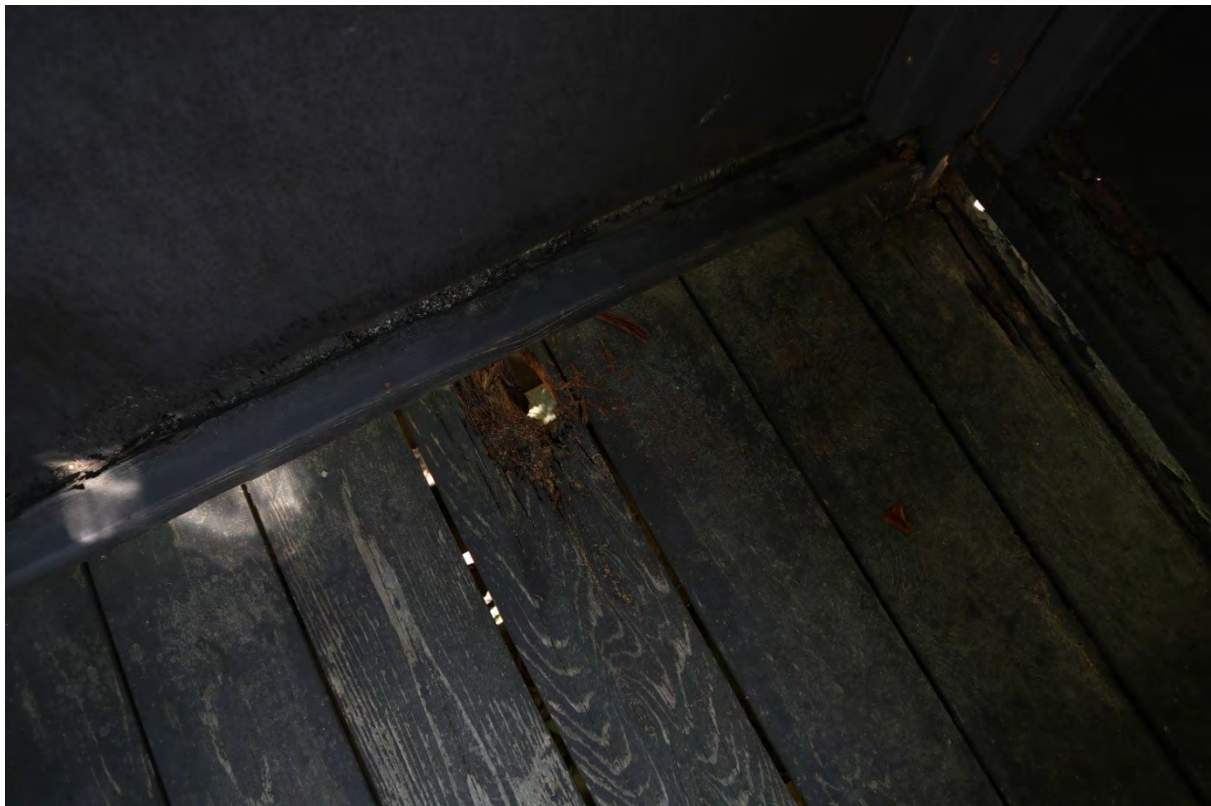
At the time of this inspection, two holes were put into the deck flooring, simply by a kicking motion with one shoe toward the deck. Please see a sample on the photograph below.

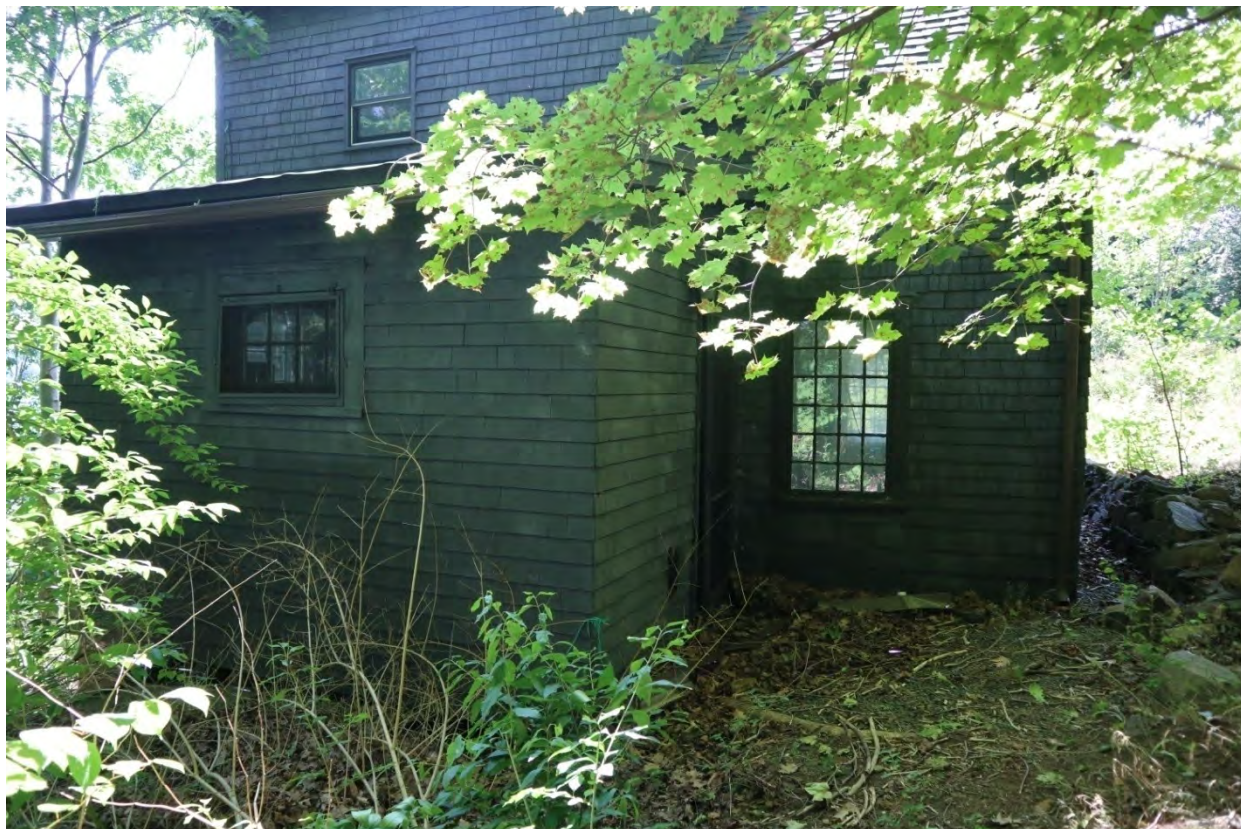
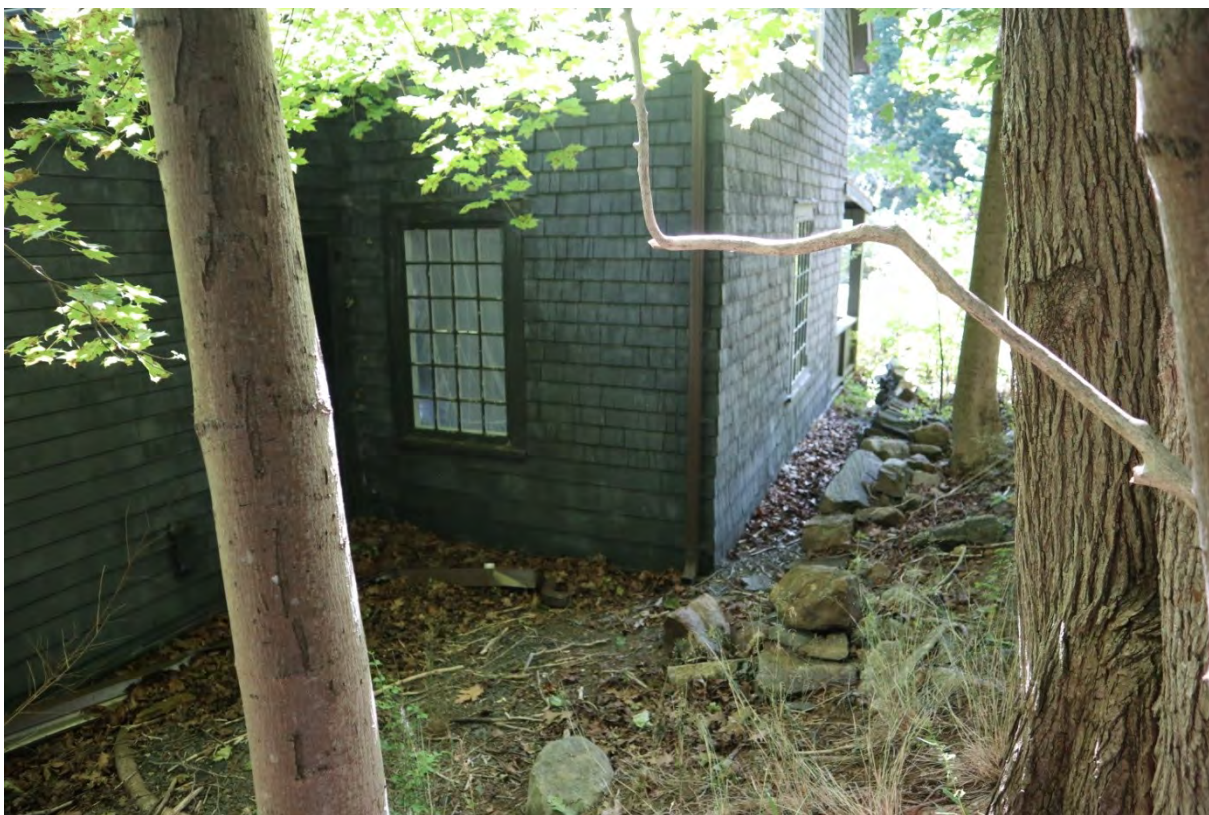
2) The lot grading along two sides of the was totally improper, resulting in water flow towards the building rather than away from the wall. See below.

Compounding this improper problem, was the fact that a good portion of the building exterior walls have the wood siding at or near the grade line. This has led to rot of the siding and the wood wall structure, and water infiltration below building. The space below the building is basically a crawl space.

The National Building Code minimum distance from the exterior ground elevation to the top of a building foundation wall is 6 inches. This is not the case around two sides of this building. Added onto this problem is that of the water drainage flow direction. By code, the ground around the building is to be graded such that the surface water flows away from the property. In this case, surface water flows towards the building.

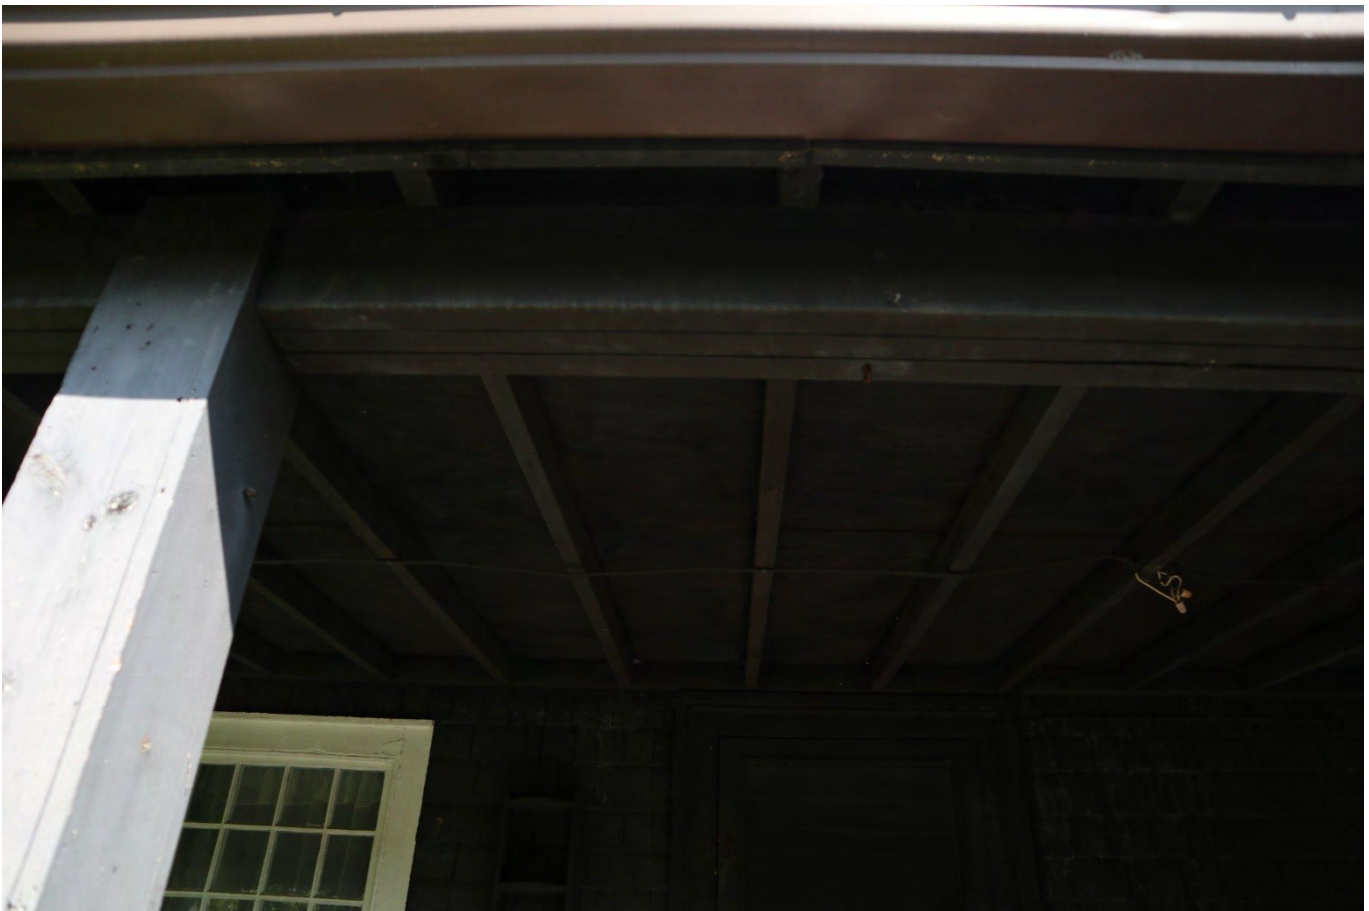
3) The building **Canopy** over front deck is constructed with 2" x 4" wood joists. These are very much undersized considering the length of the joist and the snow loading designation for this area. See photograph below.

This canopy has sections of rot scattered throughout. It is fairly large, and as is, should not pass a structural inspection, thus should fail approved if HRM staff if they were to view it.

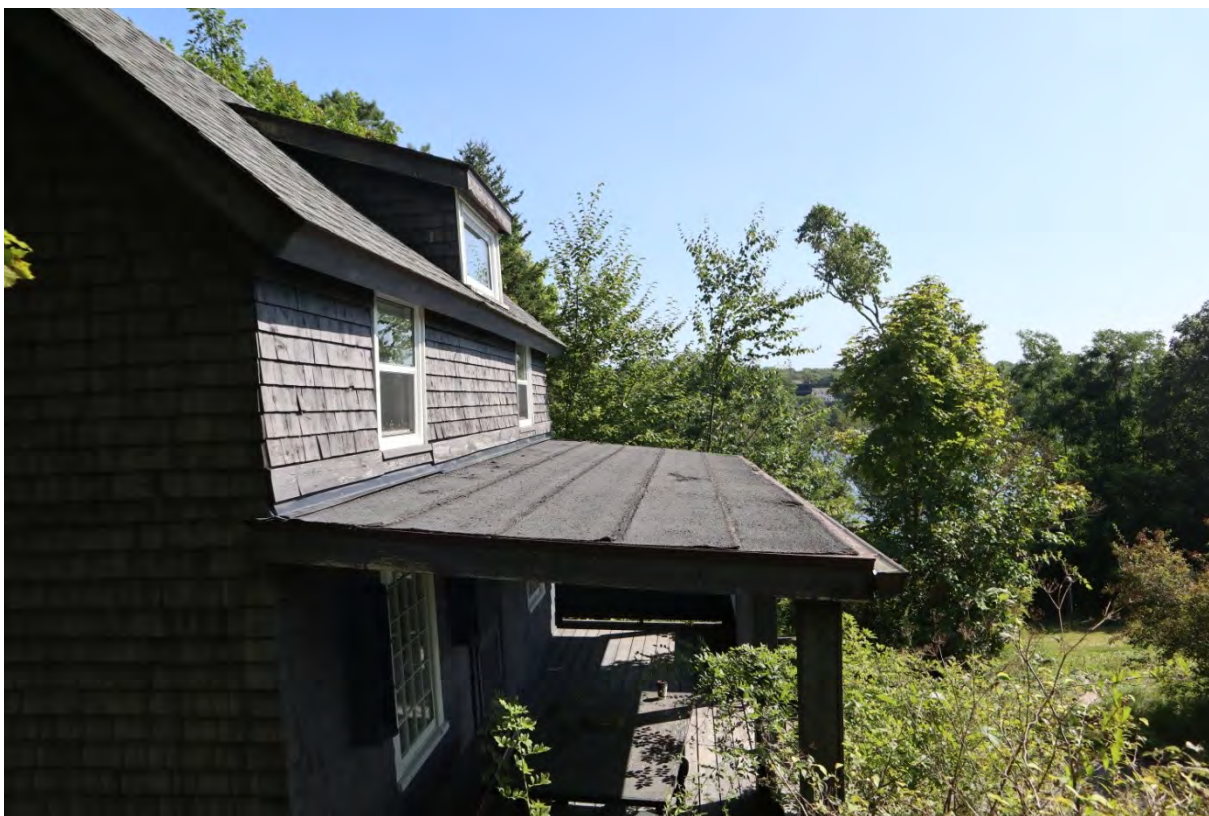
Please see in the photograph below, a side view of the canopy. The torched-on-roof membrane is in very bad condition, and visible is several areas of obvious membrane failure.

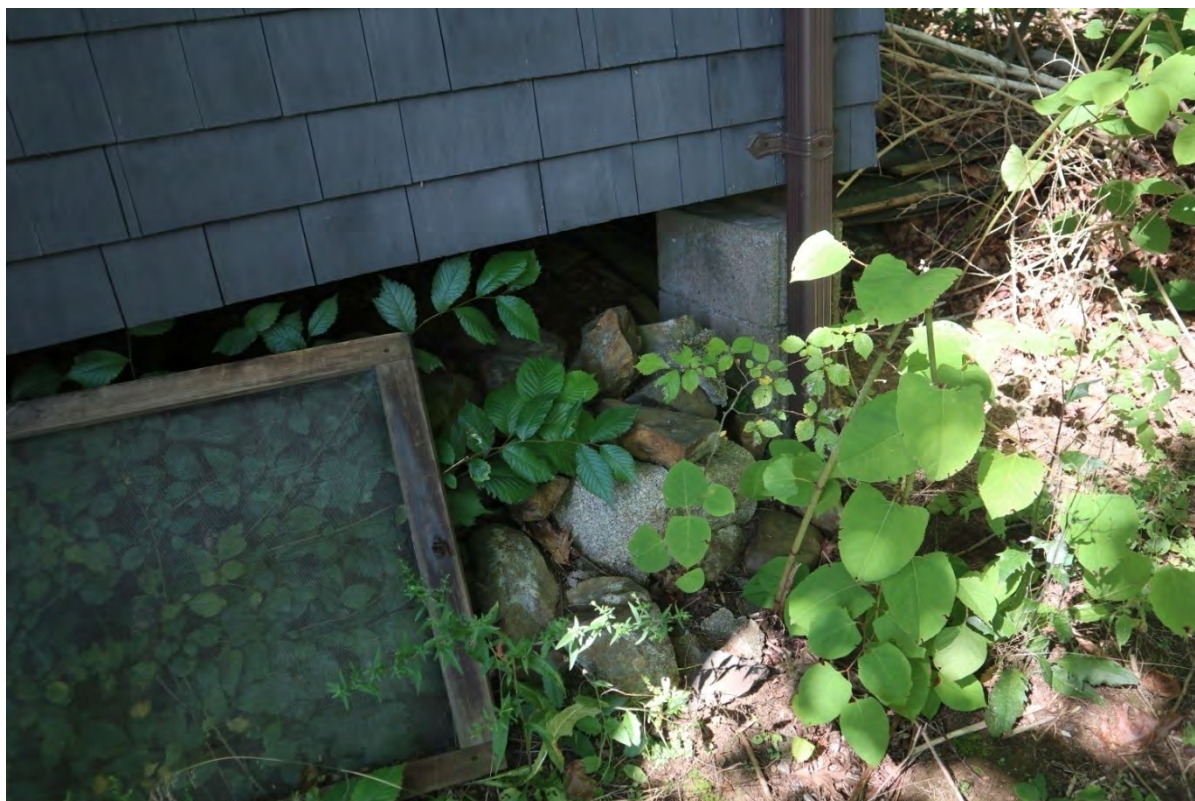
3) **The visible foundation** around the building is virtually non-existent around the exterior. See photographs below.

As is obvious in these photographs, what is there would no longer qualify as a secure foundation. It is now more along the line of a building being supported by piles of rock. There is one corner of the building which is actually supported by a few stacked concrete blocks. This is clearly shown in the photograph on the previous page.

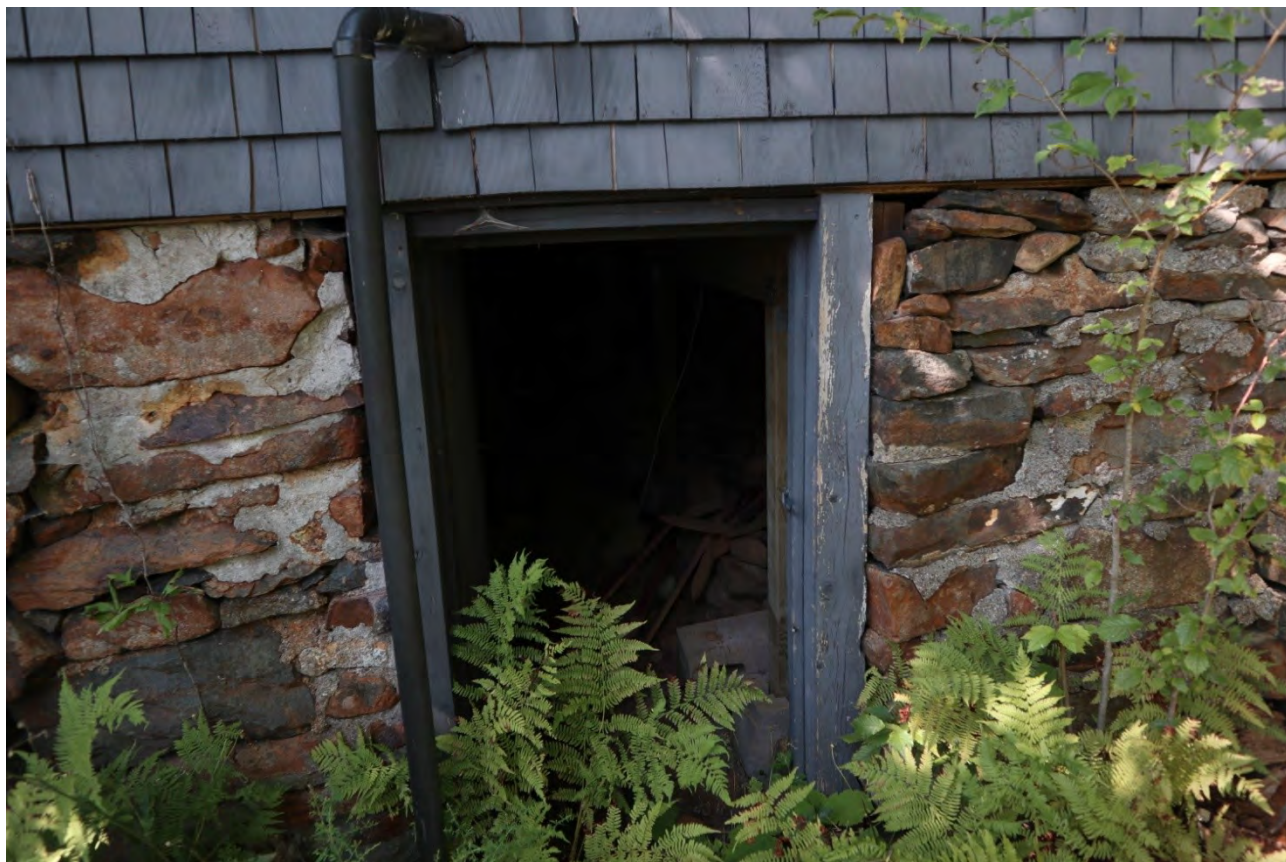
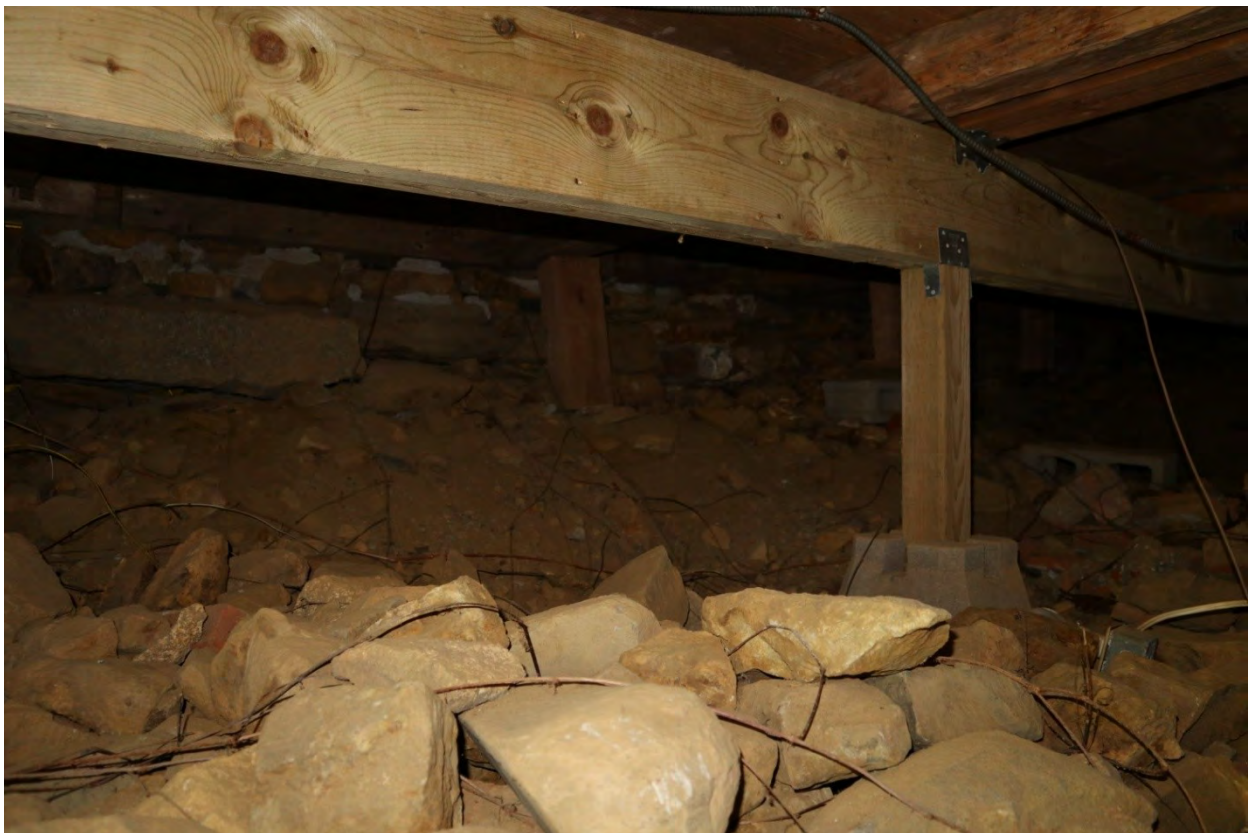
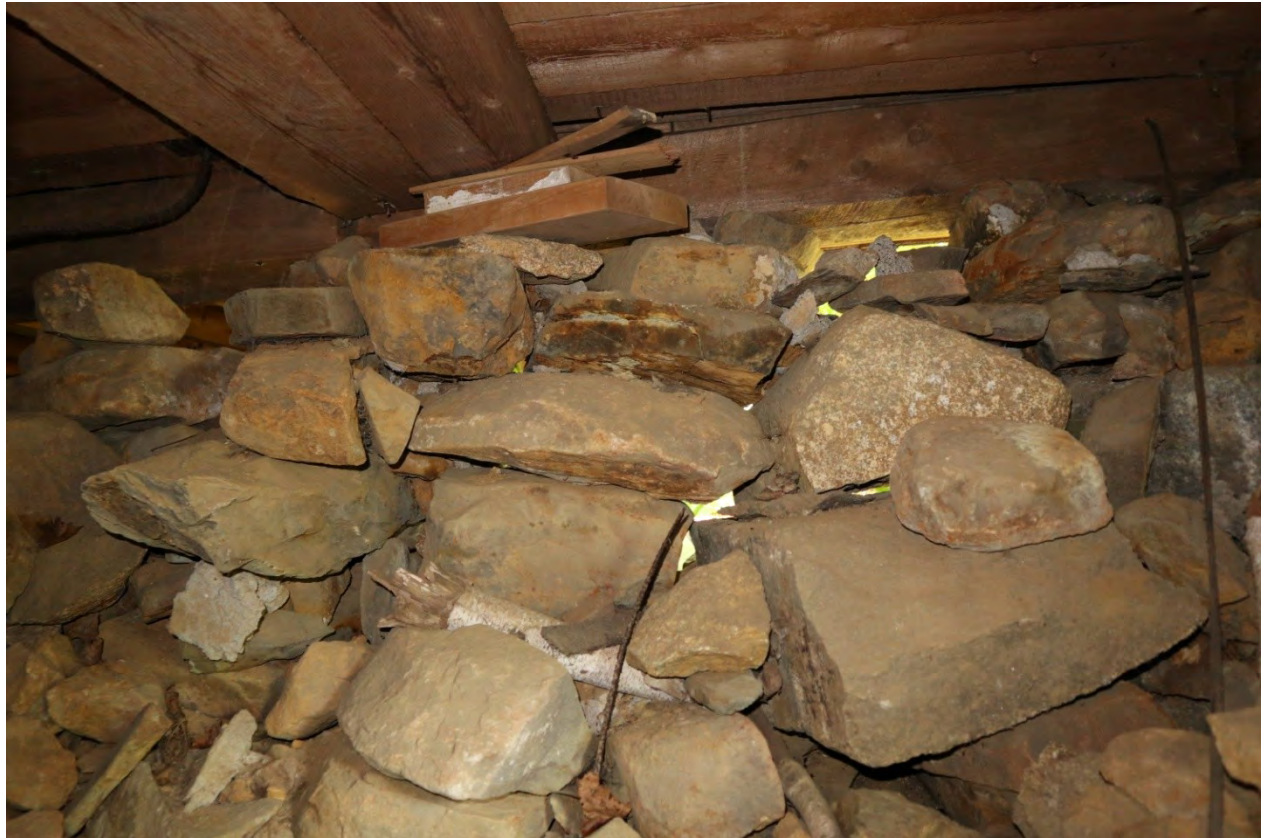
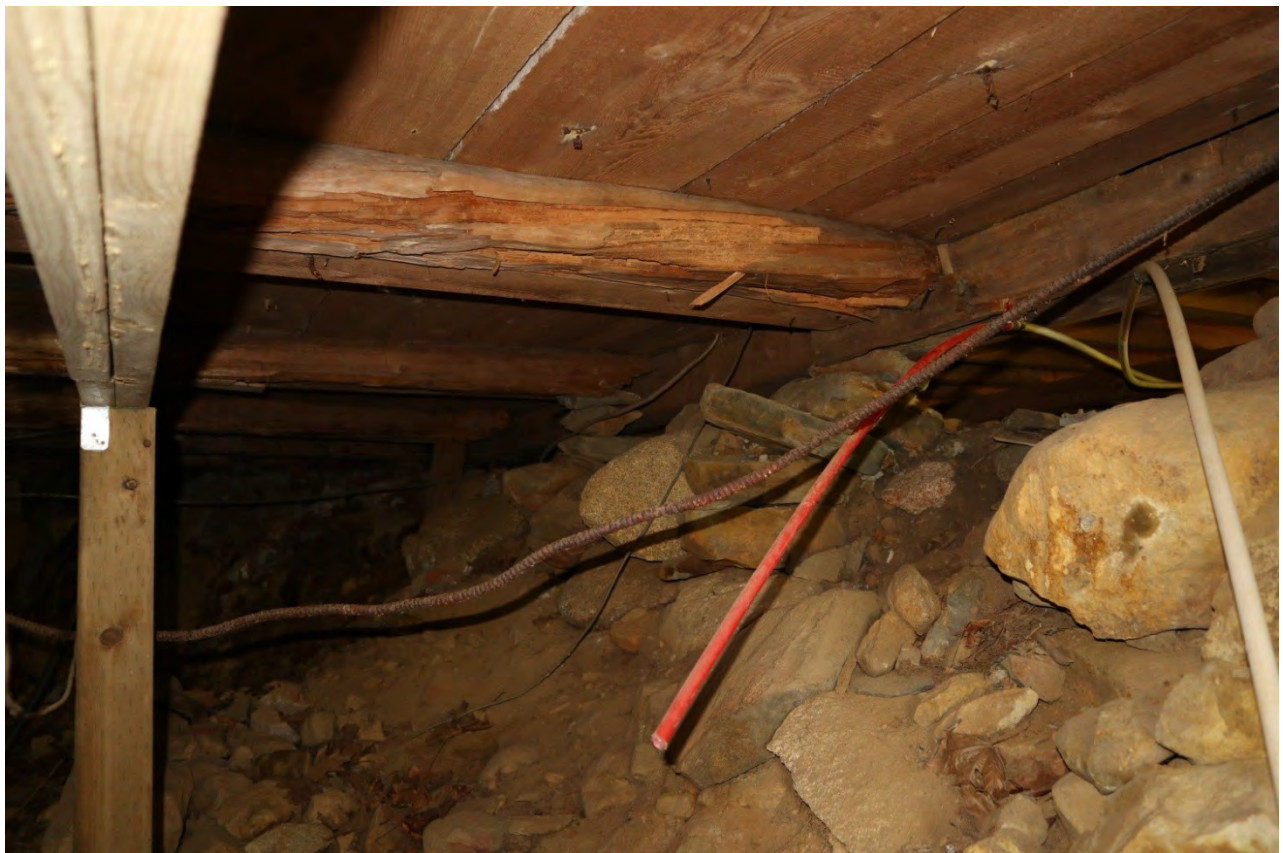
4) **Building Crawl Space** is the area under the building as previously mentioned. This area shows the interior side of the exterior foundation walls. There has been some effort to stabilize the structure with the addition of mid area wooden supports, but little of this would suffice to be classified as structurally sound. There are mid span wood beam which may be acceptable, but they are supported by 4" x 4" columns, which are resting on block. Visible are also columns resting on the rock. All have no frost protection and are susceptible to sliding, settlement, and frost heaving. Summarizing, this foundation is no were near structurally sound.

Also discovered was the fact that the floor system above was not capable of supporting a residential or commercial load, and that the spacing between rotted joists was non-consistent and extremely wide.

Please see in the photographs below some of the discovered conditions of the foundation in the crawl space.

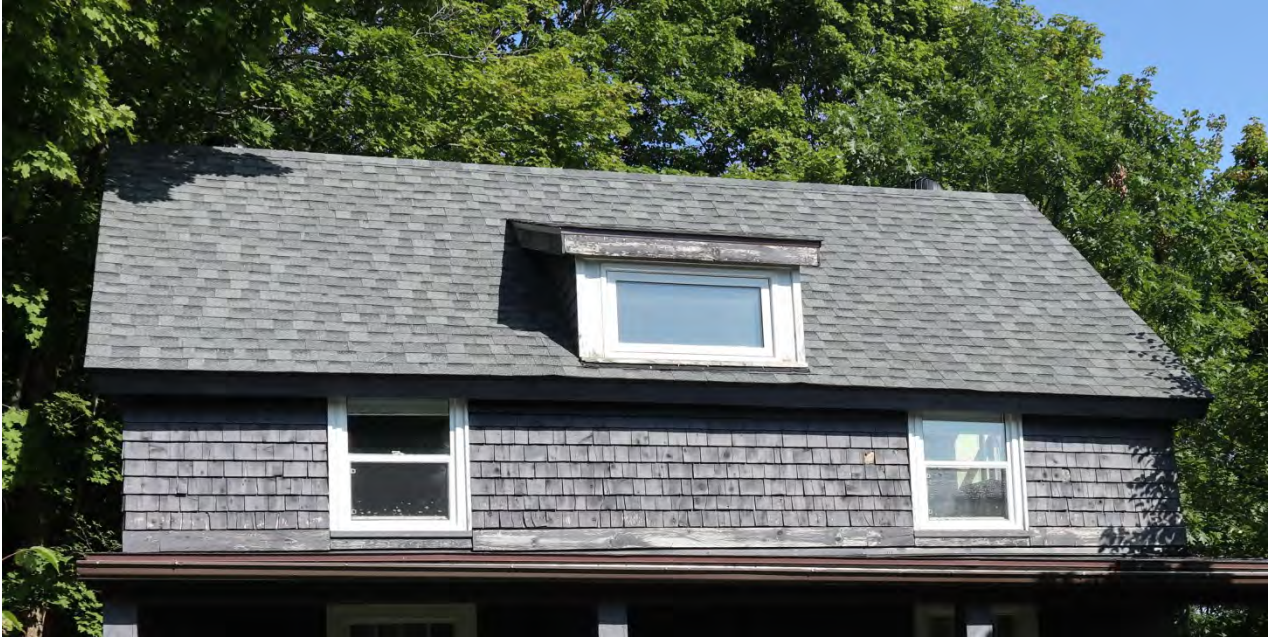
4) The **Building Roof Structure** generally showed well. It asphalt shingles appear to have been replaced recently. The exact age is unknown. However there are no gutters or down spouts. See photograph below.

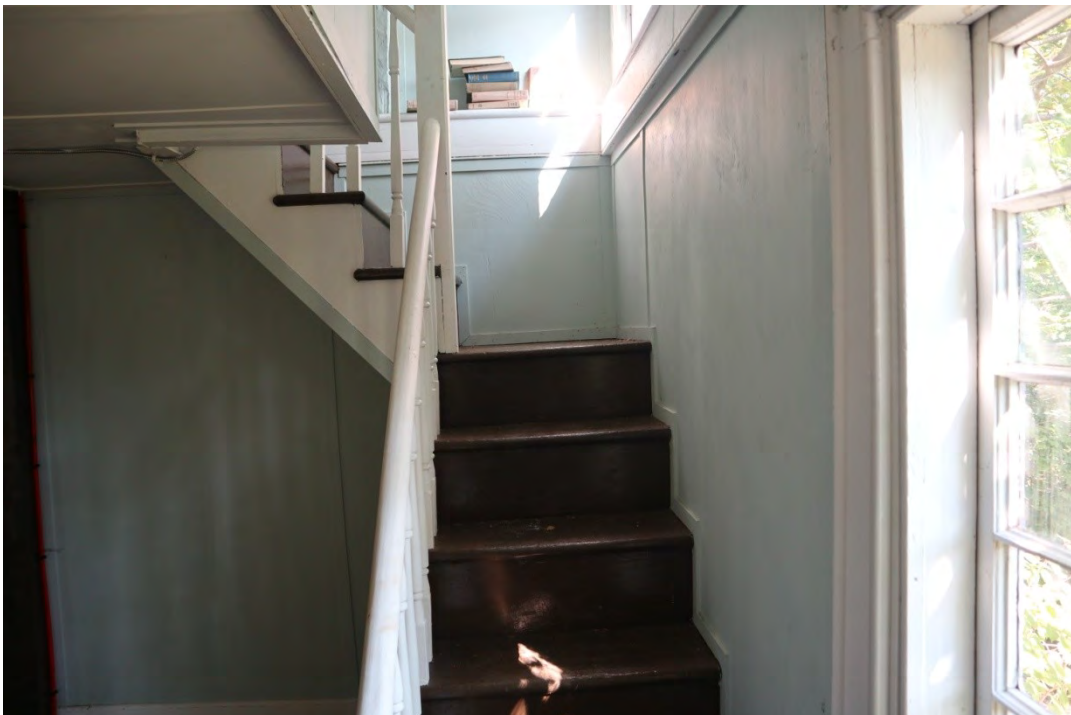
Top floor of this building was inspected next. What stood out the most was the fact that it had little accessibility. The stairway leading up to the top floor was approximately 24 inches wide. See photograph below.

This width of a stairway, makes it very difficult to load furniture or any large item to the top floor.
