**Item No. 15.7.1**  
**Halifax Regional Council**  
**August 22, 2023**

**DATE:** July 26, 2023

**SUBJECT:** **Case H00528: Substantial Alteration to the municipally registered heritage property at 10 Kirk Road, Halifax**

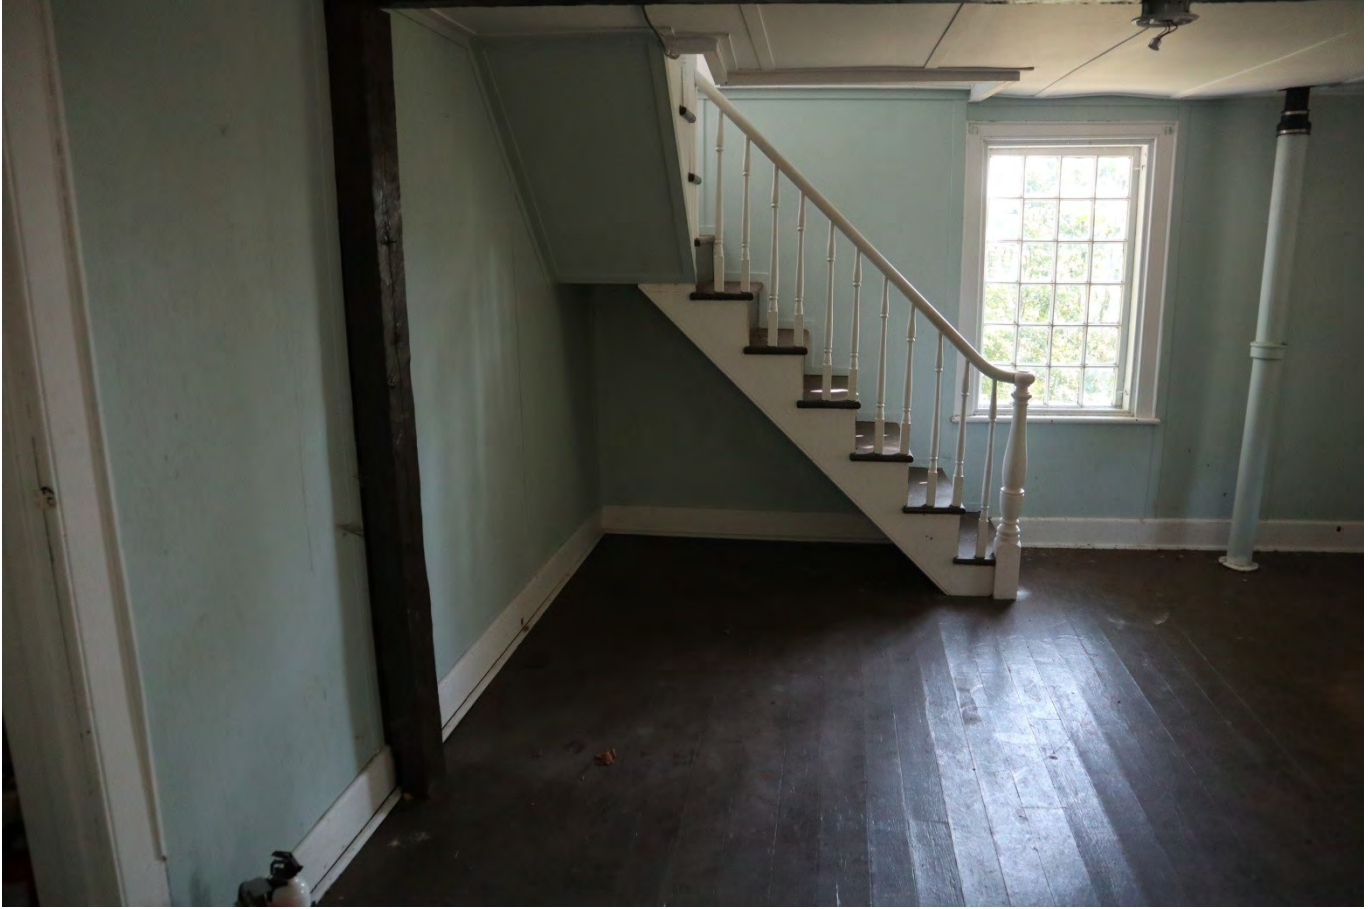
The landing on this stairway was viewed, and considered as structurally unsound. As can be seen in the photograph below, there are no bearing supports below the landing at the corner. The landing is supported only by the end walls on either side. See the photograph below.

Any heavy loading on the landing will immediately result in downward deflection, and if heavy enough, would cause instant failure of the landing.

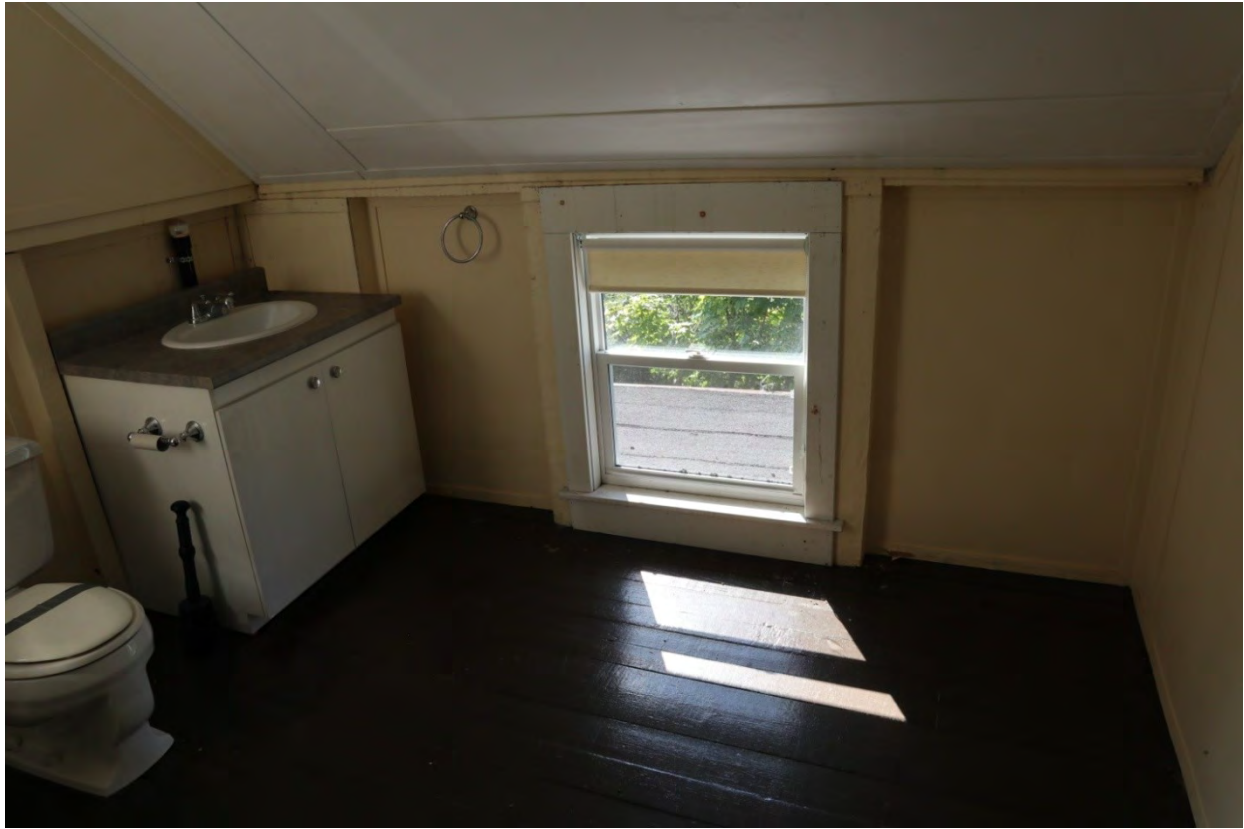
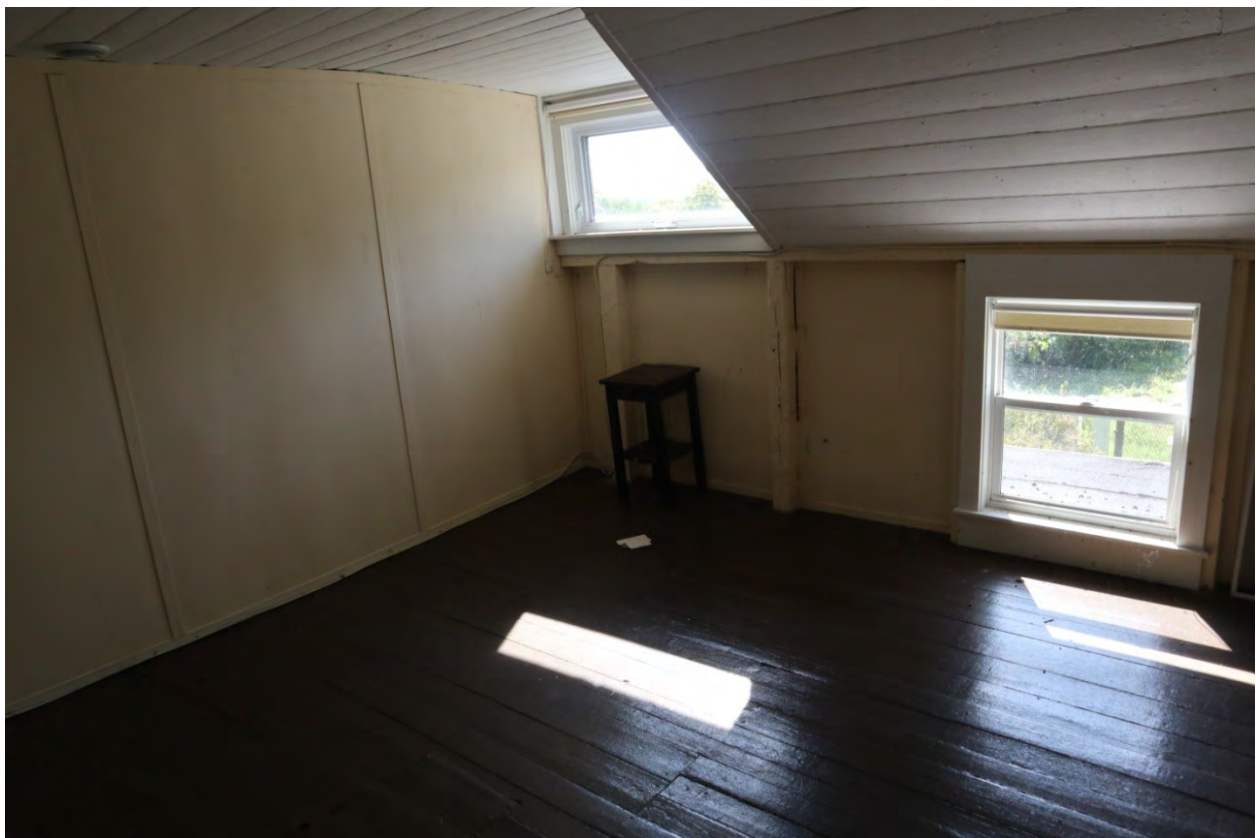
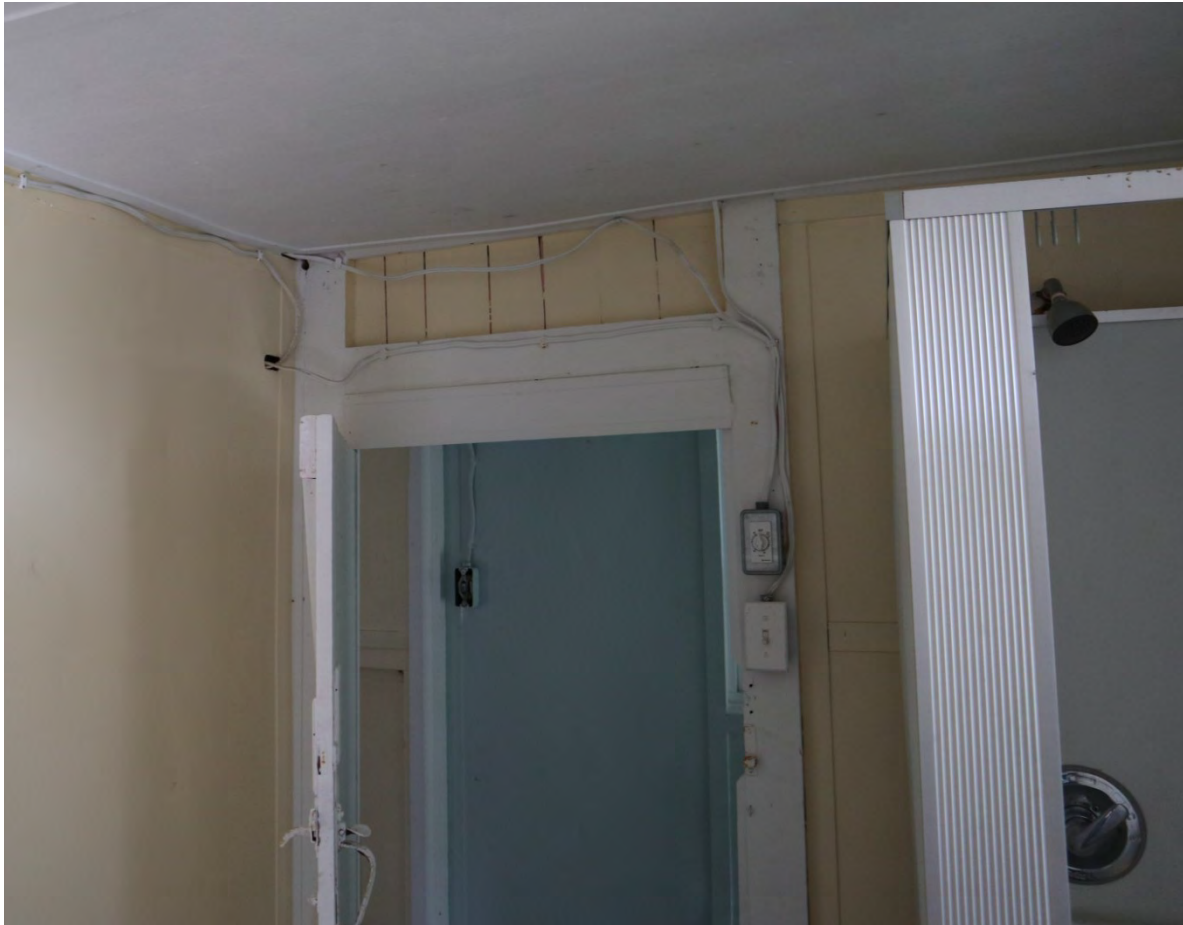
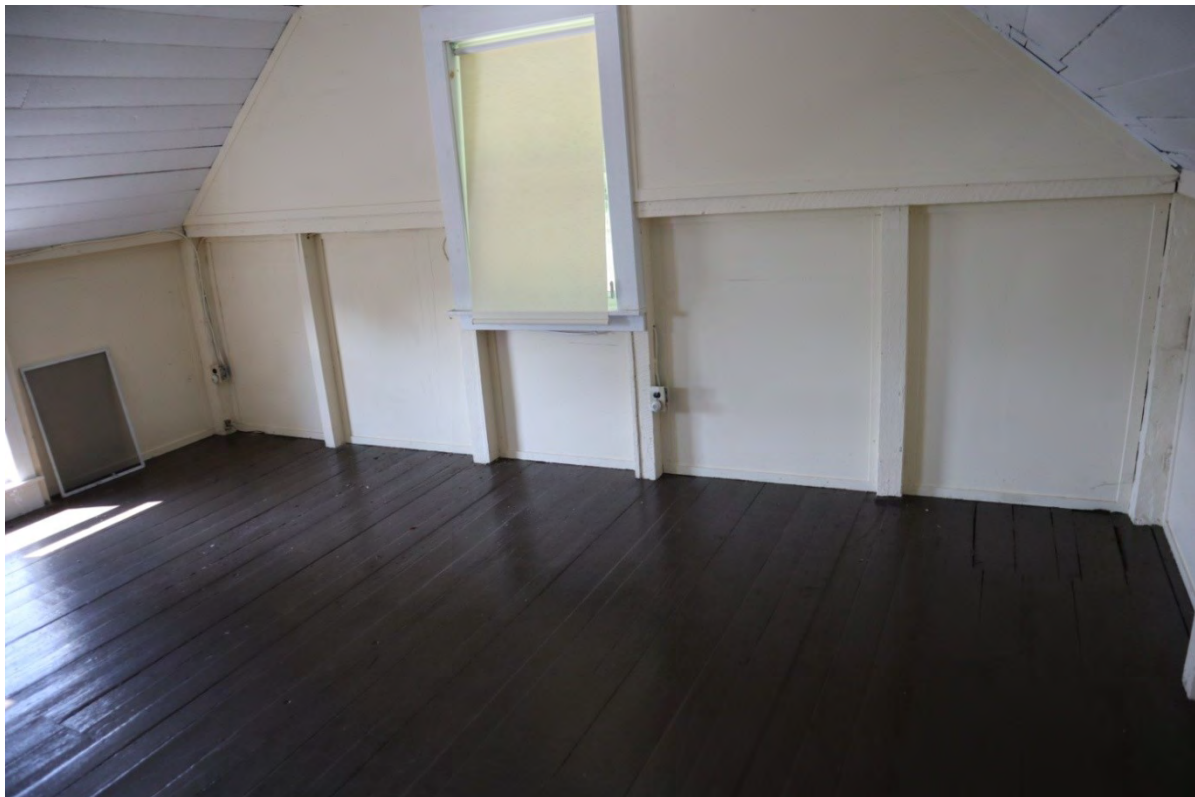
- : A windows in the bathroom and "bedroom" were 5 inches above the floor level. This is not within the acceptable height based on the National Building Code.
- : There was minimal electrical service only on the hallway and bathroom. Not enough plugs or lighting.
- : The available electrical service did not meet code and ran exposed on the wall surface.
- : There was no heating at all on this level
- : There was no insulation in the walls or ceiling
- : There was no finish surface on the wall, as the framing member were visible. These were painted.

Please see photographs below of the top floor.

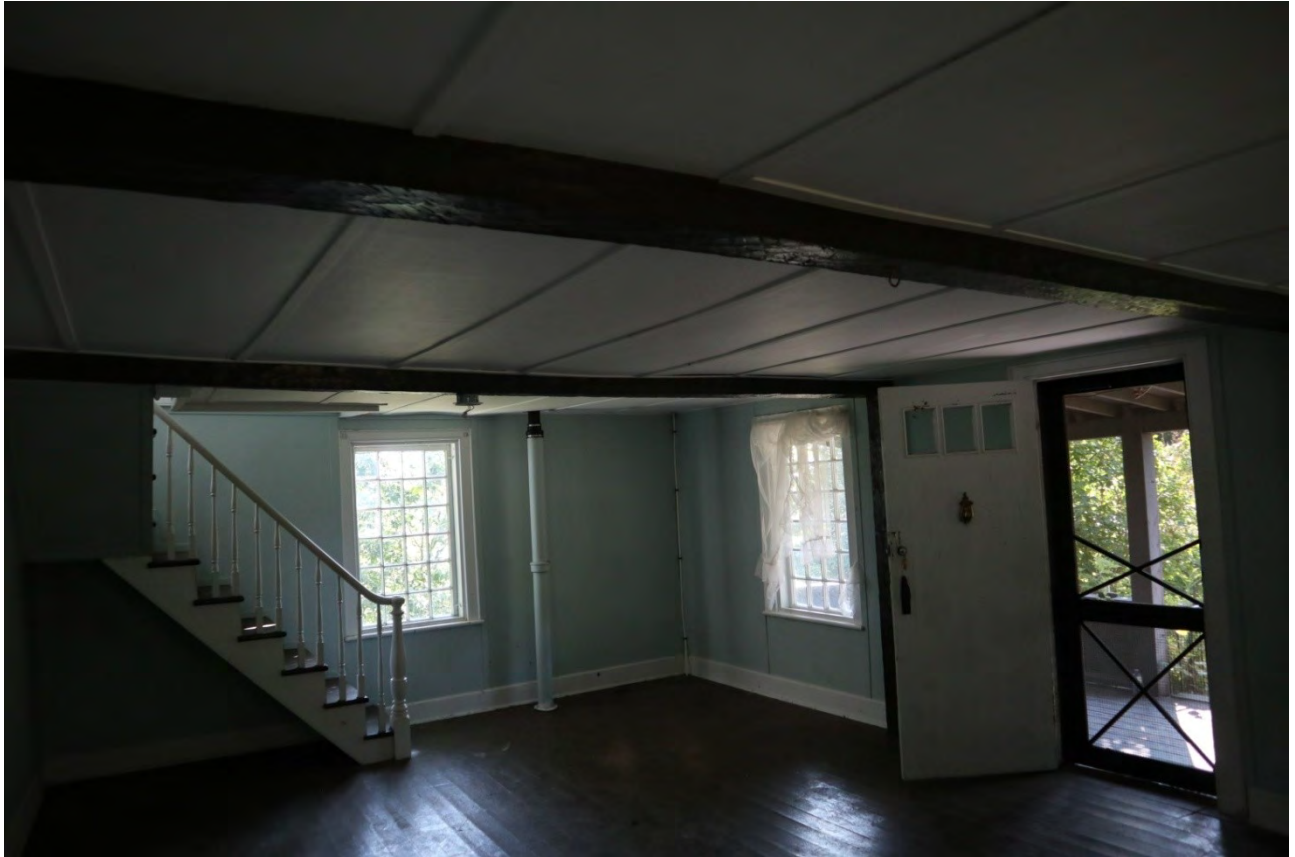
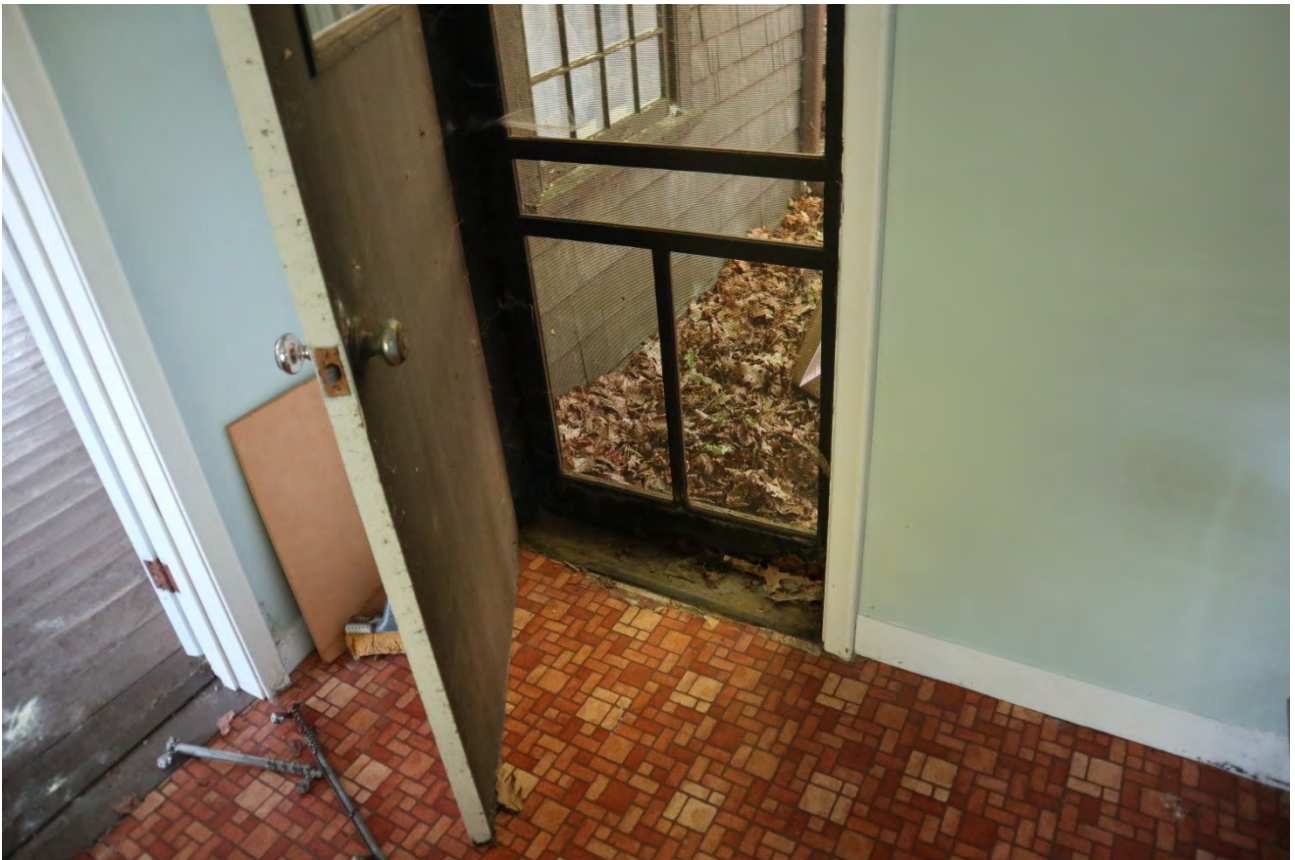
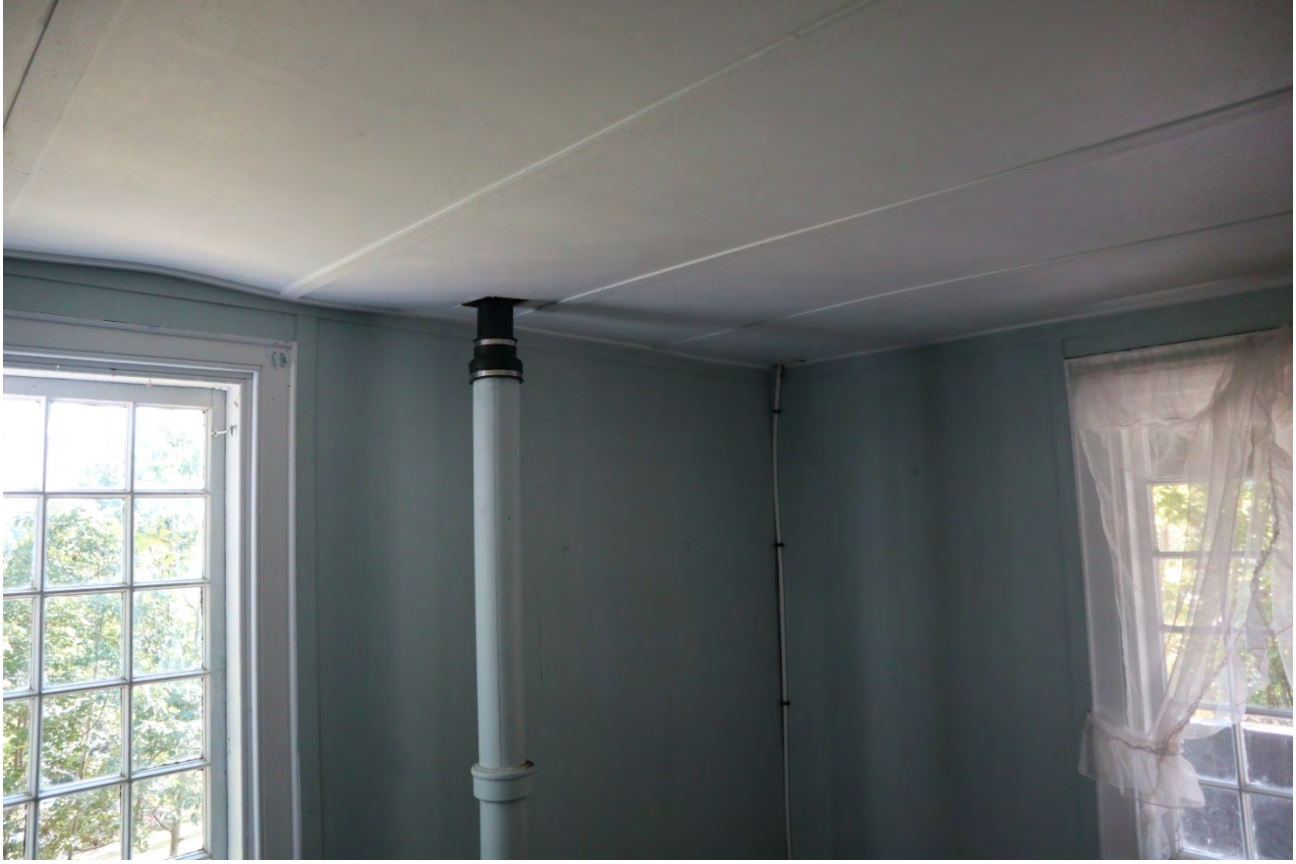
What stood out on the main floor was the way the floor bounced due to lack of structural support. The floor joists are clearly undersized for the span.

- : The drainage line for the upstairs bathroom ran down exposed through the living room area.
- : There was no electrical service at all in the living room area
- : There was minimal electrical service in the kitchen, which also appears to be an addition onto the main structure.
- : The back door was at ground level and susceptible to rot, insects, mice and water infiltration
- : There was not source of heating on this level. Thus there is no heating in the building at all.

Please see below, 3 photographs taken of the main floor space.

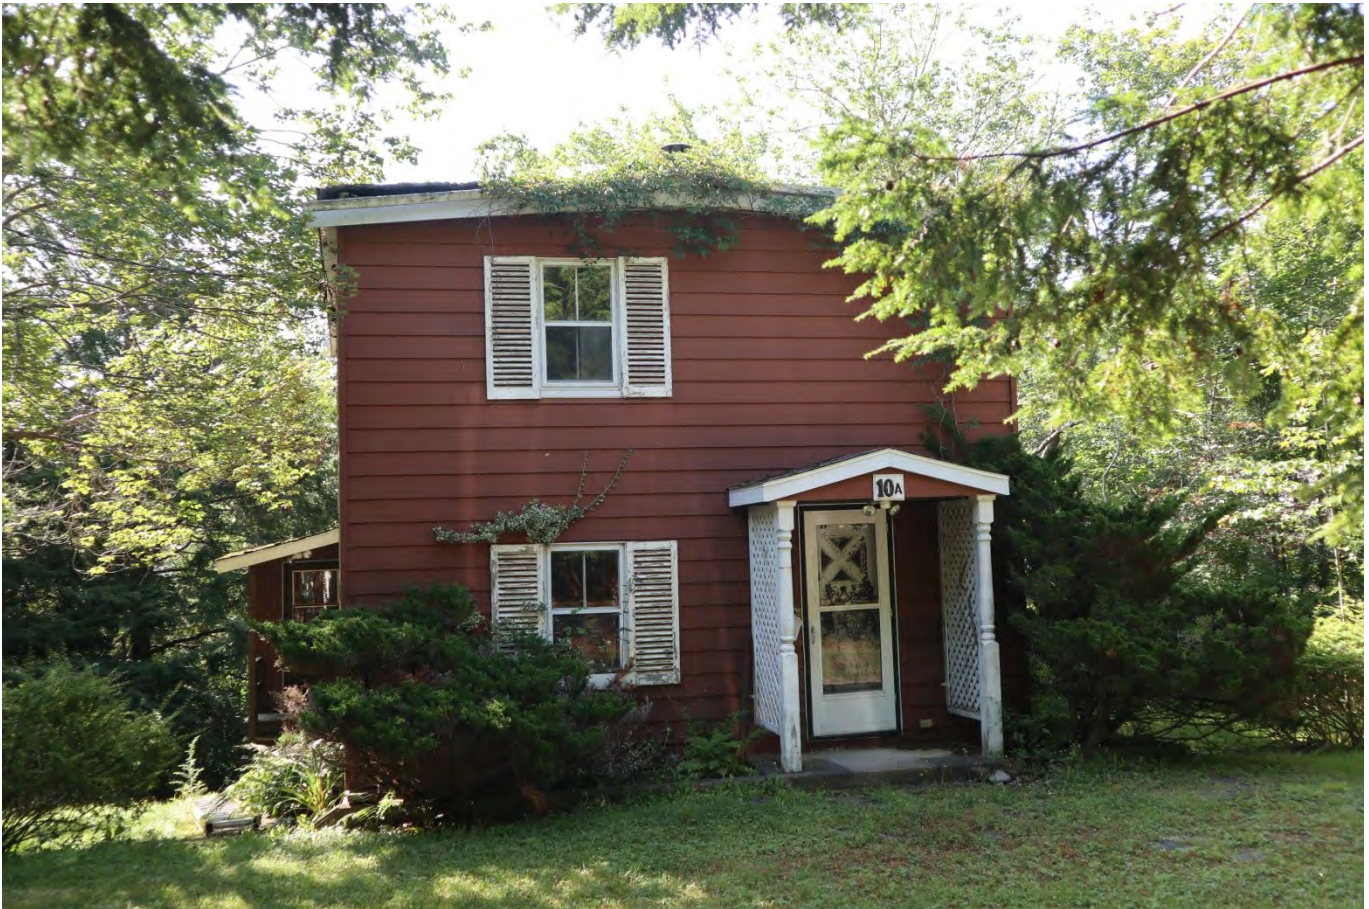
1) The overall condition of the building is quickly pointed as you approach the building. The main front entry is the first visible element of note. It is obvious as to the total lack of maintenance over the years. Visible is a totally rotted front entrance in particular the front door.

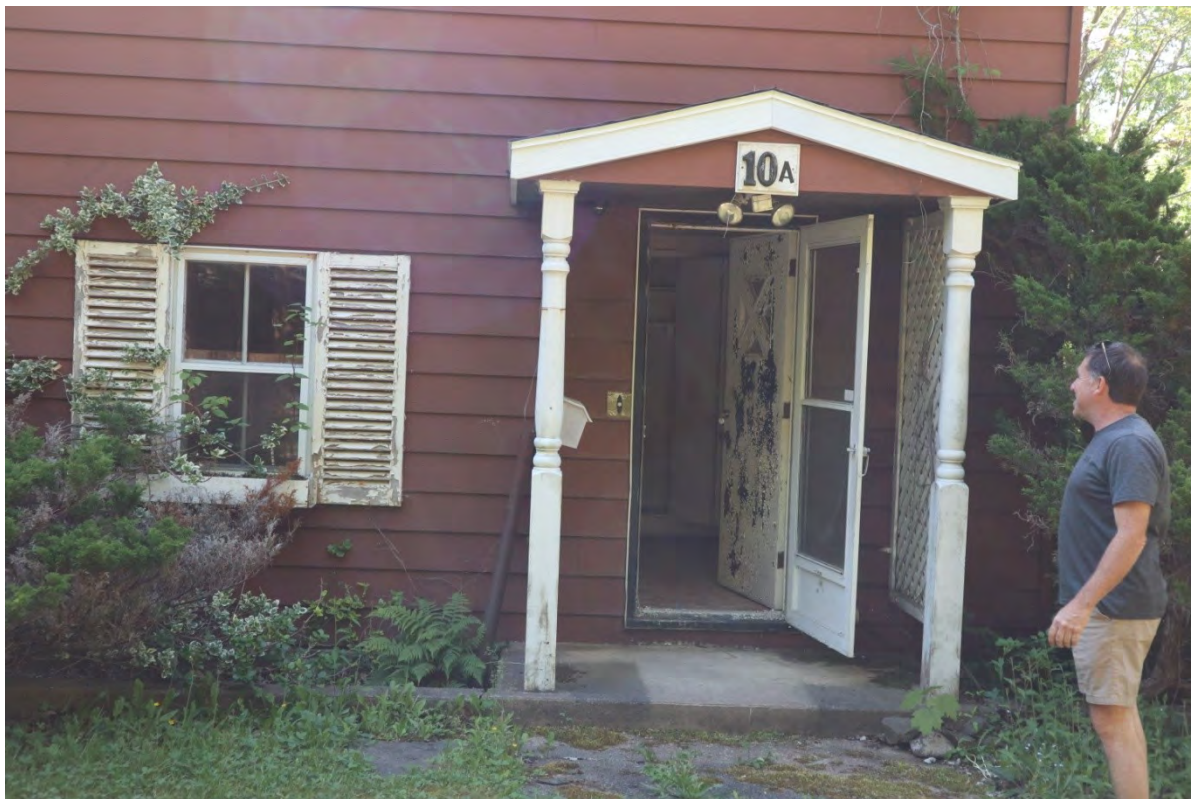
This rot is also evident on the window and window shutters. The windows, which are of both wood and vinyl construction are in generally very bad condition. The wood windows mostly show rot, and the vinyl show a significant build-up of mold.

The shutters are very deteriorated with paint damages and significant mold.

Please see in the photograph below this section of the building exterior.

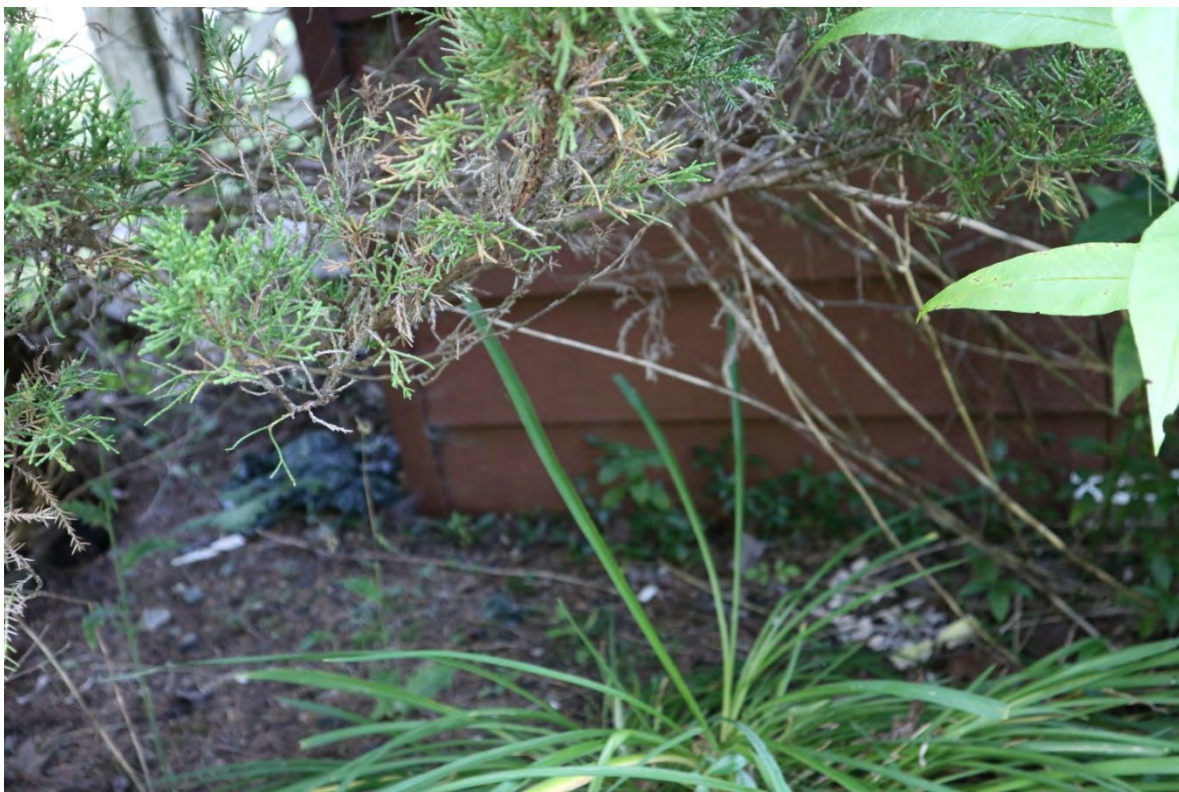
2) The lot grading along to front and side elevations, and a section of the back is totally improper, resulting in water flow towards the building rather than away from the wall. See below.

Compounding this improper condition, there is a good portion of the building exterior wall in which the wood siding is at or near the grade line. This can and probably has led to water infiltration into the building. Visible evidence of this is in the rot and possible mold along the lower coursed of wood siding.

The National Building Code minimum distance from the exterior ground elevation to the top of a building foundation wall is 6 inches. There is great doubt as to whether this distance is maintained around the perimeter of the building. Added onto this problem is that of the water drainage. By code, the ground around the building is to be graded such that the surface water flows away from the property. In this case, surface water flows towards the building.

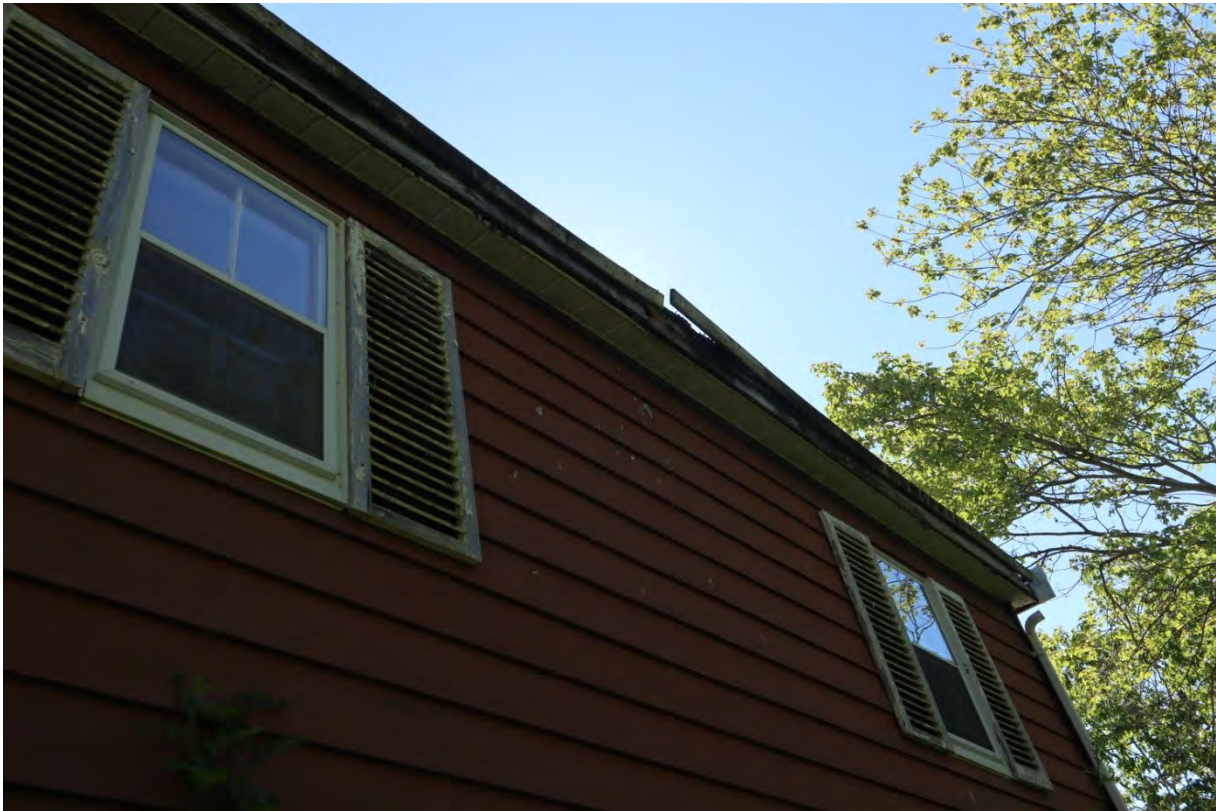
3) The building soffit and fascia were clearly visible as being in very bad condition. See photograph below.

This item is actually in a worse state than is evident in this photograph. The structural components have severe rot. There is even a section where the roof is rotted out clear through to the soffit face allowing water to pour through.

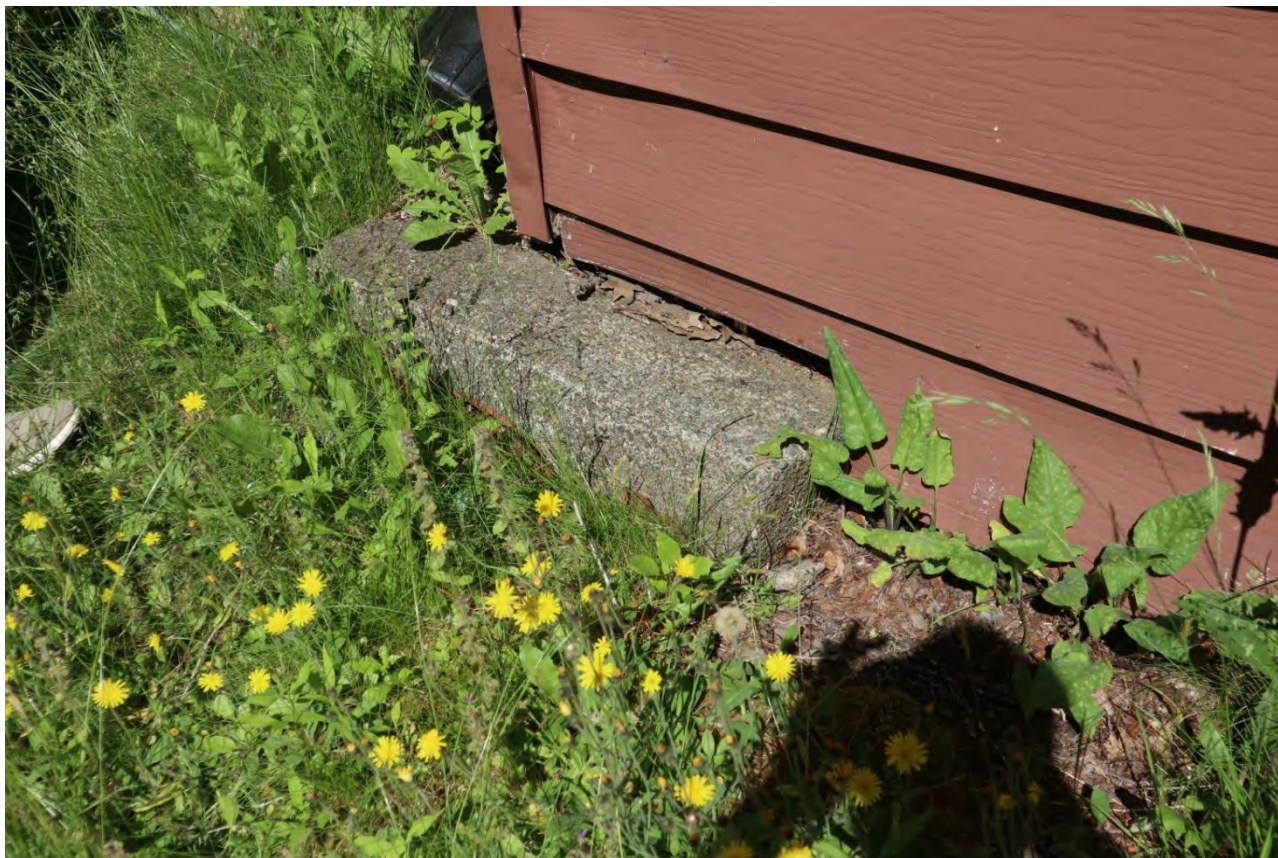
3) The visible foundation around the building is in very bad condition. Being of rock construction this can and has lead to much water infiltration into the building. The extent of these damages are not well known due to the fact that there is little to no foundation wall face visible along a major portion of the building.

There is also a portion of the building, that at the rear left corner, in which there does not appear to be a foundation wall present. The building actually appears to sit directly on a concrete footing. This footing sits on the surface of the ground. Please see photograph below.

As is evident in the above photograph, the building is resting directly on the footing. Being on the surface of the ground, this footing has visible cracking.

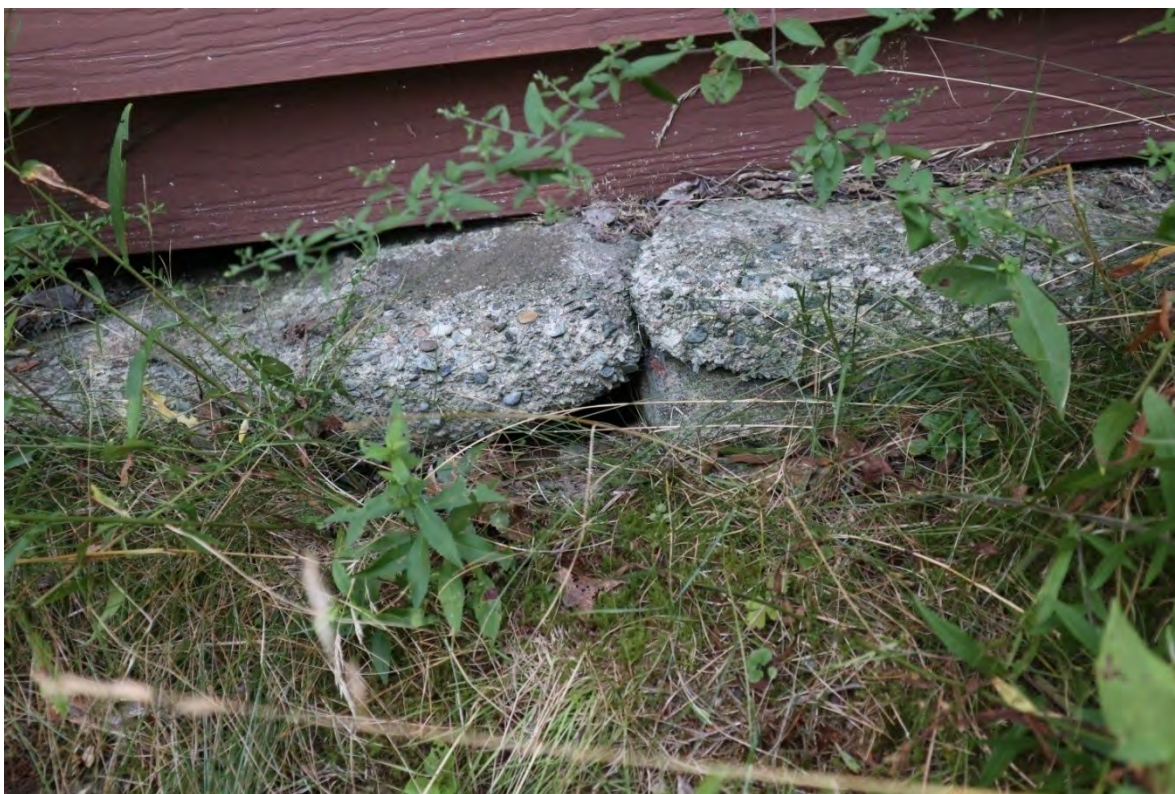
The footing is also not continuous. There are sections where the building appears to be resting on the ground.

- a) There is no frost protection on the foundation leading to up and down movement of the building during the freeze-thaw cycles.
- b) There is major settlement of the building on this face and surrounding area of the building.
- c) Prime location for the infiltration of water, bugs, mice, etc.
- d) Prime location for wood rot and resulting mold formation.

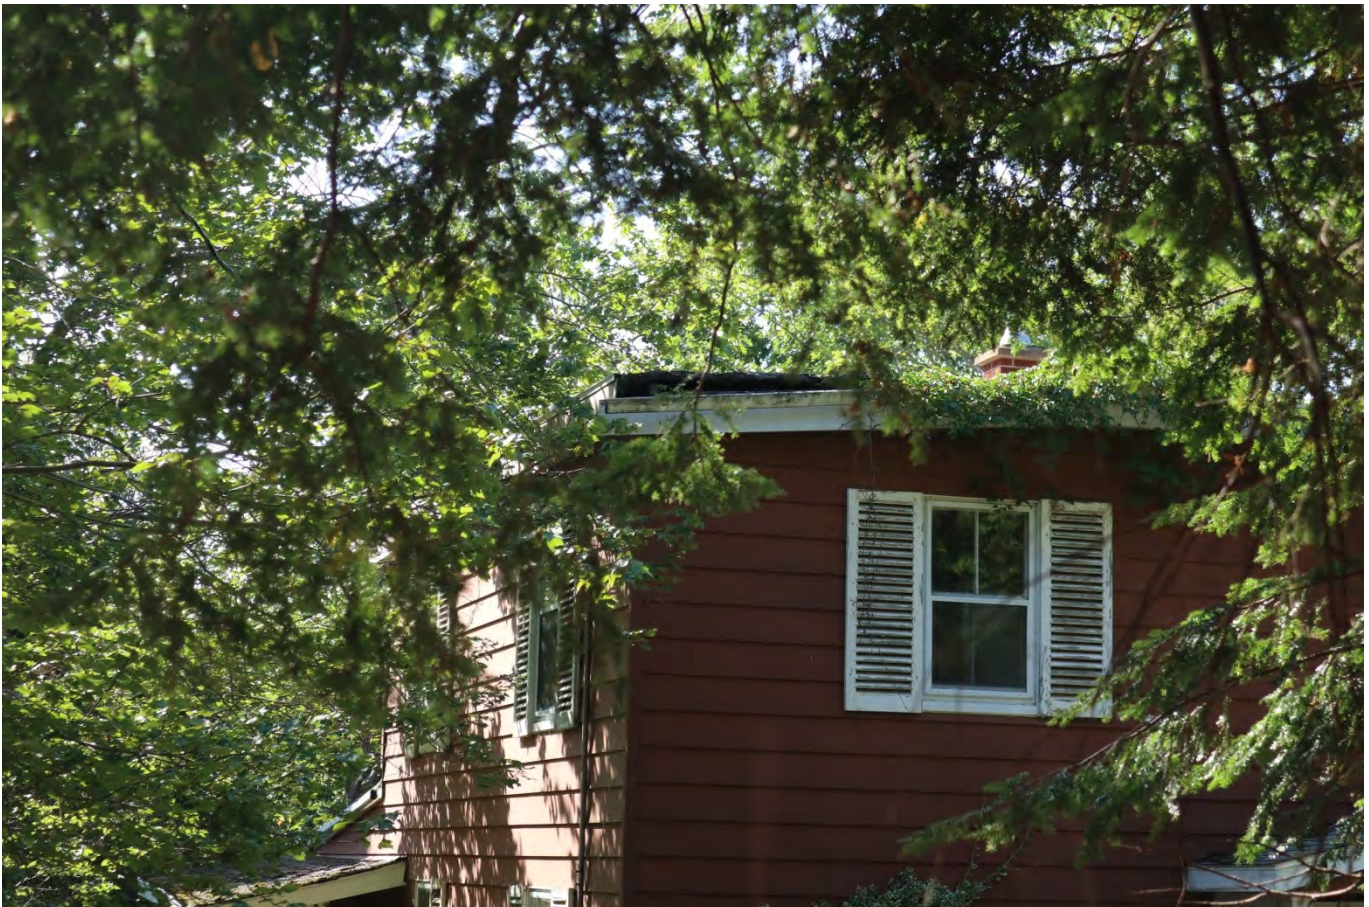
The roof structure was only viewed briefly as was suggested by Mr. Daren Sweet. He stated that it was not structurally sound. This was very understandable as is what was readily apparent.

Please see in the photograph below the front face of the building at the roof line. The roof is wide open. It appears that the section of the roof over the soffit has collapsed.

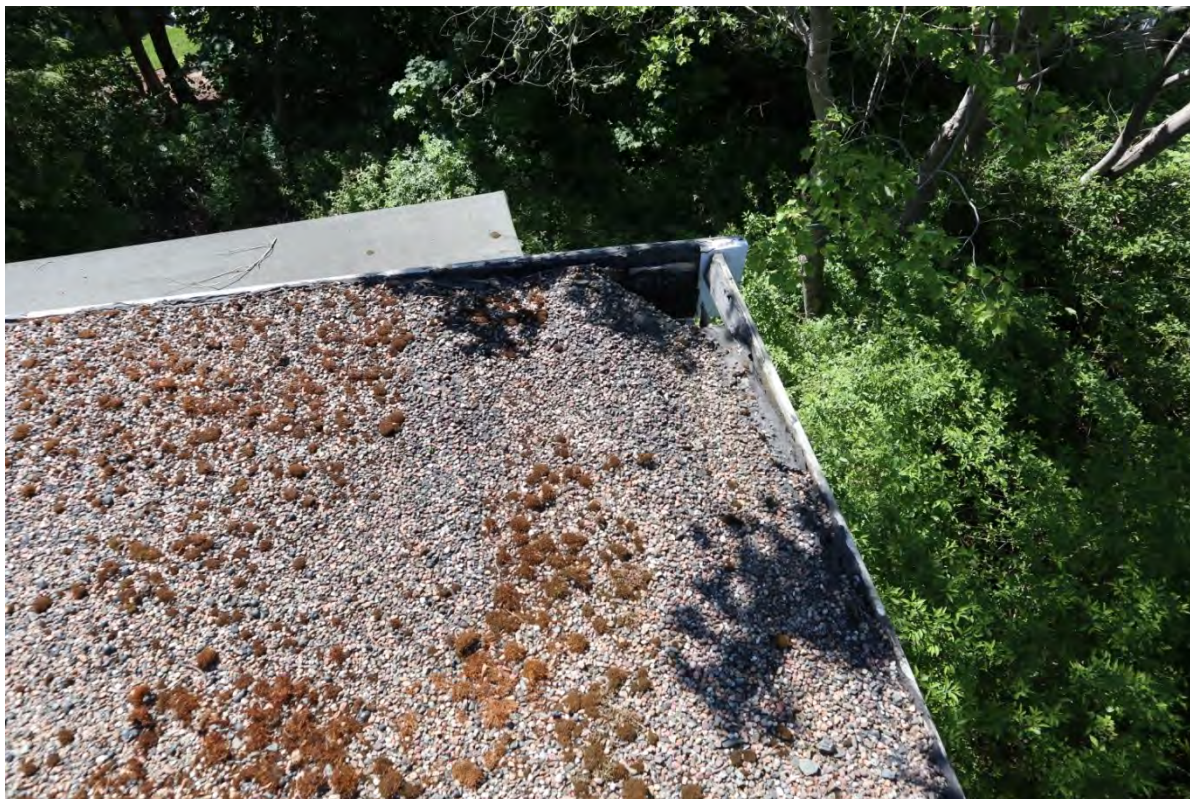
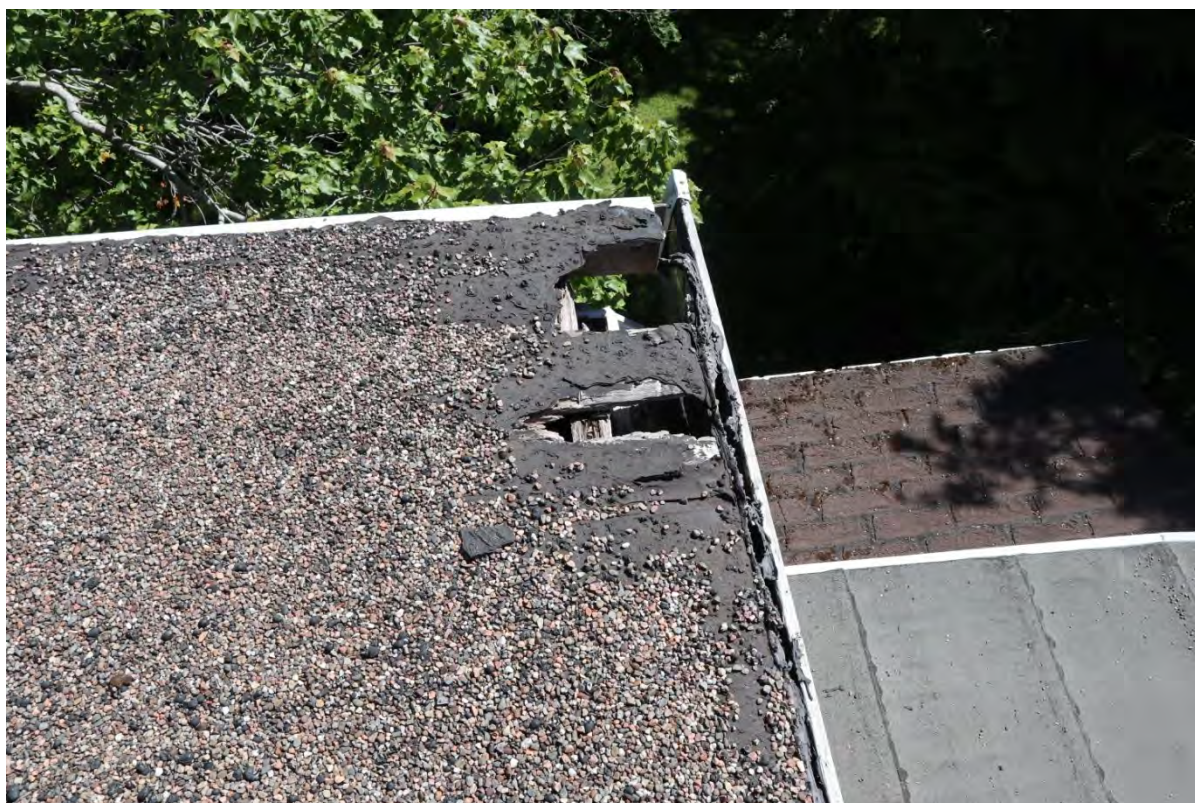
From the top of the roof, on the rear side, there is visible another sections of the roof which have totally collapsed. The first photograph is on the right side, and the second photograph is on the left.
