**Item No. 15.7.1**  
**Halifax Regional Council**  
**August 22, 2023**

**DATE:** July 26, 2023

**SUBJECT:** **Case H00528: Substantial Alteration to the municipally registered heritage property at 10 Kirk Road, Halifax**

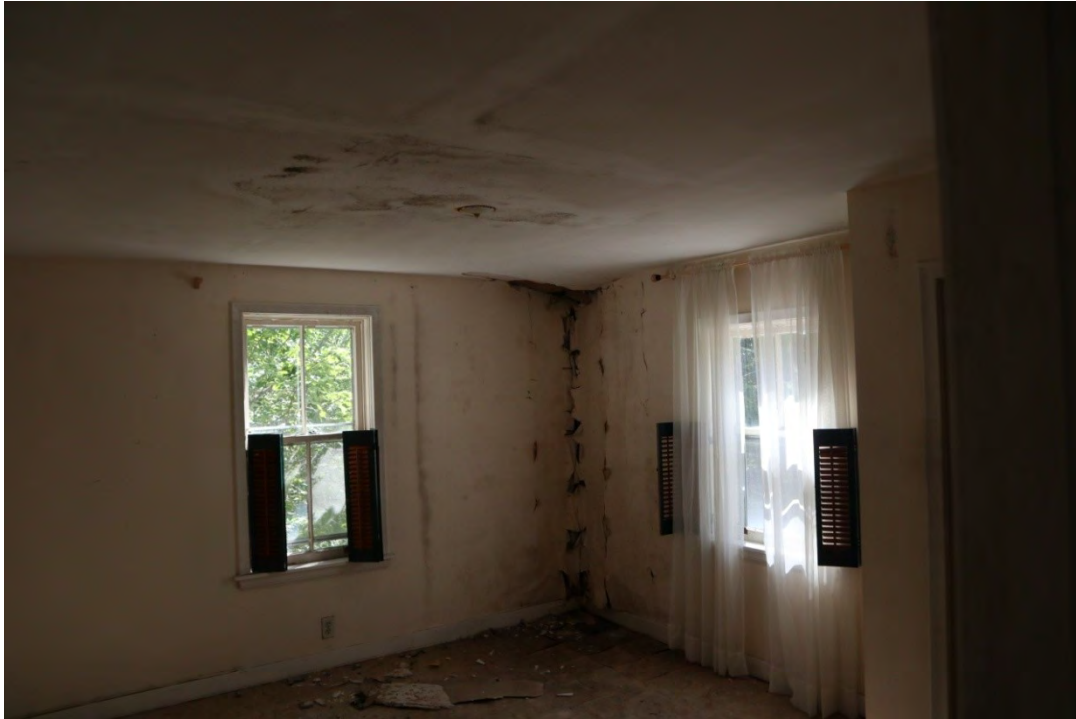
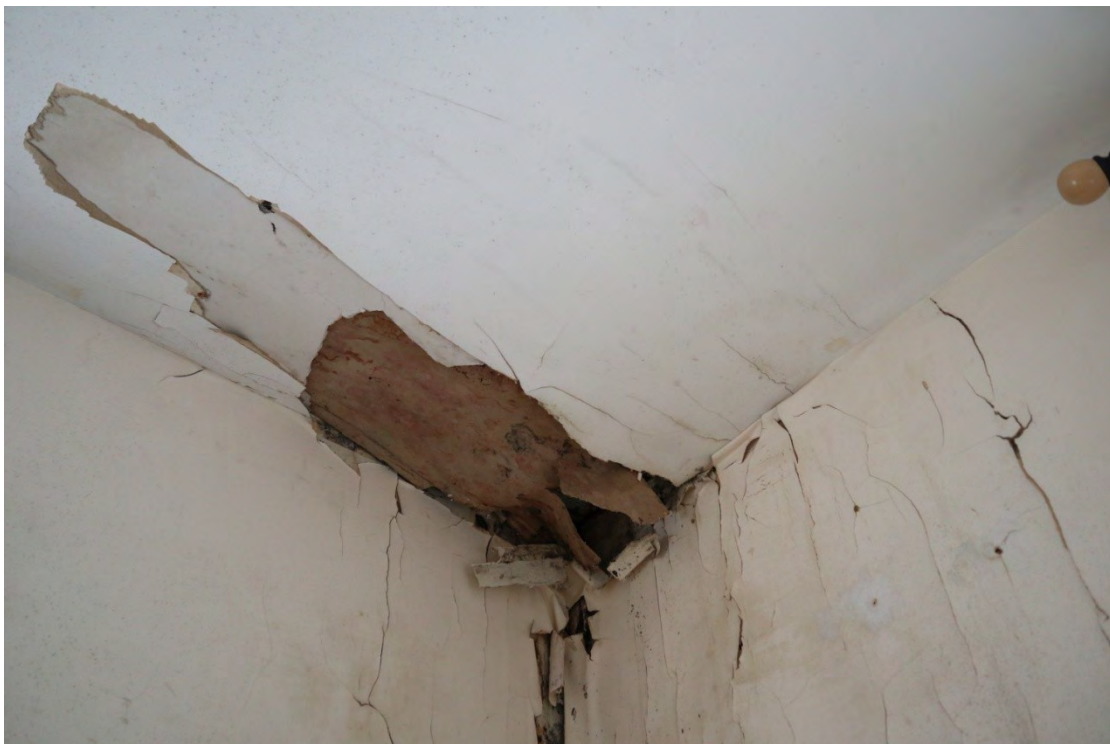
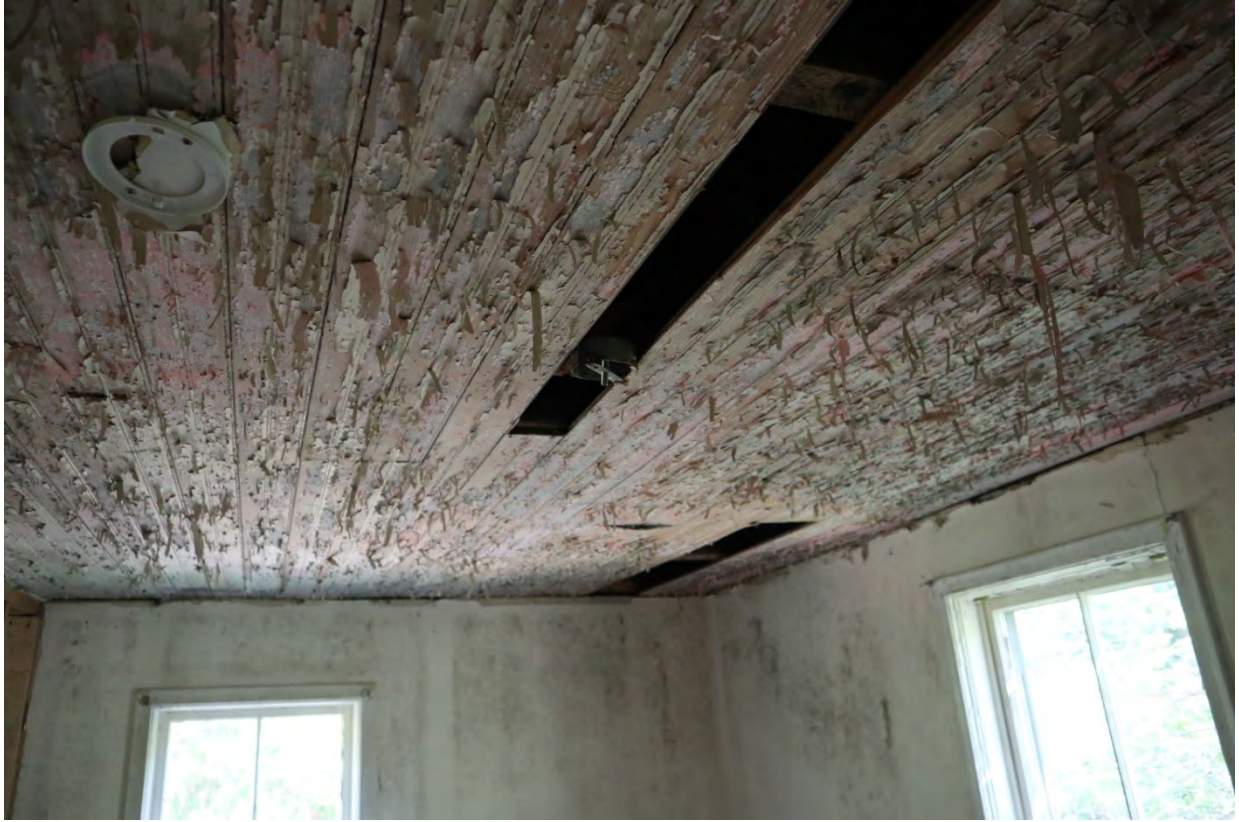
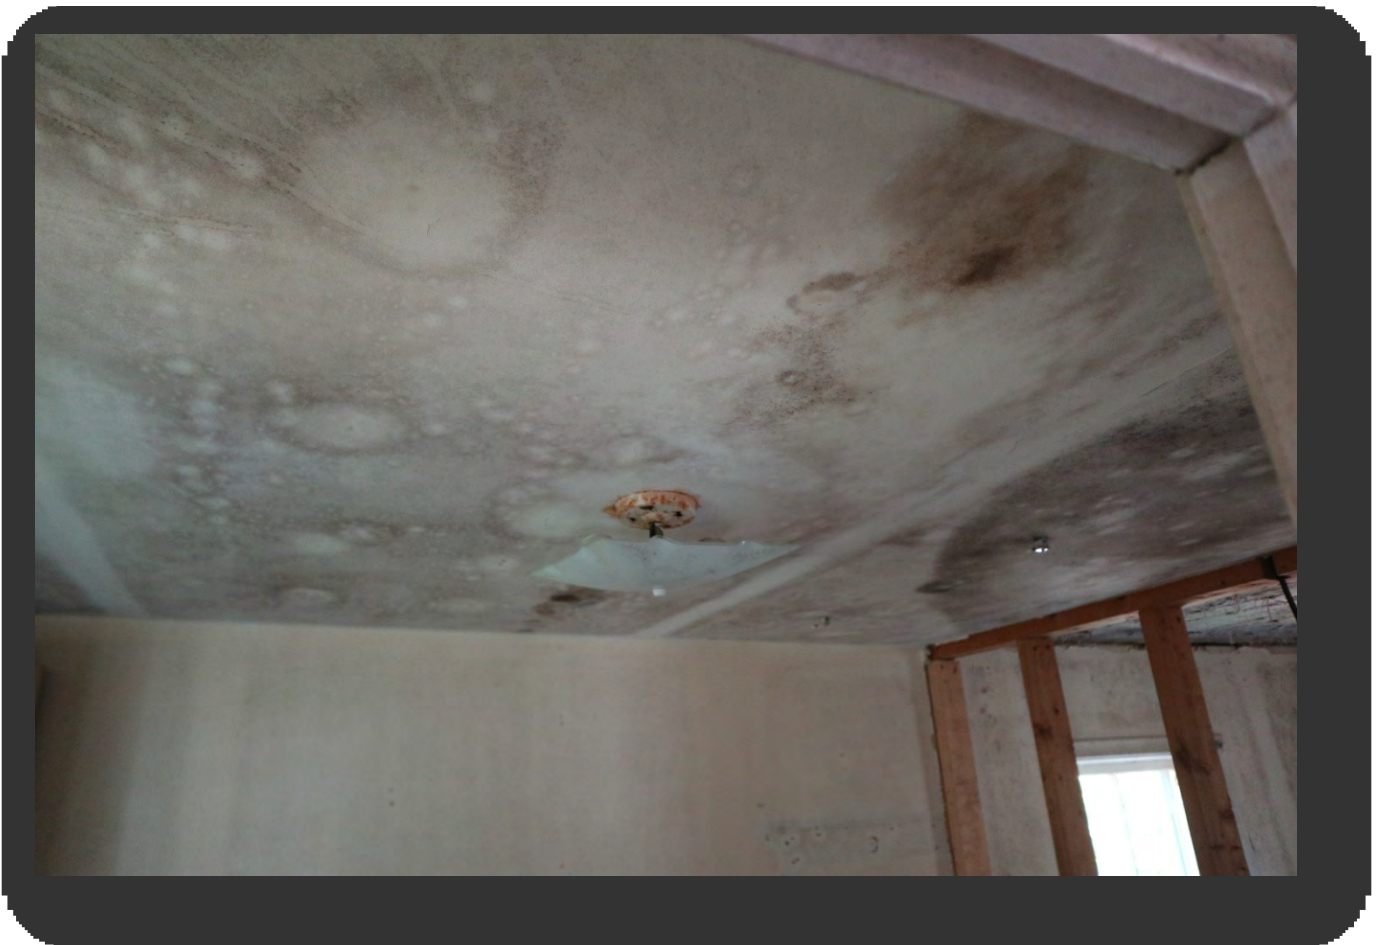
In the building interior, the upper level was viewed, and it basically was in worse state than that which the exterior of the building might have revealed. The conditions in general are quite evident in the following photographs.

As is evident in the previous four photographs there is little of the upper floor level which is considered as worth salvaging. Amongst the defects were:

- a) Numerous punctures of the ceiling drywall caused by what appears to be water infiltration
- b) Rusted out light fixtures and other electrical components, including electrical wiring
- c) Soft drywall or plaster is evident in most locations
- d) Mold all over the surface of the ceilings and the walls
- e) All the flooring is viewed as requiring replacement
- f) Railing on stairs show evidence of rot
- g) Windows and their trim are rotted and are substantially covered in mold

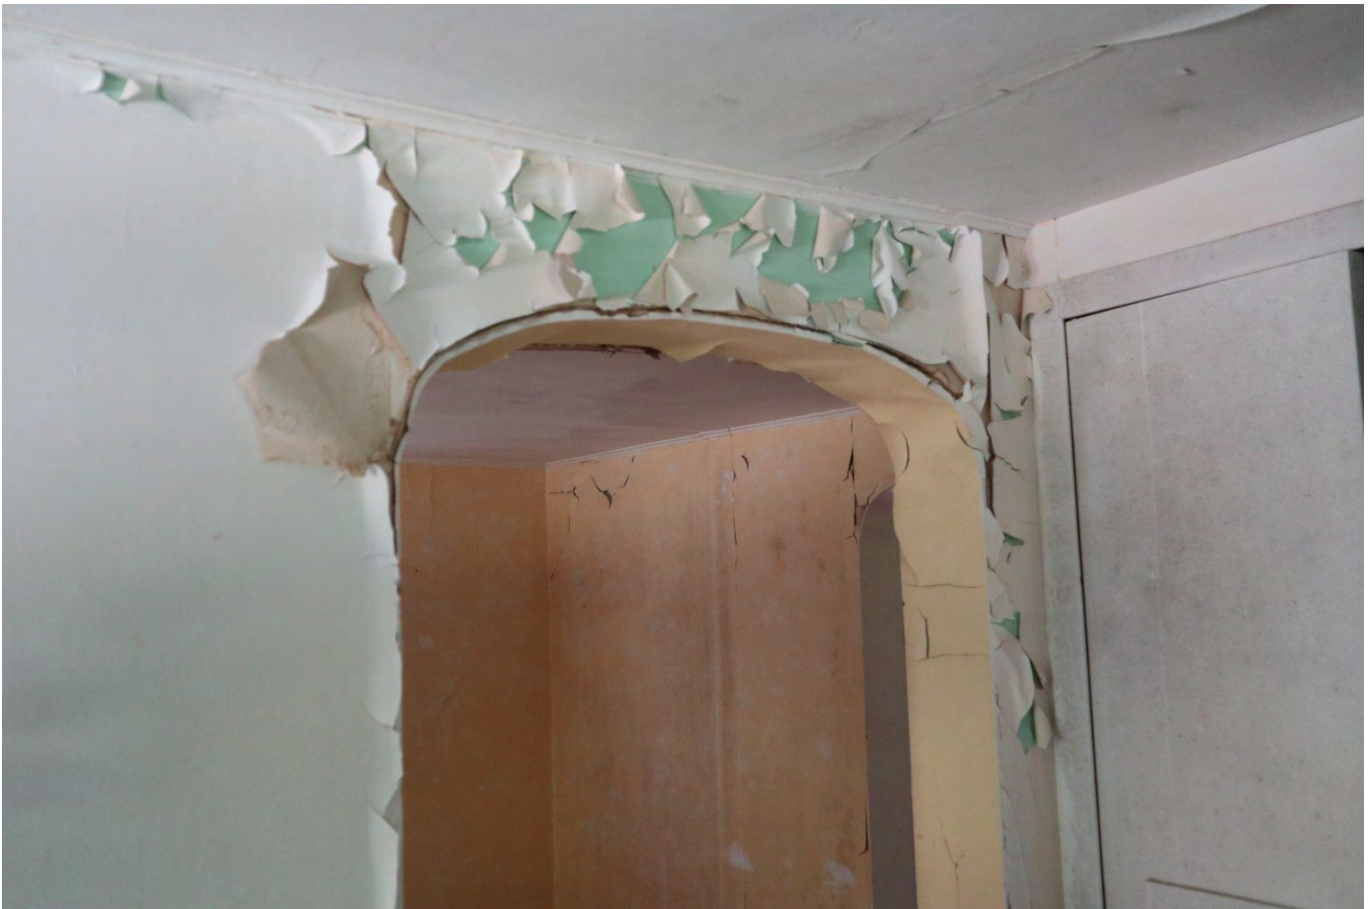
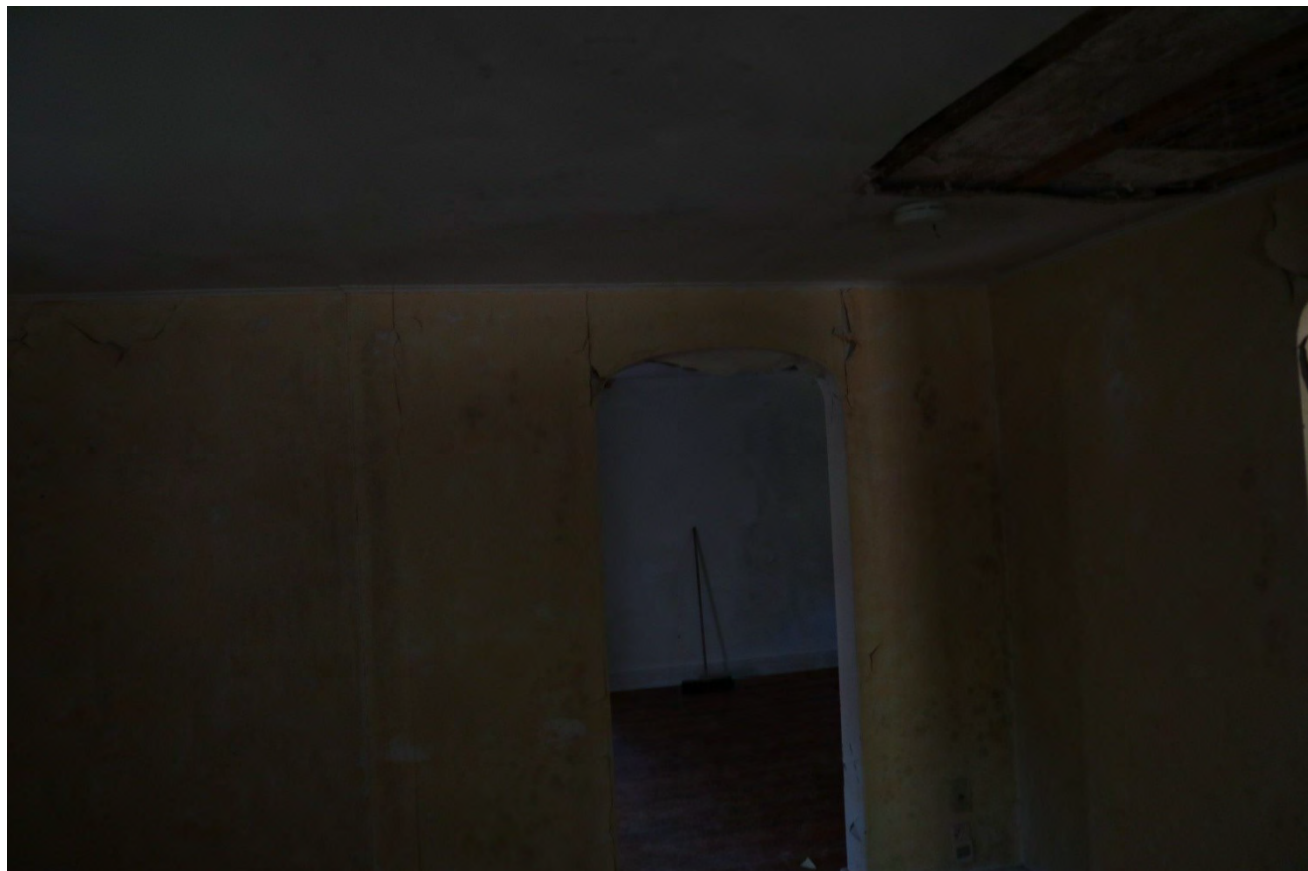
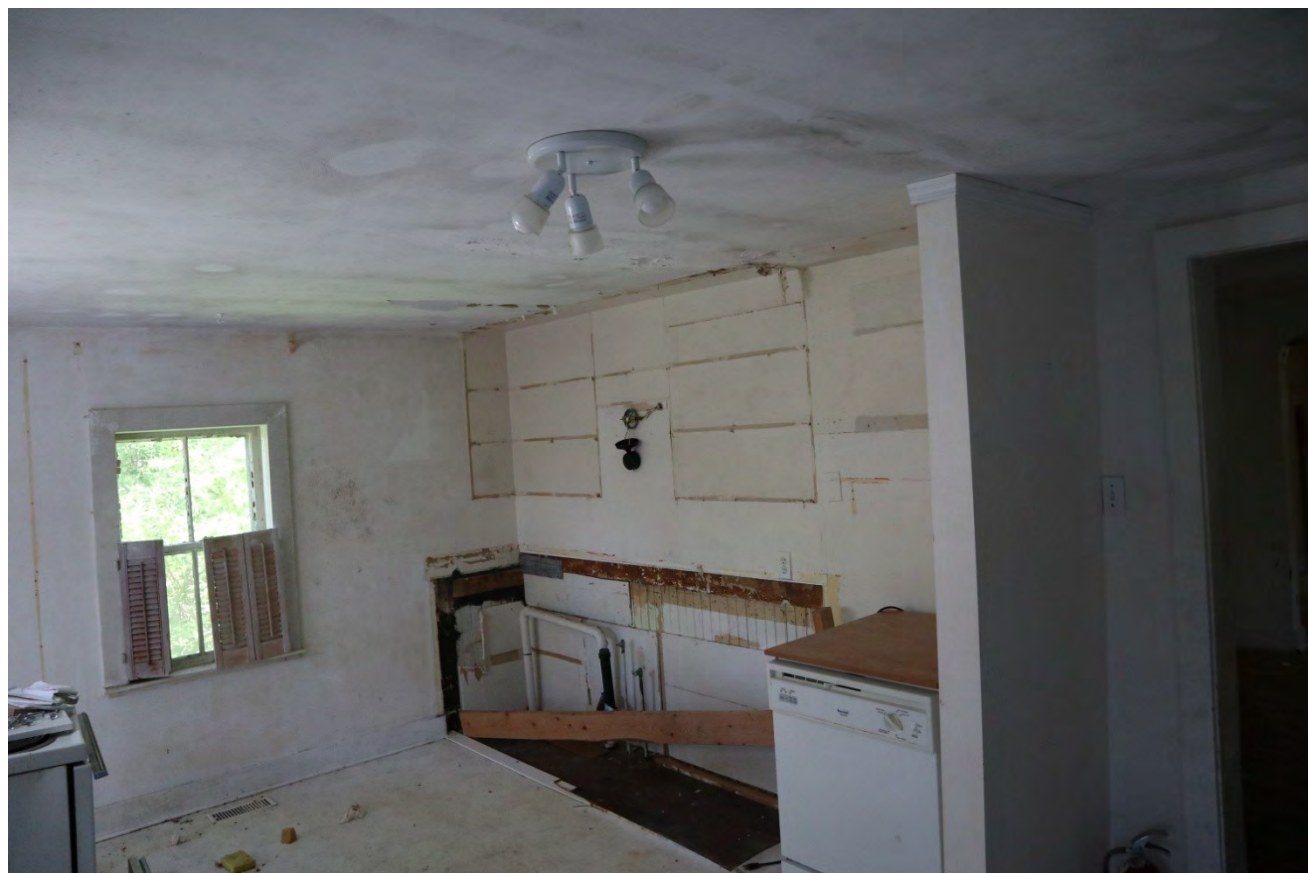
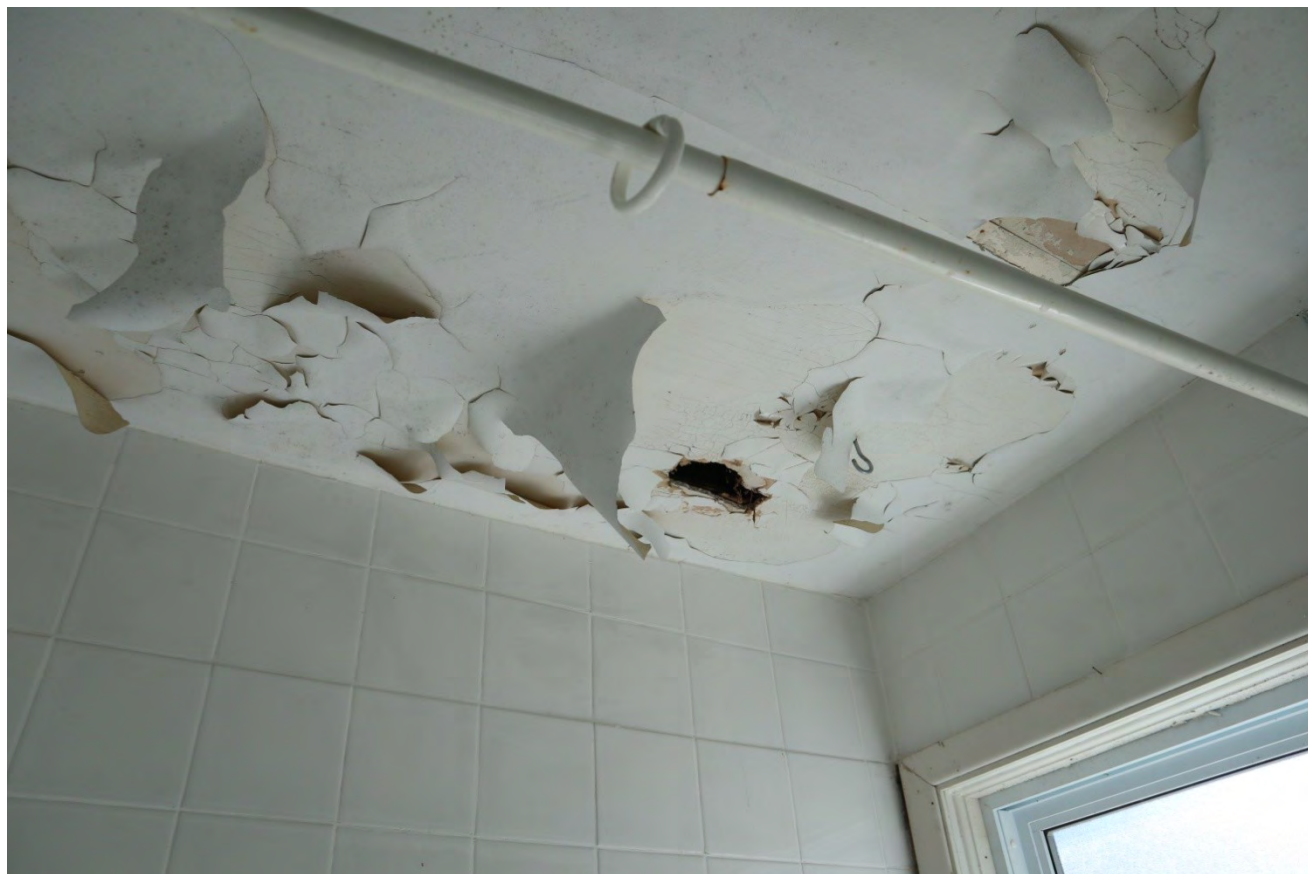
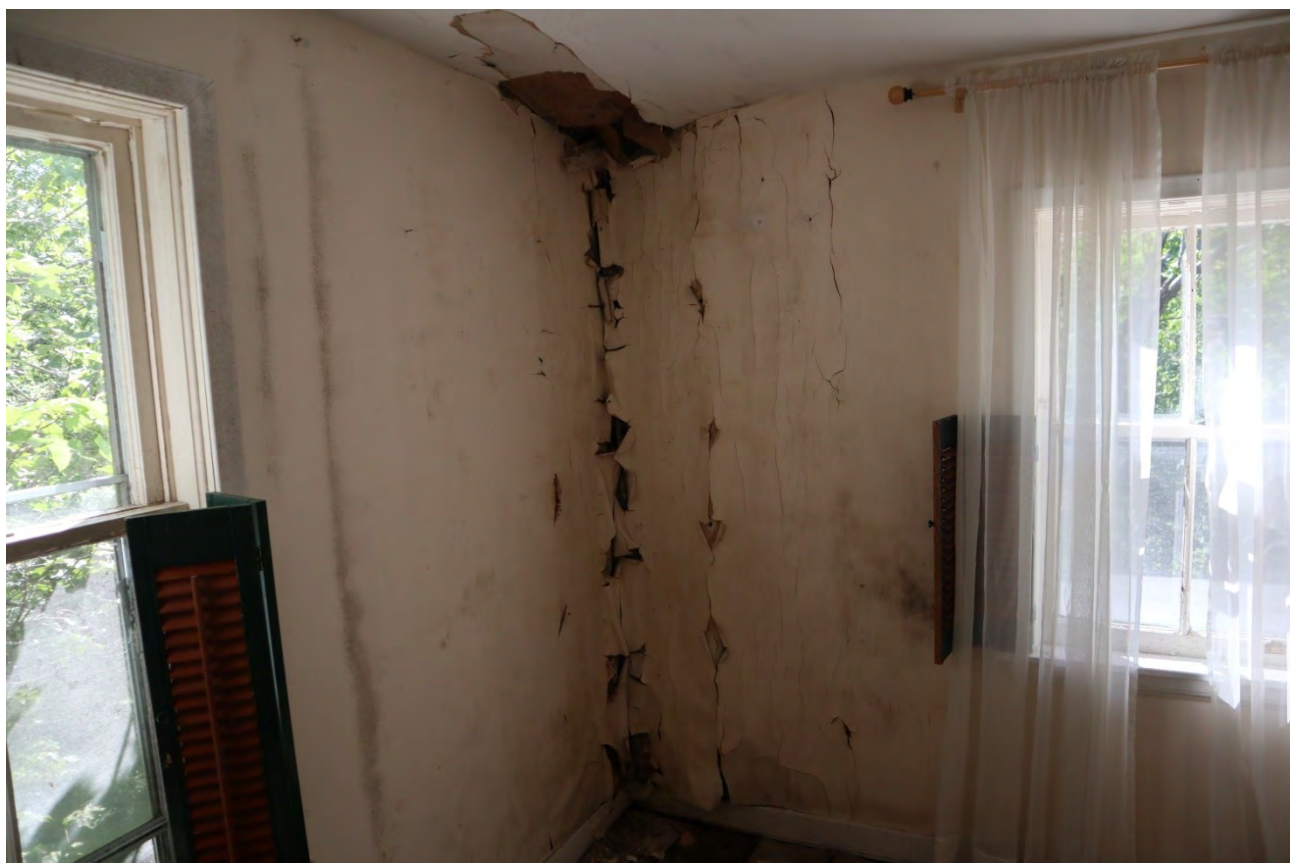
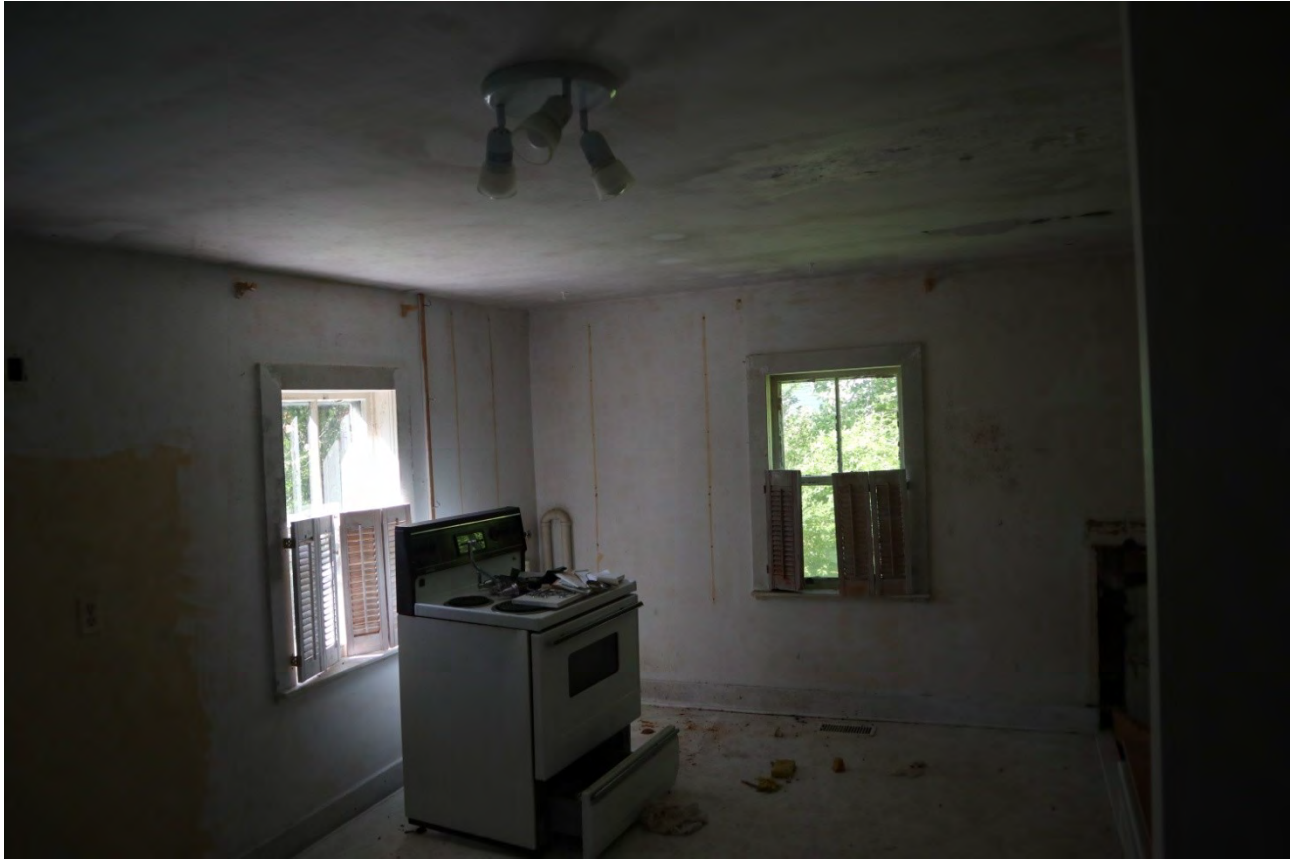
The conditions on the main floor are similar to that in the floor above. See photographs below.

As was evident in the floor above, this level showed little improvement. Amongst the defects were:

- a) Settled floor system, falling from the front to the back of the house
- b) Rusted out light fixtures and other electrical components, including electrical wiring
- c) Soft drywall or plaster is evident in most locations
- d) Mold all over the surface of the ceilings and the walls
- e) All the flooring is viewed as requiring replacement
- f) Windows and their trim are rotted and are substantially covered in mold

The electrical outlets, switches and fixtures were all deteriorated. The complete new wiring of the house is clearly evident. There is little chance that Nova Scotia Power would pass any aspect of the electrical system in the building.

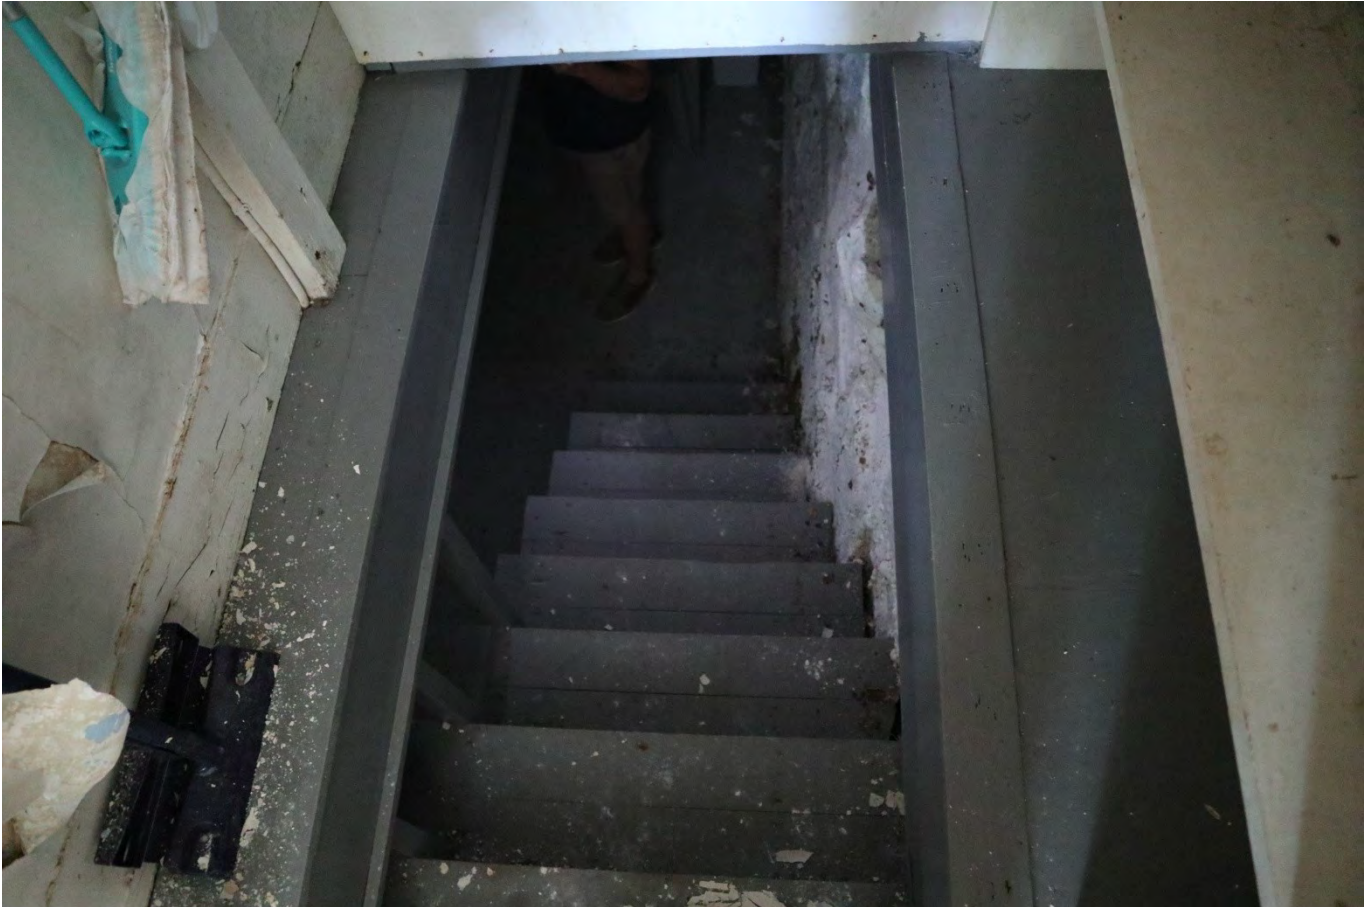
Going down into the basement was a challenge in itself. The stairway was rotted out. It was relatively dark, and a flashlight had to be used in order to get a good idea of the conditions. Please see below some of the photographs taken.

These stairs actually showed better than the upper level stairway, at least in terms of deterioration. However the walls around them were all deteriorated and would require significant upgrade.

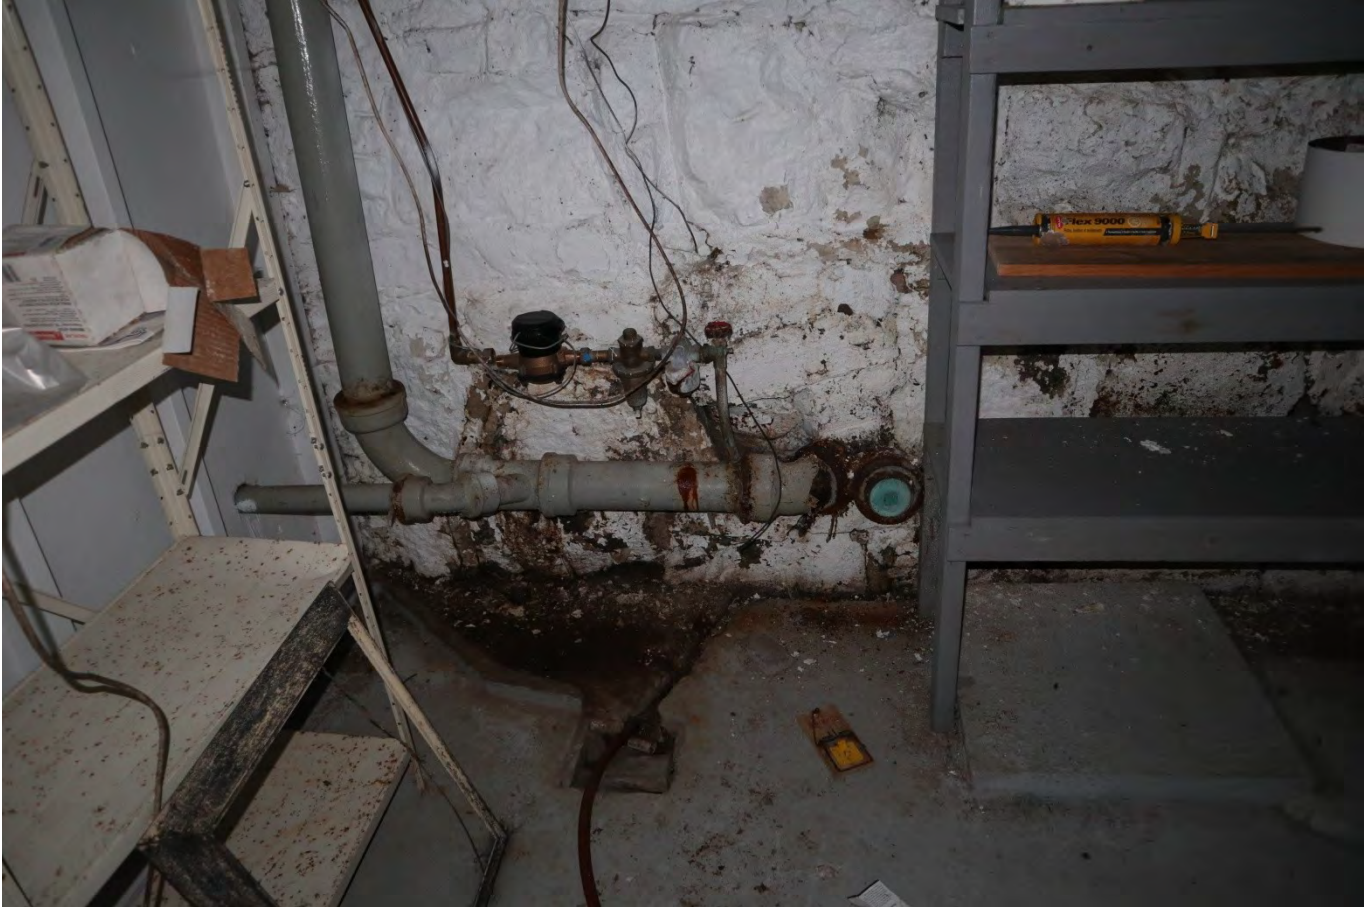
In the two photographs below, is shown the point of sewer and water entry into the building. You can see the rust and mildew on the piping caused by the infiltration of water.

You can also see the area for pooling of water underneath the service lines. This is one of many points of water entry into the basement. The foundation walls are of rock construction, and easily allow water to enter through cavities between the rock.

- a) Rusted out light fixtures and other electrical components, including electrical wiring
- b) Ponding of water in various locations
- c) Water entry through the foundation walls
