Heritage Impact Statement

St. Mark's Church, 5522 Russell Street, Halifax

Updated June 2024

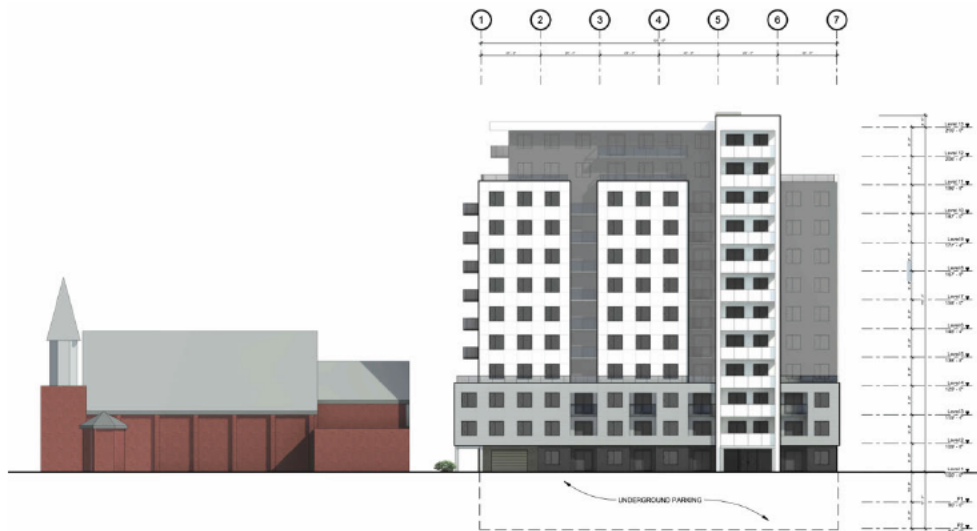
Figure 5: Development Proposal – As seen from Russell Street

1. The retention and conservation of St. Mark's Church at 5522 Russell Street, and;
2. The removal of the adjacent building at 5540 Russell Street with full restoration of the exterior, and;
3. The partial removal of a later addition to the church (Figure 4).
4. The development of a 12-storey mixed-use residential building on the westerly portion of the site, fully detached from St. Mark's Church (Figure 5).

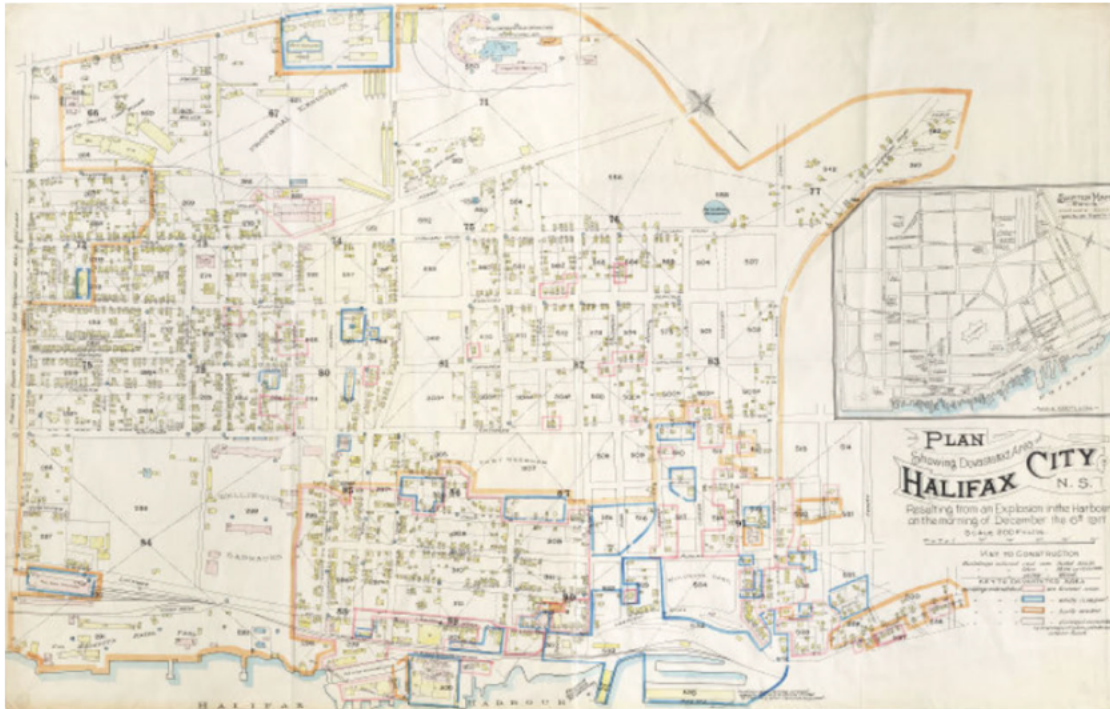
Figure 7: Plan showing devastated area of Halifax City, N.S., 1918

The extent of the destruction caused by the explosion and subsequent fires is illustrated in Figure 7.

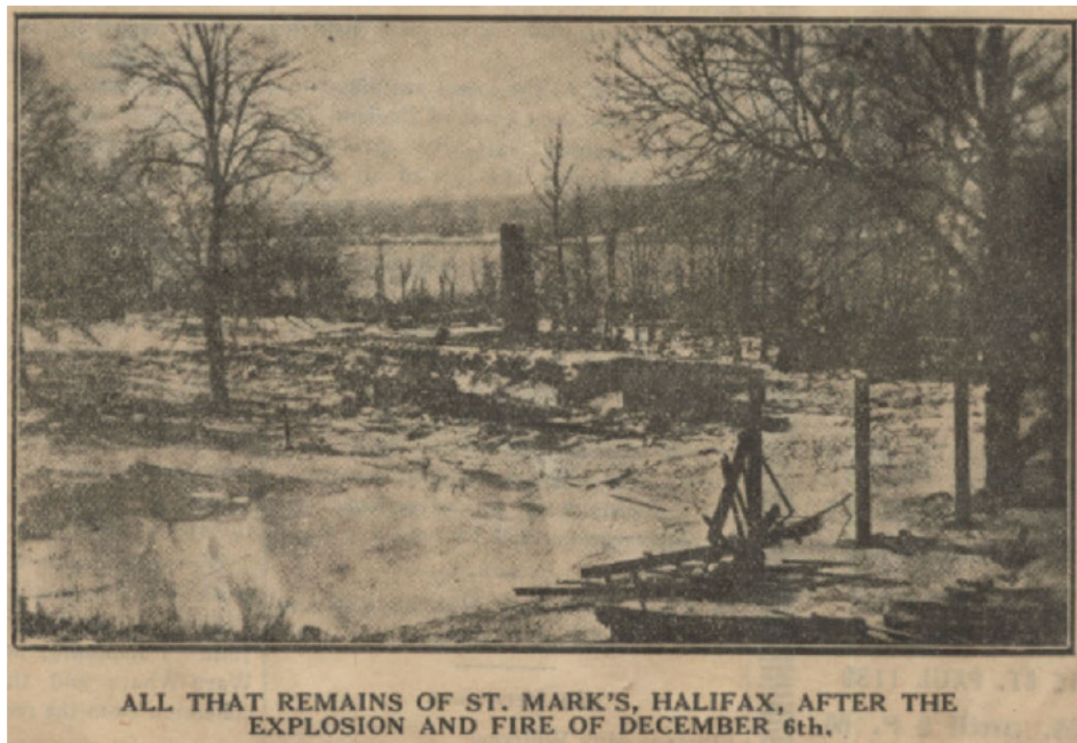
Figure 21: St. Mark's Church After the Halifax Explosion, 1917
Source: Nova Scotia Archives, Item MG1, Vol. 2124, No. 366C

The Halifax Explosion of December 6, 1917, destroyed St. Mark's Church and killed roughly 200 parishioners making up roughly 70% of the congregation⁴ (Figure 21).

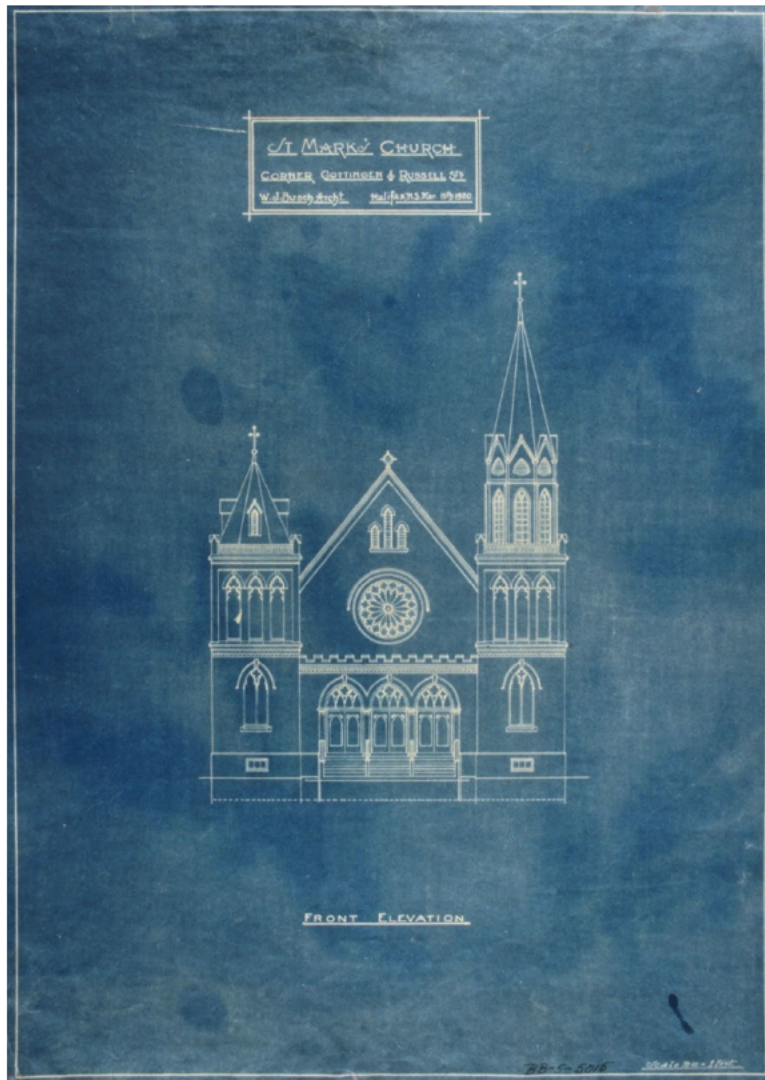
Figure 23: St. Mark's Church, Corner Gottingen and Russell [Streets], front elevation, March 15, 1920. Architect/draftsman W.J. Busch. Source: Nova Scotia Archives, 1.3.5.13. original drawing BB-5-5015.

By early 1920, plans had been completed by architect W.J. Busch (Figure 23).

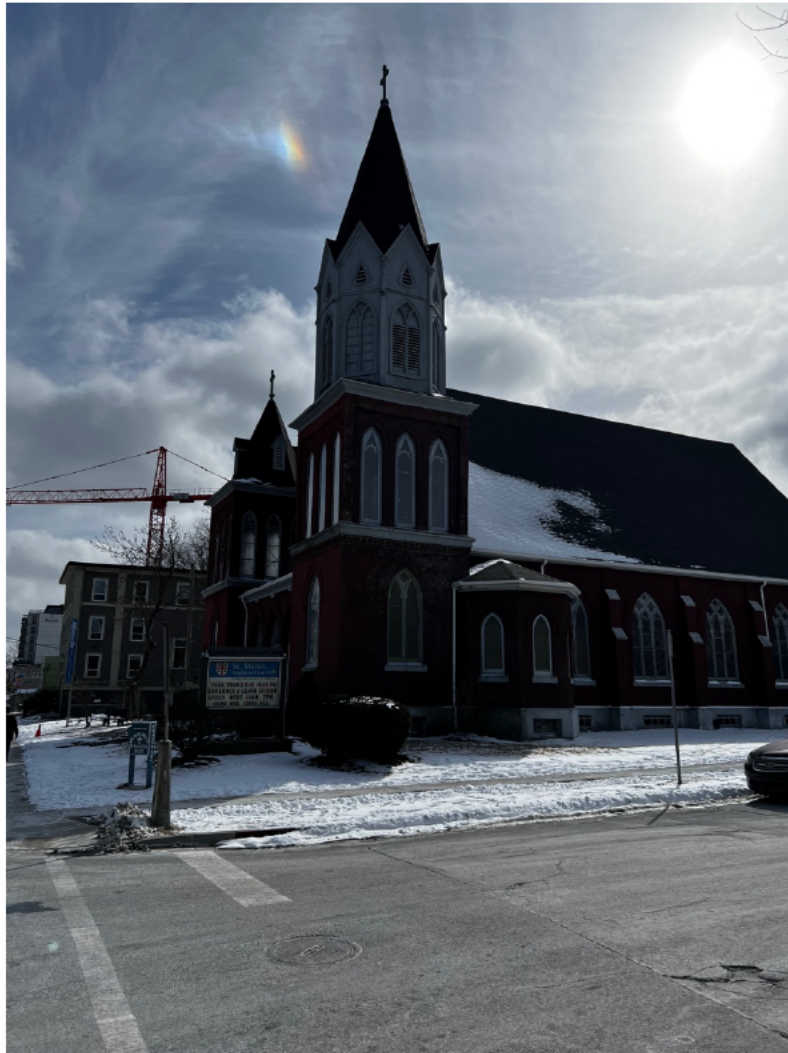
St. Mark's Church is an excellent example of places of worship, specifically churches, built in the inter-war era, in the Gothic Revival style that was commonly used for churches at that time. It is set on a prominent corner location, highly visible from both Gottingen and Russel Streets, with a prominent square tower topped by an octagonal extension, a large rosary window, a secondary tower, between which is set the main entry (Figure 29).

Figure 29a: Context of St. Mark's Church, 5522 Russell Street (seen from corner looking south along Gottingen Street)

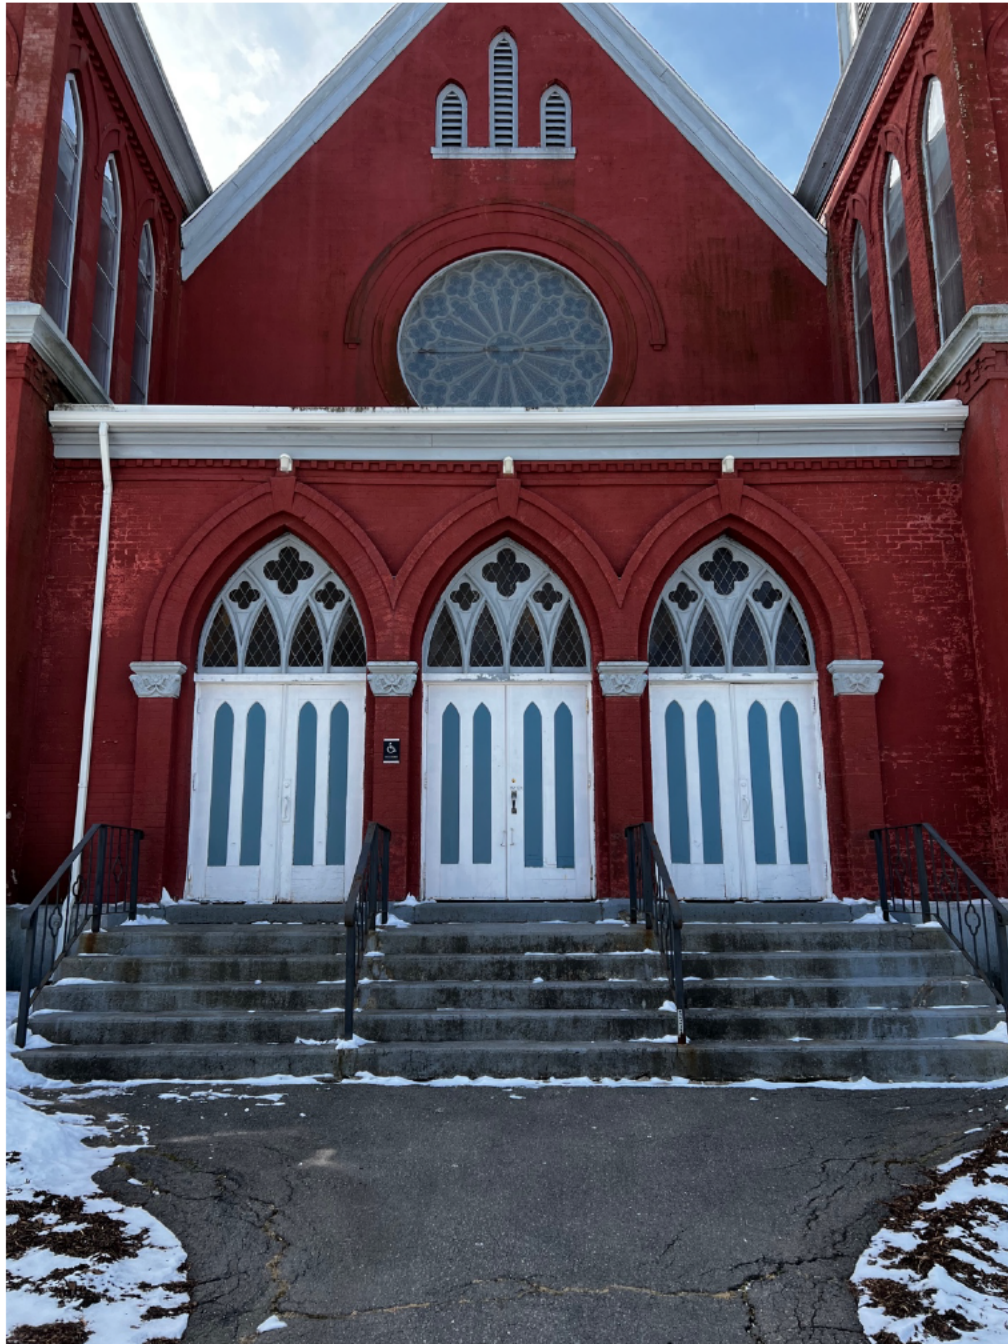
Its front-gabled form is common to the Gothic Revival style, with the primary entry comprising tripartite doors set dominantly in front of the gable wall on which the rosary window is set. The main entry is flanked by two towers: while the base of each is identical, the north tower is notably taller with more design elements such as an octagonal extension, while the south tower has a simple hipped roof with dormers extending from its base (Figures 30 and 31).

Figure 30a: Front entry of 5522 Russell Street with flanking towers

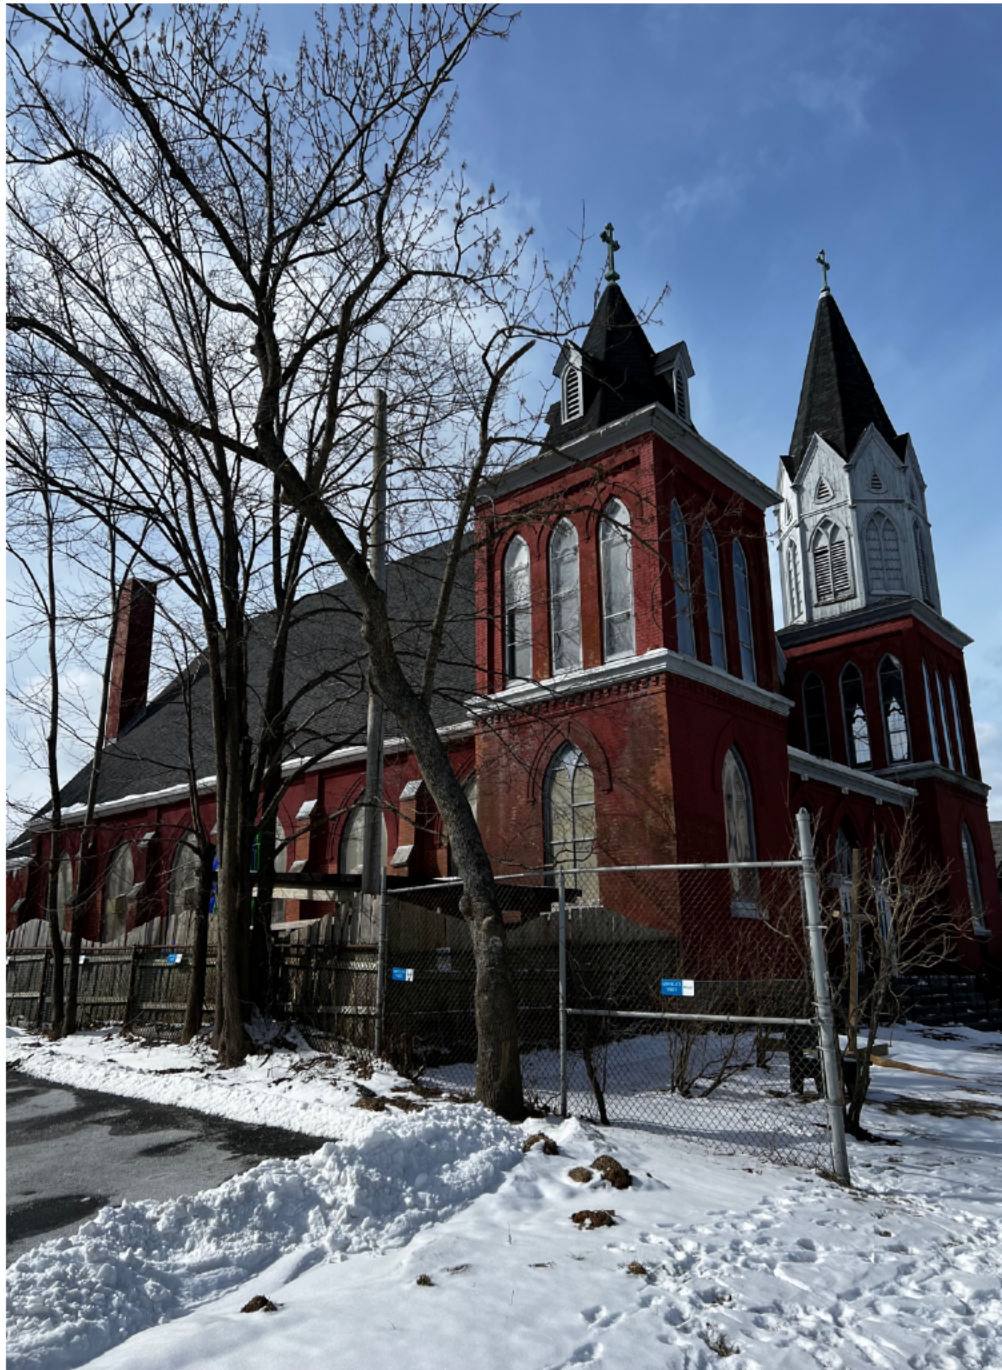
Each of the towers has the pointed arch windows set in singles and pairs, in typical Gothic form. Along the sides of the building, behind the towers, the windows are similarly set in singles (in the protruding alcove on the north side) and tripartite. Where the windows are set in pairs or tripartite, there is a traditional lancet, mullion divider and plate tracery (Figures 30b to 31d).

Figure 30b: Front and south side of 5522 Russell Street

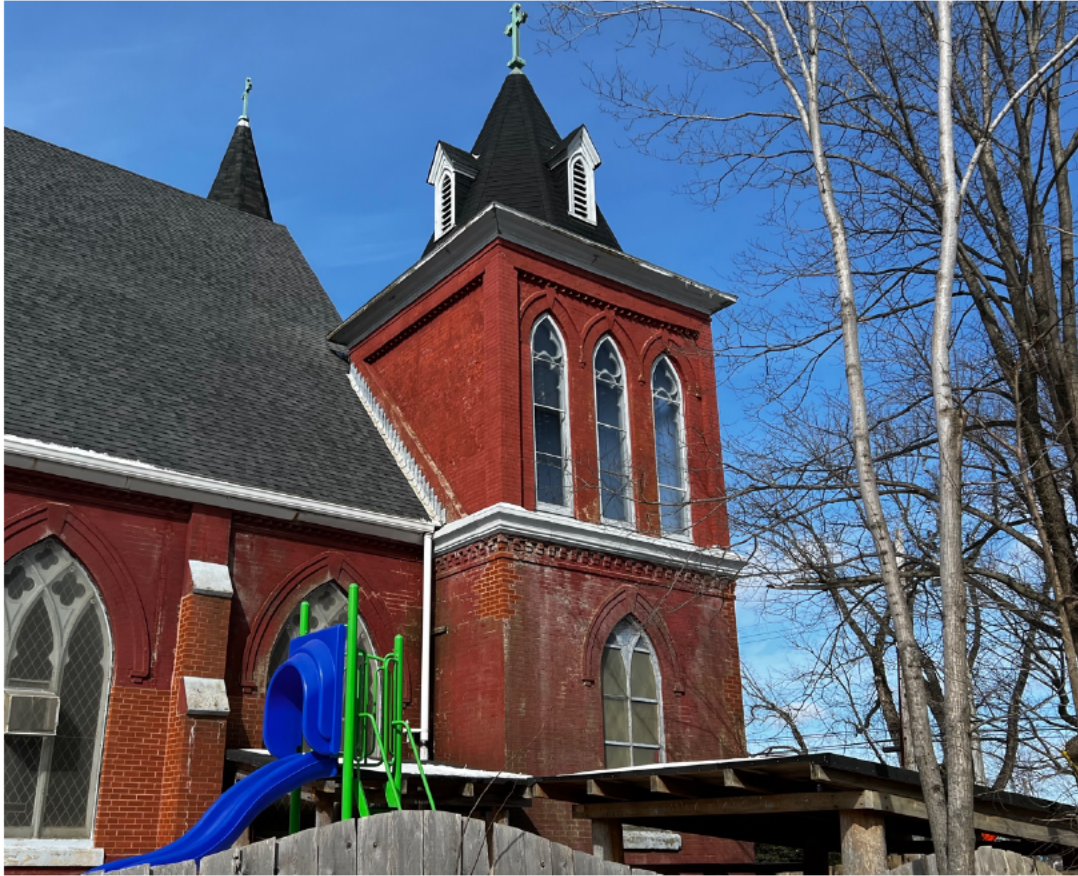
Figure 30c: South side tower

North and South Towers: Generally poor condition. The brick in both the south and north towers has extensive efflorescence with some spalling and likely aggravated by freeze-thaw weathering. Furthermore, the brick has been painted at some point in the past and this has likely exacerbated the efflorescence and spalling, if it has not been able to “breathe.” This is especially notable on the north wall of the north tower. This is also apparent on the south tower, but to a lesser degree.

More extensive repair work consisting of brick replacement and re-pointing has also been done on the south tower.

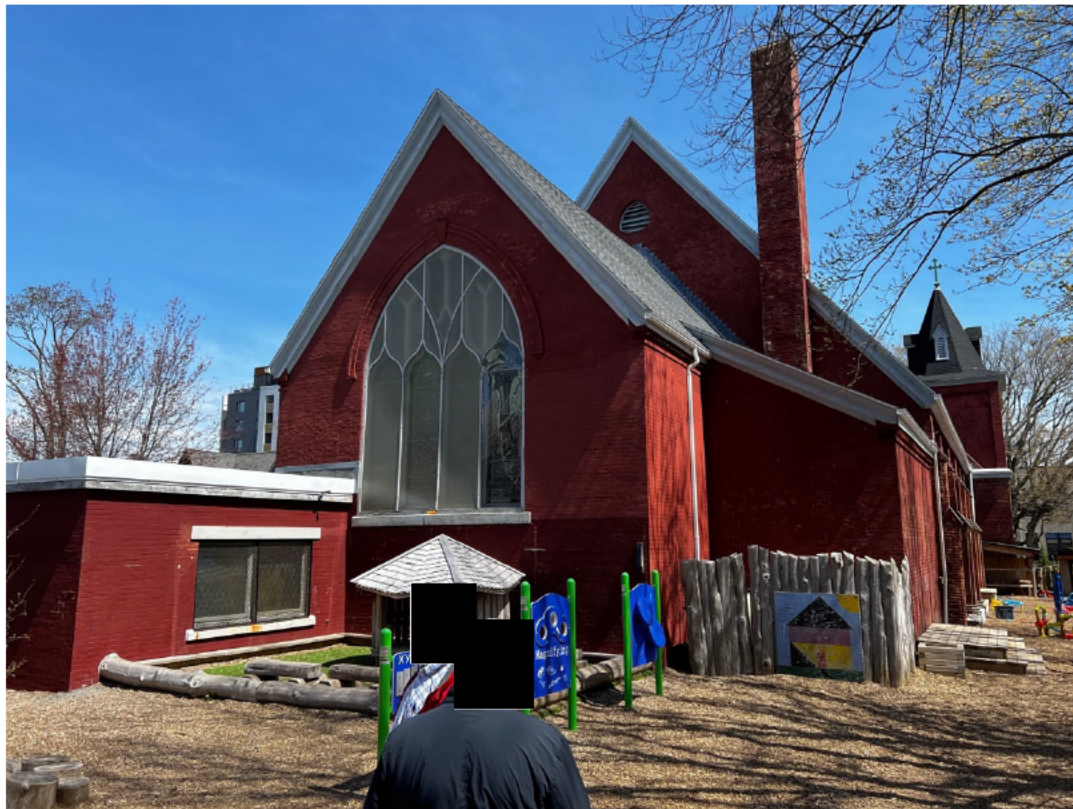
The north side includes a one-storey addition made in 1960, that expresses the evolution of the church over time. The rear has also been affected by this alteration, as it covers not only the north side but also a limited section of the rear (Figure 30d).

Figure 30d: Rear, 5522 Russell Street

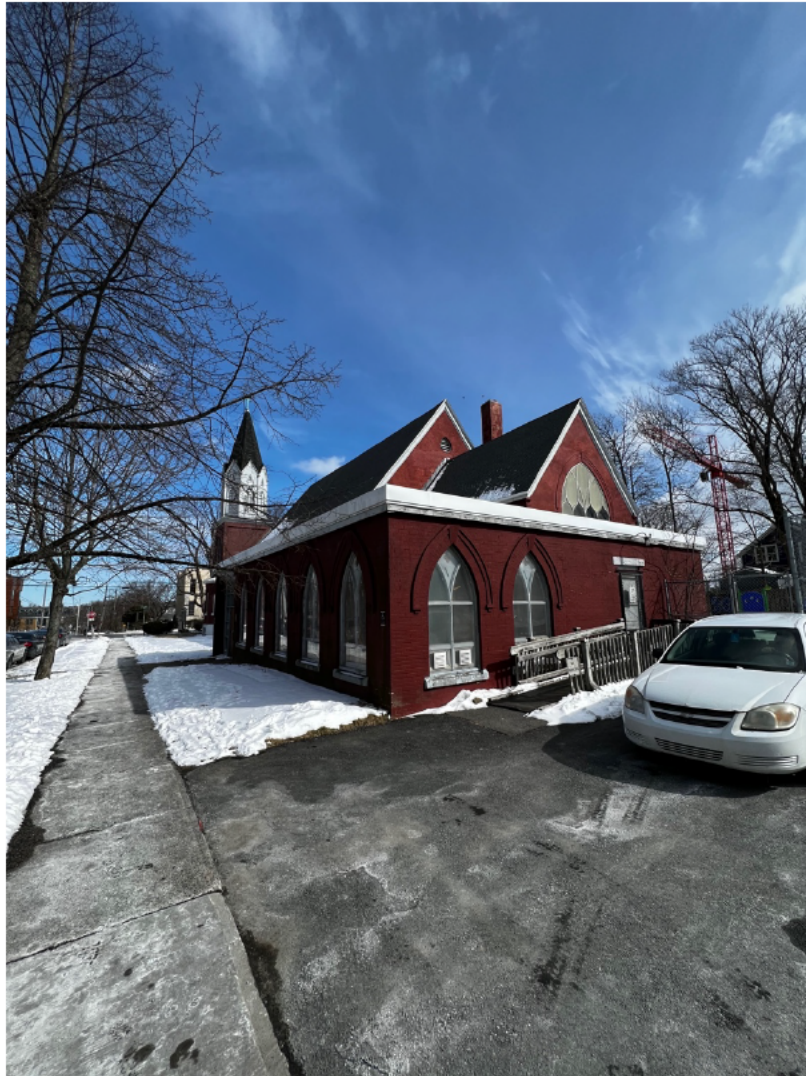
Overall, the integrity of St. Mark's Church is excellent. The only notable alteration is the single storey addition of a church office that protrudes from the main body of the church along the rear section of the north side and wraps partly around the rear (Figure 31a to 31c).

Figure 31a: Single-storey addition on the north side of 5522 Russell Street, as seen from Russell Street

North Side and Rear: It is not known the extent of, or condition of, brick that was covered up by the 1960 addition. The brick on the 1960 addition itself is in generally good condition although it appears to have been painted and in some places the paint is failing.

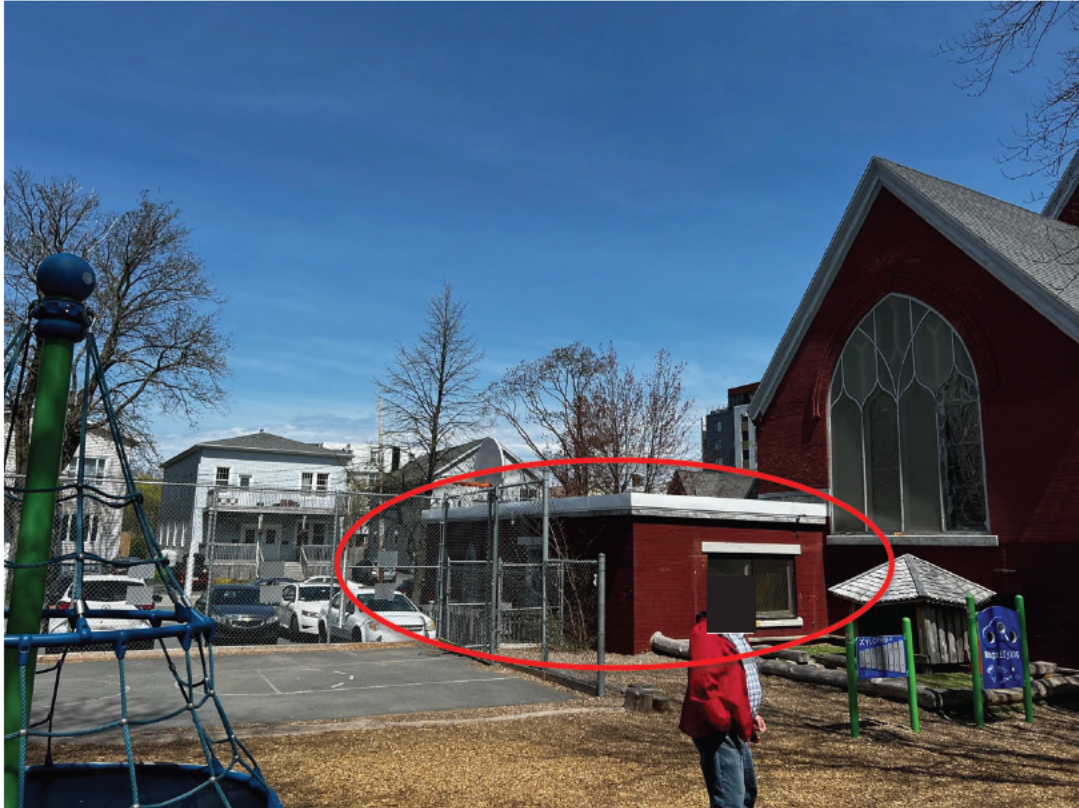
This addition was made in 1960, with plans drawn up by Webber, Harrington and Weld. While it is compatible, with the use of similar colour brick and window openings that follow the other arched-peak form on the early part of the church, it is distinguishable with its flat roof and simple fenestration. This enclosure obscures an original side entry but it does not appear to affect any windows, and it notably does not interfere with the large apse window set at the rear (Figure 31b).

Figure 31b: Single-storey addition on the north side of 5522 Russell Street, seen from the rear and ending at the edge of the apse windows (circled)

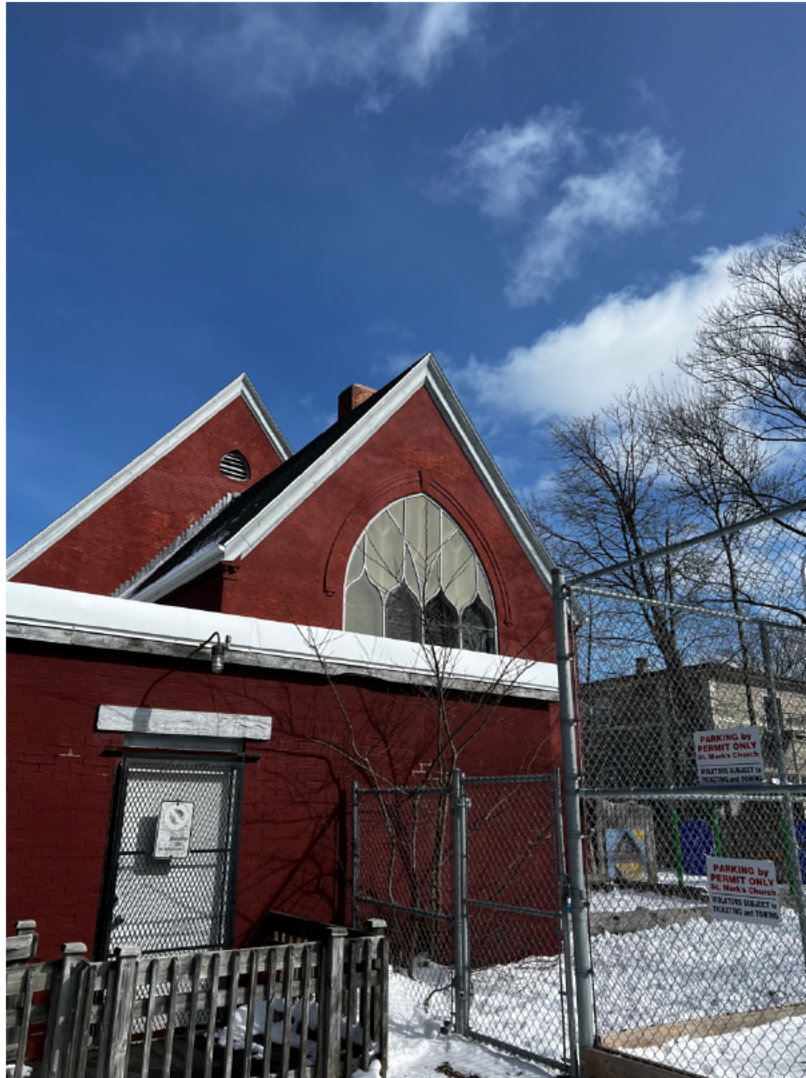
Figure 31c: Single-storey addition wrapping around the west side of 5522 Russell Street, with a single emergency exit door

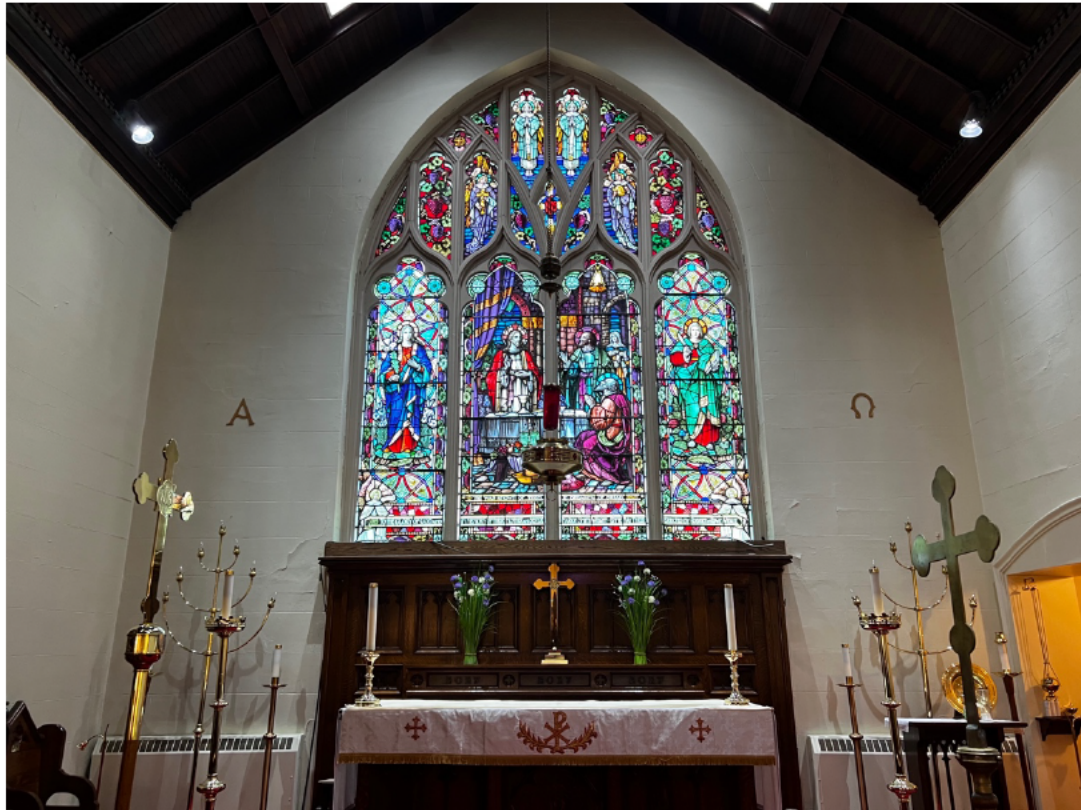
It does appear that an alcove or a small room set immediately adjacent the apse, on the north side, was enclosed (Figures 32 and 33). The opening in that north wall appears to be original and as such the 1960 addition of the offices and other rooms has changed the interior layout but not the configuration of the apse itself.

Figure 32: Apse with side room access on far right

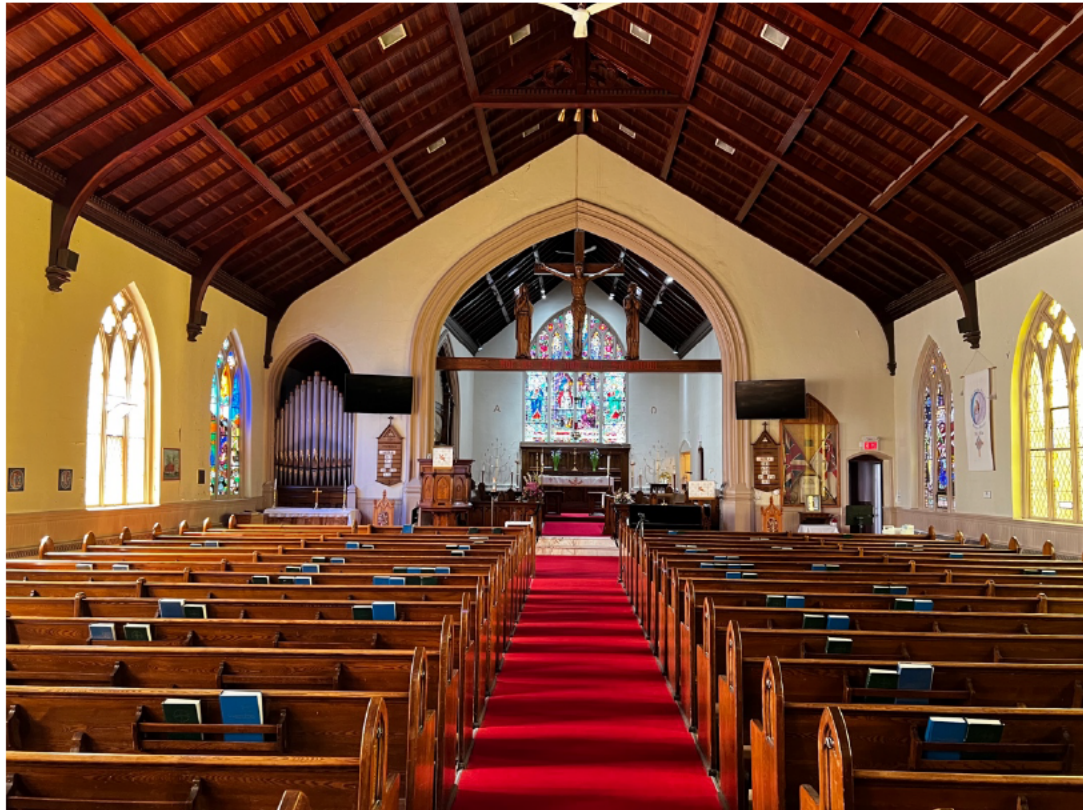
Figure 34: Interior as seen from rear

When comparing the early (c. 1921) photograph (Figure 26, page 26) to the current photographs, the only notable alterations on the interior are at the entry to the apse where a crucifix and horizontal crossbeam has been installed, and the removal of the original light fixtures that hung from the ceiling, and two television monitors (Figures 34 and 35). While the loss of light fixtures is unfortunate, the crucifix addition has enhanced the overall character as expressed through its interior.

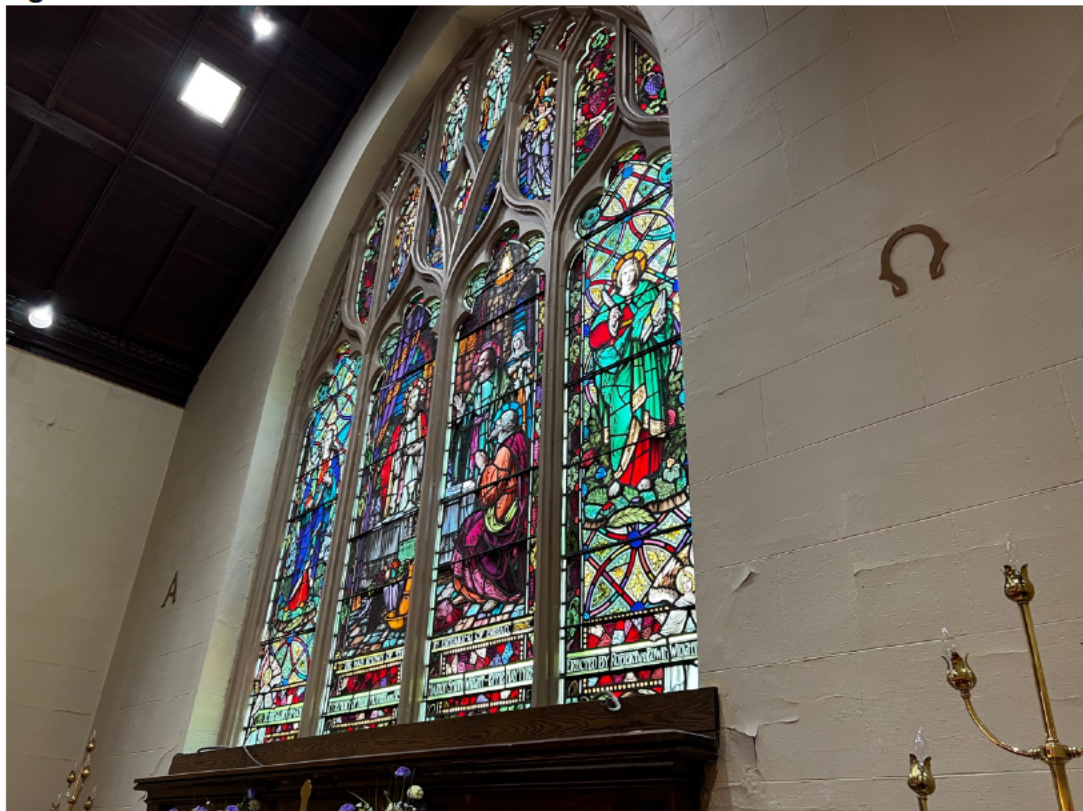
Figure 35: Detail of apse window

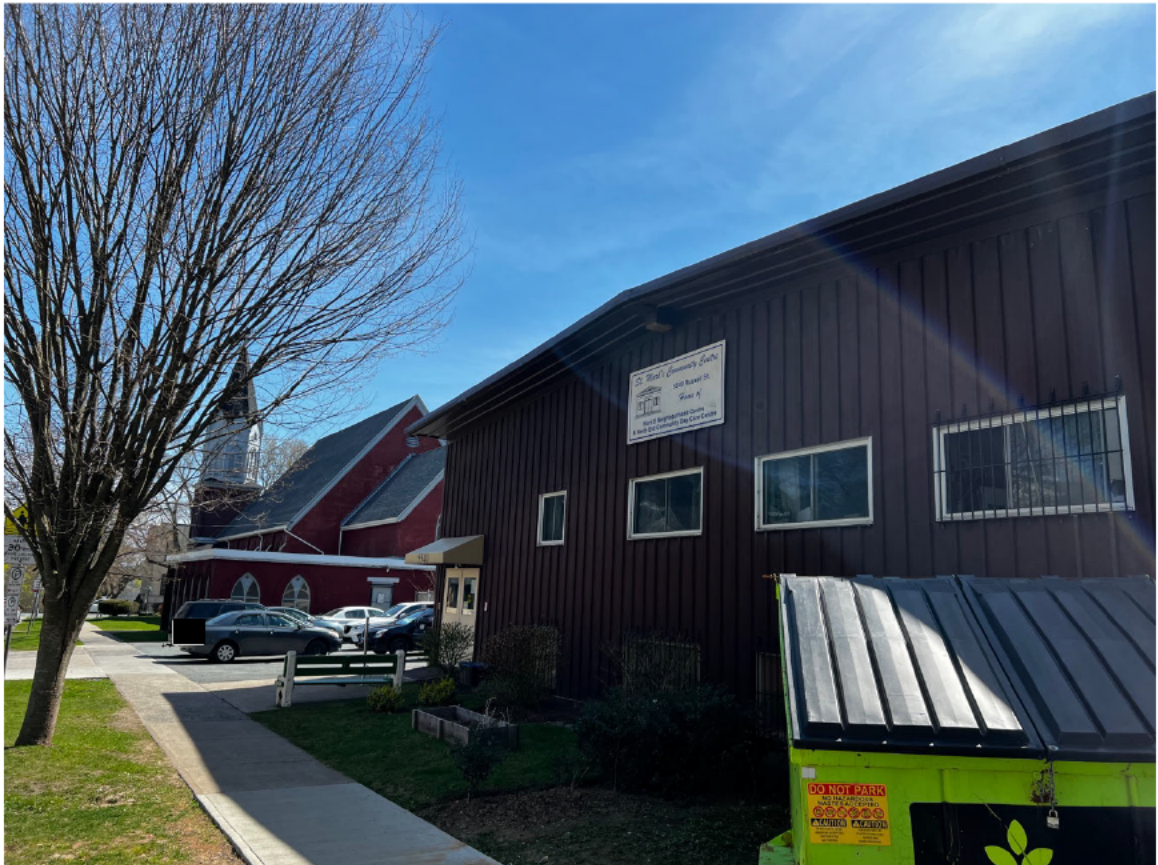
5540 Russell Street is a one-storey plus basement low-pitched wood frame and metal-clad building that is plain and unadorned. It has minimal setback from the street, and no setback at the rear, with a minimal west side setback. It is only the east side yard that allows for access and notable separation from its neighbours (Figure 38).

Figure 38: Context of 5540 Russell Street, St. Mark's Church in the background

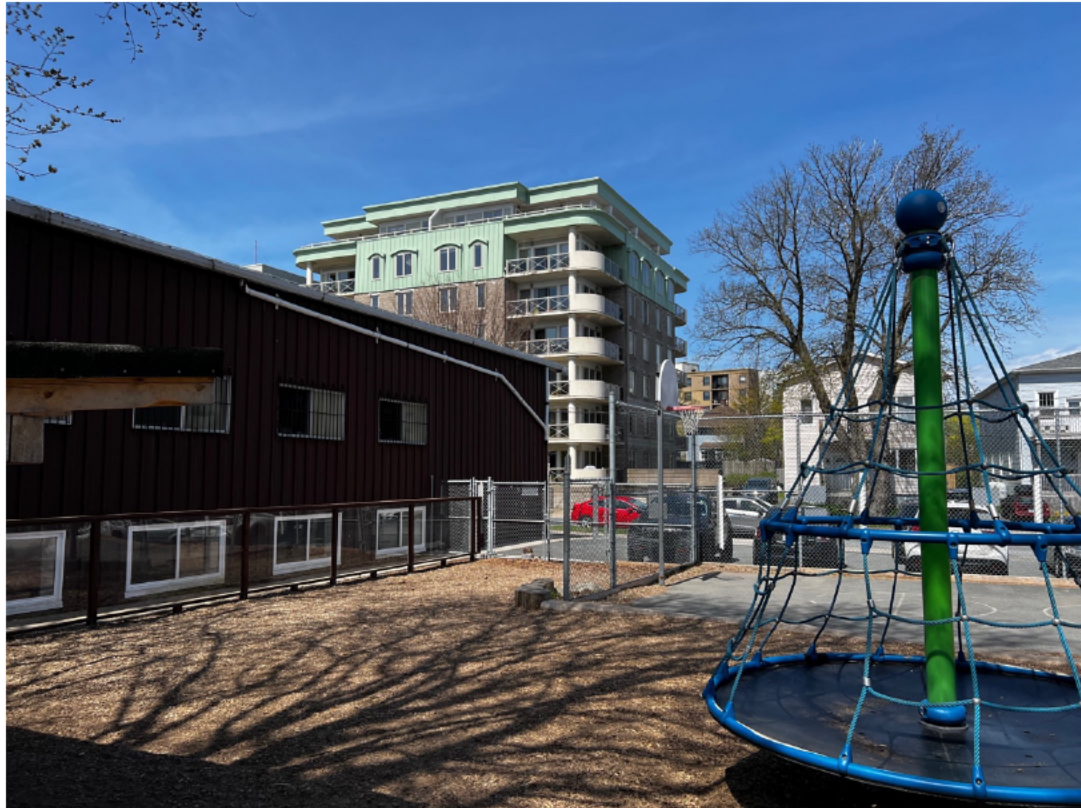
These elements are illustrated in Figures 39a to 39c.

Figure 39a: 5540 Russell Street – east side and open space between church

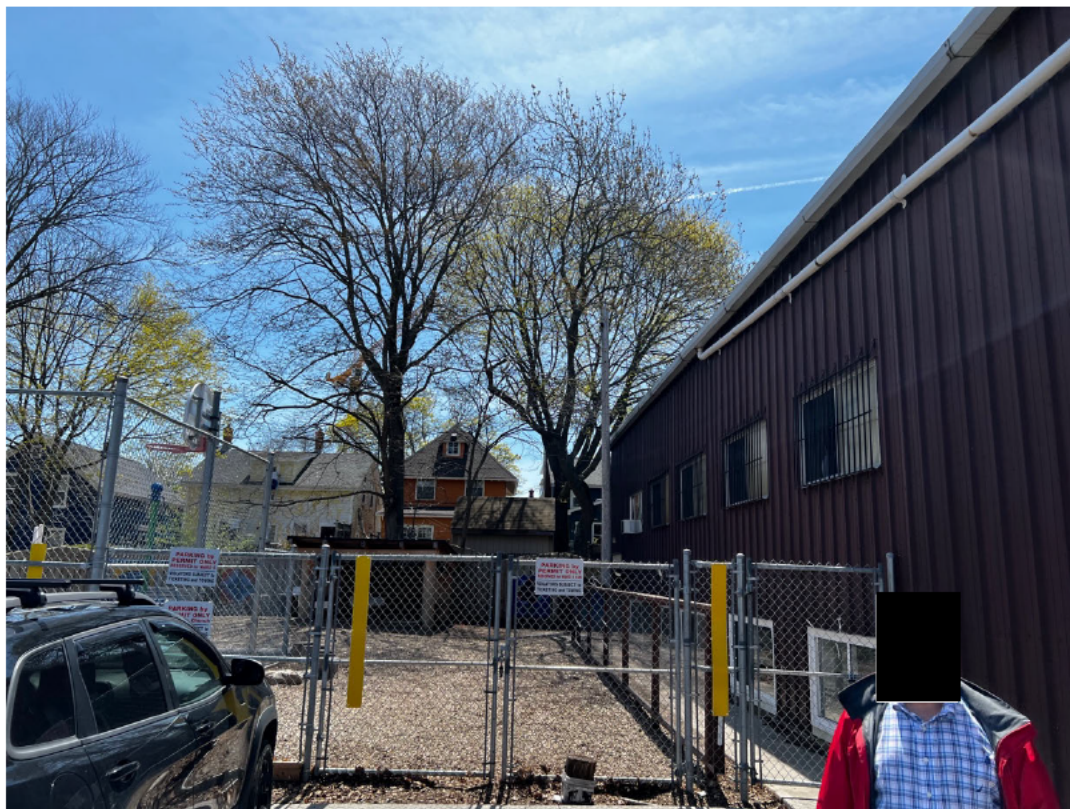
Figure 39b: 5540 Russell Street – east side

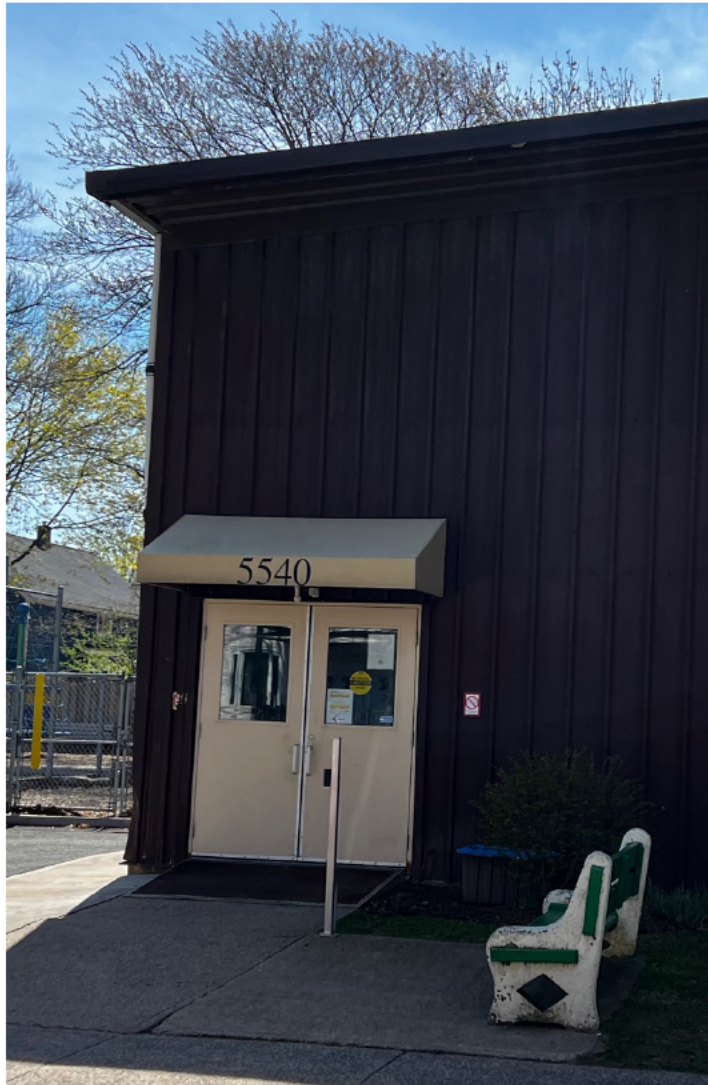
The overall form of 5540 Russell Street is intact. A relatively unadorned building, it can be classified as Vernacular style. The front, sides or rear are clad with corrugated metal, which is presumed to be an additional material – it is not known what the original cladding might have been or whether it may still exist underneath. The windows on the front, west and east sides are single-set metal sliders and are presumed to be original. Neither of these detract significantly from the style. The paired front entry doors appear to be a more recent alteration – they are nondescript metal doors with inset glazing (Figure 40).

Figure 40: Paired entry doors, 5540 Russell Street

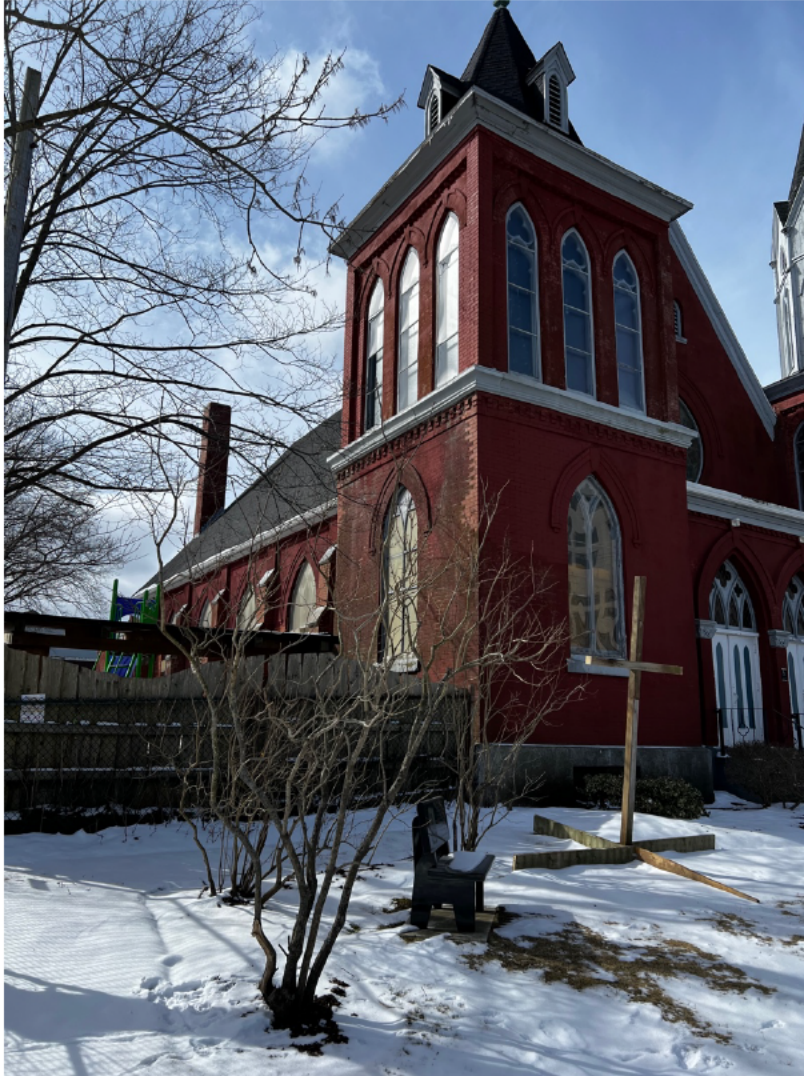
Figure 41c: St. Mark's Church, 5522 Russell Street (south tower)
