Heritage Impact Statement

St. Mark's Church, 5522 Russell Street, Halifax

Updated June 2024

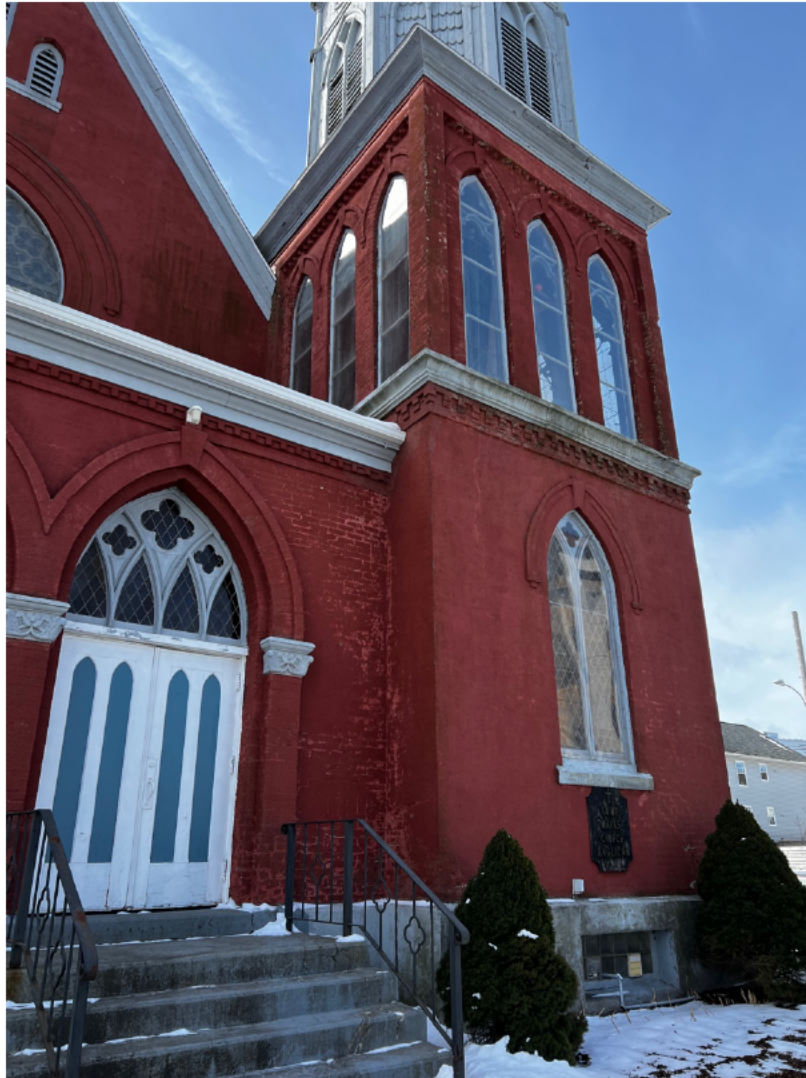
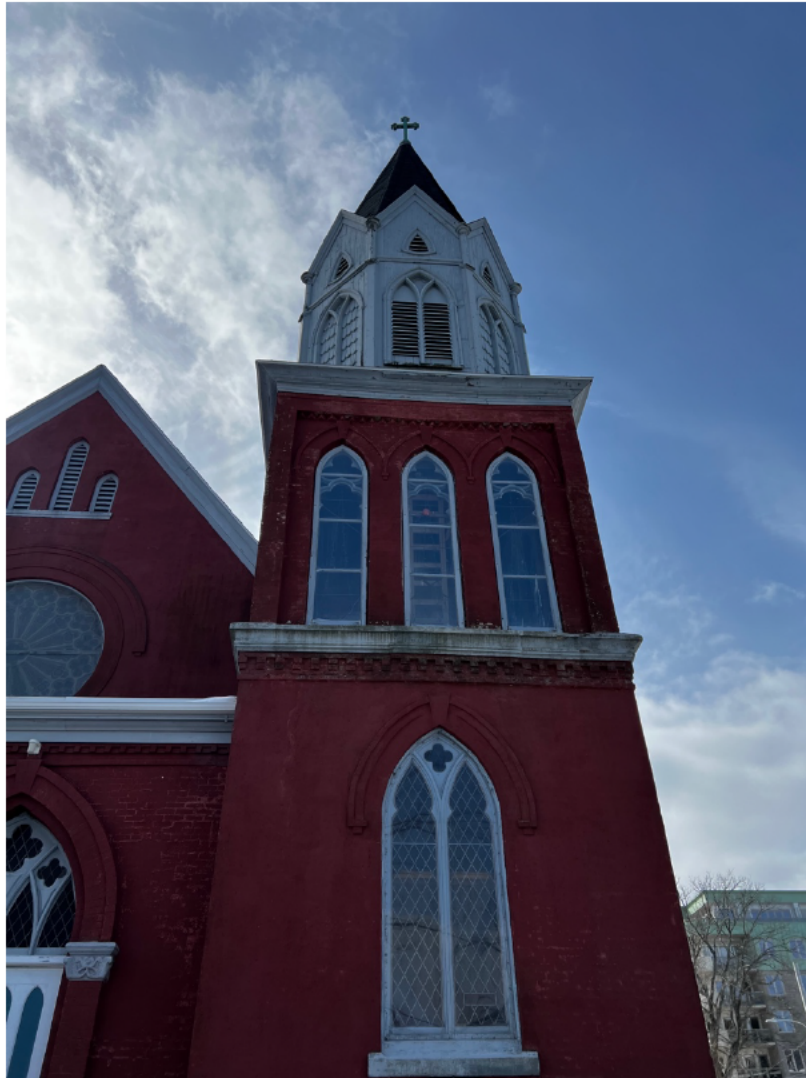
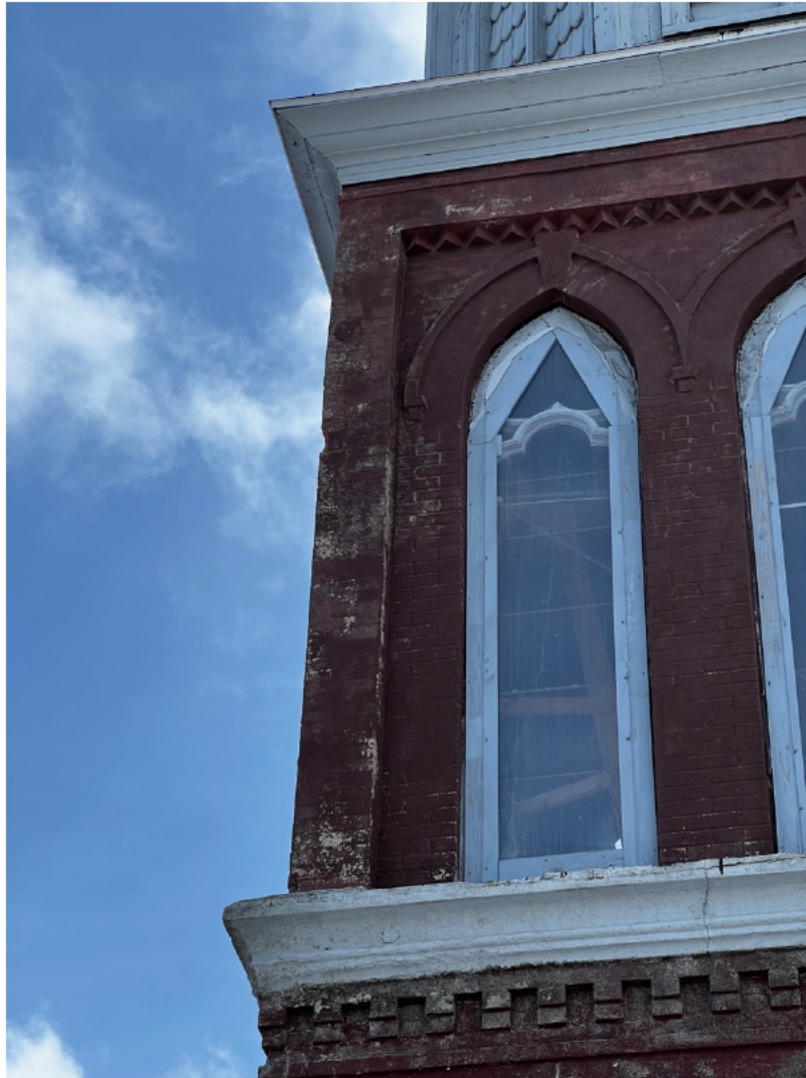
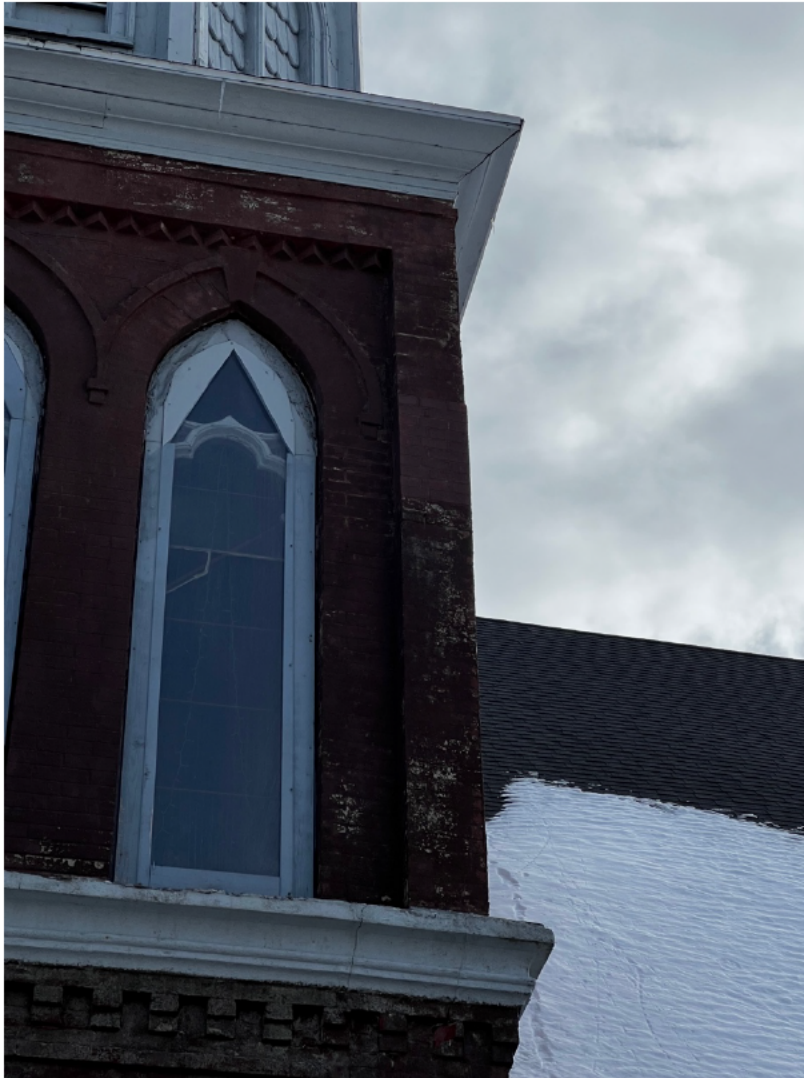
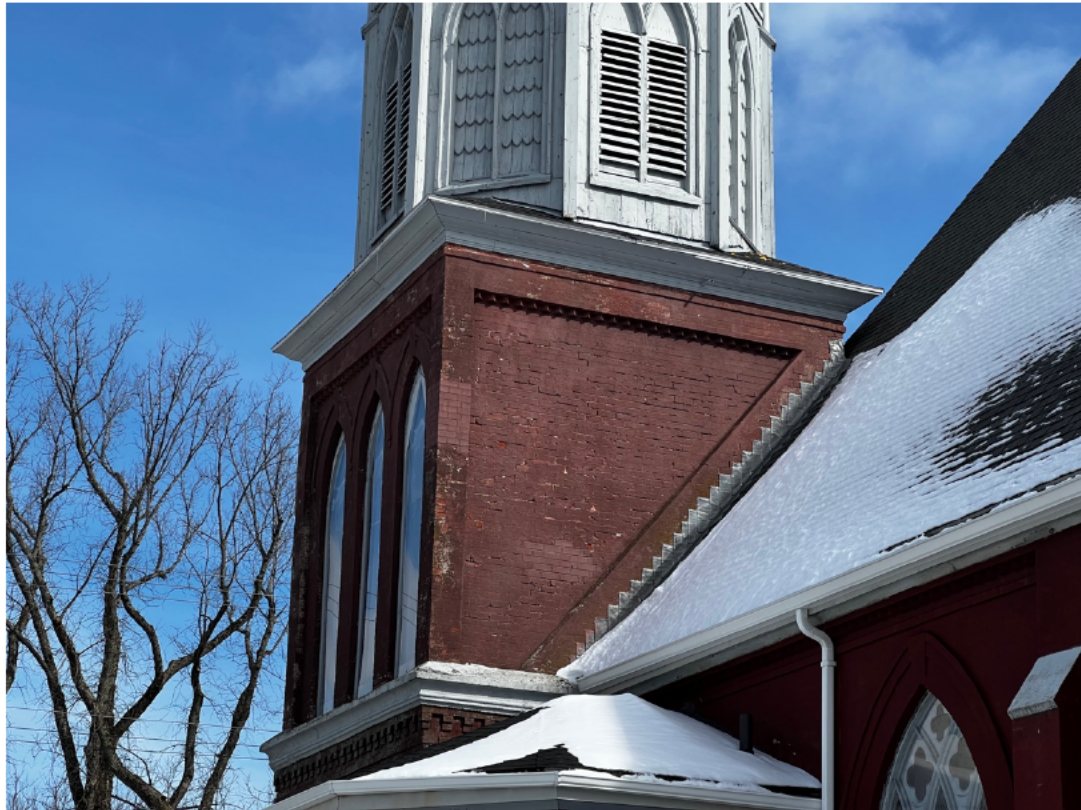
Figure 41f: St. Mark's Church, 5522 Russell Street (north tower)

Figure 41g: St. Mark's Church, 5522 Russell Street (north tower)

Figure 41h: St. Mark's Church, 5522 Russell Street (upper front corner section of north tower)

Figure 41i: St. Mark's Church, 5522 Russell Street (upper side section of north tower)

Figure 41j: St. Mark's Church, 5522 Russell Street (upper rear section of north tower)

North and South Towers: Generally poor condition. The brick in both the south and north towers has extensive efflorescence with some spalling and likely aggravated by freeze-thaw weathering. Furthermore, the brick has been painted at some point in the past and this has likely exacerbated the efflorescence and spalling, if it has not been able to “breathe.” This is especially notable on the north wall of the north tower. This is also apparent on the south tower, but to a lesser degree.

The base of the north tower has been covered with parging, likely to address water ingress at some part, either from above or on that section of wall itself. The condition of the brick underneath is not known.

Assess the parging on the north tower to determine whether it should remain in place or should be removed and replaced or remain as is.

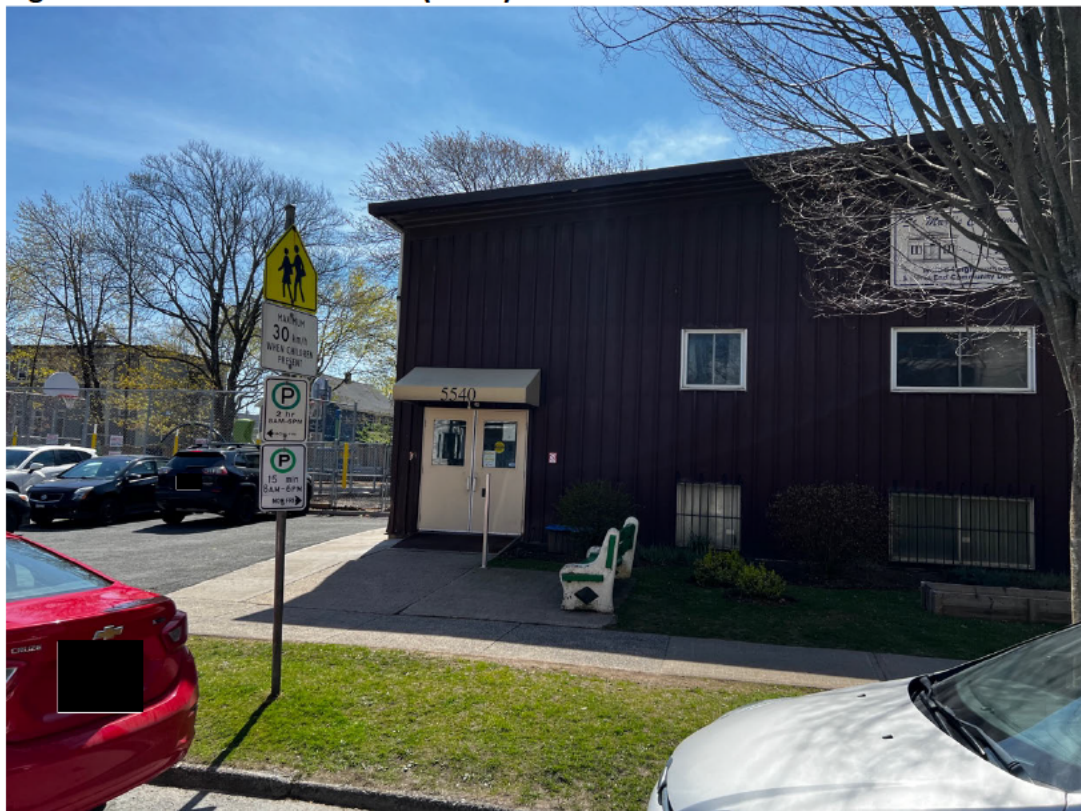
Figure 42c: 5540 Russell Street (Front – east half)

The following comprehensive set of photos of the church hall begins on at the west side and continues clockwise around the building to the east side. The rear was not accessible to be documented, as it abuts the property line and there is no rear lane (Figure 42).

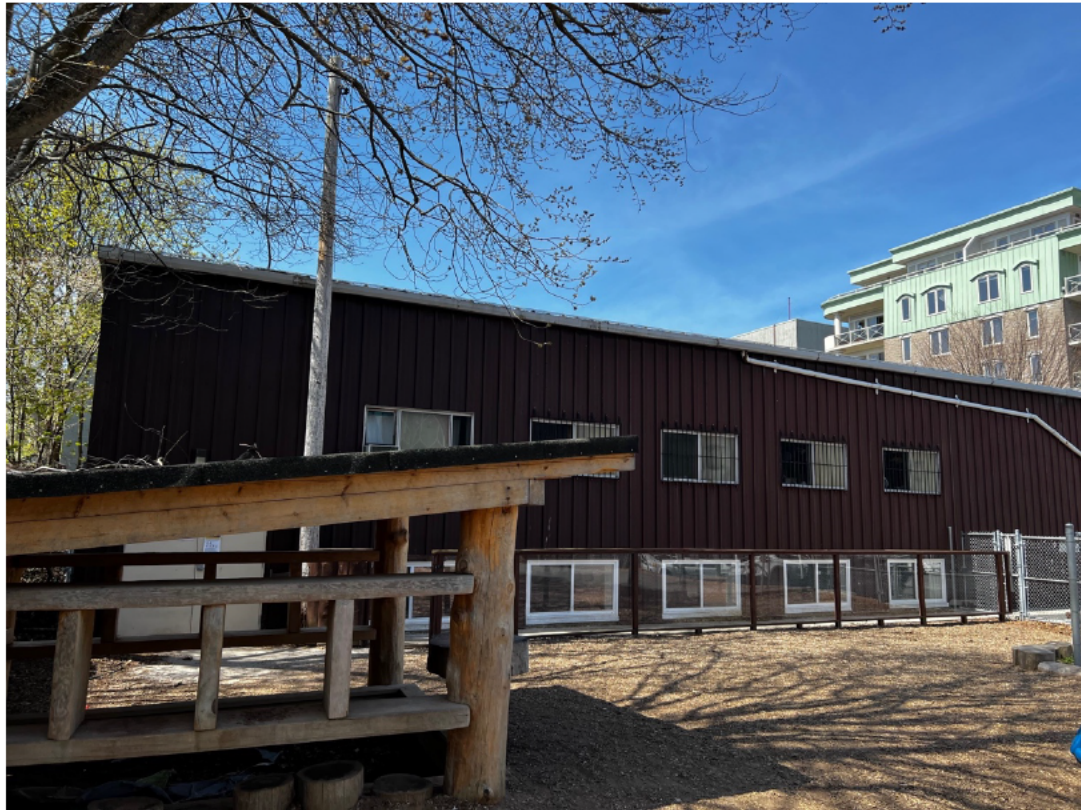
Figure 42d: 5540 Russell Street (East side)

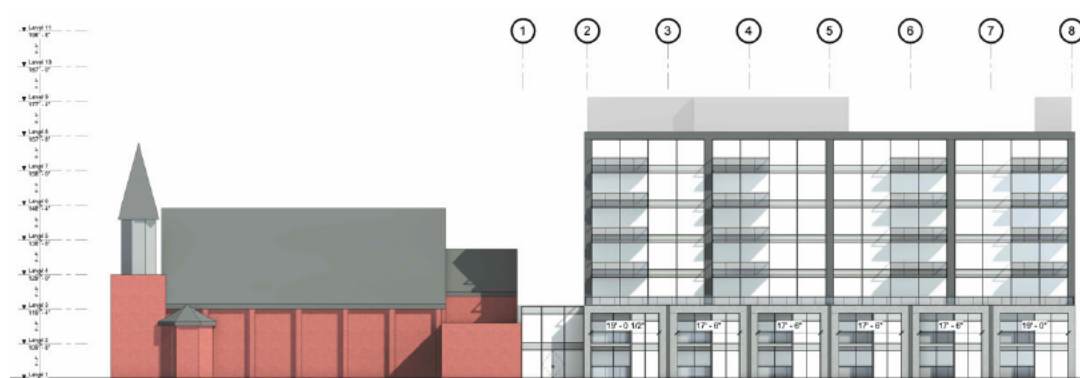
Figure 44b: Alternative north elevation

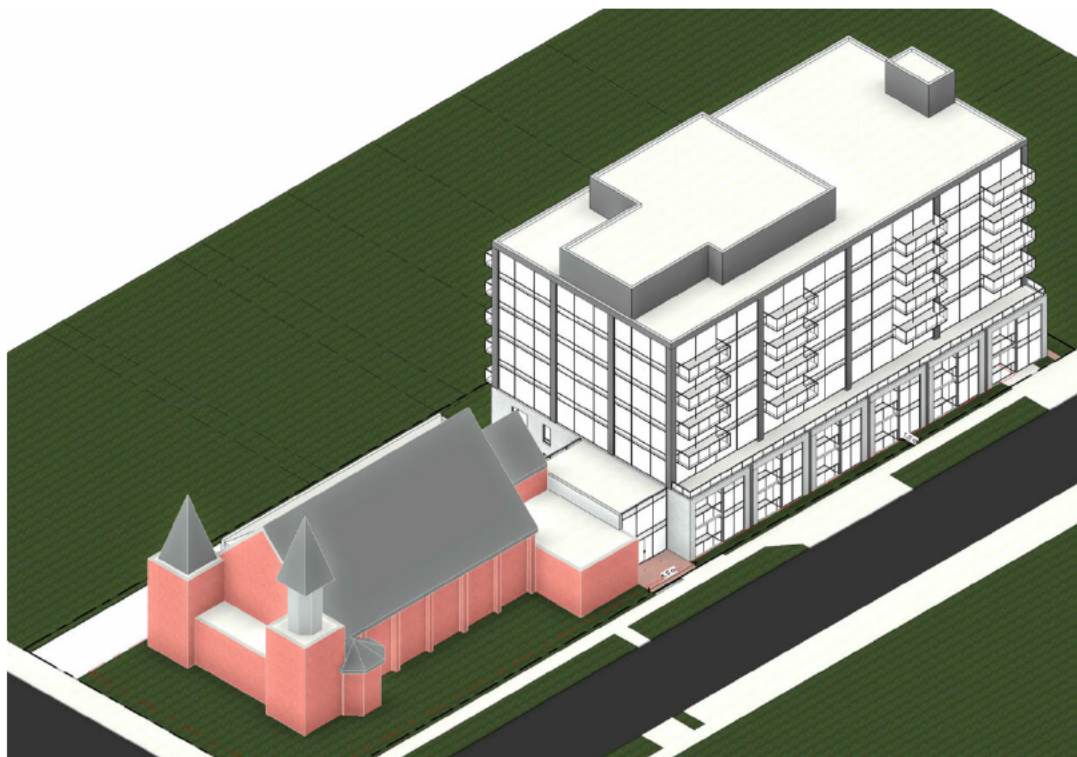
Figure 44c: Alternative 3D rendering

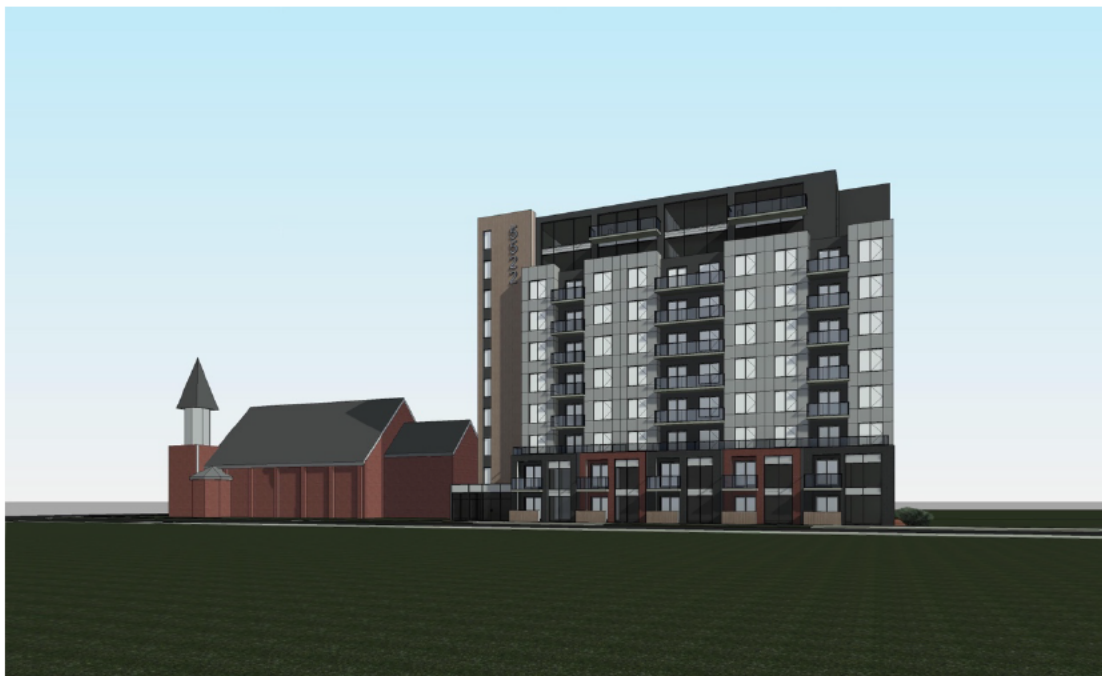
Figure 44d: Second alternative 3D rendering – detached from the church (March 2024)

Further changes were made to the design concept for the new building in March 2024, which separated the new building from the church. While this was a step in the right direction, it was wider and bulkier in massing than what is now proposed (Figure 44d).

Although two floors have been added to the proposal since then, the currently proposed massing is slenderer, and the 4th through 10th floors are set in from the podium. Further setbacks have been applied to the additional two top floors, bringing the total number of floors to 12 from the previous 10.

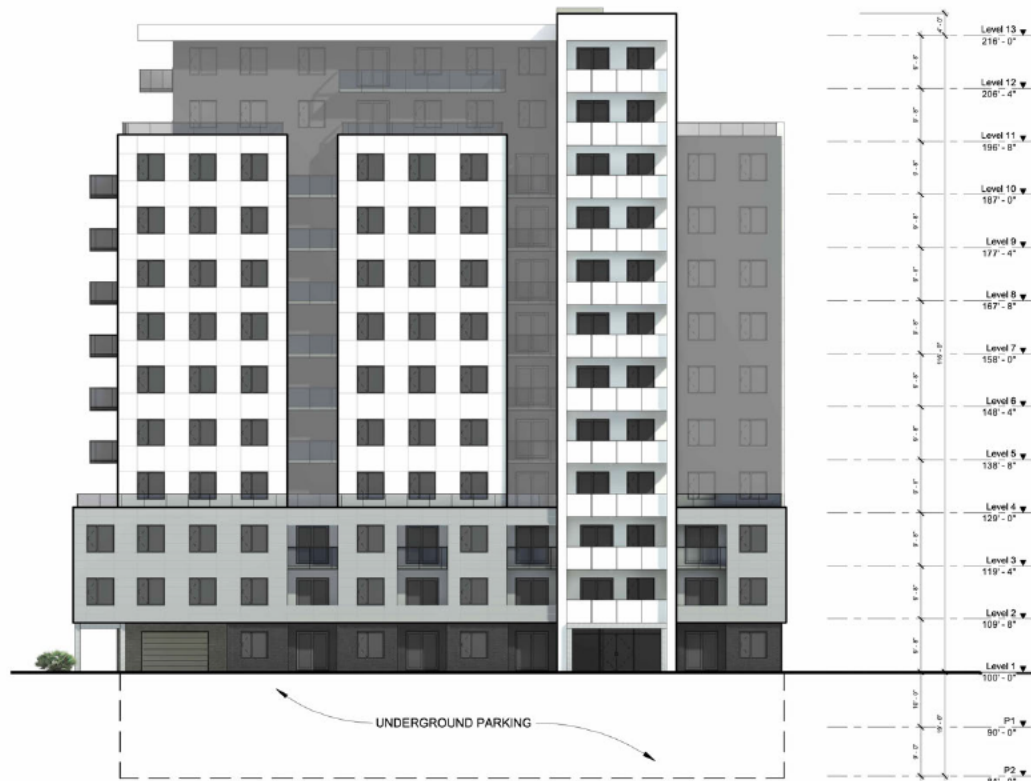
Figure 45: North-west elevation

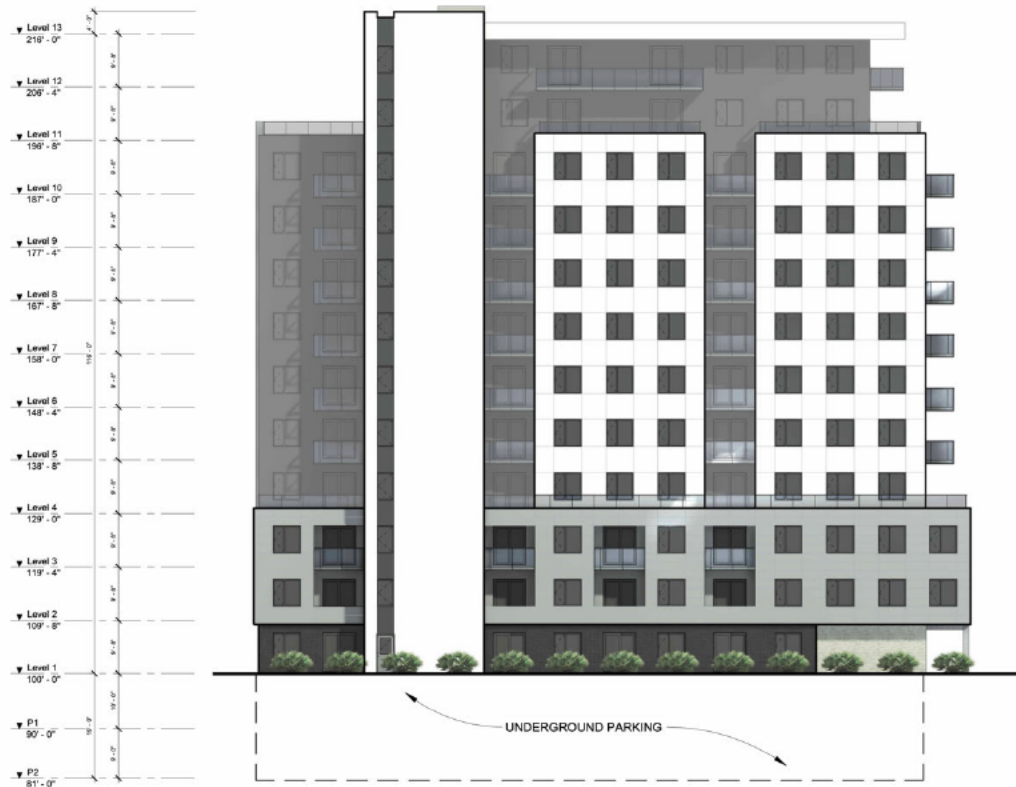
Figure 46: South-east elevation

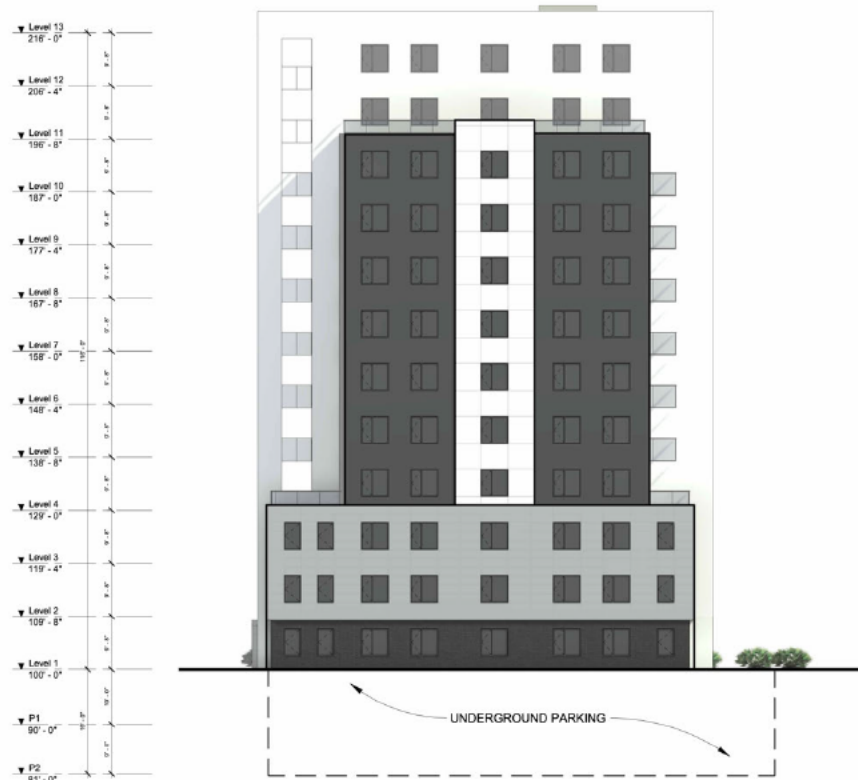
Figure 48: North-east elevation

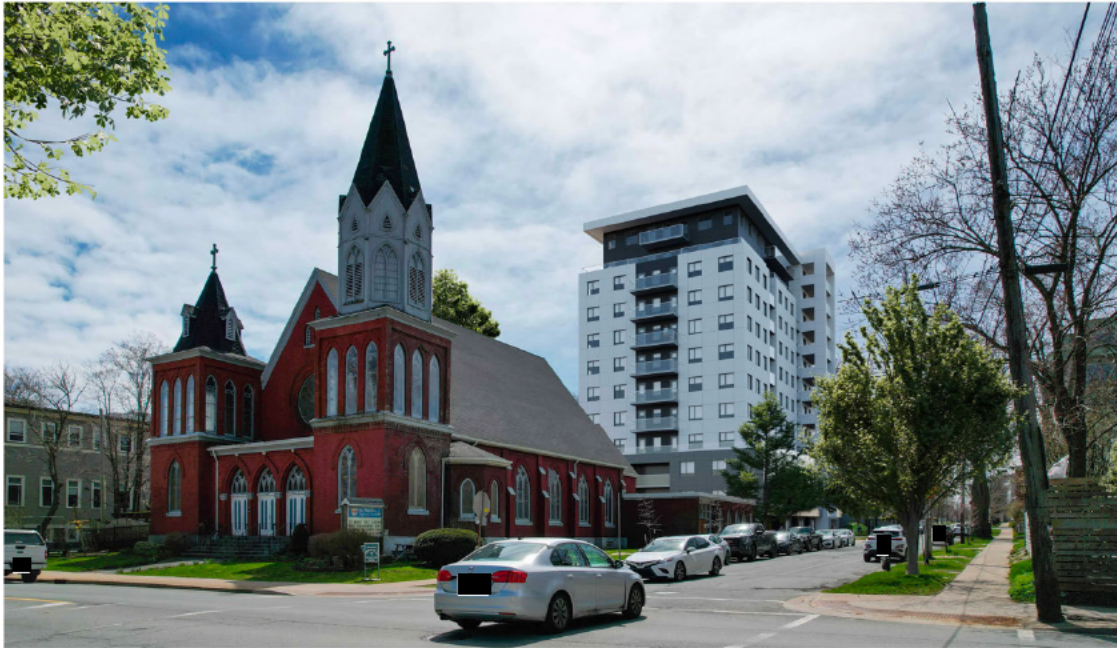
Figure 49: 3D Rendering of front and north side of church

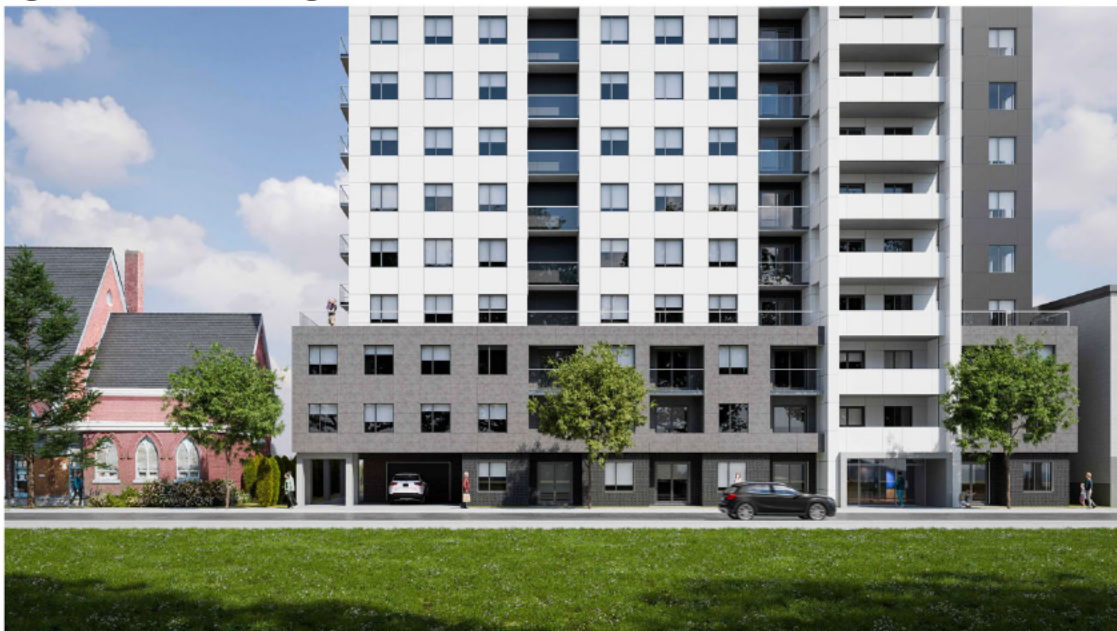
Figure 50: 3D Rendering of north side with partial view of church

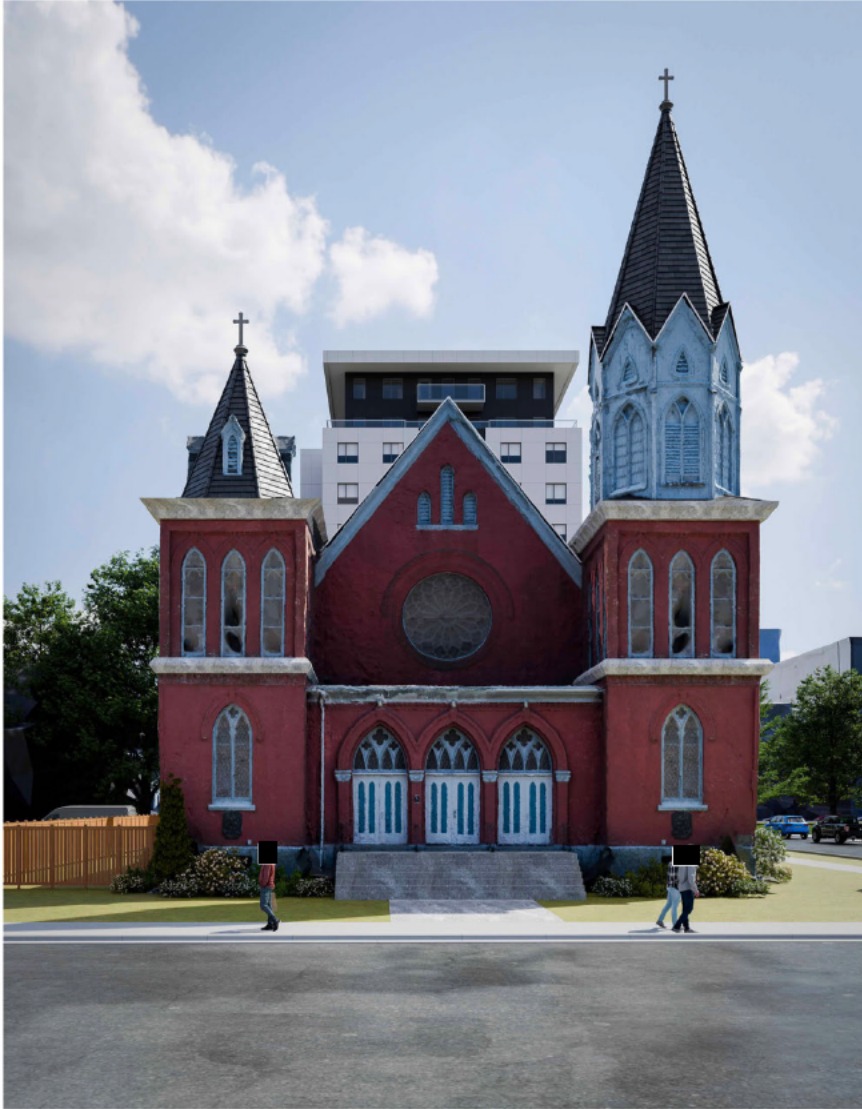
Figure 51: 3D Rendering of front of church

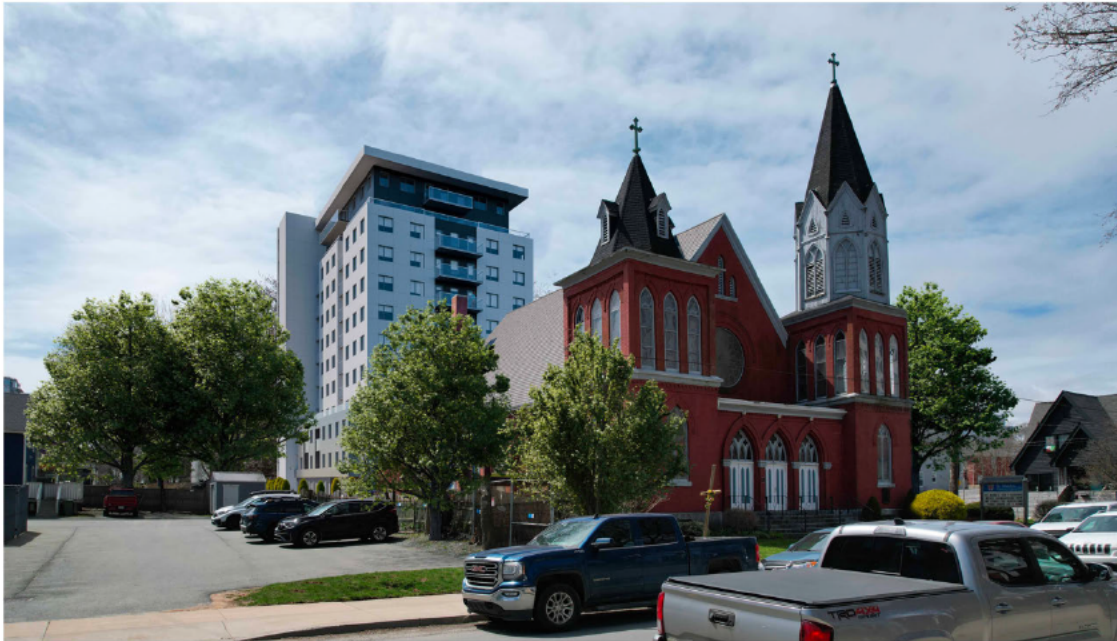
Figure 52: 3D Rendering of front and south side of church

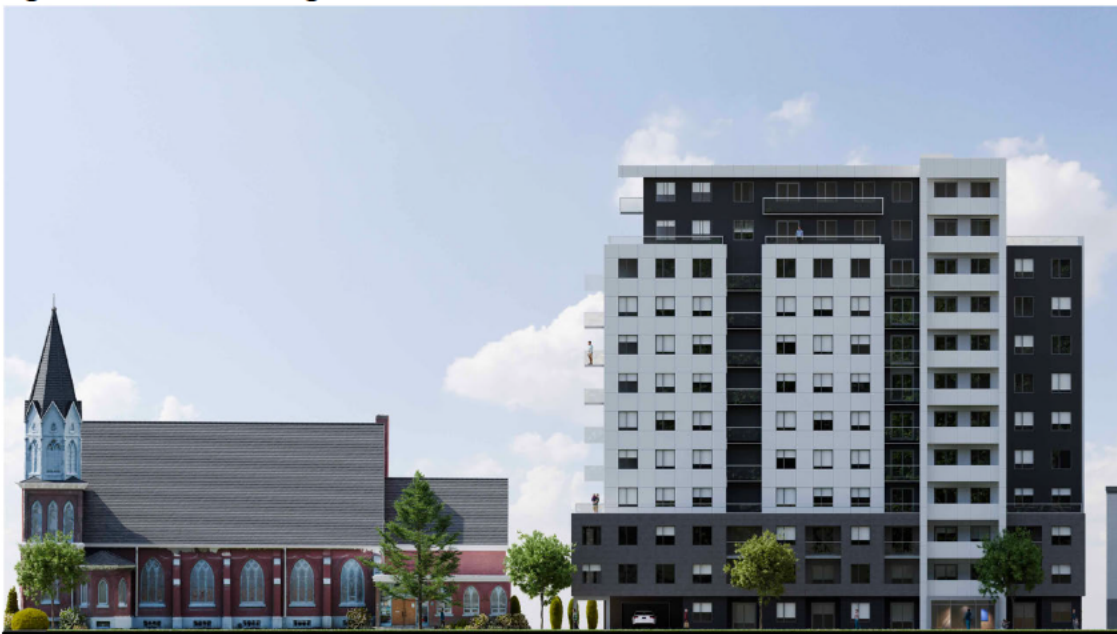
Figure 53: 3D Rendering of north side with full view of church

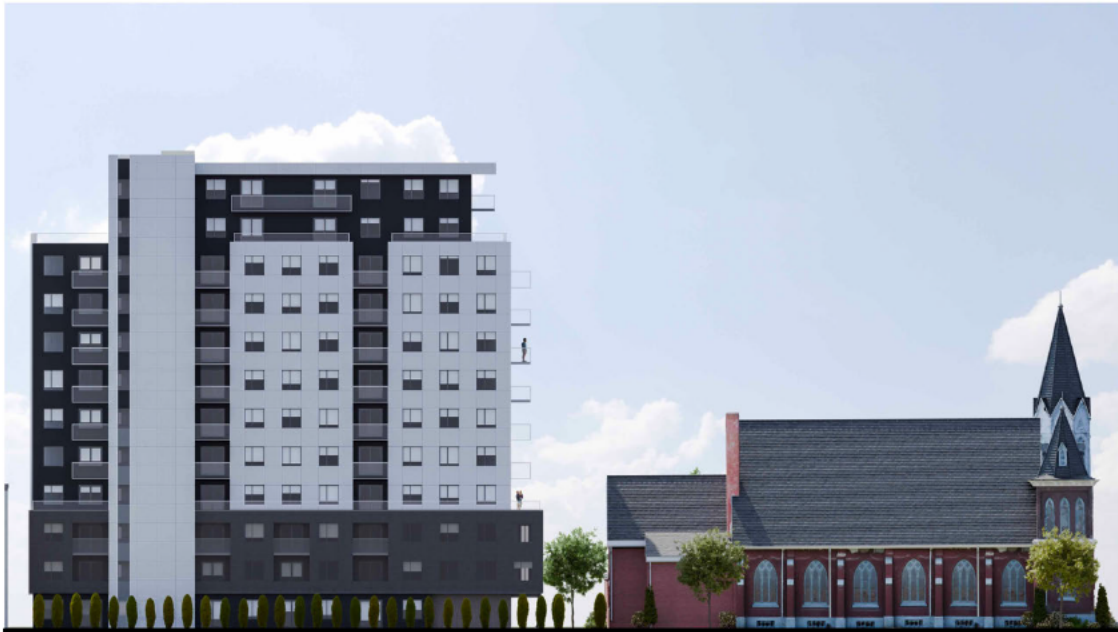
Figure 54: 3D Rendering of south side with full view of church
