SUBJECT: **Case HRTG-2023-00201: Substantial Alteration to St Mark's Church, a registered municipal heritage property at 5522 Russell Street, Halifax**

Heritage Impact Statement

St. Mark's Church, 5522 Russell Street, Halifax

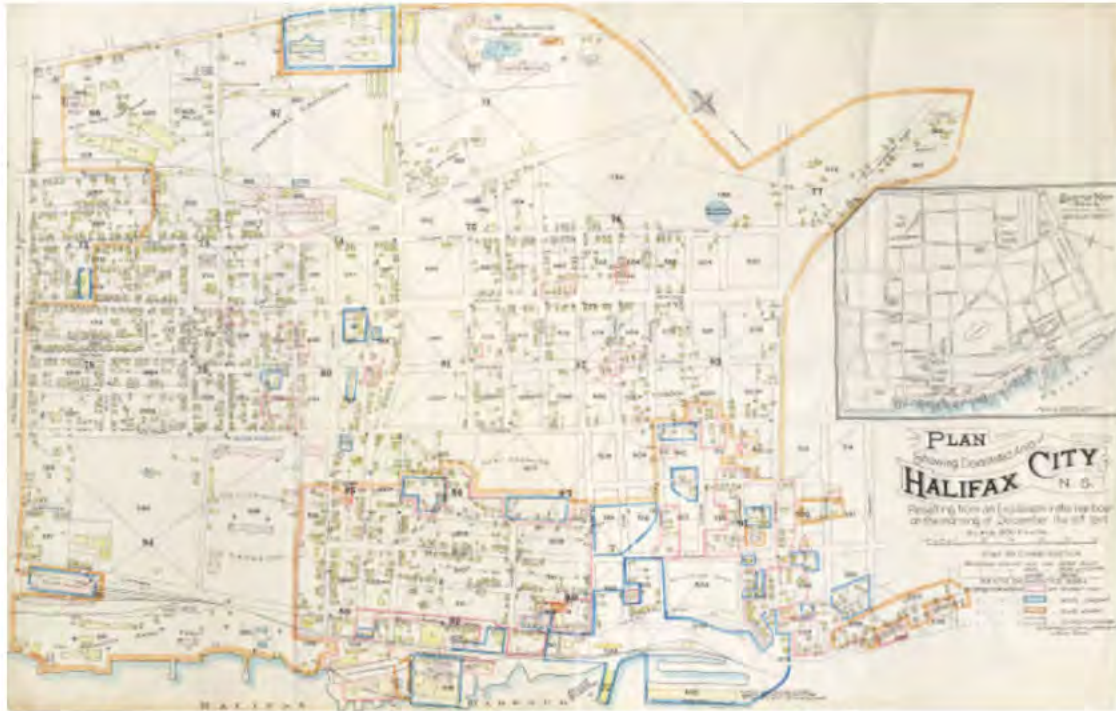
Figure 7: Plan showing devastated area of Halifax City, N.S., 1918

The extent of the destruction caused by the explosion and subsequent fires is illustrated in Figure 7.

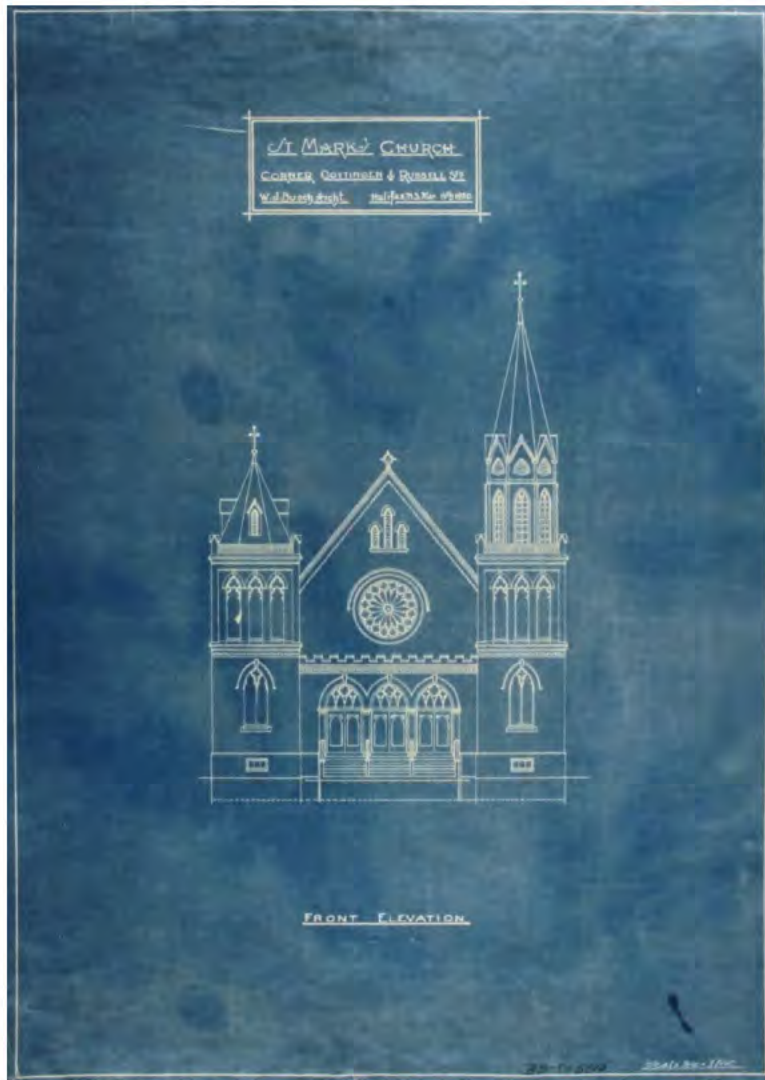
Figure 23: St. Mark's Church, Corner Gottingen and Russell [Streets], front elevation, March 15, 1920. Architect/draftsman W.J. Busch. Source: Nova Scotia Archives, 1.3.5.13. original drawing BB-5-5015.

By early 1920, plans had been completed by architect W.J. Busch (Figure 23).

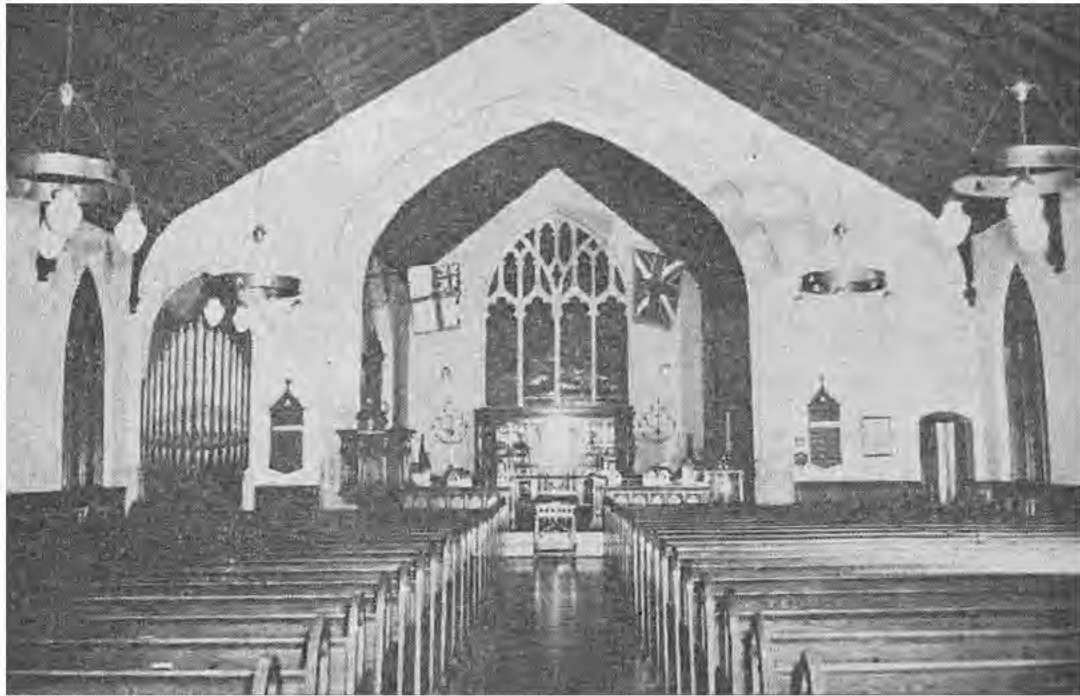
It has always been the Garrison church of both the Royal Canadian Regiment and the Royal Canadian Navy. In its early days, military parades marched from the Wellington Barracks and the dockyards to the church. This was reflected in some of the interior elements in the then-newly constructed church (Figure 26).

Figure 26: Interior of the new church, c. 1921

When comparing the early (c. 1921) photograph (Figure 26, page 26) to the current photographs, the only notable alterations on the interior are at the entry to the apse where a crucifix and horizontal crossbeam has been installed, and the removal of the original light fixtures that hung from the ceiling, and two television monitors (Figures 34 and 35). While the loss of light fixtures is unfortunate, the crucifix addition has enhanced the overall character as expressed through its interior.

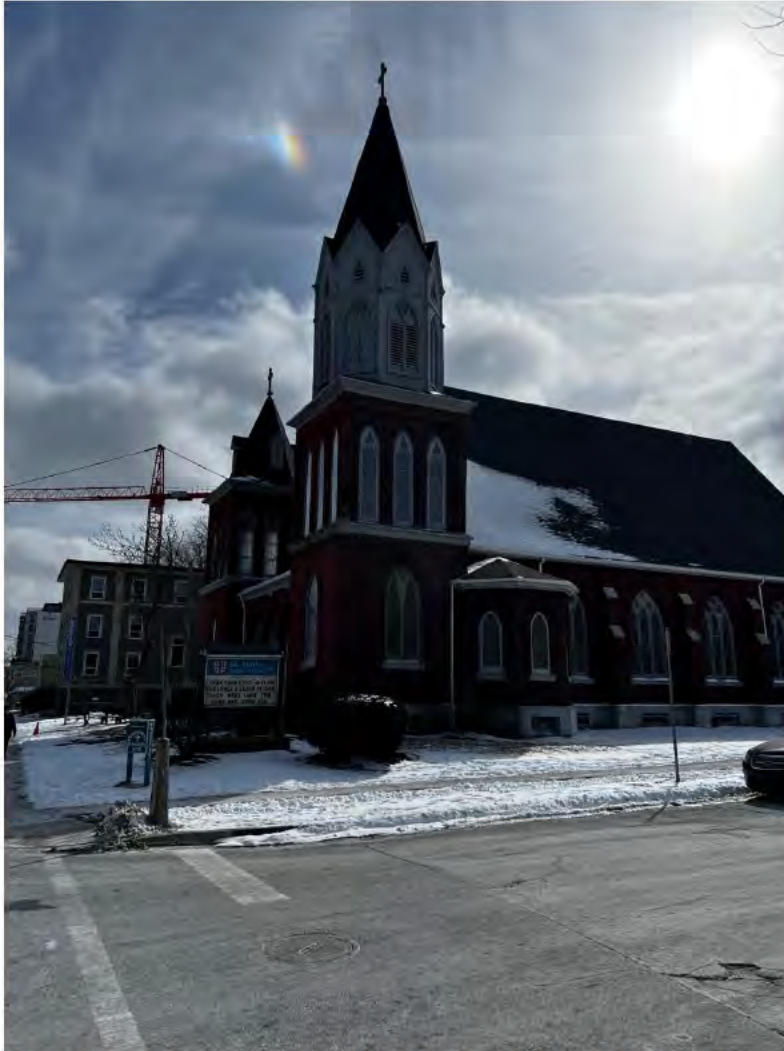
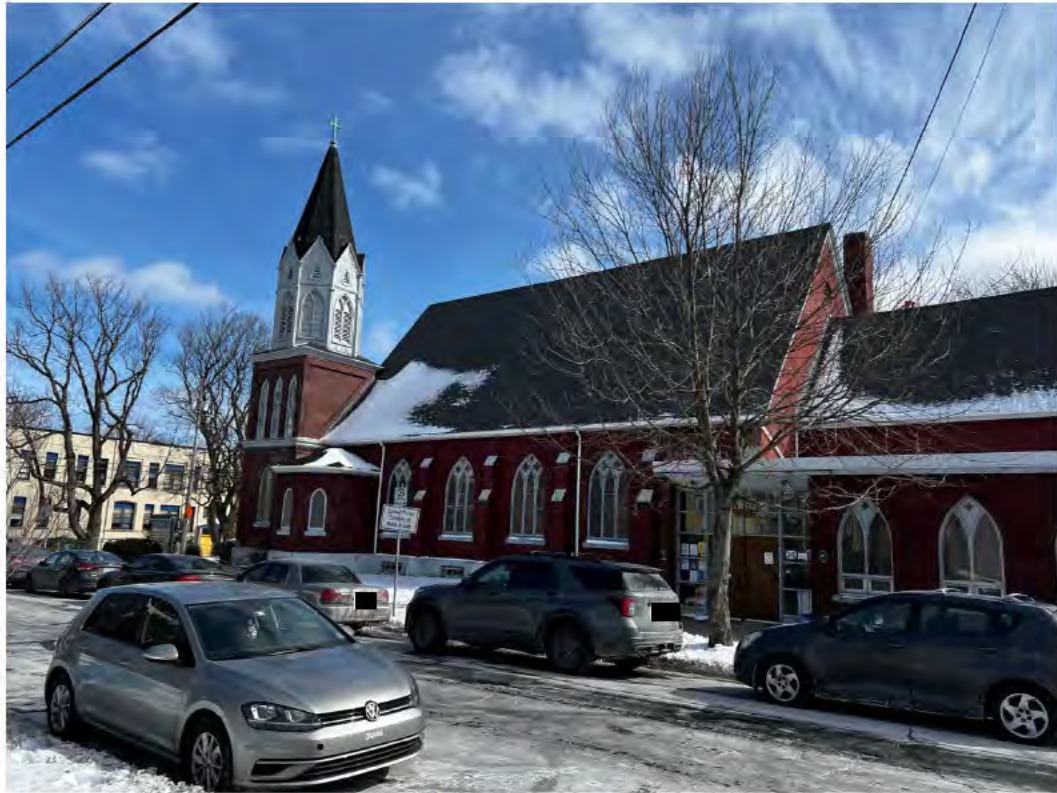
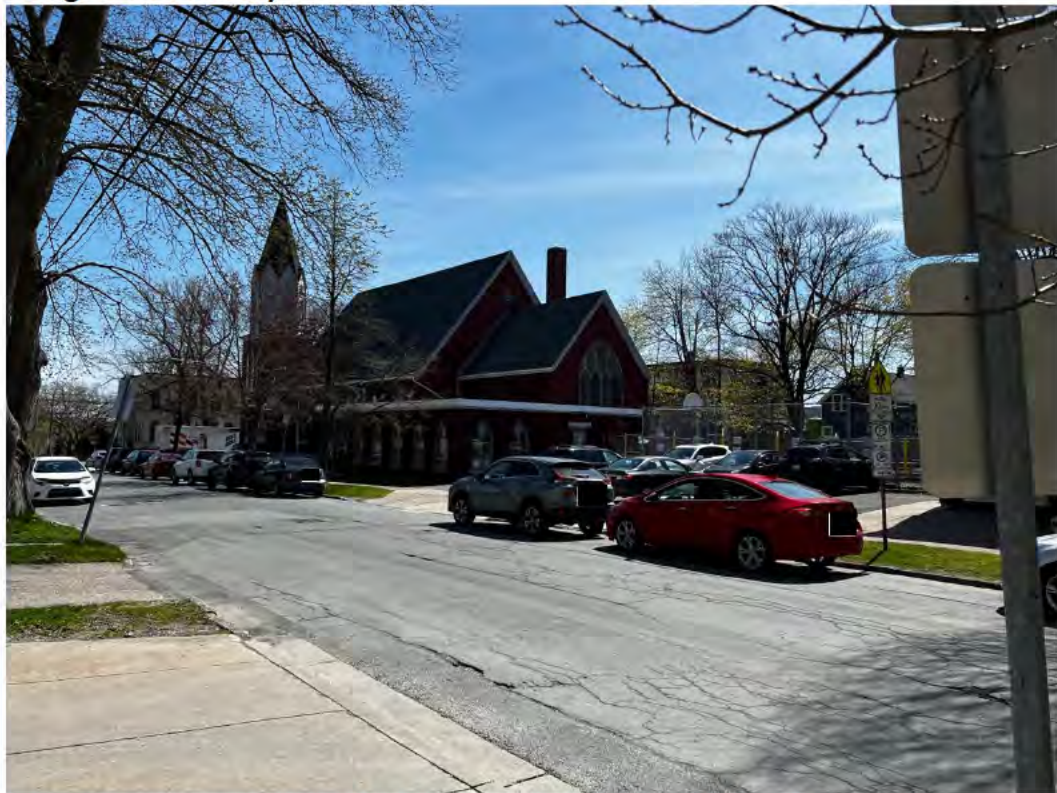
St. Mark's Church is an excellent example of places of worship, specifically churches, built in the inter-war era, in the Gothic Revival style that was commonly used for churches at that time. It is set on a prominent corner location, highly visible from both Gottingen and Russel Streets, with a prominent square tower topped by an octagonal extension, a large rosary window, a secondary tower, between which is set the main entry (Figure 29).

Figure 29a: Context of St. Mark's Church, 5522 Russell Street (seen from corner looking south along Gottingen Street)

Figure 29b: Context of St. Mark's Church, 5522 Russell Street (seen from side, along Russell Street)

Figure 29c: Context of St. Mark's Church, 5522 Russell Street (seen from rear, looking east along Russell Street)

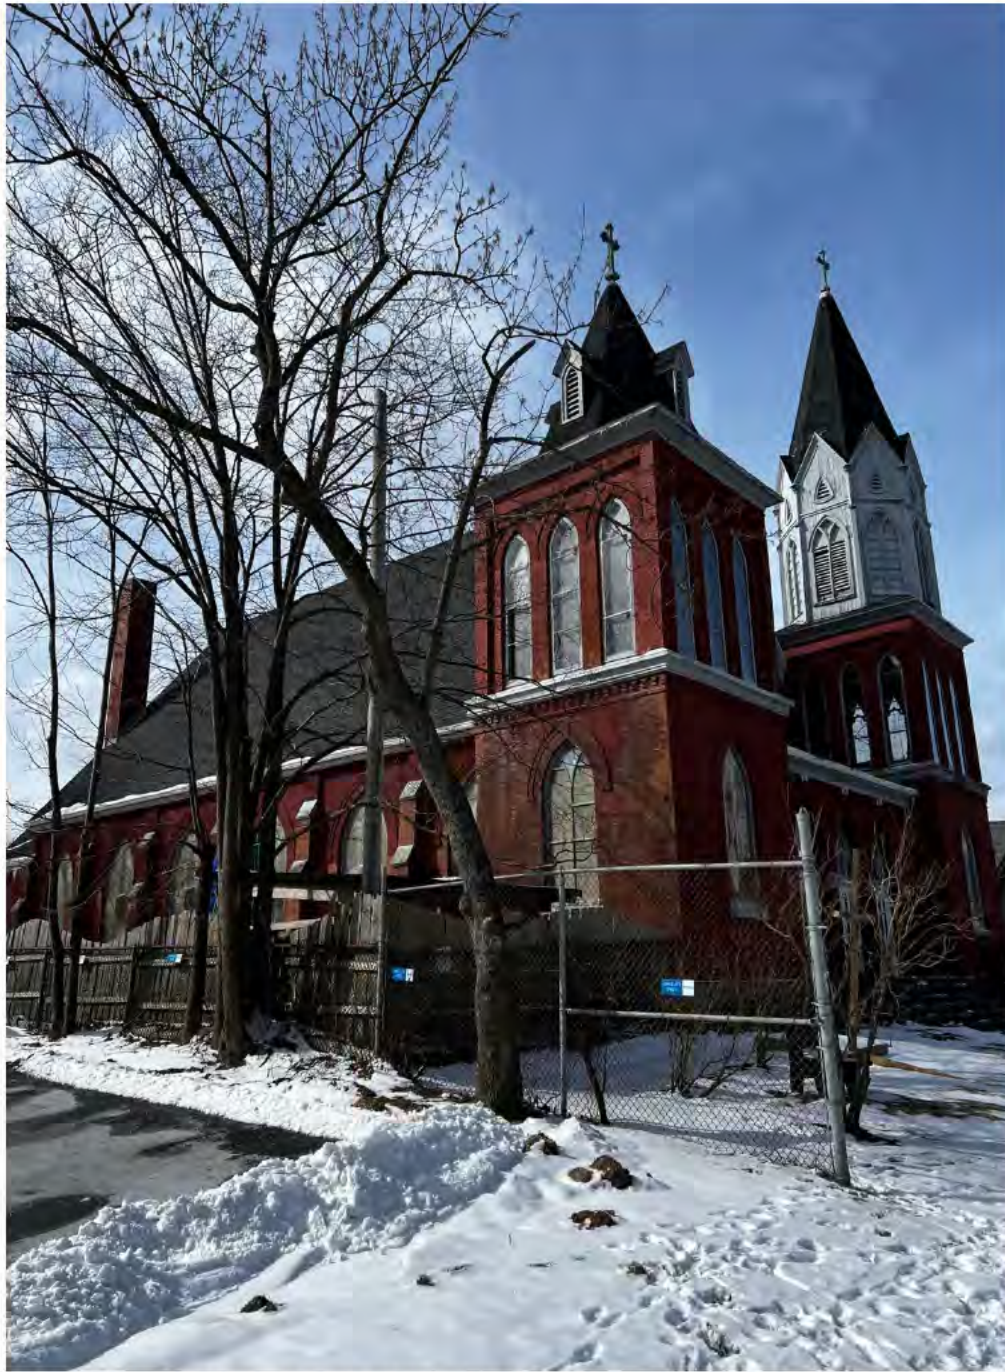
Each of the towers has the pointed arch windows set in singles and pairs, in typical Gothic form. Along the sides of the building, behind the towers, the windows are similarly set in singles (in the protruding alcove on the north side) and tripartite. Where the windows are set in pairs or tripartite, there is a traditional lancet, mullion divider and plate tracery (Figures 30b to 31d).

Figure 30b: Front and south side of 5522 Russell Street

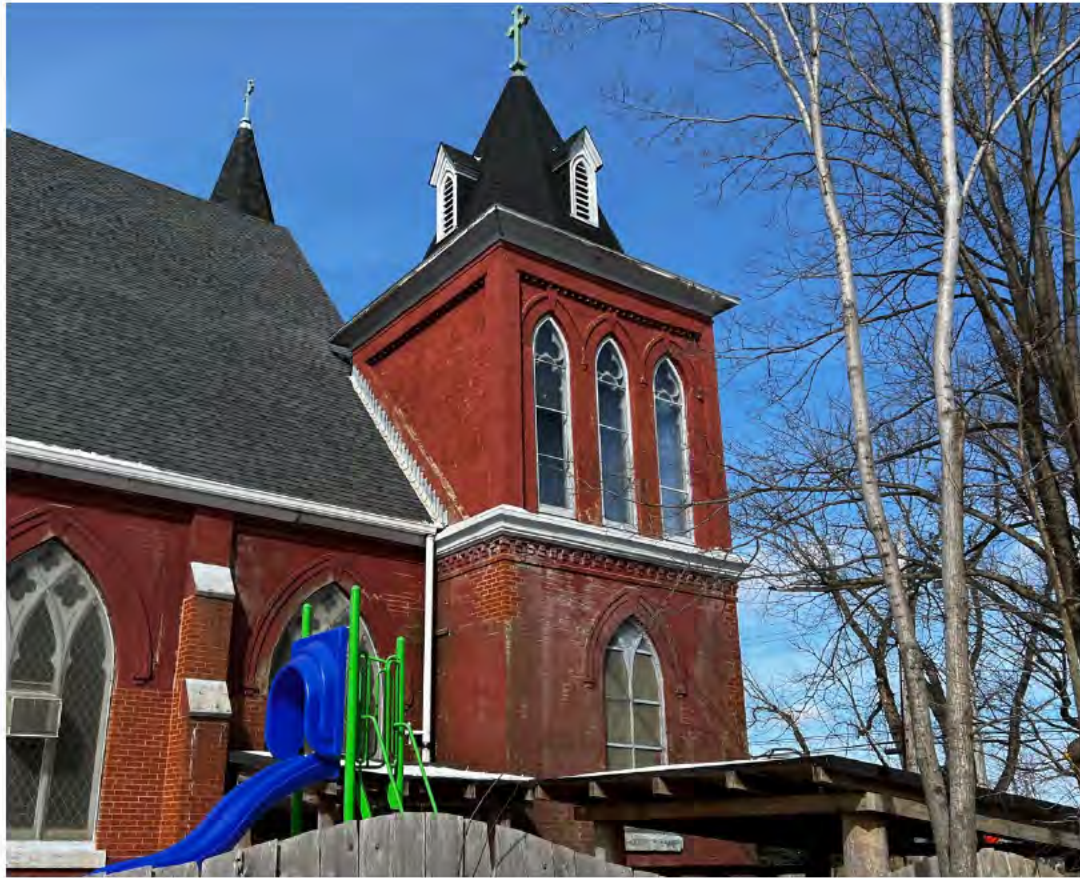
Figure 30c: South side tower

North and South Towers: Generally poor condition. The brick in both the south and north towers has extensive efflorescence with some spalling and likely aggravated by freeze-thaw weathering. Furthermore, the brick has been painted at some point in the past and this has likely exacerbated the efflorescence and spalling, if it has not been able to “breathe.” This is especially notable on the north wall of the north tower. This is also apparent on the south tower, but to a lesser degree.

More extensive repair work consisting of brick replacement and re-pointing has also been done on the south tower.

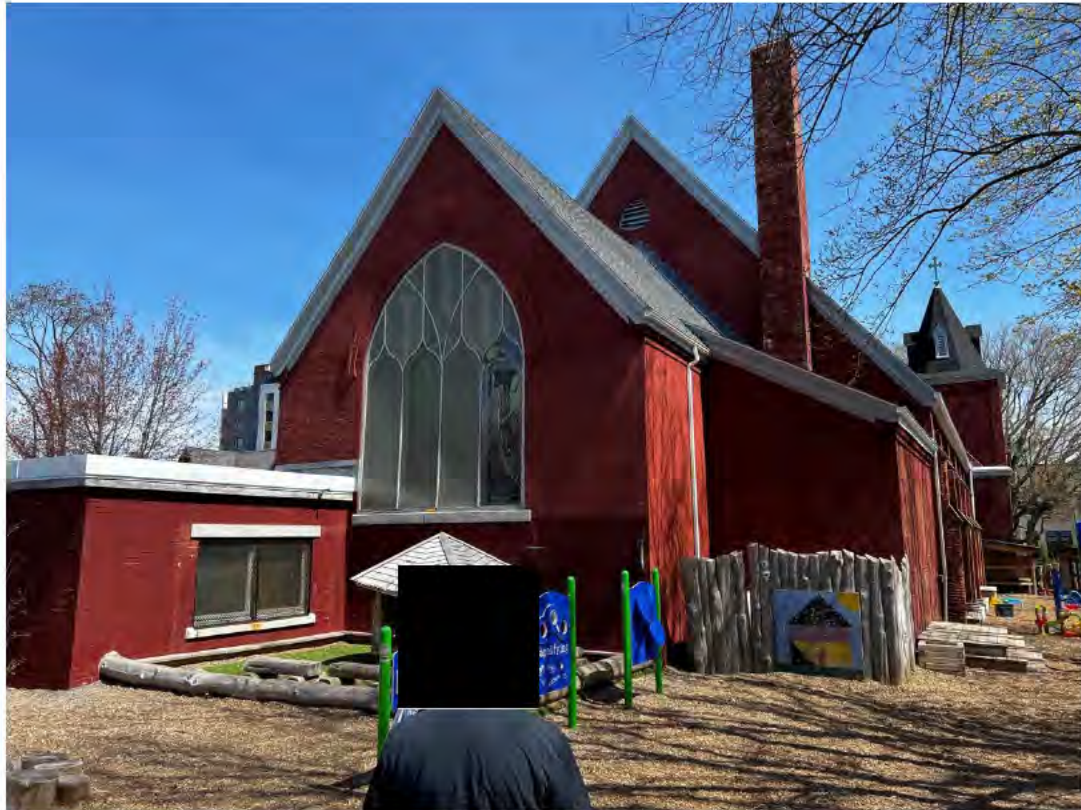
The north side includes a one-storey addition made in 1960, that expresses the evolution of the church over time. The rear has also been affected by this alteration, as it covers not only the north side but also a limited section of the rear (Figure 30d).

Figure 30d: Rear, 5522 Russell Street

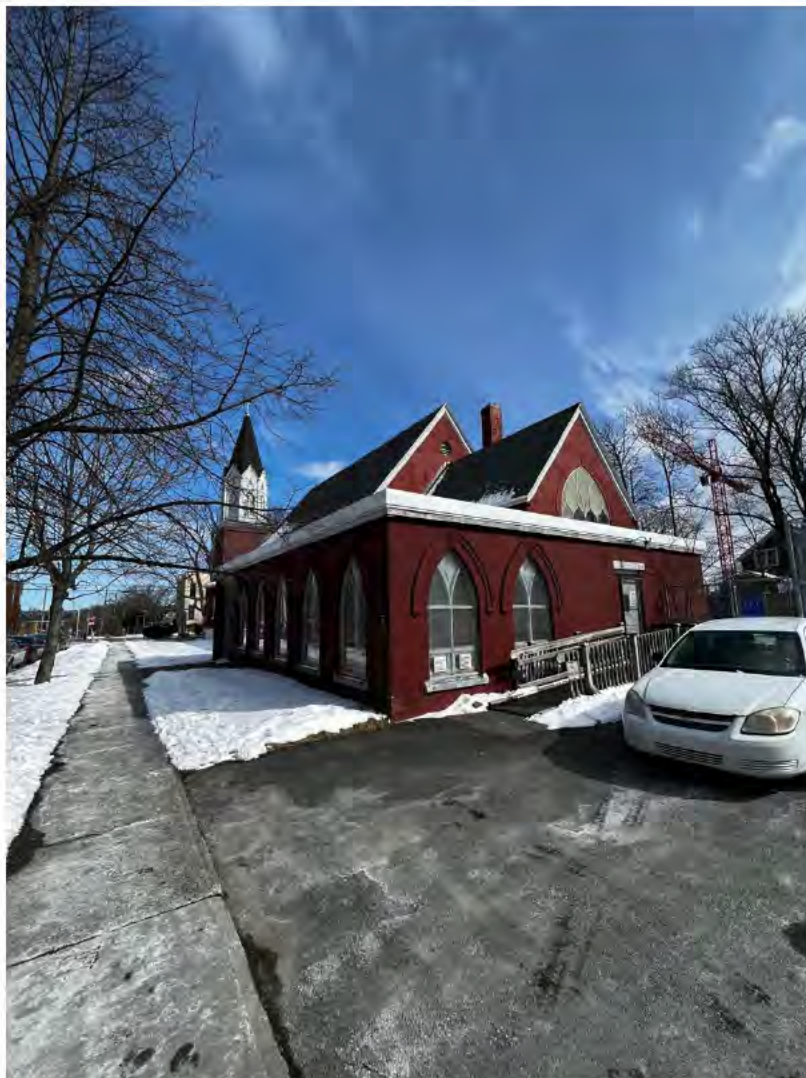
Overall, the integrity of St. Mark's Church is excellent. The only notable alteration is the single storey addition of a church office that protrudes from the main body of the church along the rear section of the north side and wraps partly around the rear (Figure 31a to 31c).

Figure 31a: Single-storey addition on the north side of 5522 Russell Street, as seen from Russell Street

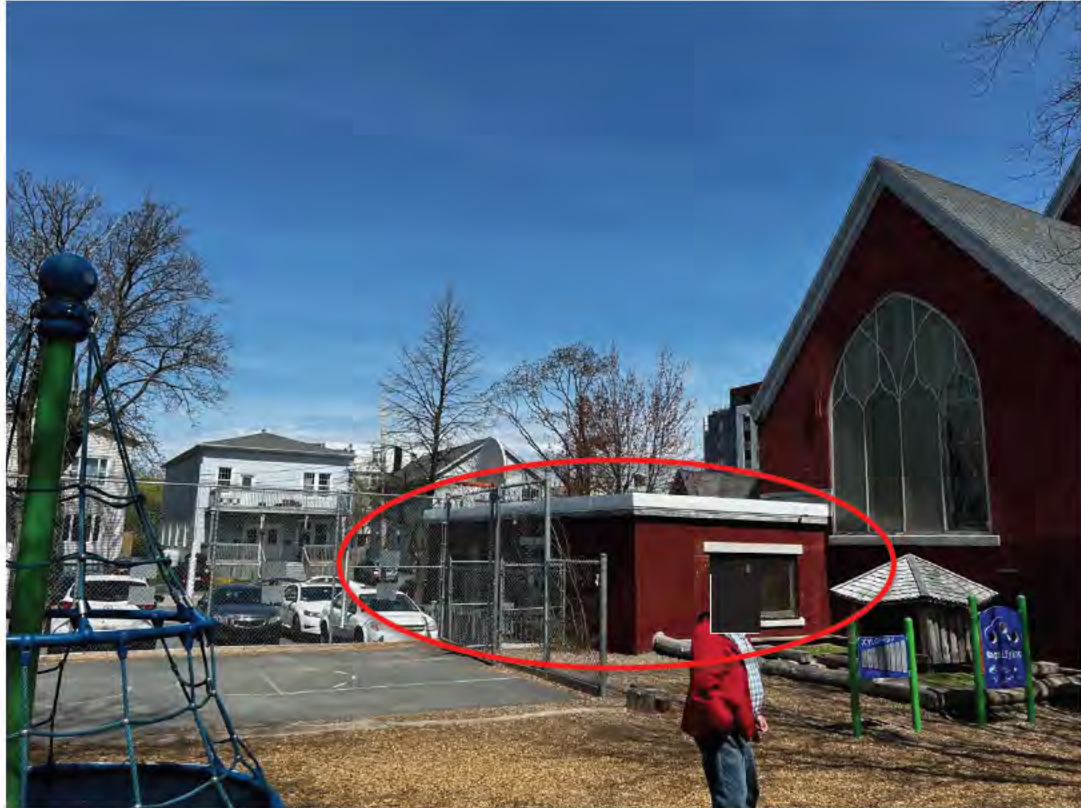
This addition was made in 1960, with plans drawn up by Webber, Harrington and Weld. While it is compatible, with the use of similar colour brick and window openings that follow the other arched-peak form on the early part of the church, it is distinguishable with its flat roof and simple fenestration. This enclosure obscures an original side entry but it does not appear to affect any windows, and it notably does not interfere with the large apse window set at the rear (Figure 31b).

Figure 31b: Single-storey addition on the north side of 5522 Russell Street, seen from the rear and ending at the edge of the apse windows (circled)

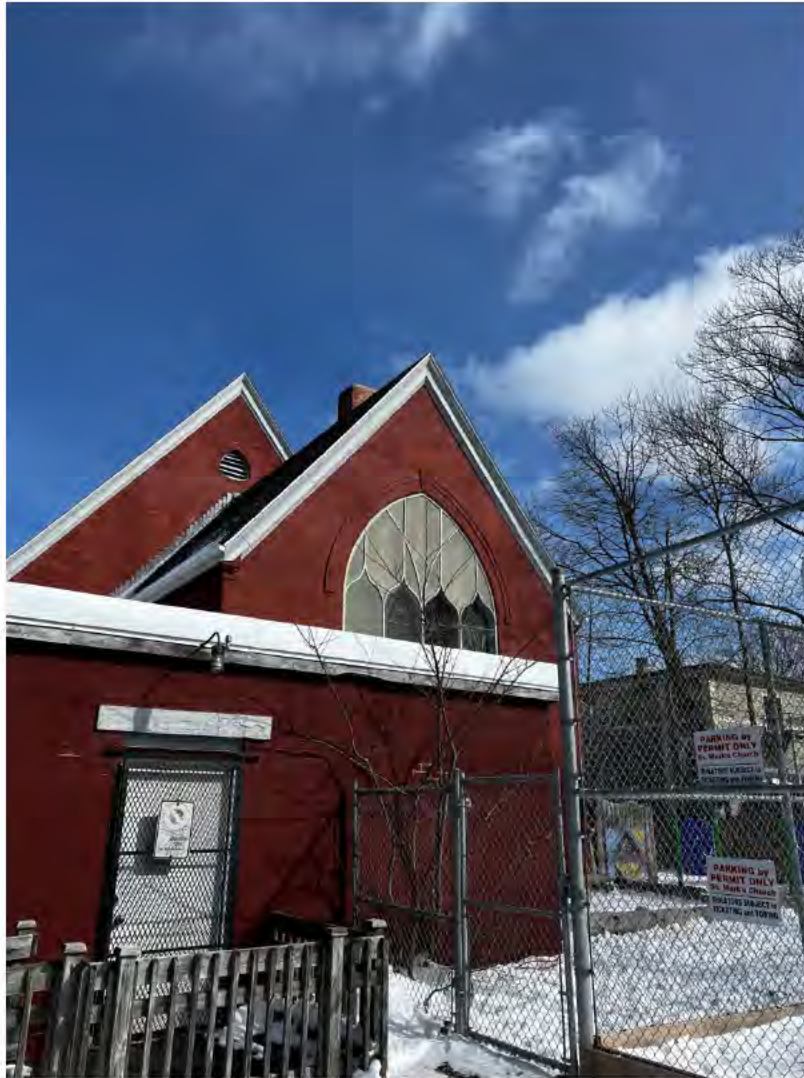
Figure 31c: Single-storey addition wrapping around the west side of 5522 Russell Street, with a single emergency exit door

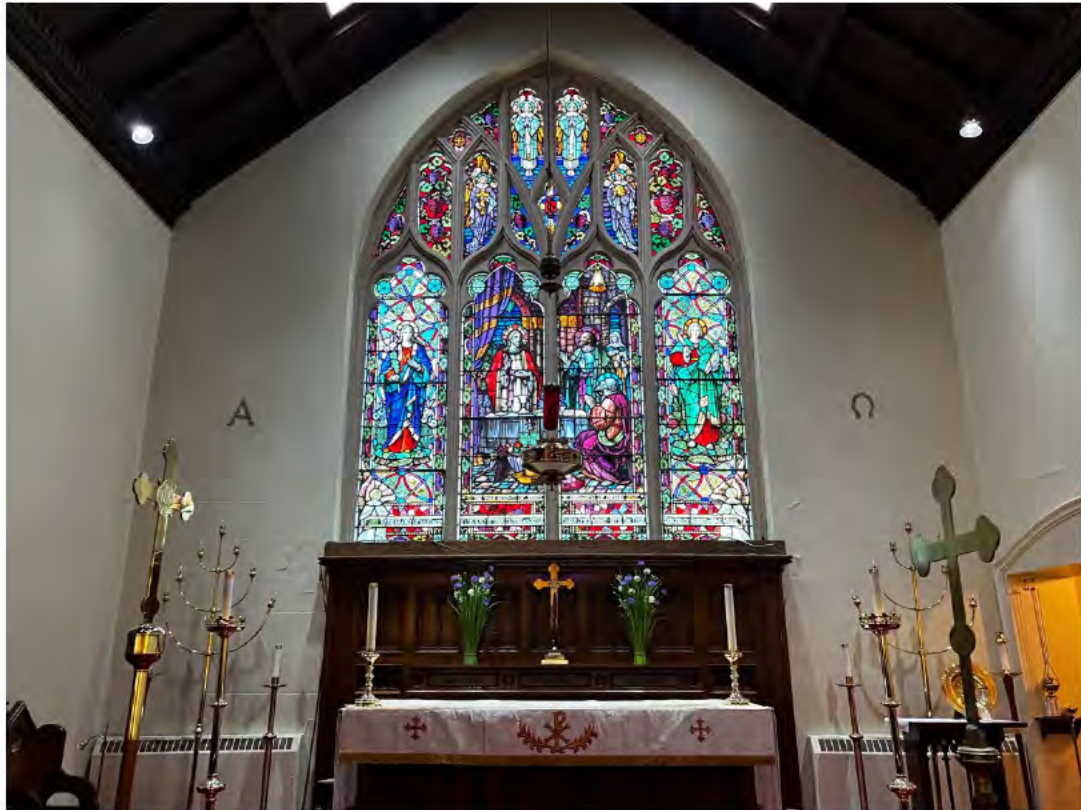
It does appear that an alcove or a small room set immediately adjacent the apse, on the north side, was enclosed (Figures 32 and 33). The opening in that north wall appears to be original and as such the 1960 addition of the offices and other rooms has changed the interior layout but not the configuration of the apse itself.

Figure 32: Apse with side room access on far right

Figure 33: Opening from the apse into a side room

The wall face on the right side of the apse does not appear to have been altered to create a new opening, suggesting that there was already a side room that may have provided for access or for other tasks as part of regular church services. Further investigation as to how this opening will be affected by the partial removal of the 1960 addition, and how it is to be addressed as part of the exterior rehabilitation.

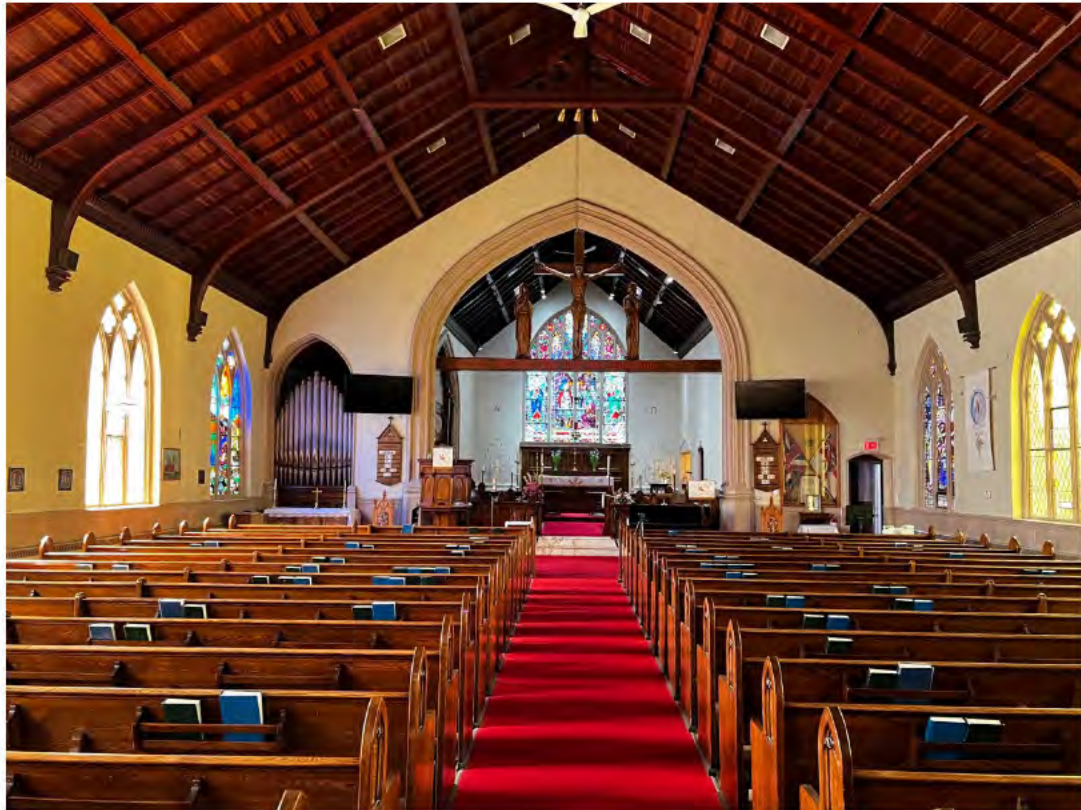
Figure 34: Interior as seen from rear

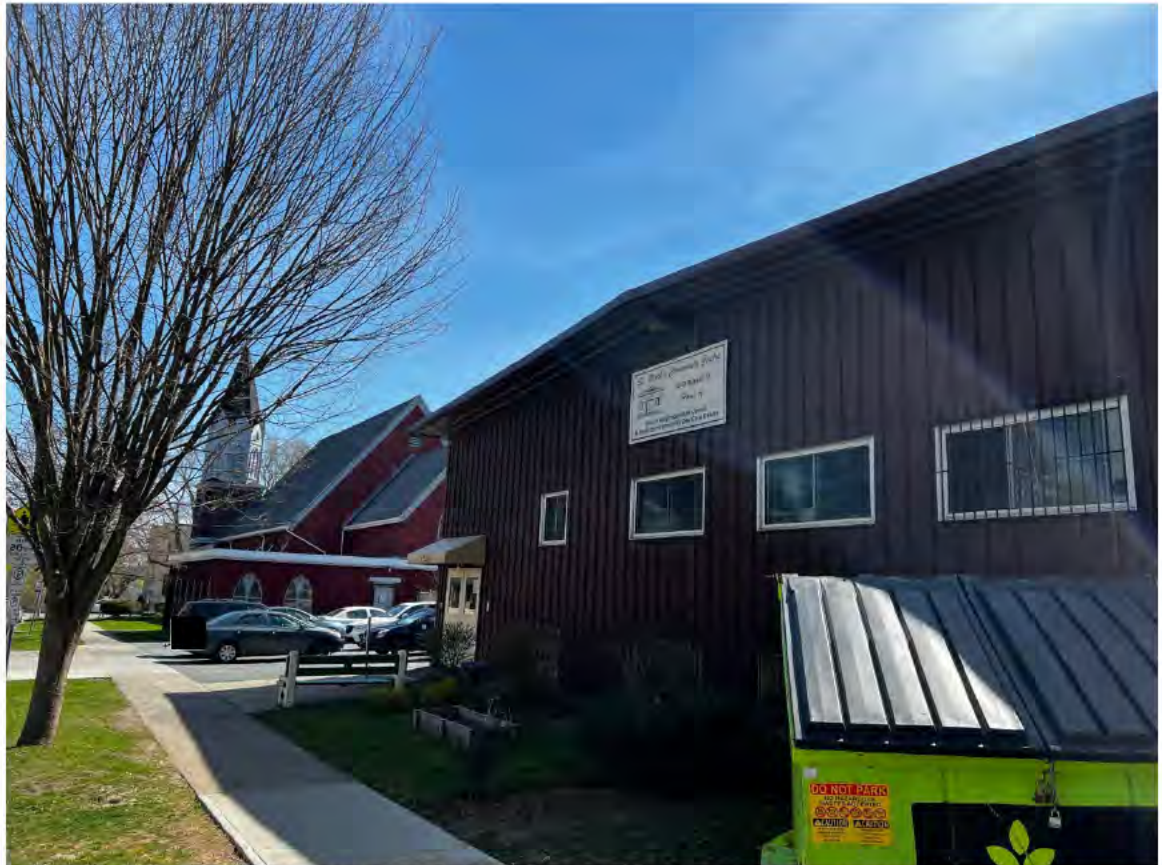
5540 Russell Street is a one-storey plus basement low-pitched wood frame and metal-clad building that is plain and unadorned. It has minimal setback from the street, and no setback at the rear, with a minimal west side setback. It is only the east side yard that allows for access and notable separation from its neighbours (Figure 38).

Figure 38: Context of 5540 Russell Street, St. Mark's Church in the background

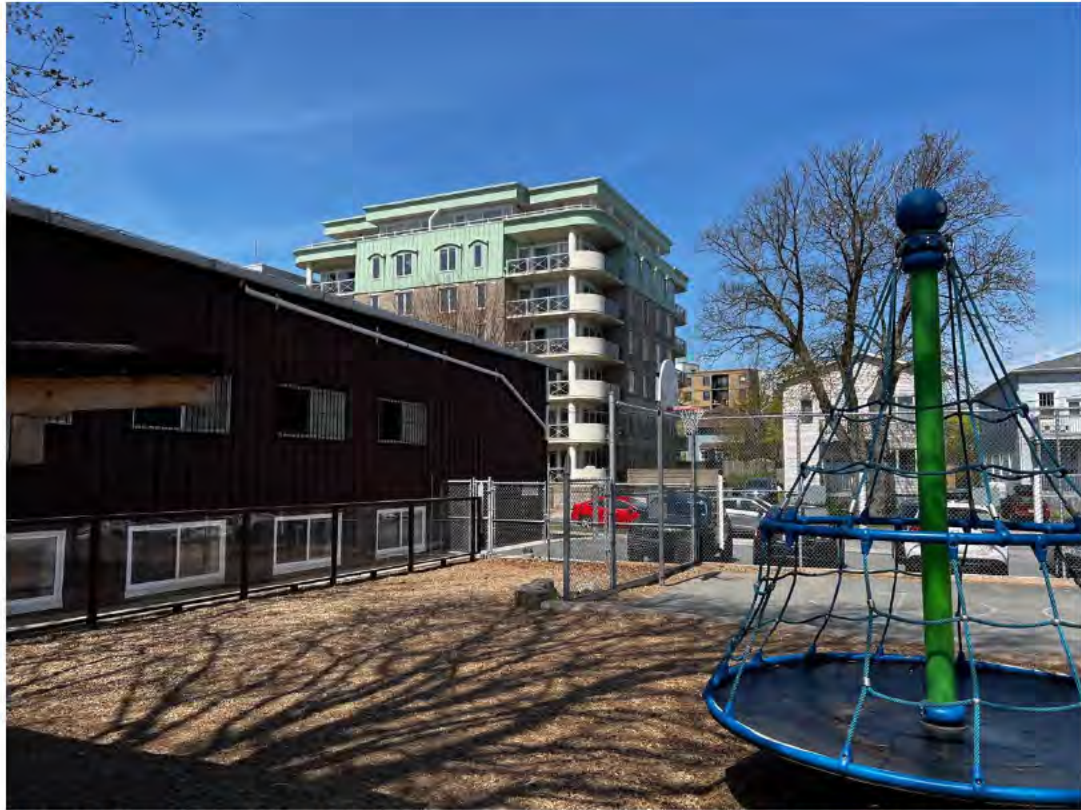
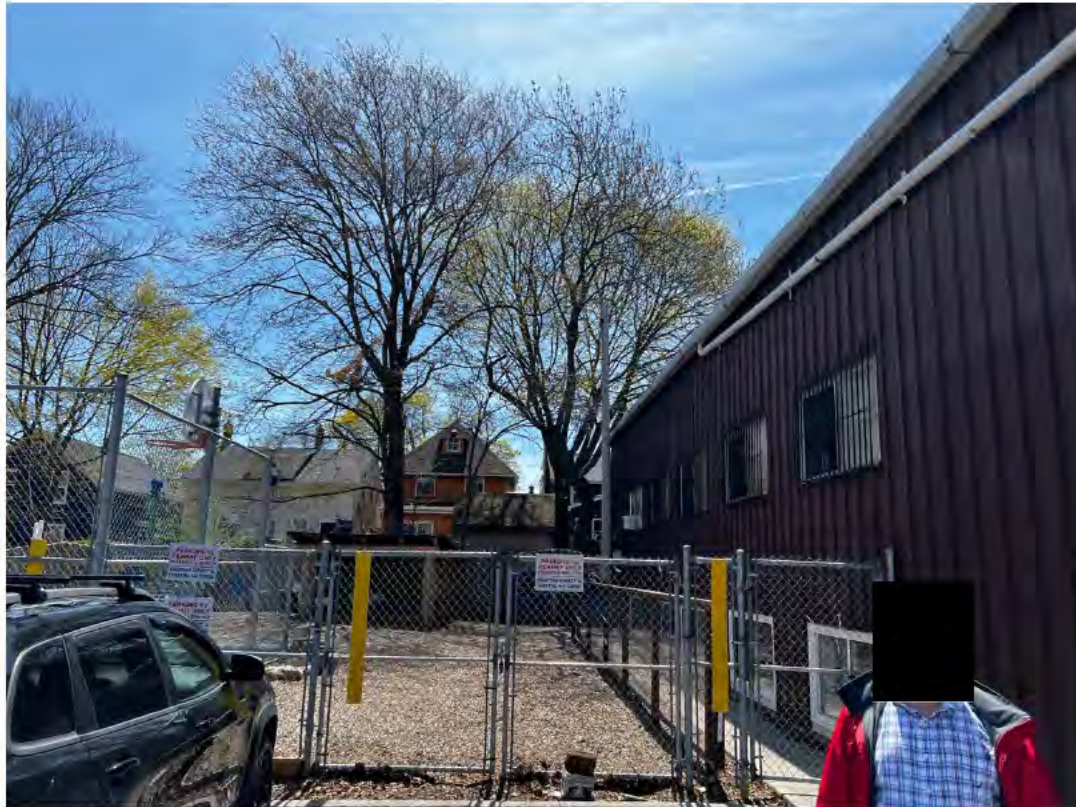
- Location mid-block between Gottingen Street and Isleville Street;
- Continuous community and church use;
- Main floor set nearly at grade;
- Front-gabled form in the Vernacular style;
- Paired modern front door with inset glazing;
- Variety of single-set narrow horizontally-oriented metal windows;
- Corrugated metal cladding.

These elements are illustrated in Figures 39a to 39c.

Figure 39a: 5540 Russell Street – east side and open space between church

Figure 39b: 5540 Russell Street – east side

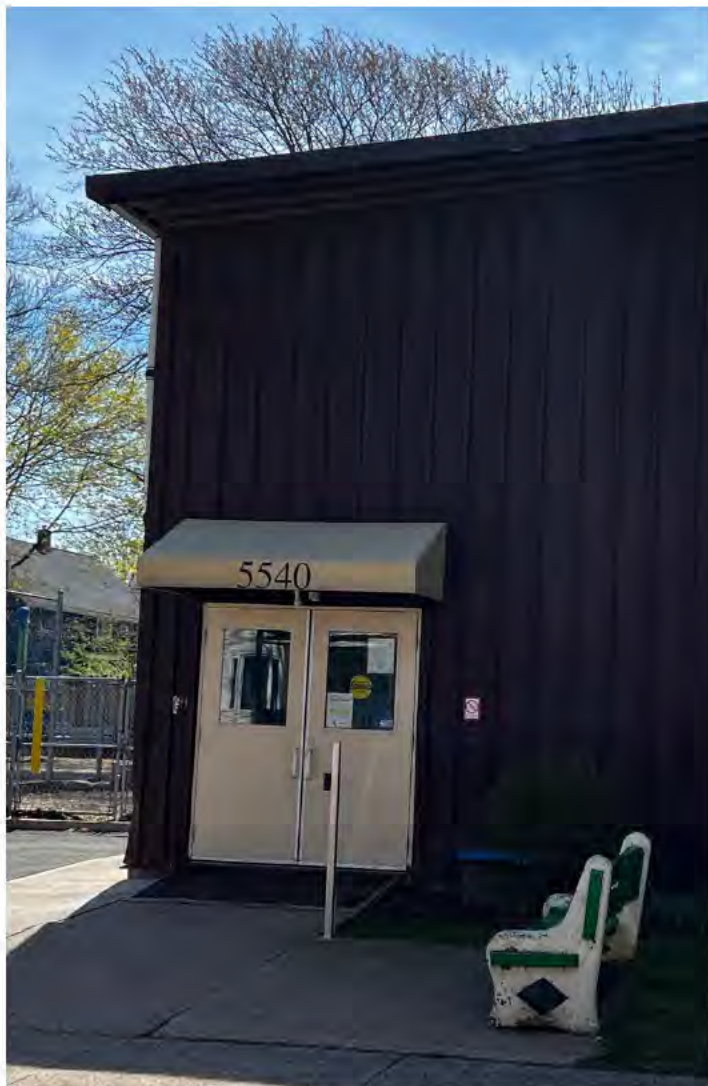
The overall form of 5540 Russell Street is intact. A relatively unadorned building, it can be classified as Vernacular style. The front, sides or rear are clad with corrugated metal, which is presumed to be an additional material – it is not known what the original cladding might have been or whether it may still exist underneath. The windows on the front, west and east sides are single-set metal sliders and are presumed to be original. Neither of these detract significantly from the style. The paired front entry doors appear to be a more recent alteration – they are nondescript metal doors with inset glazing (Figure 40).

Figure 40: Paired entry doors, 5540 Russell Street

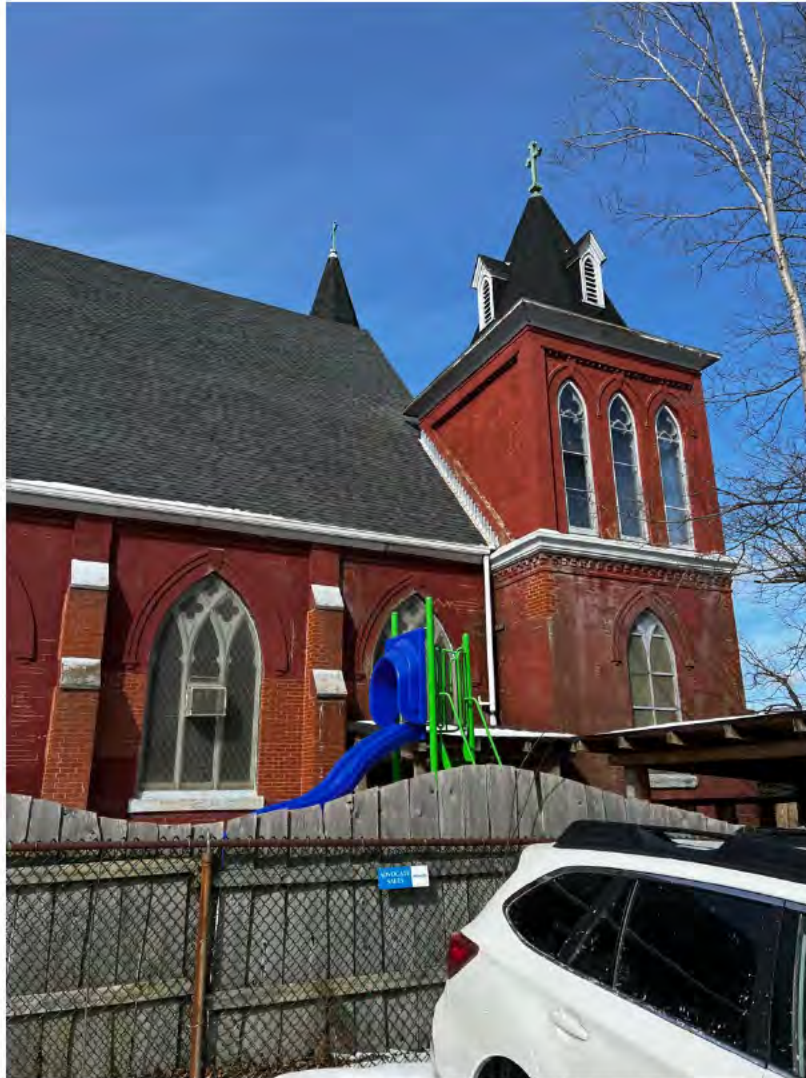
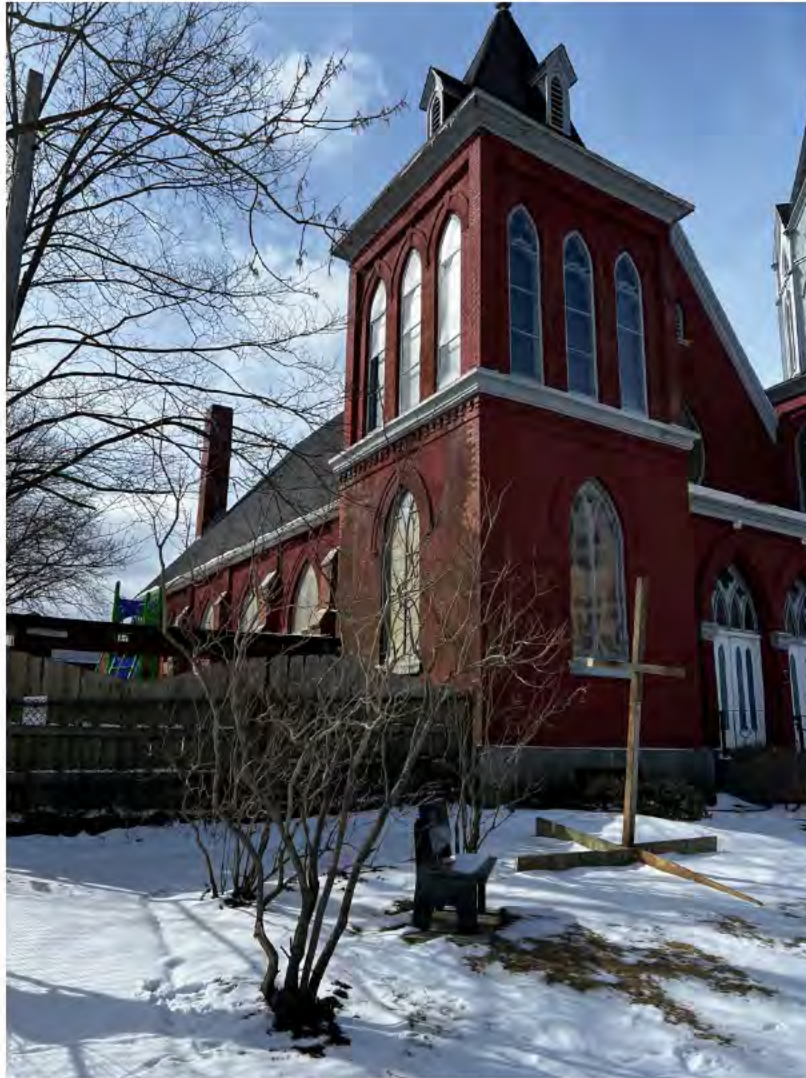
Figure 41b: St. Mark's Church, 5522 Russell Street (south side and south tower)

Figure 41c: St. Mark's Church, 5522 Russell Street (south tower)

Assess the repair work done on the south tower to determine if any further work is necessary to repair and repoint.
