SUBJECT: **Case HRTG-2023-00201: Substantial Alteration to St Mark's Church, a registered municipal heritage property at 5522 Russell Street, Halifax**

Heritage Impact Statement

St. Mark's Church, 5522 Russell Street, Halifax

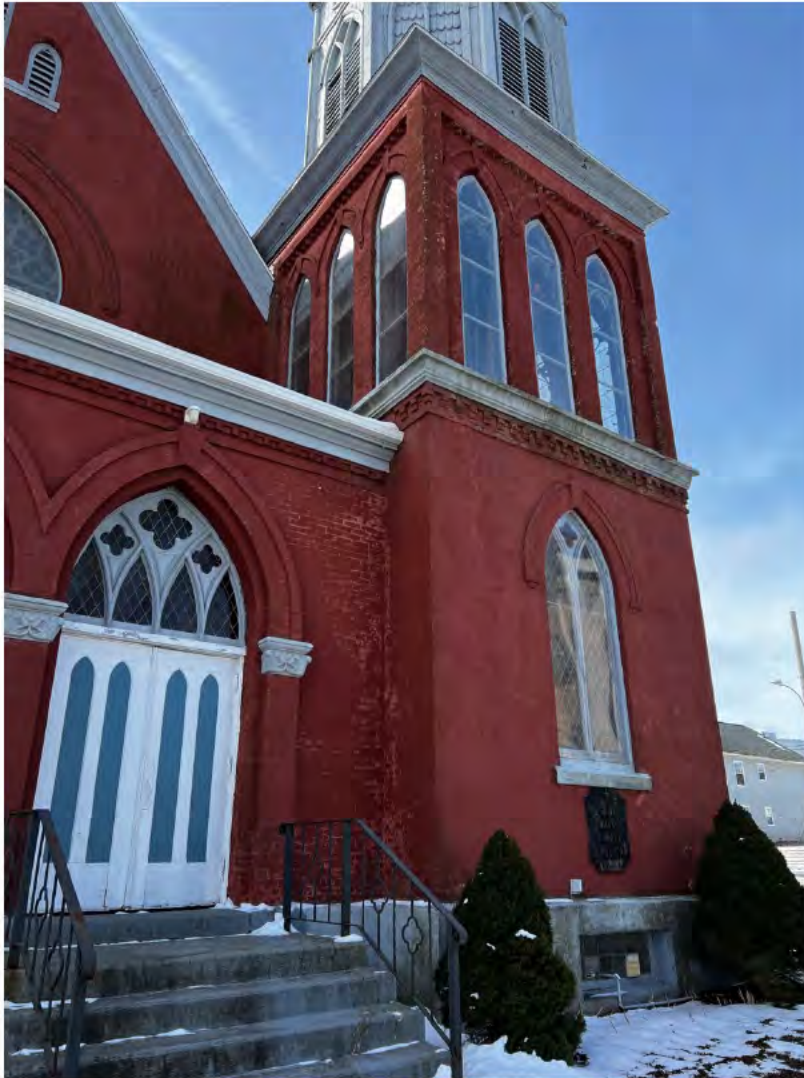
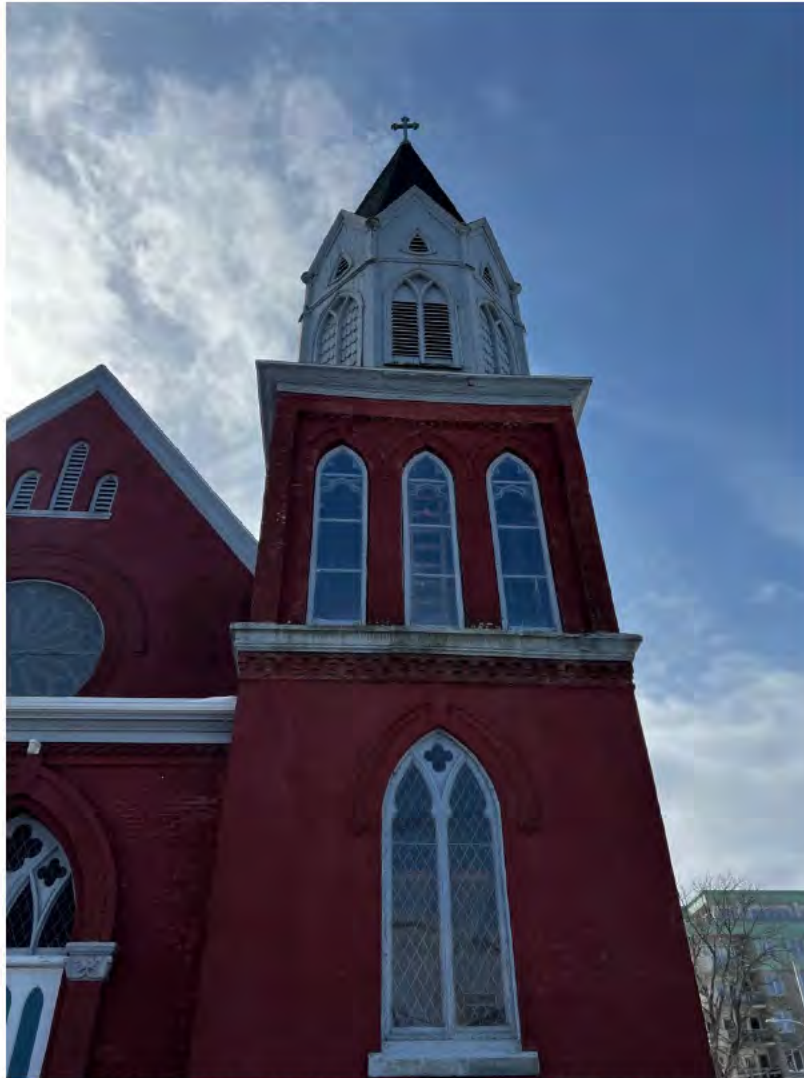
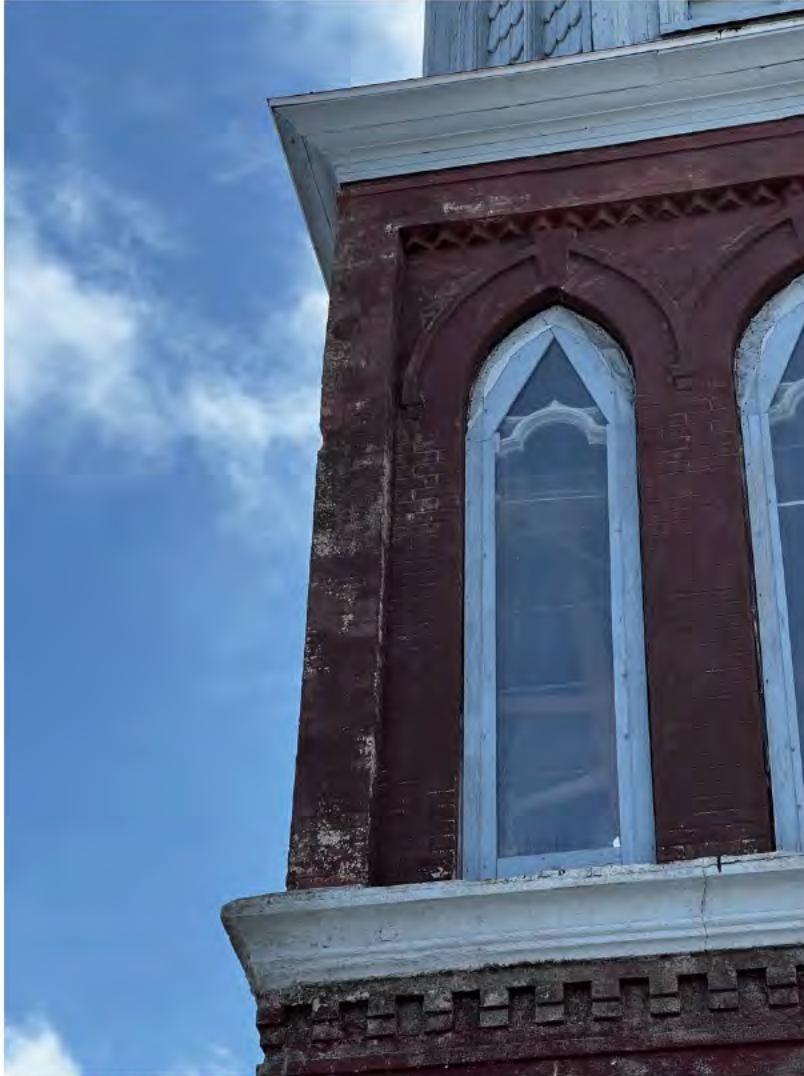
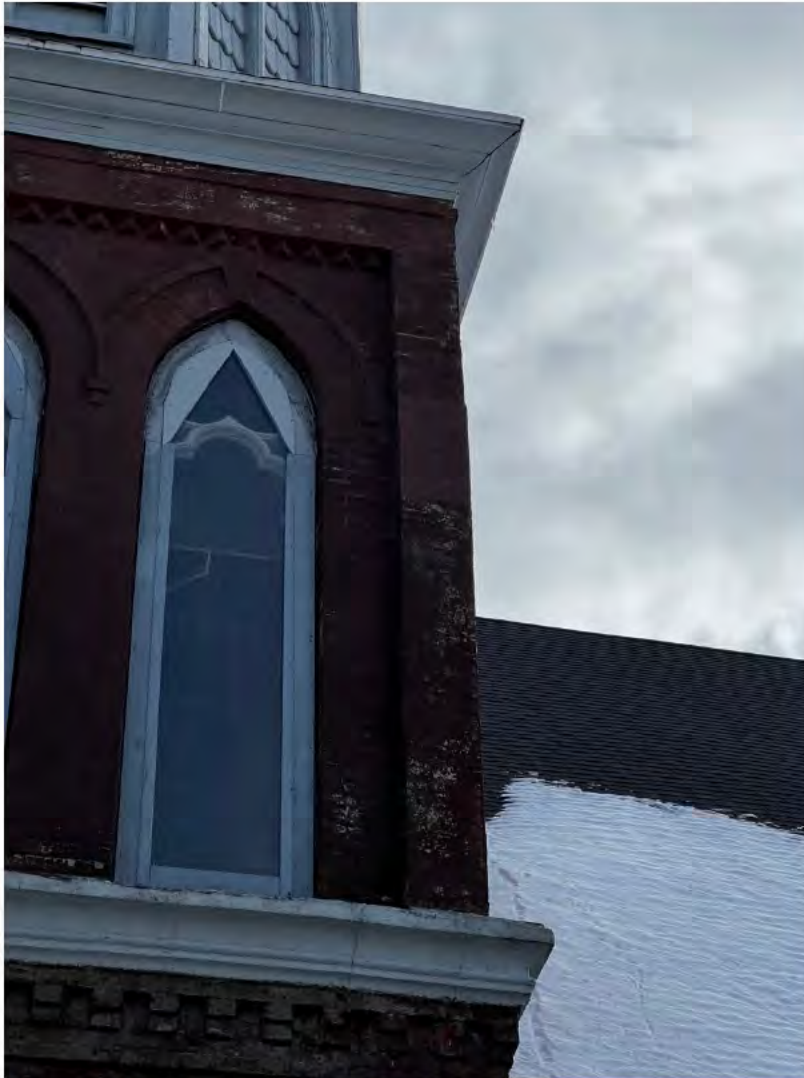
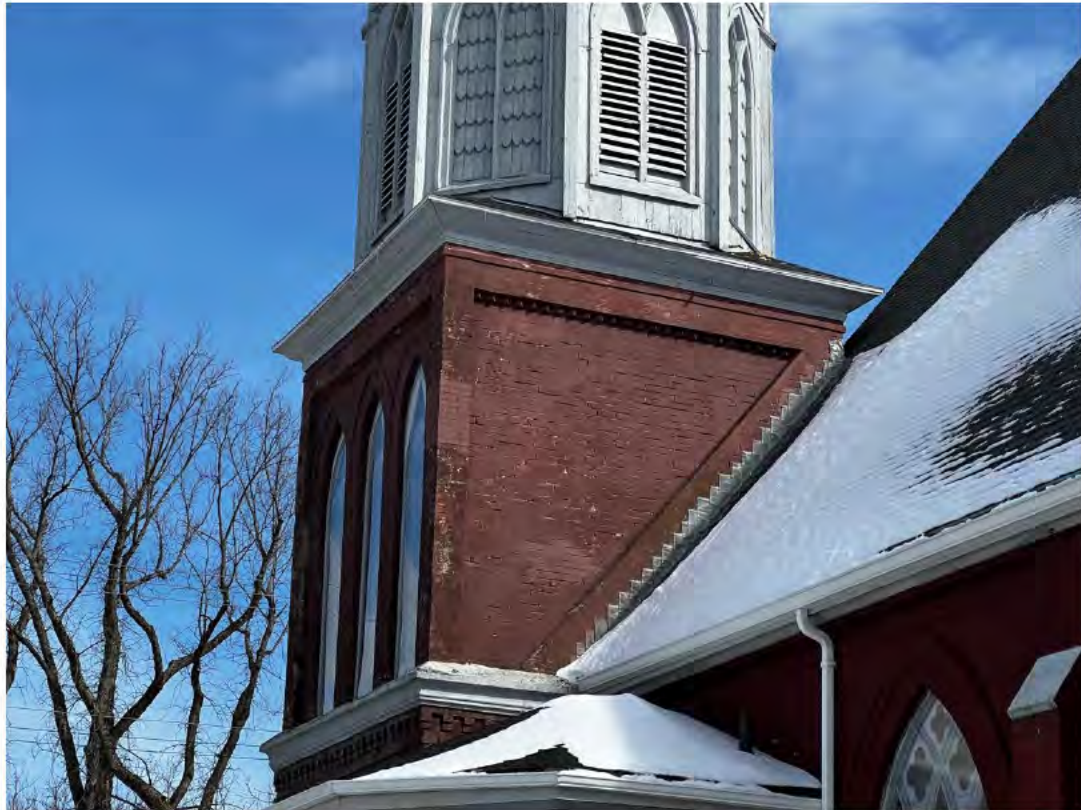
Figure 41f: St. Mark's Church, 5522 Russell Street (north tower)

Figure 41g: St. Mark's Church, 5522 Russell Street (north tower)

Figure 41h: St. Mark's Church, 5522 Russell Street (upper front corner section of north tower)

Figure 41i: St. Mark's Church, 5522 Russell Street (upper side section of north tower)

Figure 41j: St. Mark's Church, 5522 Russell Street (upper rear section of north tower)

North and South Towers: Generally poor condition. The brick in both the south and north towers has extensive efflorescence with some spalling and likely aggravated by freeze-thaw weathering. Furthermore, the brick has been painted at some point in the past and this has likely exacerbated the efflorescence and spalling, if it has not been able to “breathe.” This is especially notable on the north wall of the north tower. This is also apparent on the south tower, but to a lesser degree.

The base of the north tower has been covered with parging, likely to address water ingress at some part, either from above or on that section of wall itself. The condition of the brick underneath is not known.

Assess the parging on the north tower to determine whether it should remain in place or should be removed and replaced or remain as is.

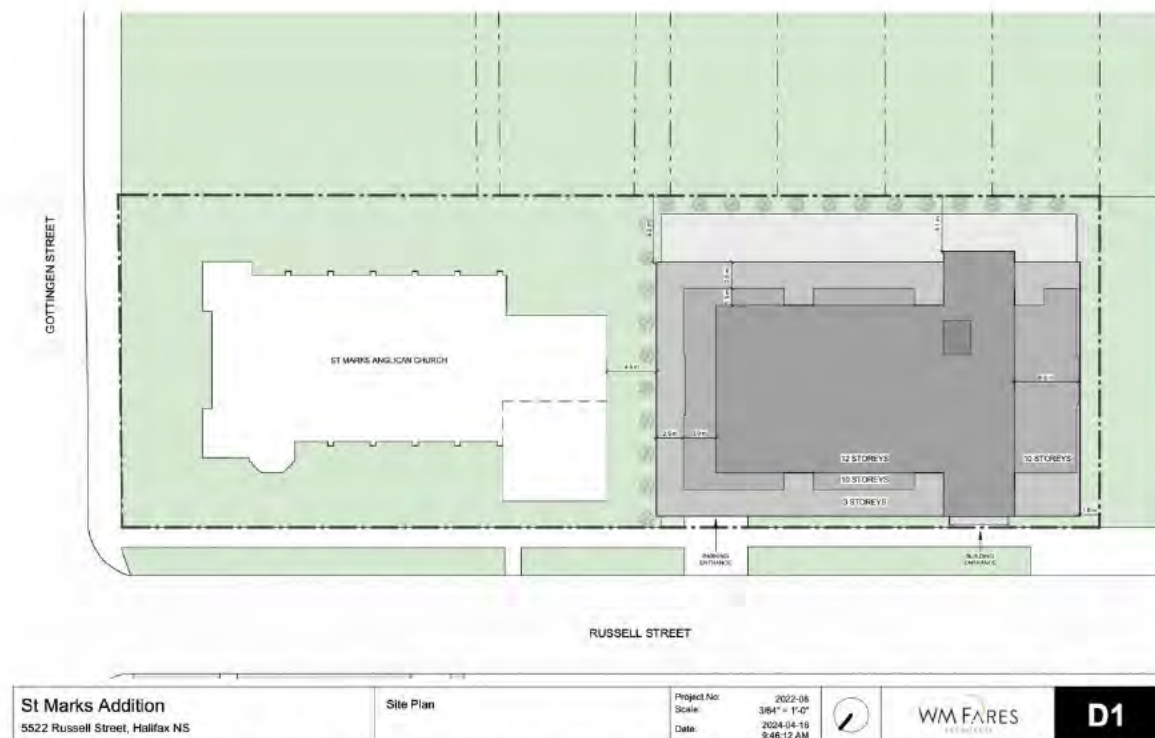
Figure 43: Revised Site Plan, April 2024, illustrating setbacks and stepped back upper floors.

Given that the new building is to be entirely detached from St. Mark's Church, and with a revised design that will set back the two of the uppermost floors – both along the front and on the side facing the church – no issues around isolation or obstruction are anticipated, and a softening of the overall massing is achieved. The new buildings will have suitable setbacks to distinguish it from the church (Figure 43).

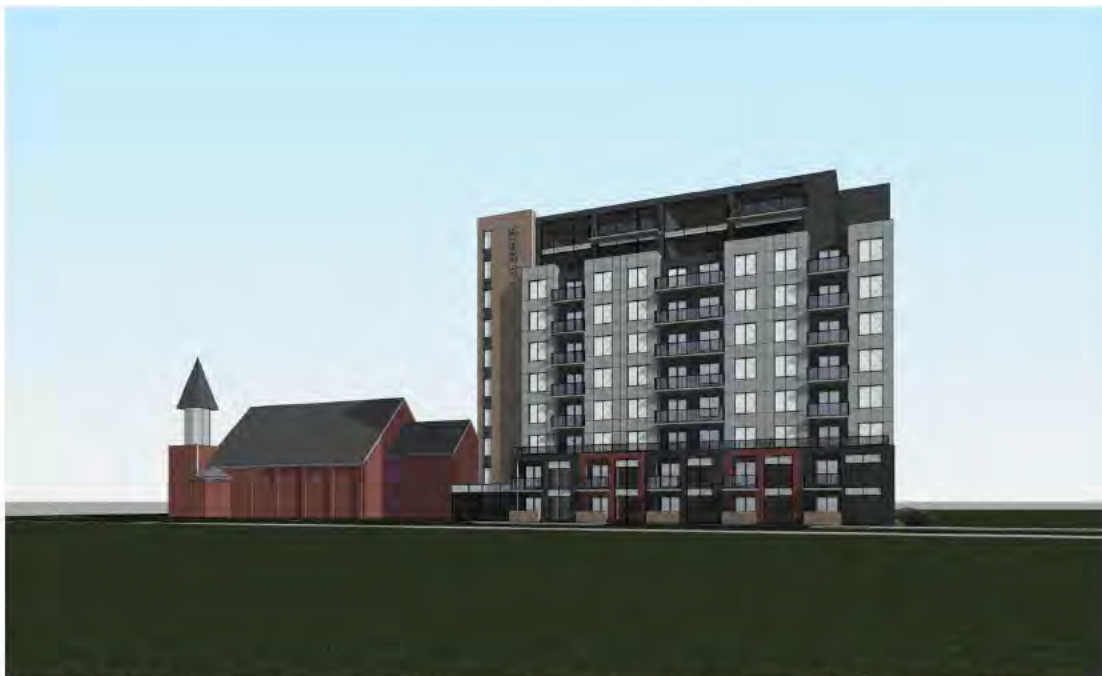
Figure 44d: Second alternative 3D rendering – detached from the church (March 2024)

Further changes were made to the design concept for the new building in March 2024, which separated the new building from the church. While this was a step in the right direction, it was wider and bulkier in massing than what is now proposed (Figure 44d).

Although two floors have been added to the proposal since then, the currently proposed massing is slenderer, and the 4th through 10th floors are set in from the podium. Further setbacks have been applied to the additional two top floors, bringing the total number of floors to 12 from the previous 10.

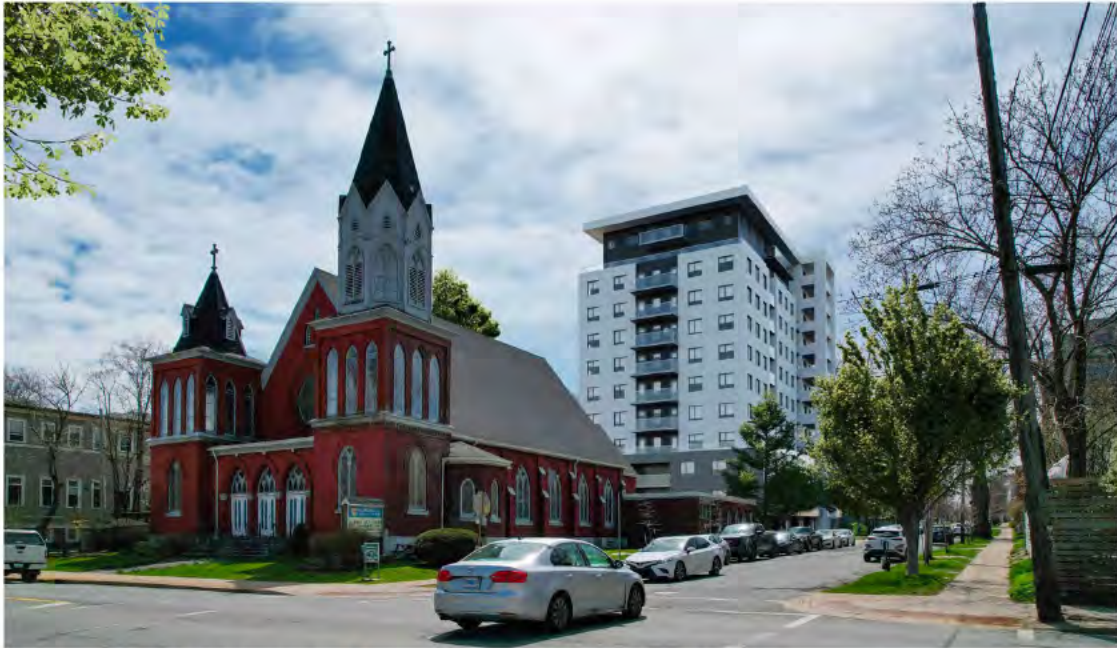
Figure 49: 3D Rendering of front and north side of church

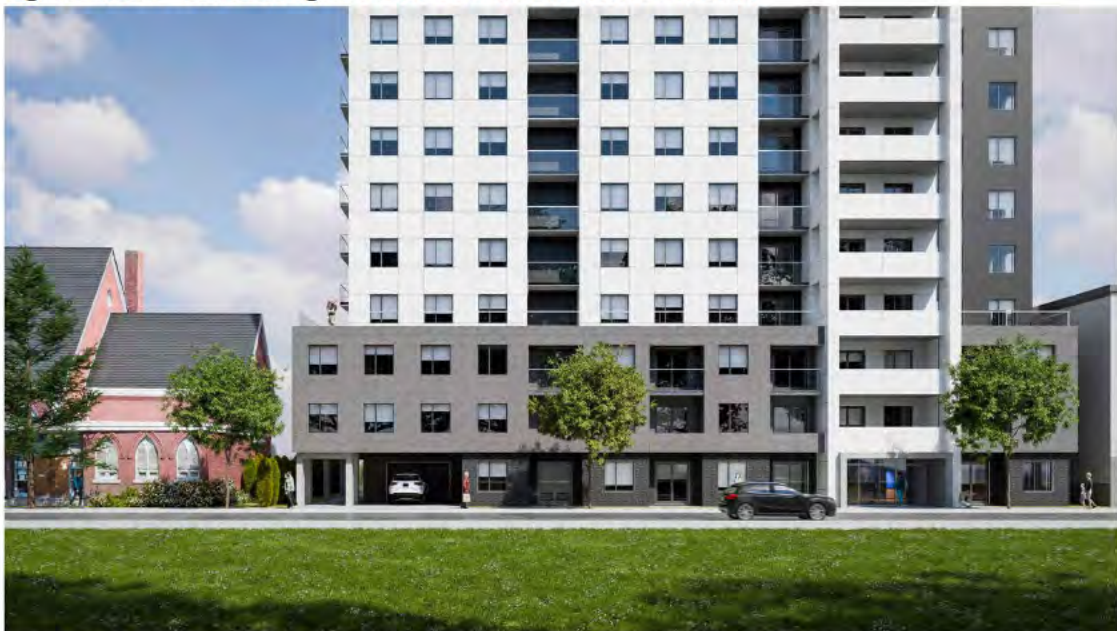
Figure 50: 3D Rendering of north side with partial view of church

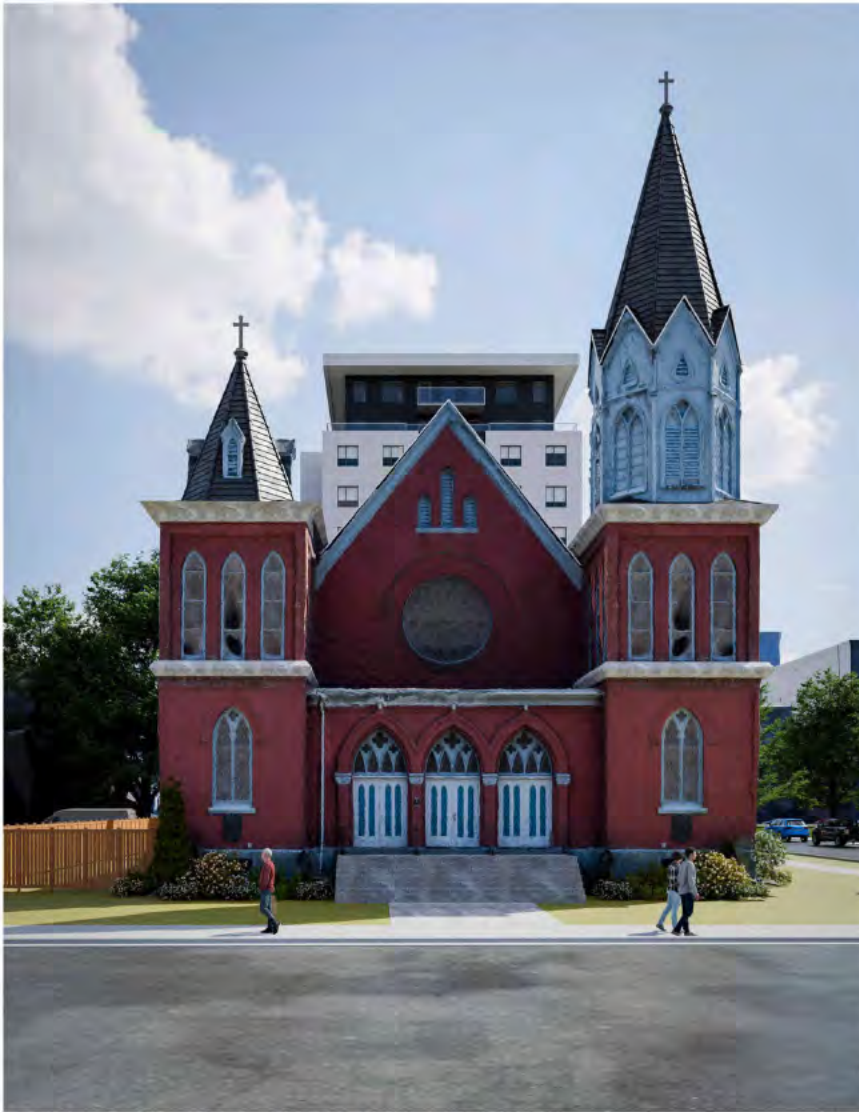
Figure 51: 3D Rendering of front of church

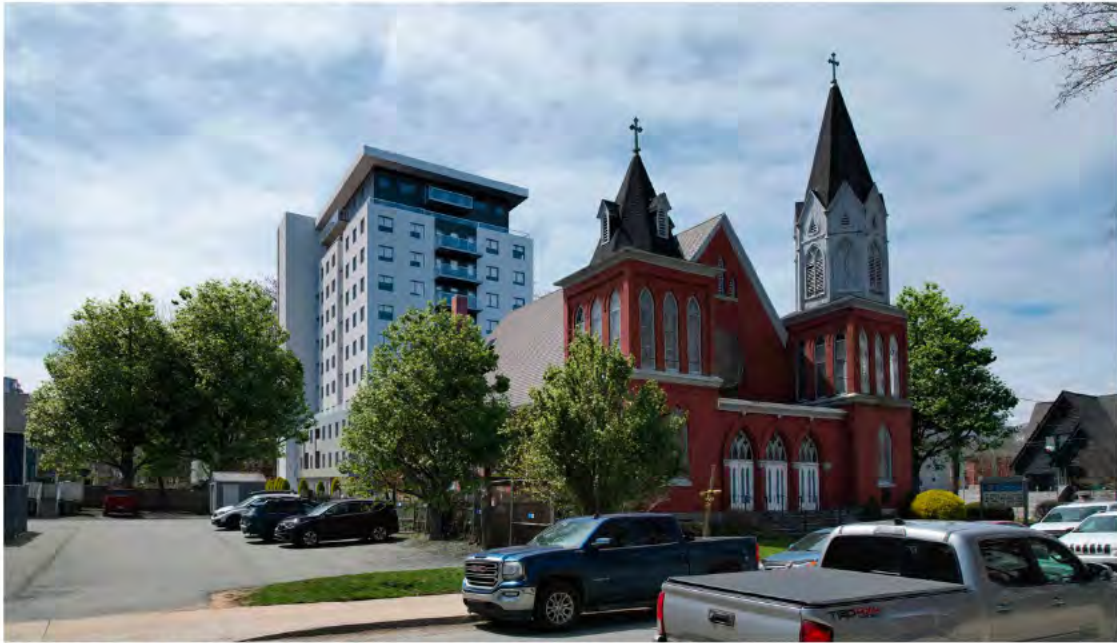
Figure 52: 3D Rendering of front and south side of church

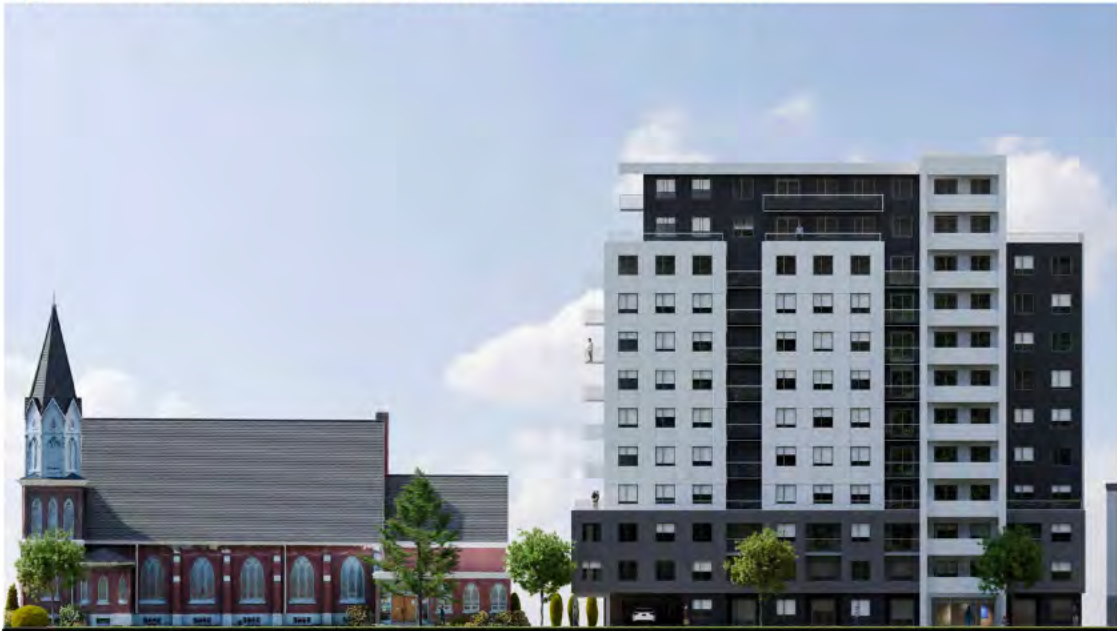
Figure 53: 3D Rendering of north side with full view of church

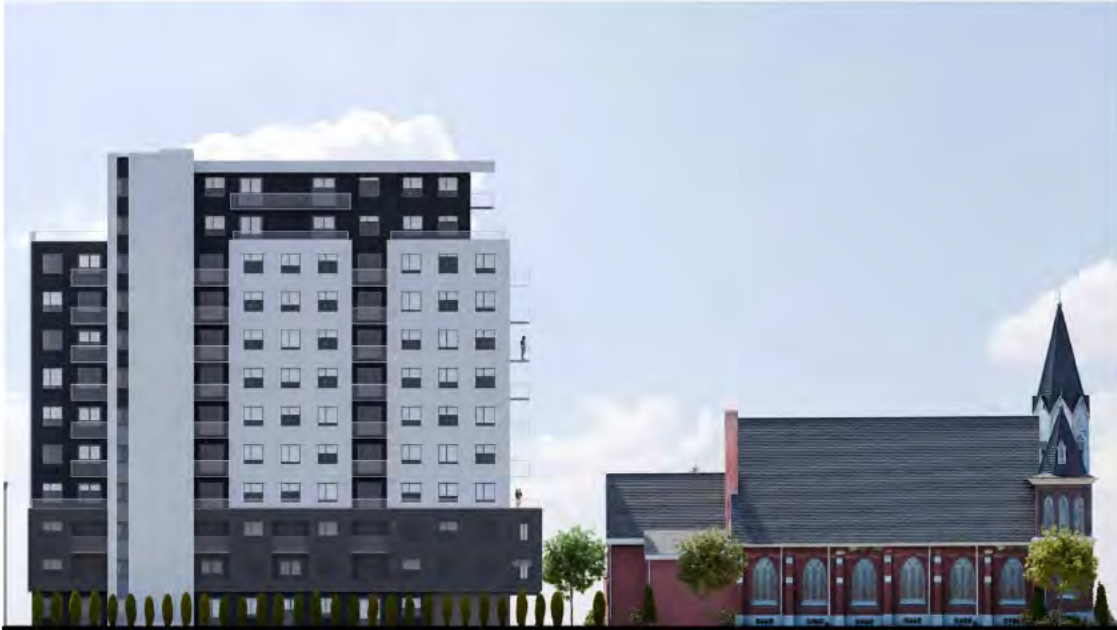
Figure 54: 3D Rendering of south side with full view of church
