**RE: A Traffic Impact Statement for a proposed development at #1268 Cole Harbour Road**

At the request of *A.J. Giles Investments Ltd. (Giles)*, the GRIFFIN transportation group inc. has completed a qualitative Stage 1 - Traffic Impact Assessment in support of the Development Agreement application being submitted to the Halifax Regional Municipality's (HRM) Planning Department. *Giles* is proposing to re-develop the civic #1268 Cole Harbour Road property from its existing commercial use to a medium density residential development comprised of 16 stacked townhome units plus a four-story building containing 30 apartment units.

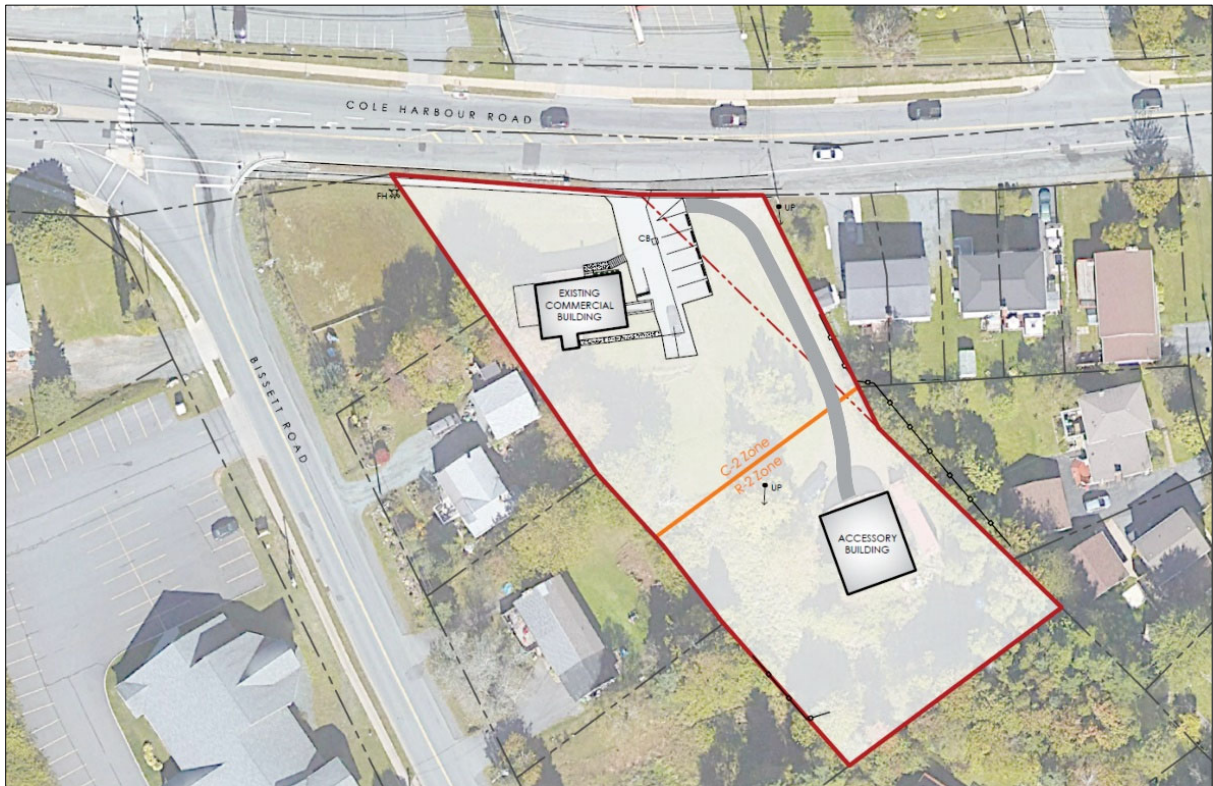
**Figure 1: Existing Site Layout and Location**

The subject properties (PID #00406702 and #41217431) are generally located in the southeast quadrant of the Cole Harbour Road / Bissett Lake Road intersection and measure approximately 1 acre in size. These lands are located in the Cole Harbour/Westphal Land Use By-Law area. Currently, the front (north) portion of the lands facing Cole Harbour Road have a C-2 (Commercial General Business) zone designation, while the rear (south) portion of the property has a R-2 (Residential Two-unit Dwelling) zone designation. The subject properties are shown in *Figure 1*.

Currently, there are two buildings located on the property which include the following:

- A detached home that has been re-purposed into office space for an interior decorating business, and
  - A small accessory storage building.
-

The civic #1268 property is comprised of two separate PID’s (PID #00406702 and #41217431), as shown in *Figure 1*. The proponent is proposing to remove the existing buildings and replace them with a four-floor multi-unit residential building containing 30 apartments, as well as 16 stacked townhome units. This will result in a total of 46 new medium-density residential units on this property. A concept drawing showing the proposed building locations, parking areas and site driveway is contained in *Figure 2*.
