**SUBJECT:** **Case HRTG-2023-00201: Substantial Alteration to St Mark's Church, a registered municipal heritage property at 5522 Russell Street, Halifax**

# Heritage Impact Statement

St. Mark's Church, 5522 Russell Street, Halifax

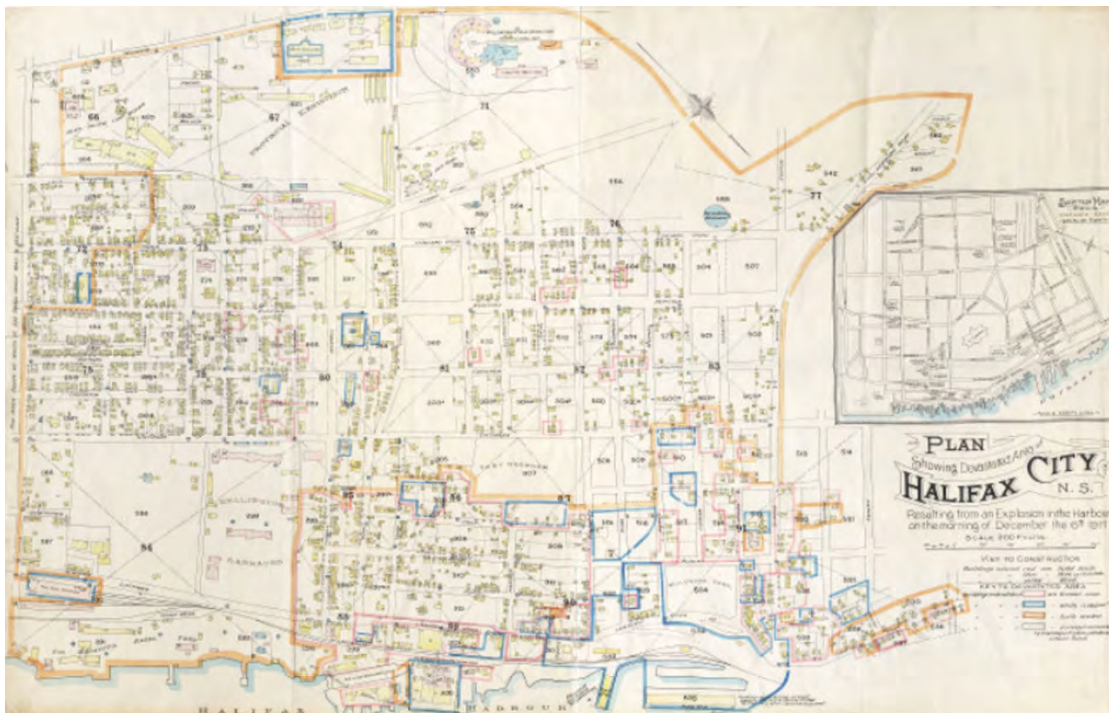
**Figure 7: Plan showing devastated area of Halifax City, N.S., 1918**

The extent of the destruction caused by the explosion and subsequent fires is illustrated in Figure 7.

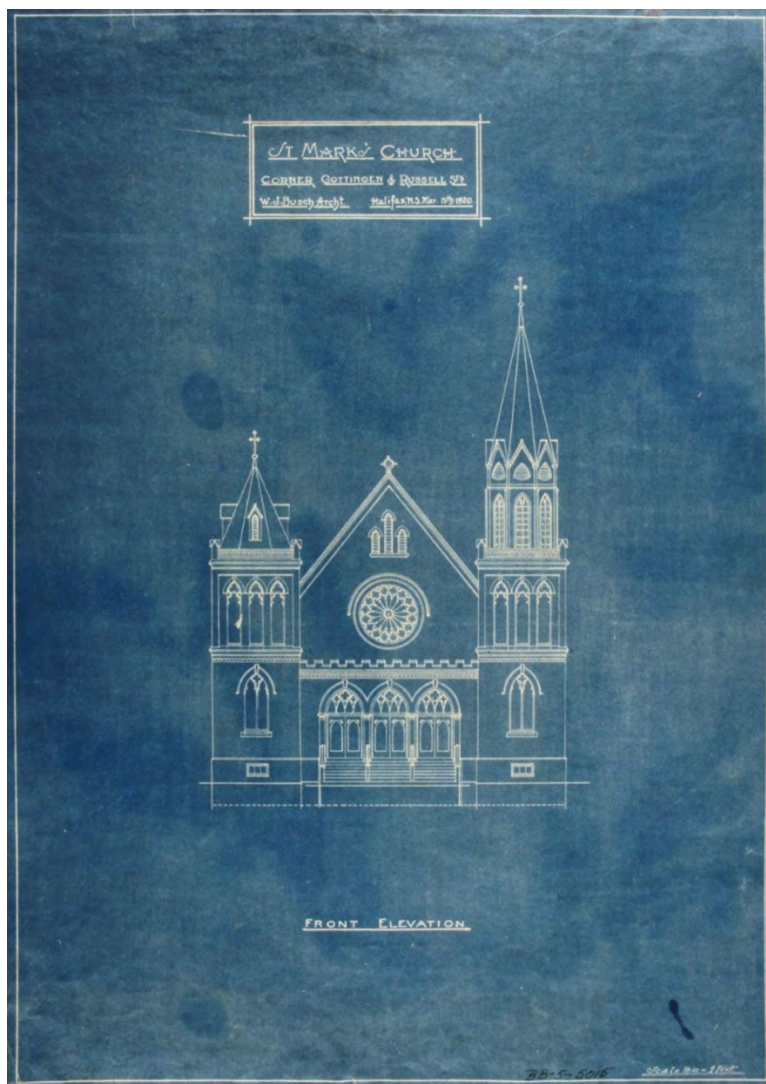
By early 1920, plans had been completed by architect W.J. Busch (Figure 23).

**Figure 23: St. Mark's Church, Corner Gottingen and Russell [Streets], front elevation, March 15, 1920. Architect/draftsman W.J. Busch. Source: Nova Scotia Archives, 1.3.5.13. original drawing BB-5-5015.**

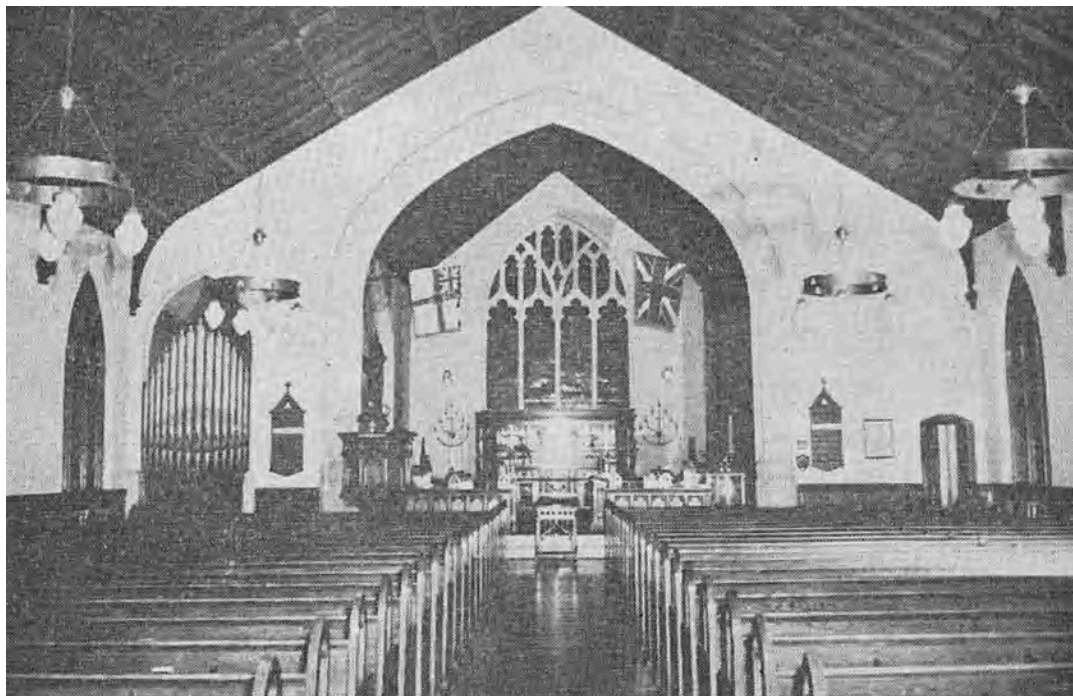
It has always been the Garrison church of both the Royal Canadian Regiment and the Royal Canadian Navy. In its early days, military parades marched from the Wellington Barracks and the dockyards to the church. This was reflected in some of the interior elements in the then-newly constructed church (Figure 26).

**Figure 26: Interior of the new church, c. 1921**

When comparing the early (c. 1921) photograph (Figure 26, page 26) to the current photographs, the only notable alterations on the interior are at the entry to the apse where a crucifix and horizontal crossbeam has been installed, and the removal of the original light fixtures that hung from the ceiling, and two television monitors (Figures 34 and 35). While the loss of light fixtures is unfortunate, the crucifix addition has enhanced the overall character as expressed through its interior.

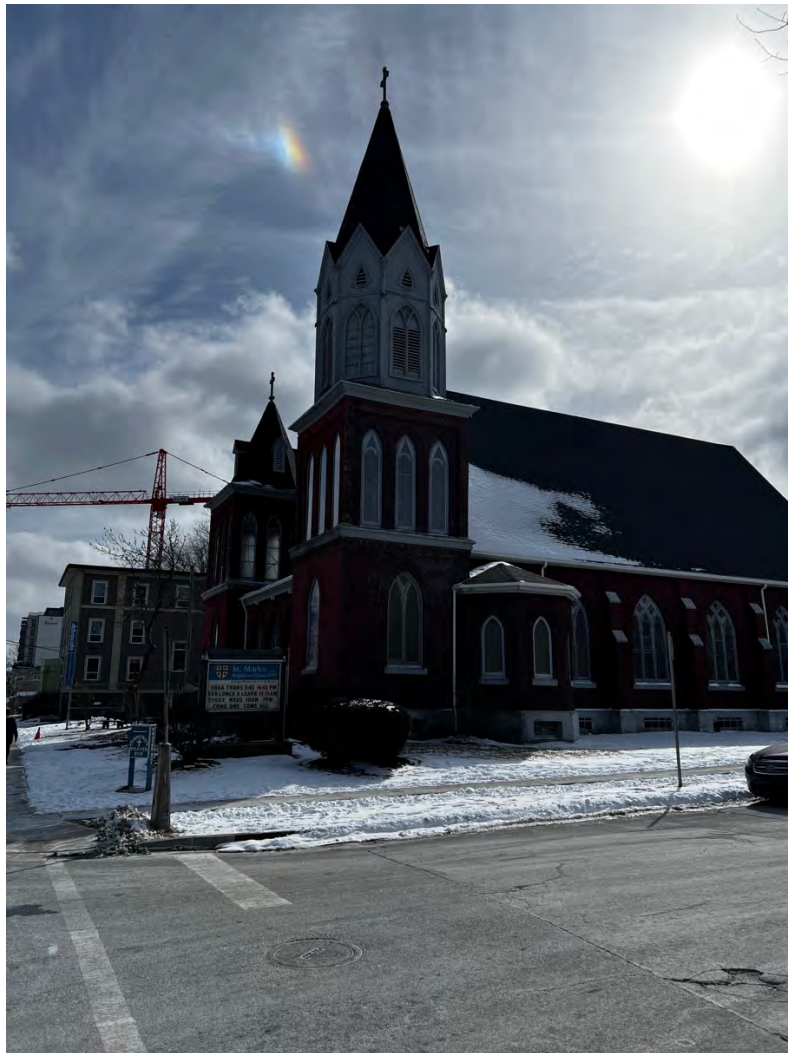
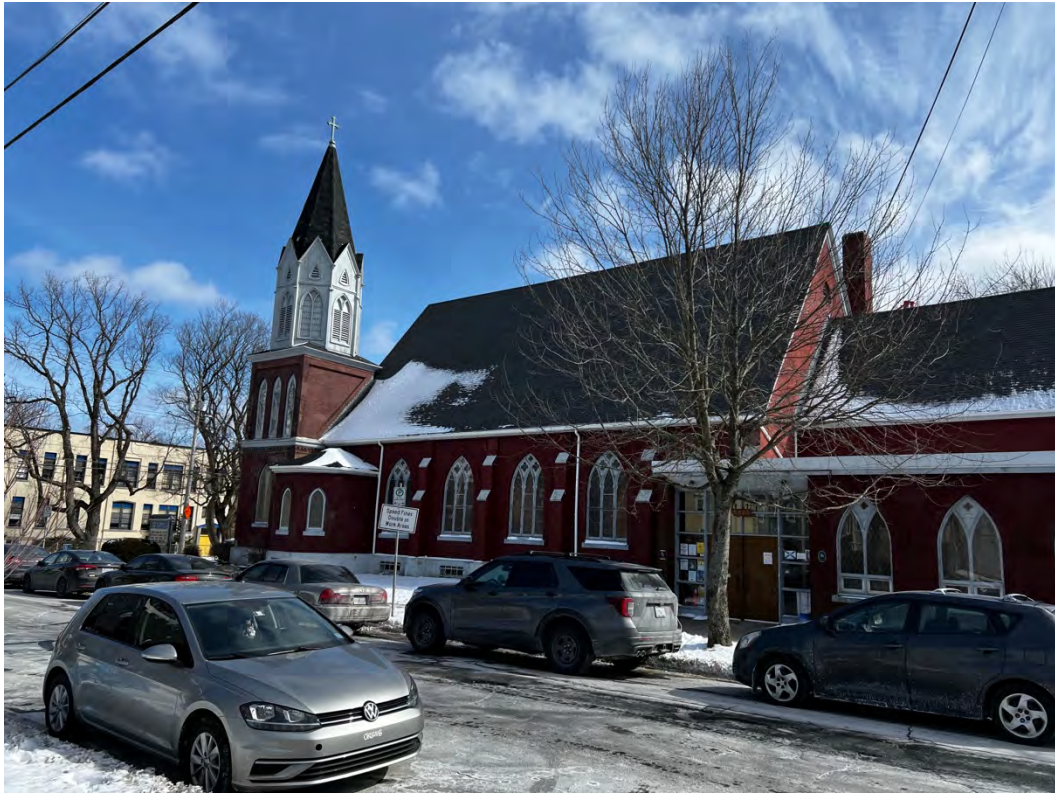
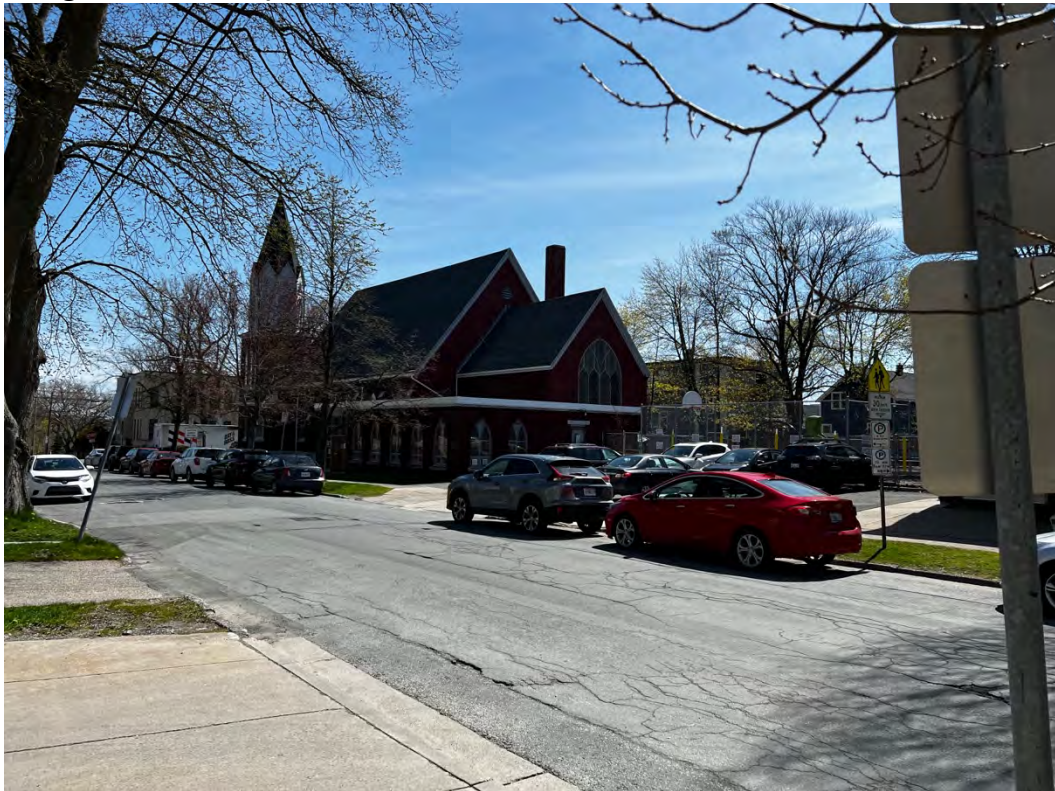
St. Mark's Church is an excellent example of places of worship, specifically churches, built in the inter-war era, in the Gothic Revival style that was commonly used for churches at that time. It is set on a prominent corner location, highly visible from both Gottingen and Russel Streets, with a prominent square tower topped by an octagonal extension, a large rosary window, a secondary tower, between which is set the main entry (Figure 29).

**Figure 29a: Context of St. Mark's Church, 5522 Russell Street (seen from corner looking south along Gottingen Street)**

**Figure 29b: Context of St. Mark's Church, 5522 Russell Street (seen from side, along Russell Street)**

**Figure 29c: Context of St. Mark's Church, 5522 Russell Street (seen from rear, looking east along Russell Street)**

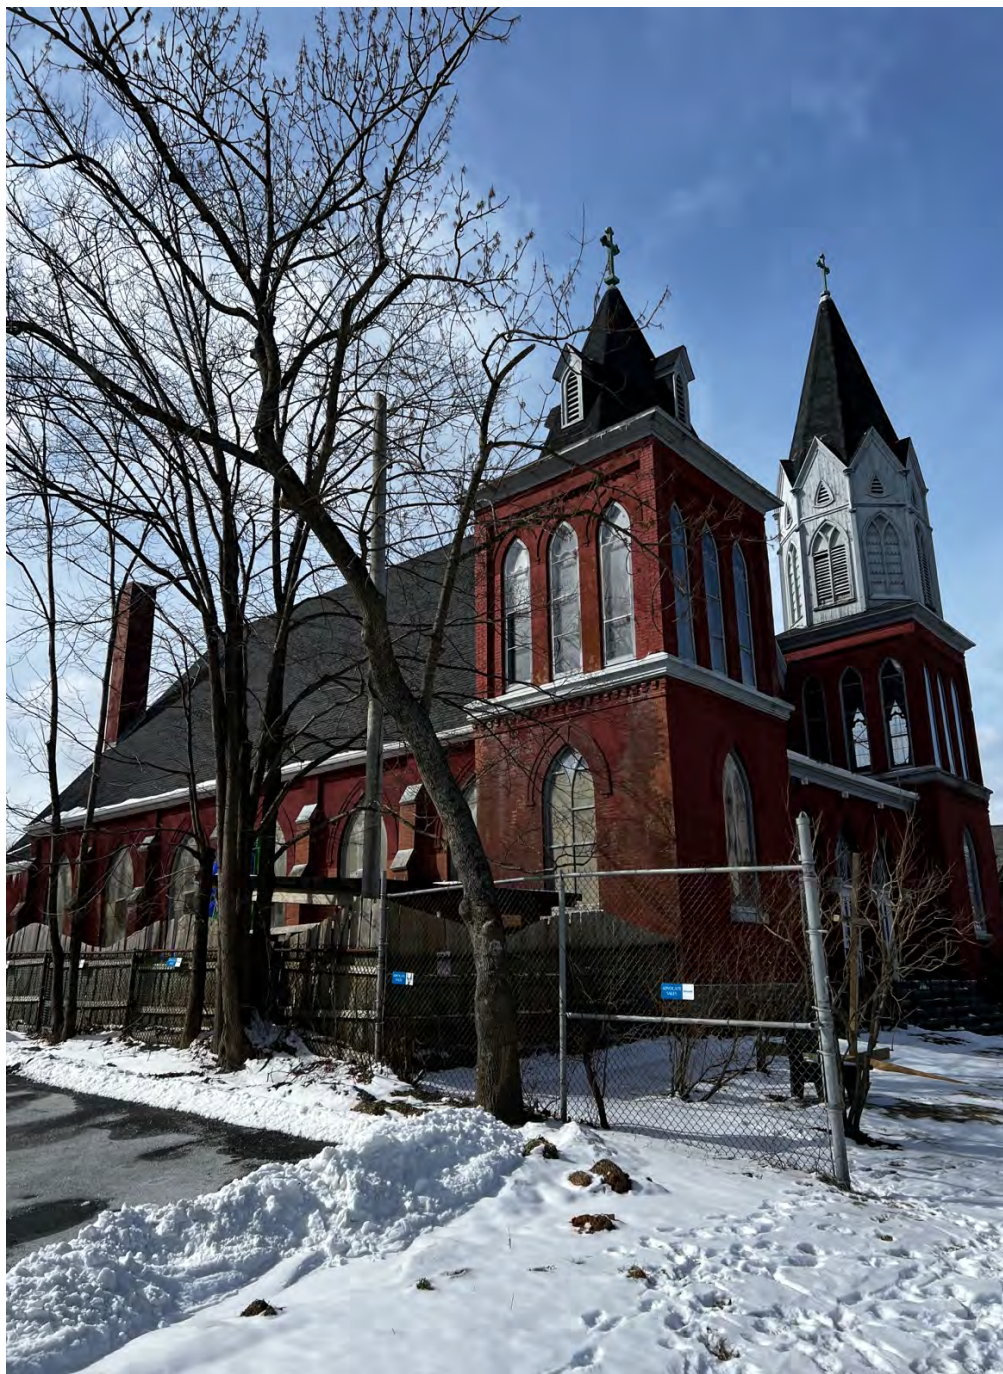
Each of the towers has the pointed arch windows set in singles and pairs, in typical Gothic form. Along the sides of the building, behind the towers, the windows are similarly set in singles (in the protruding alcove on the north side) and tripartite. Where the windows are set in pairs or tripartite, there is a traditional lancet, mullion divider and plate tracery (Figures 30b to 31d).

**Figure 30b: Front and south side of 5522 Russell Street**

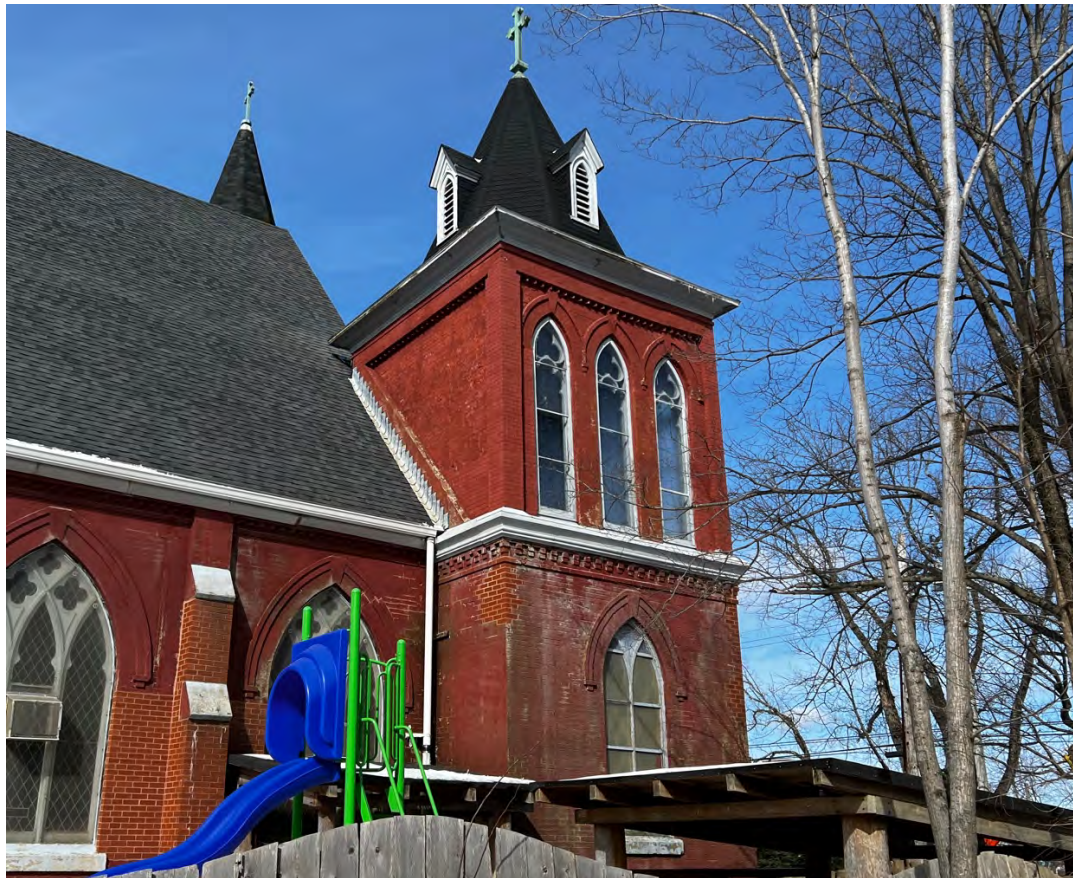
**Figure 30c: South side tower**

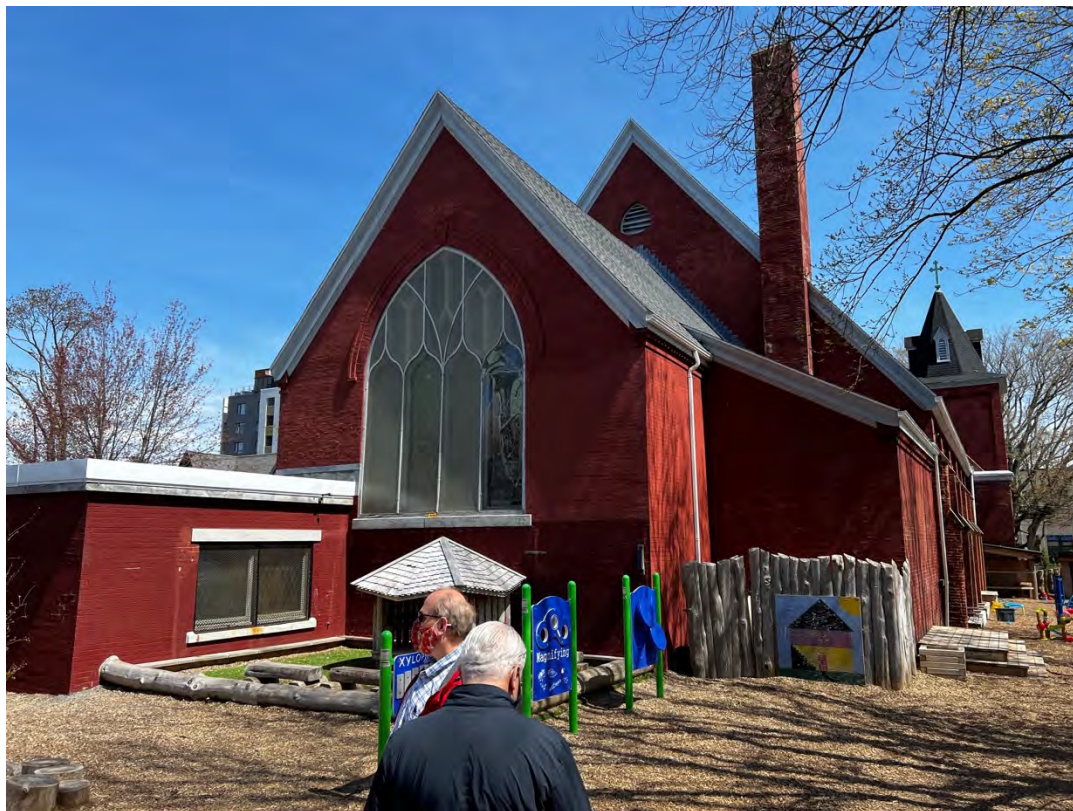
The north side includes a one-storey addition made in 1960, that expresses the evolution of the church over time. The rear has also been affected by this alteration, as it covers not only the north side but also a limited section of the rear (Figure 30d).

**Figure 30d: Rear, 5522 Russell Street**

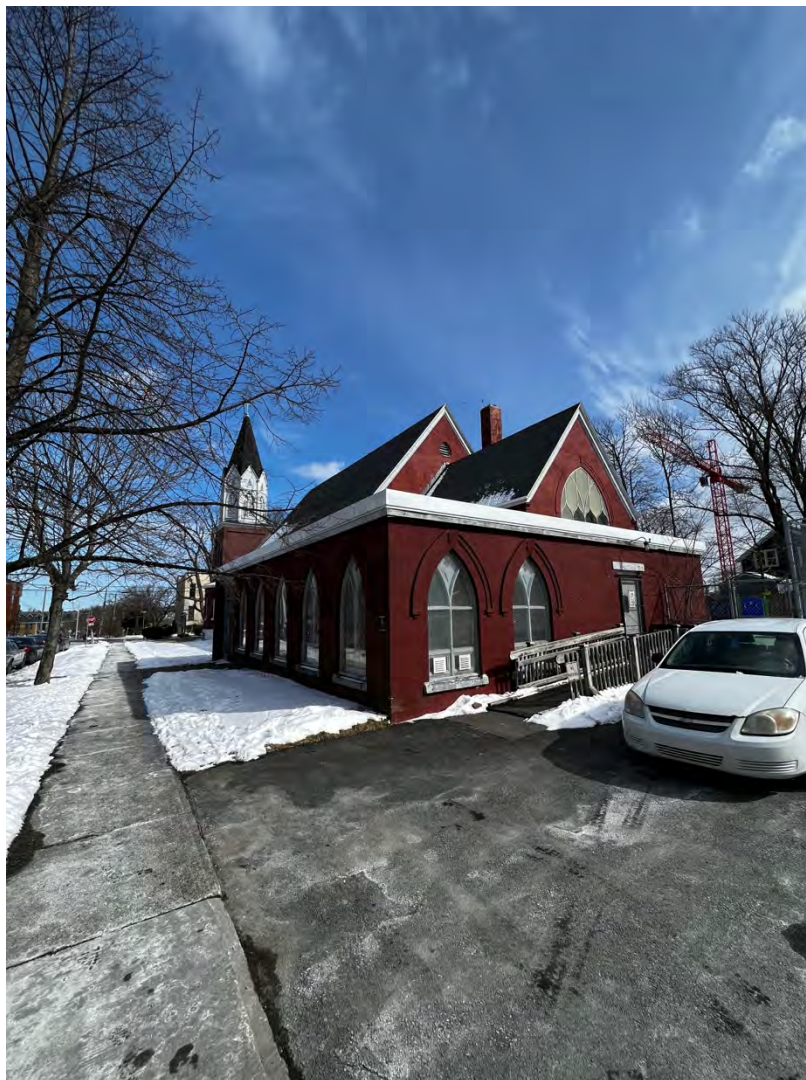
Overall, the integrity of St. Mark's Church is excellent. The only notable alteration is the single storey addition of a church office that protrudes from the main body of the church along the rear section of the north side and wraps partly around the rear (Figure 31a to 31c).

**Figure 31a: Single-storey addition on the north side of 5522 Russell Street, as seen from Russell Street**

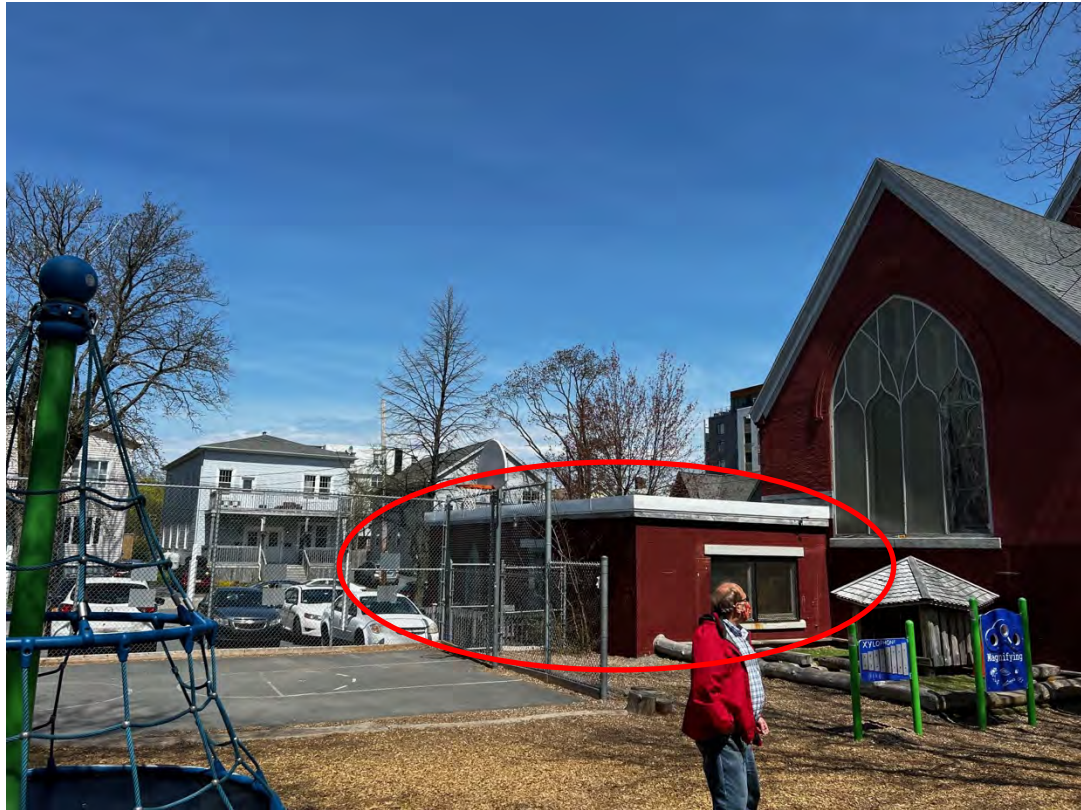
This addition was made in 1960, with plans drawn up by Webber, Harrington and Weld. While it is compatible, with the use of similar colour brick and window openings that follow the other arched-peak form on the early part of the church, it is distinguishable with its flat roof and simple fenestration. This enclosure obscures an original side entry but it does not appear to affect any windows, and it notably does not interfere with the large apse window set at the rear (Figure 31b).

**Figure 31b: Single-storey addition on the north side of 5522 Russell Street, seen from the rear and ending at the edge of the apse windows (circled)**

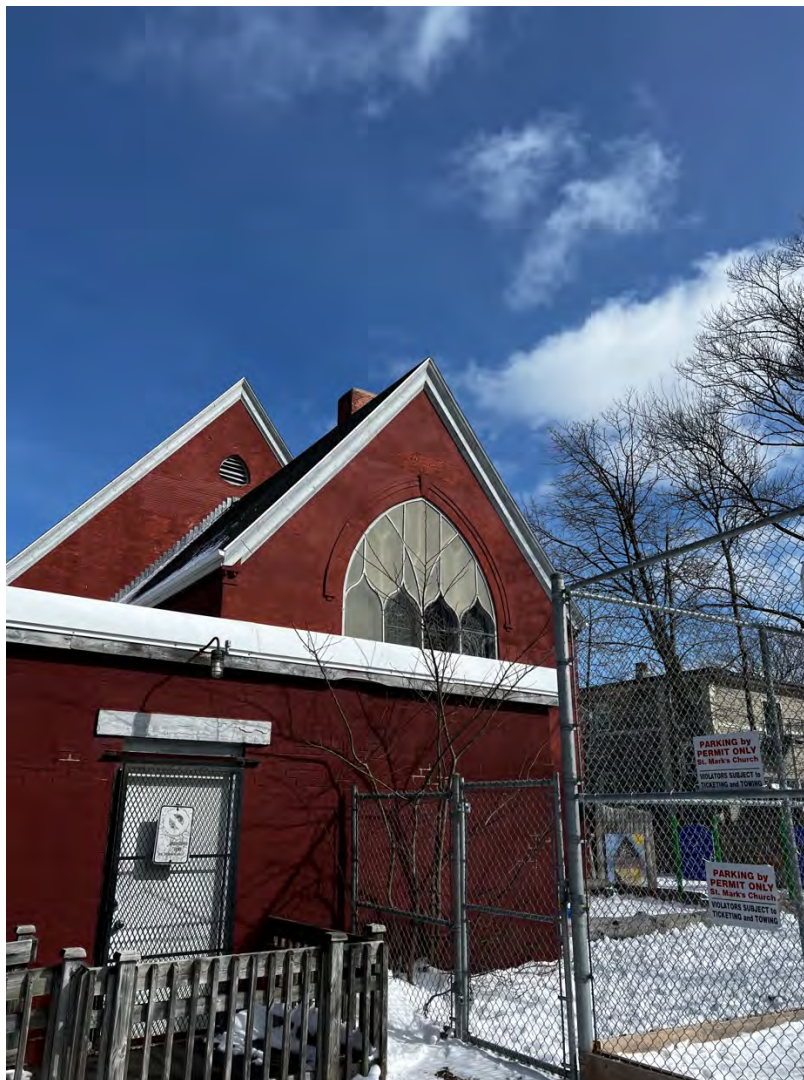
**Figure 31c: Single-storey addition wrapping around the west side of 5522 Russell Street, with a single emergency exit door**

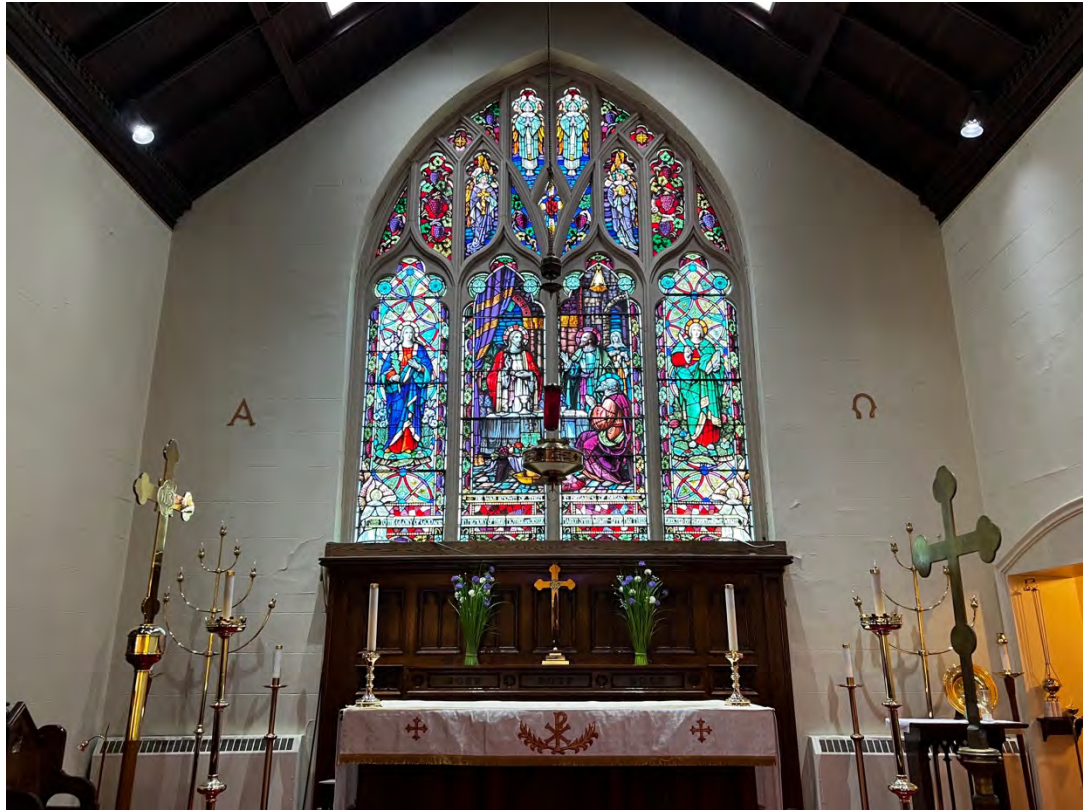
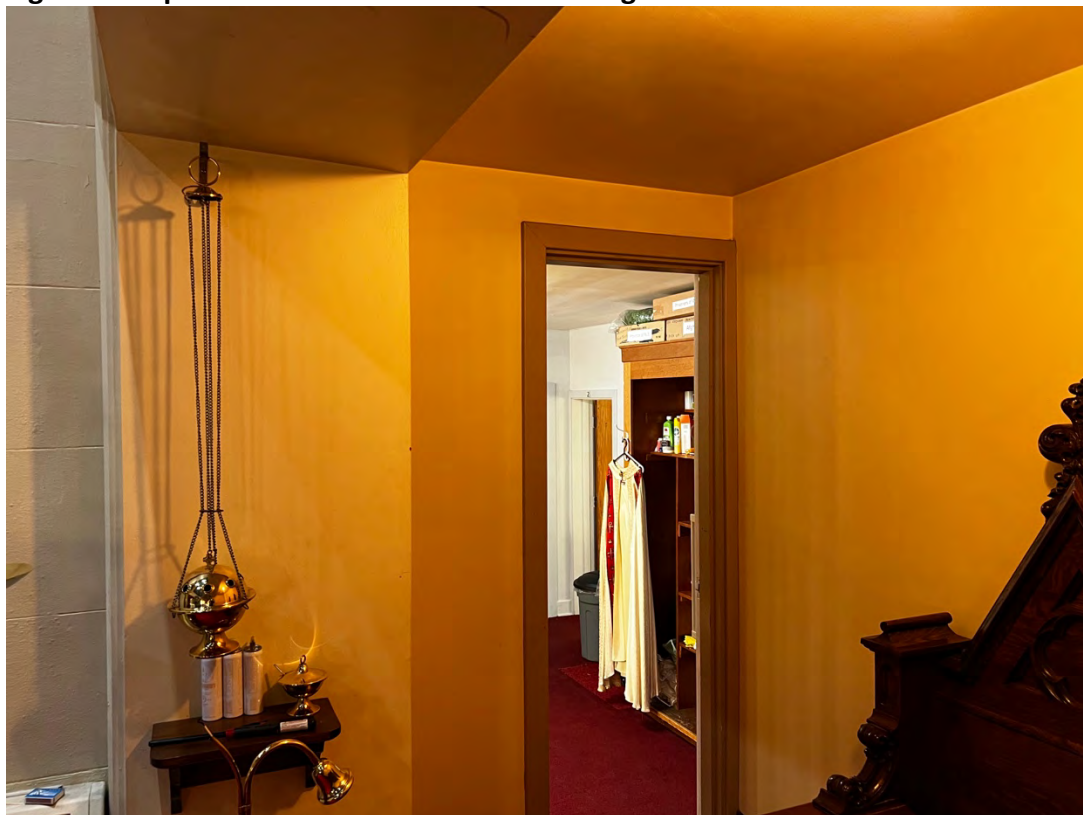
It does appear that an alcove or a small room set immediately adjacent the apse, on the north side, was enclosed (Figures 32 and 33). The opening in that north wall appears to be original and as such the 1960 addition of the offices and other rooms has changed the interior layout but not the configuration of the apse itself.

Figure 32: Apse with side room access on far right

Figure 33: Opening from the apse into a side room

The wall face on the right side of the apse does not appear to have been altered to create a new opening, suggesting that there was already a side room that may have provided for access or for other tasks as part of regular church services. Further investigation as to how this opening will be affected by the partial removal of the 1960 addition, and how it is to be addressed as part of the exterior rehabilitation.

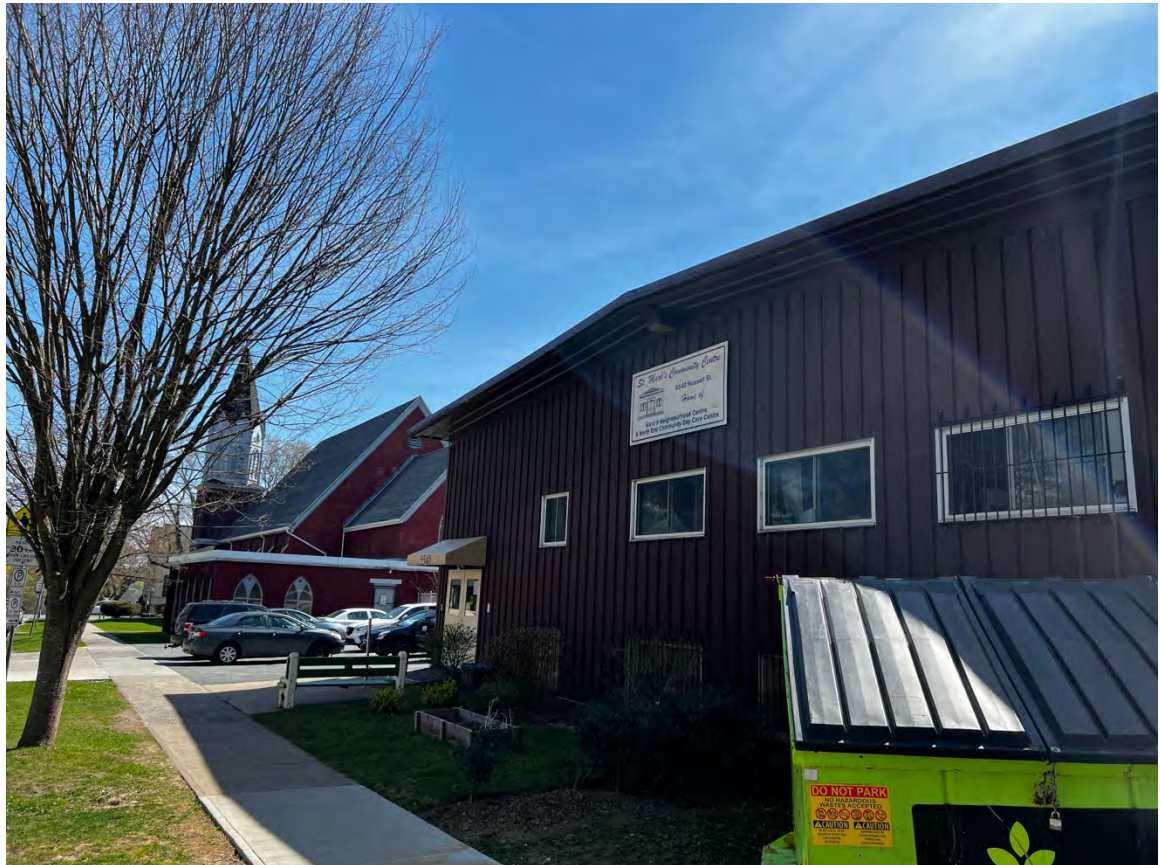
5540 Russell Street is a one-storey plus basement low-pitched wood frame and metal-clad building that is plain and unadorned. It has minimal setback from the street, and no setback at the rear, with a minimal west side setback. It is only the east side yard that allows for access and notable separation from its neighbours (Figure 38).

**Figure 38: Context of 5540 Russell Street, St. Mark's Church in the background**

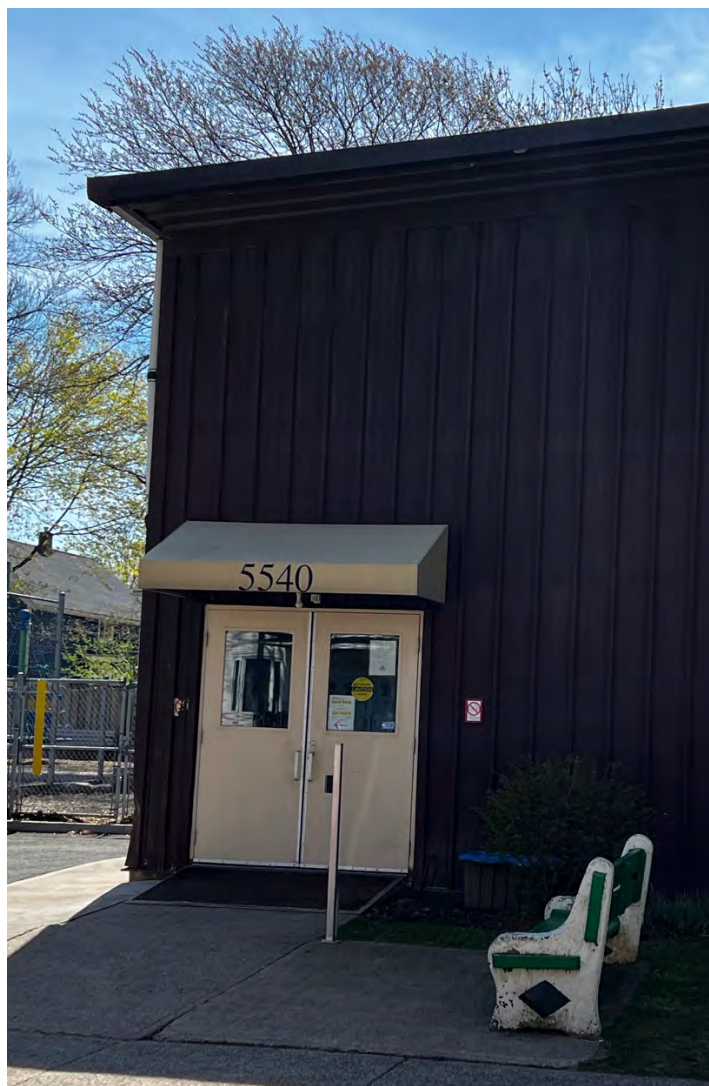
The overall form of 5540 Russell Street is intact. A relatively unadorned building, it can be classified as Vernacular style. The front, sides or rear are clad with corrugated metal, which is presumed to be an additional material – it is not known what the original cladding might have been or whether it may still exist underneath. The windows on the front, west and east sides are single-set metal sliders and are presumed to be original. Neither of these detract significantly from the style. The paired front entry doors appear to be a more recent alteration – they are nondescript metal doors with inset glazing (Figure 40).

**Figure 40: Paired entry doors, 5540 Russell Street**

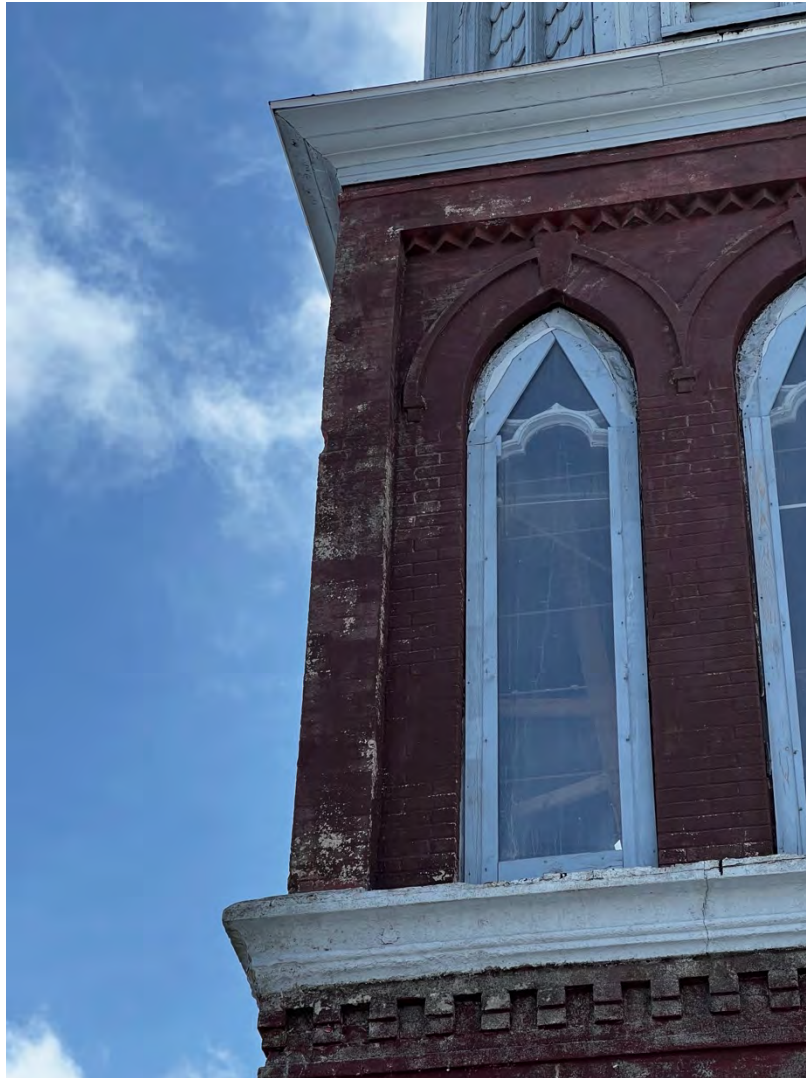
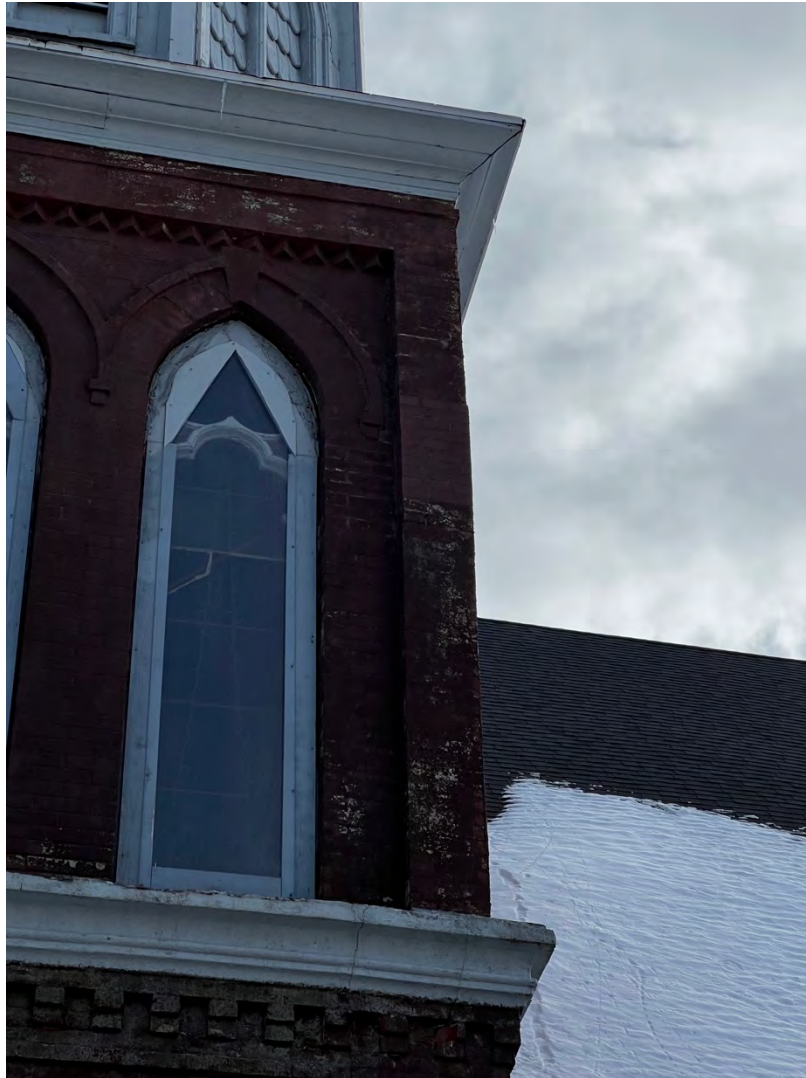
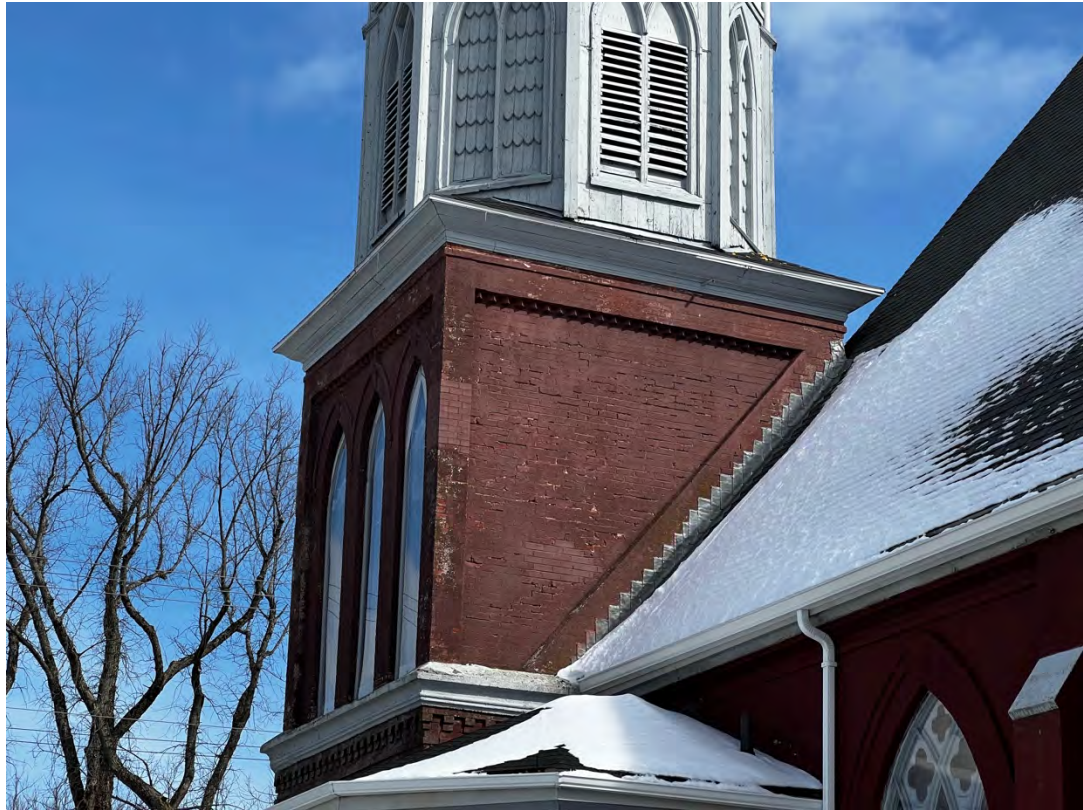
**Figure 41h: St. Mark's Church, 5522 Russell Street (upper front corner section of north tower)**

**Figure 41i: St. Mark's Church, 5522 Russell Street (upper side section of north tower)**

**Figure 41j: St. Mark's Church, 5522 Russell Street (upper rear section of north tower)**

**North and South Towers:** Generally poor condition. The brick in both the south and north towers has extensive efflorescence with some spalling and likely aggravated by freeze-thaw weathering. Furthermore, the brick has been painted at some point in the past and this has likely exacerbated the efflorescence and spalling, if it has not been able to “breathe.” This is especially notable on the north wall of the north tower. This is also apparent on the south tower, but to a lesser degree.

Wood frame and sash, in generally fair condition. The frames in the north tower, and particularly the north side face, appear to have been modified with multiple pieces of external board (possibly plywood) at the top of the arches.

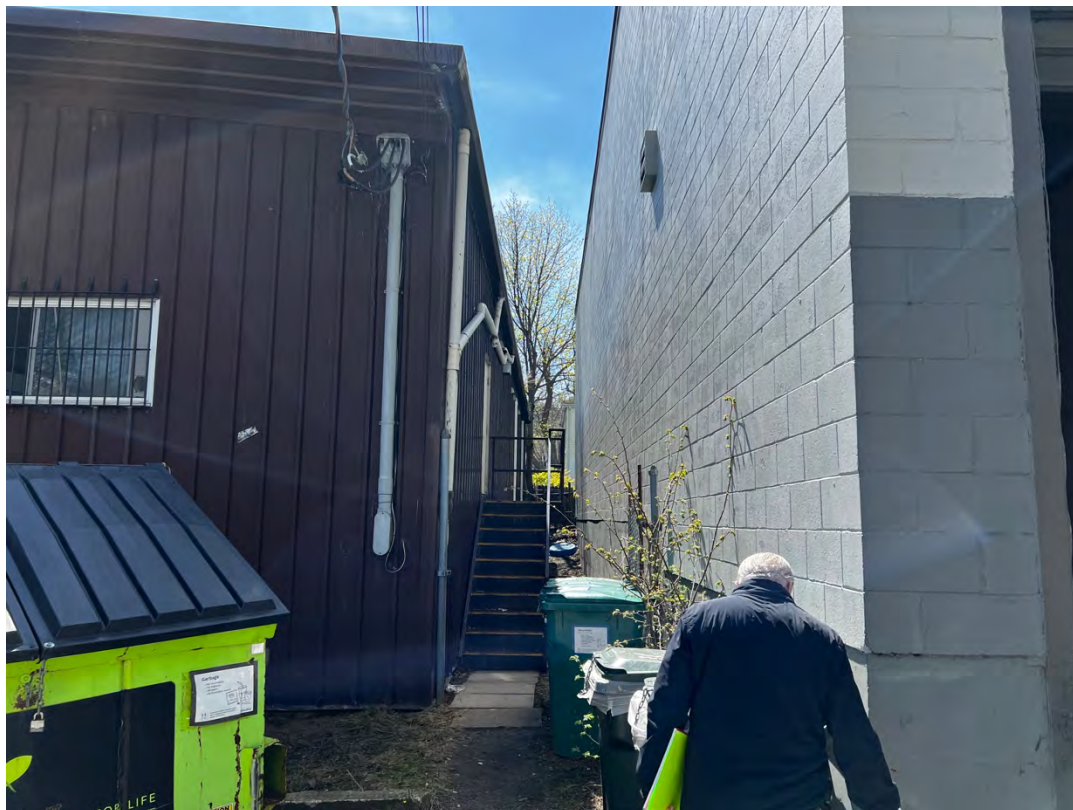
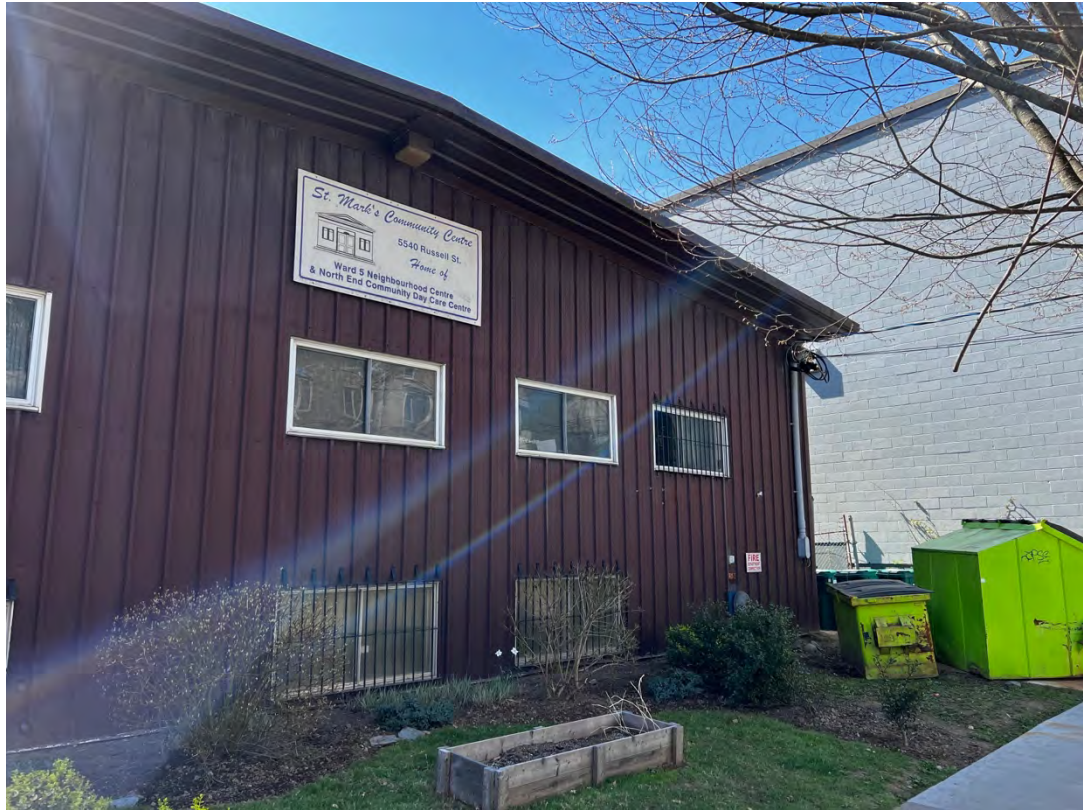
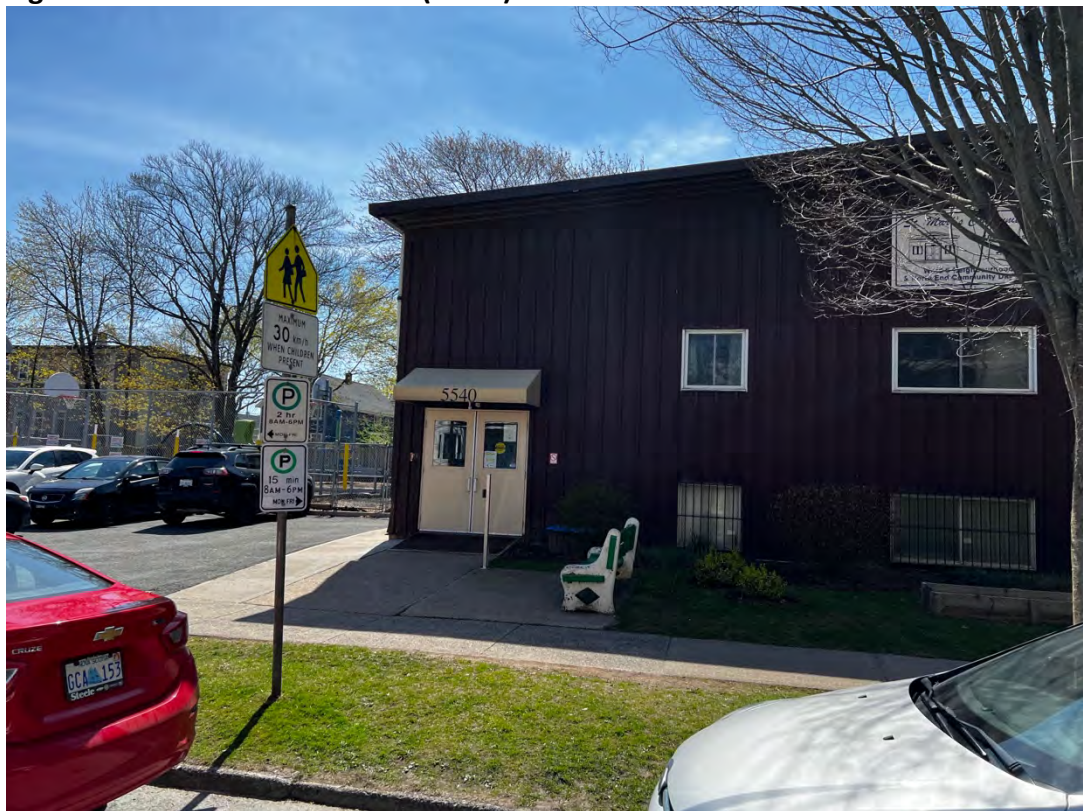
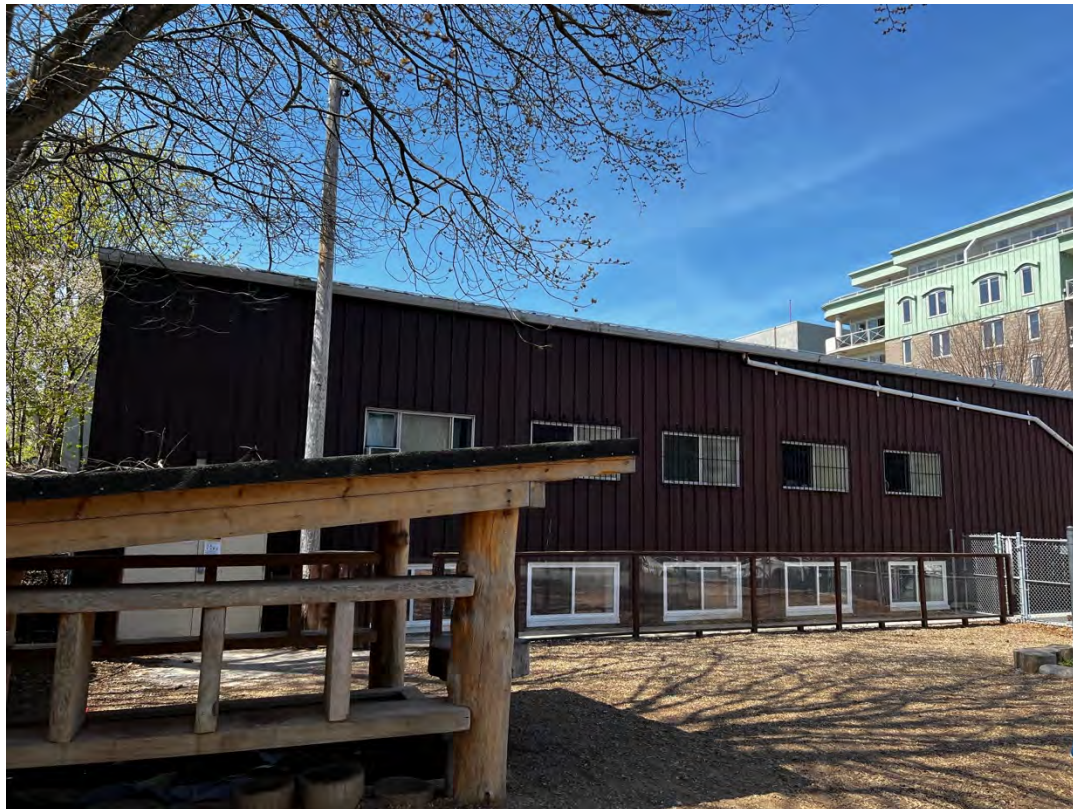
The following comprehensive set of photos of the church hall begins on at the west side and continues clockwise around the building to the east side. The rear was not accessible to be documented, as it abuts the property line and there is no rear lane (Figure 42).

Figure 42a: 5540 Russell Street (Front corner and west side)

Figure 42b: 5540 Russell Street (Front)

Figure 42c: 5540 Russell Street (Front – east half)

Figure 42d: 5540 Russell Street (East side)

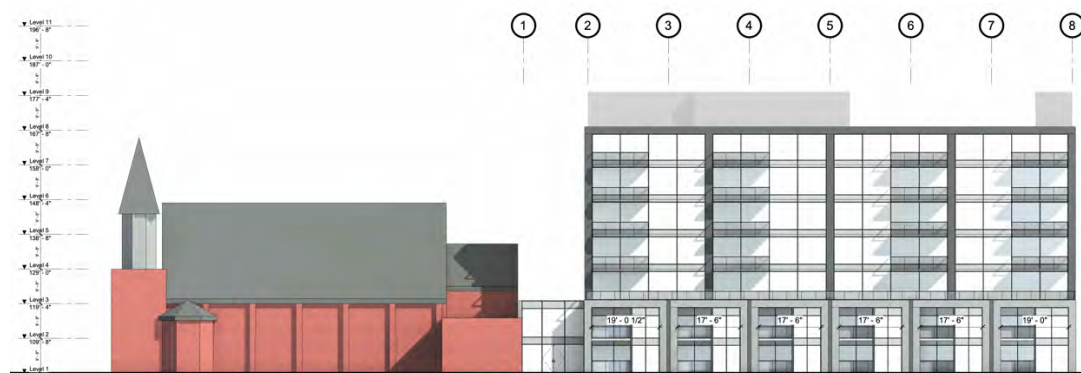
**Figure 44b: Alternative north elevation**
