**SUBJECT:** **Case HRTG-2023-00201: Substantial Alteration to St Mark's Church, a registered municipal heritage property at 5522 Russell Street, Halifax**

# Heritage Impact Statement

St. Mark's Church, 5522 Russell Street, Halifax

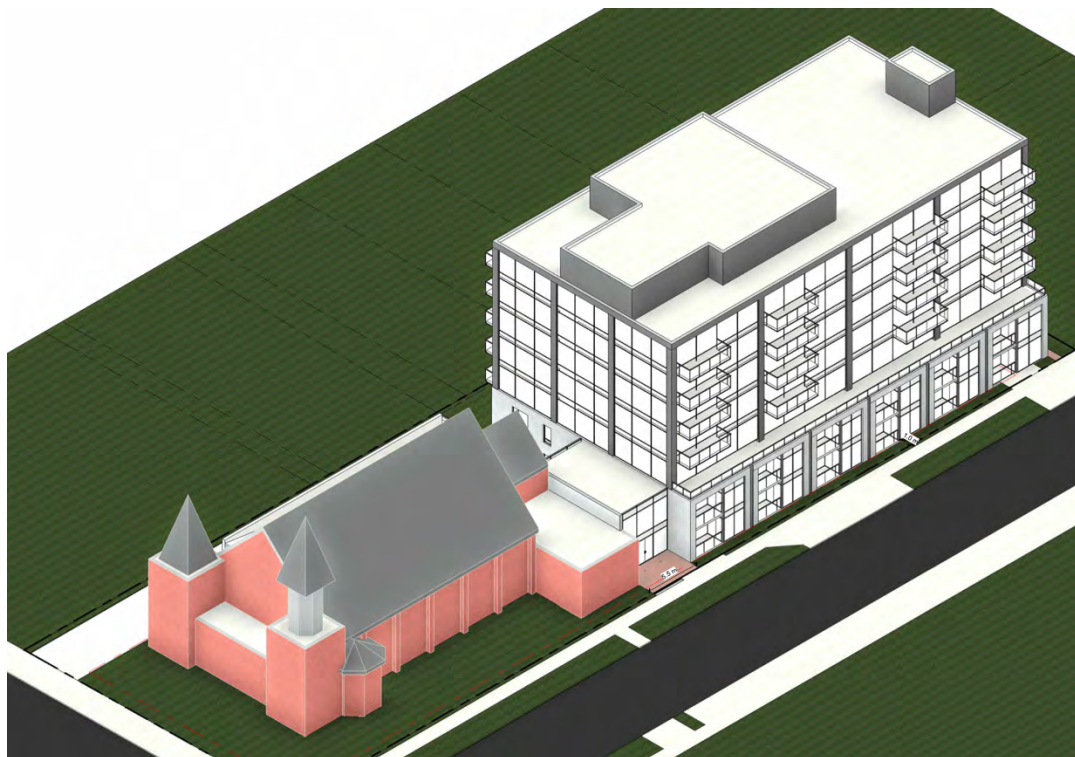
**Figure 44c: Alternative 3D rendering**

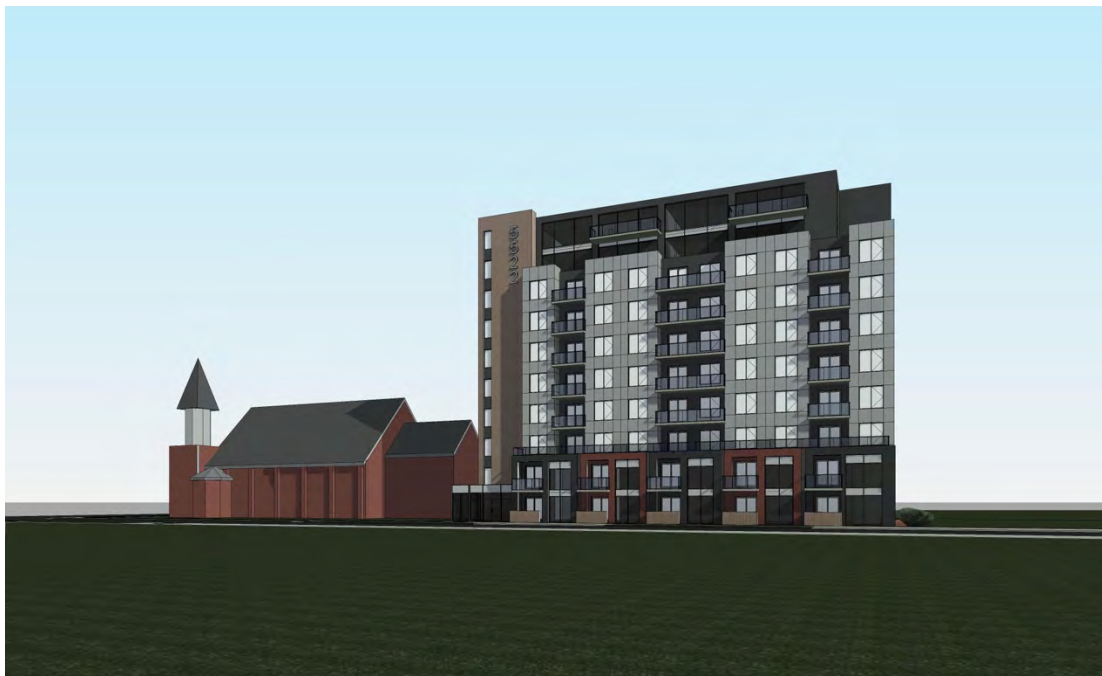
**Figure 44d: Second alternative 3D rendering – detached from the church (March 2024)**

Further changes were made to the design concept for the new building in March 2024, which separated the new building from the church. While this was a step in the right direction, it was wider and bulkier in massing than what is now proposed (Figure 44d).

Although two floors have been added to the proposal since then, the currently proposed massing is slenderer, and the 4<sup>th</sup> through 10<sup>th</sup> floors are set in from the podium. Further setbacks have been applied to the additional two top floors, bringing the total number of floors to 12 from the previous 10.

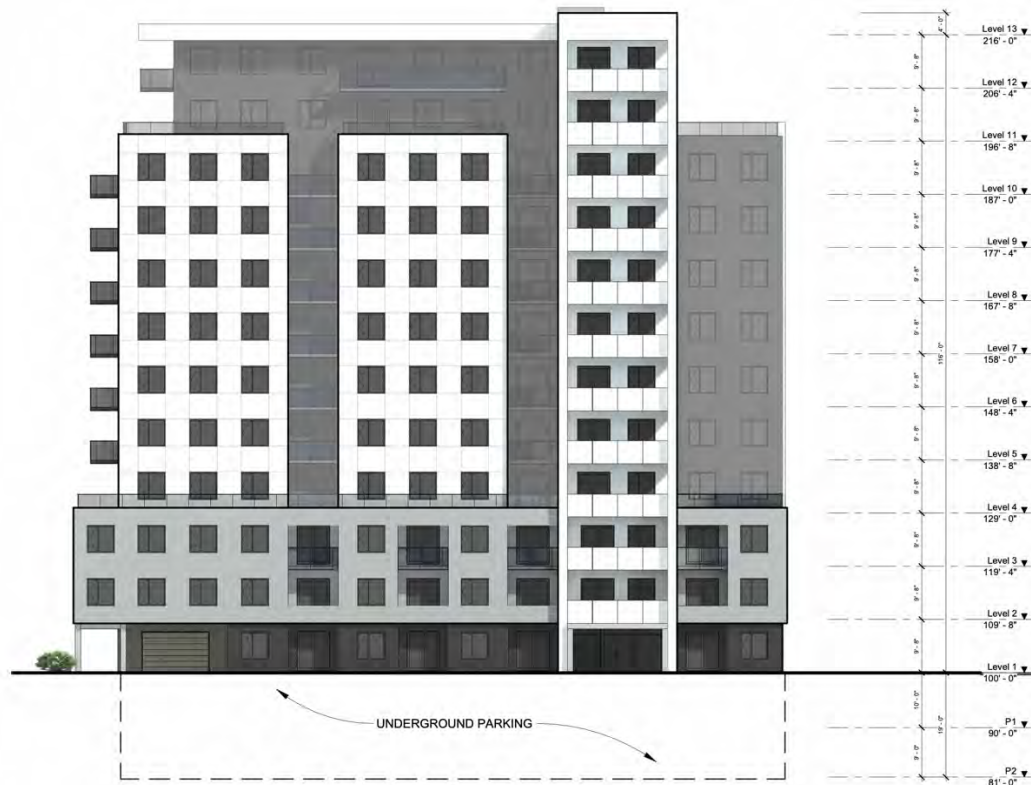
Figure 45: North-west elevation

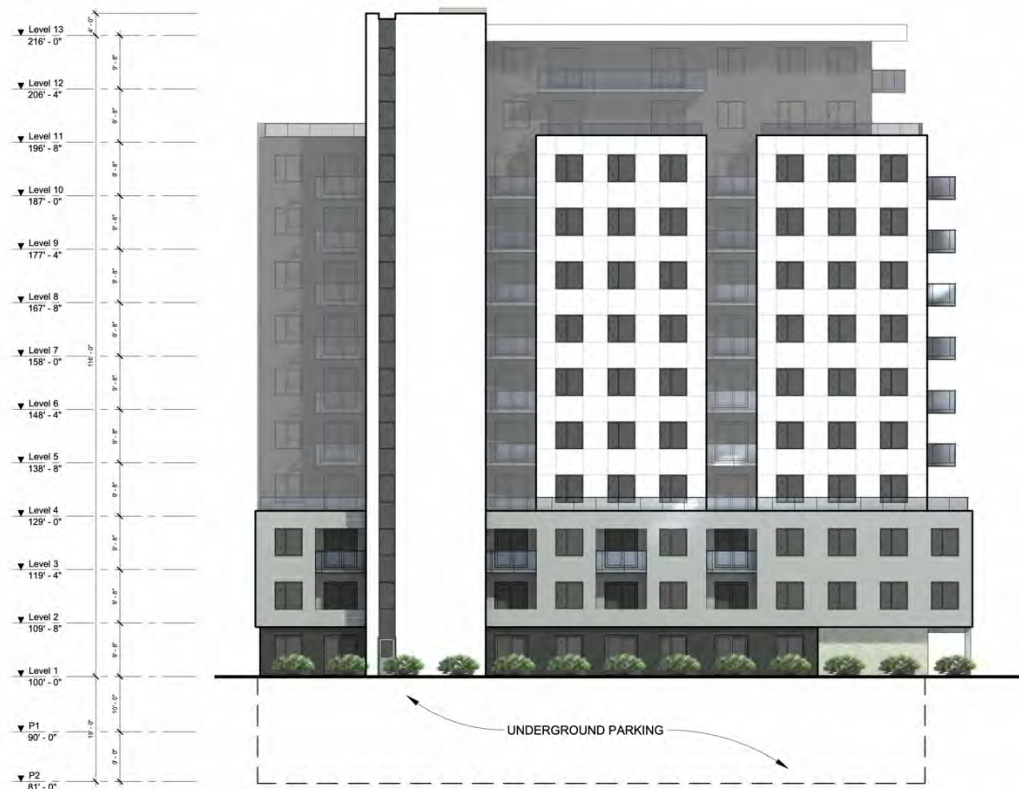
Figure 46: South-east elevation

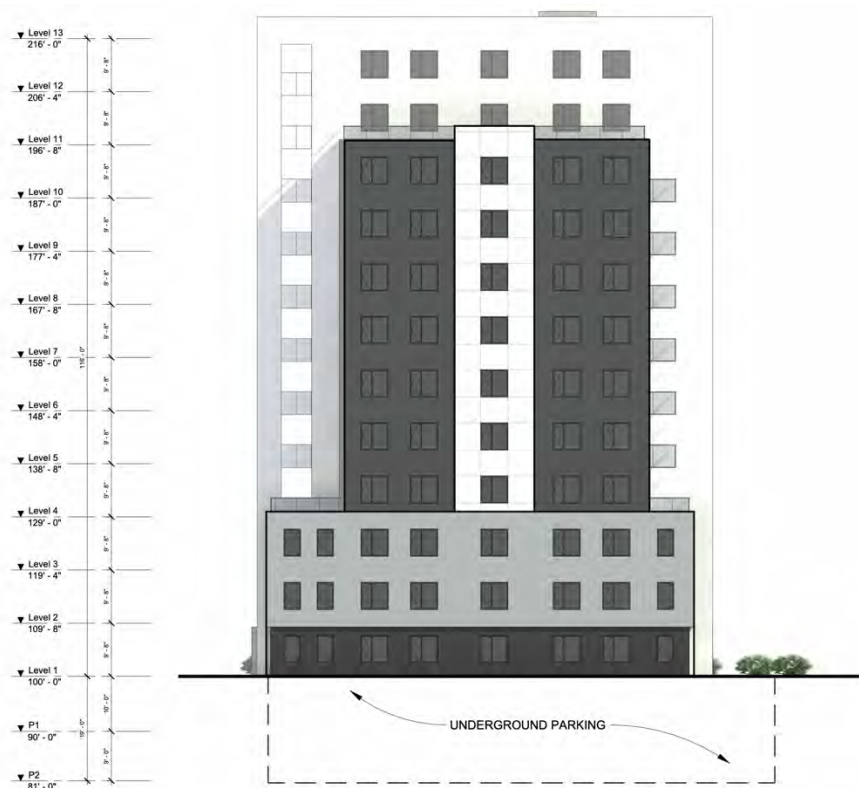
**Figure 48: North-east elevation**

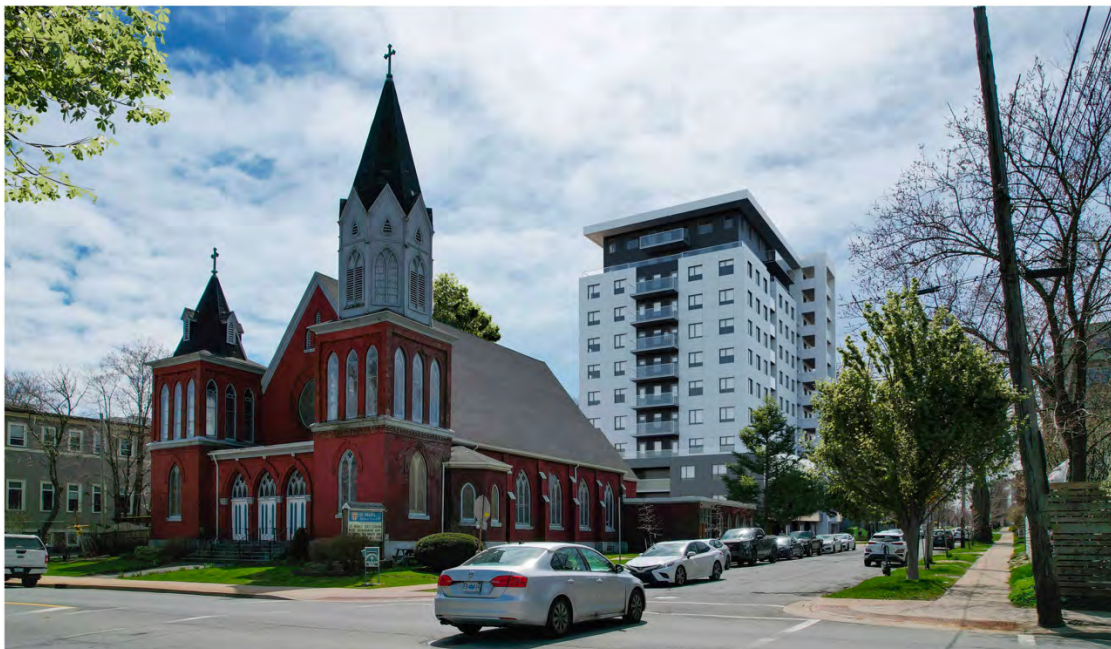
Figure 49: 3D Rendering of front and north side of church

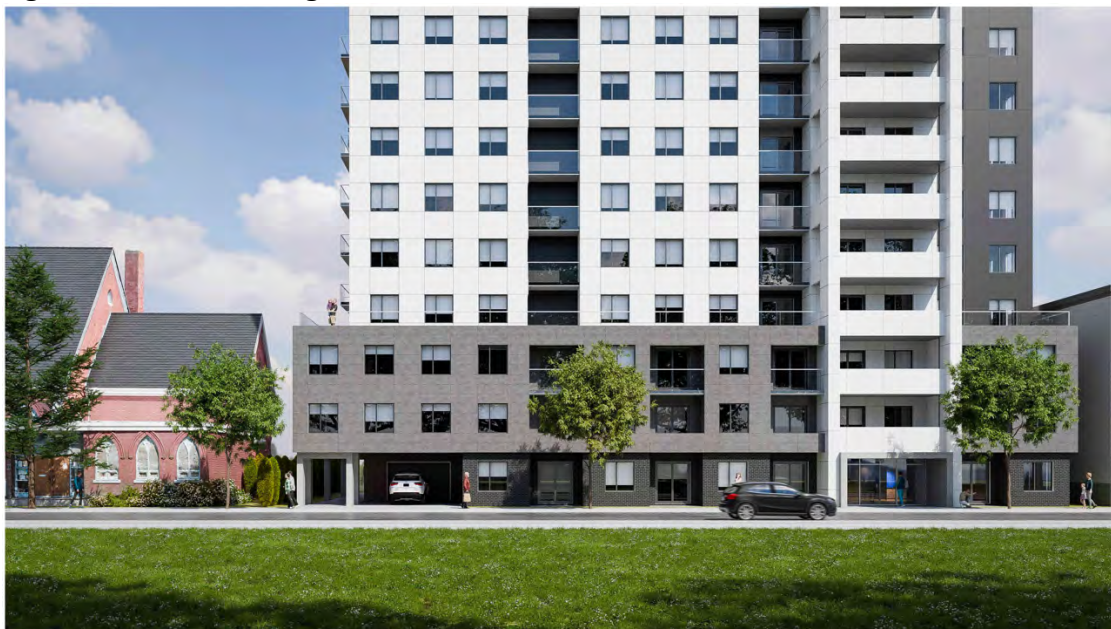
Figure 50: 3D Rendering of north side with partial view of church

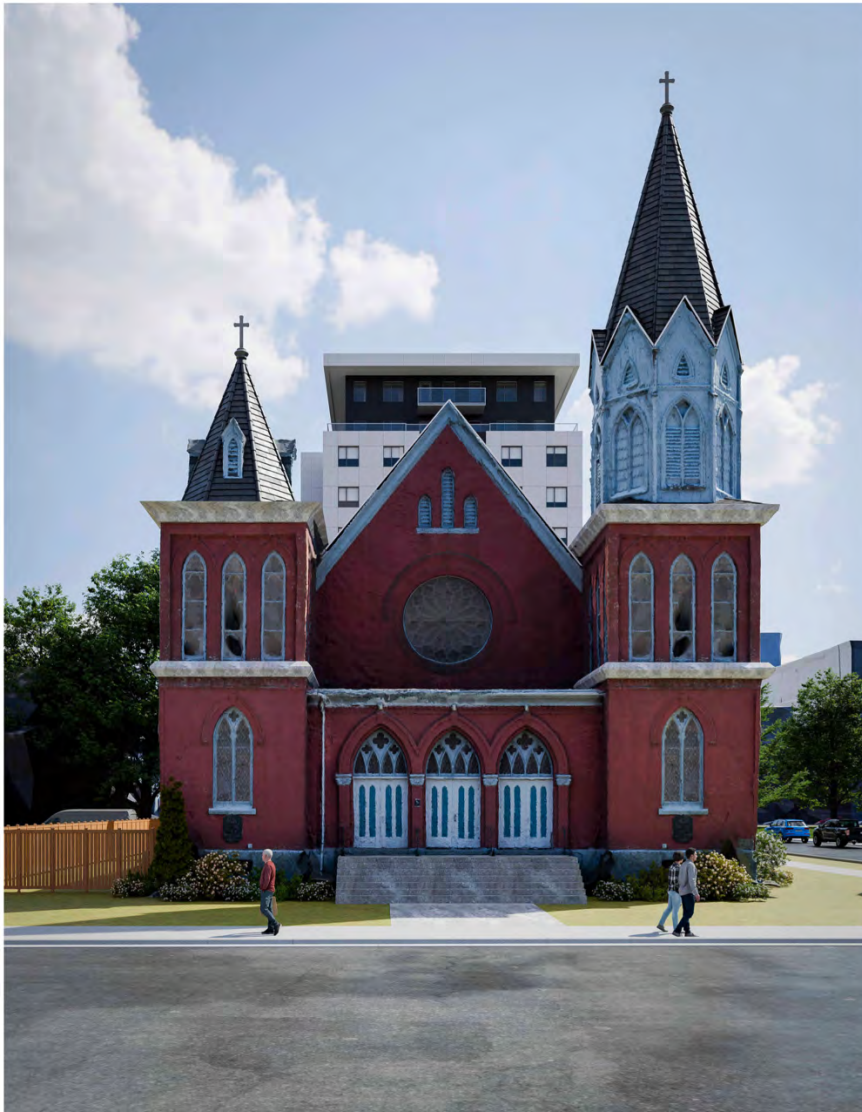
Figure 51: 3D Rendering of front of church

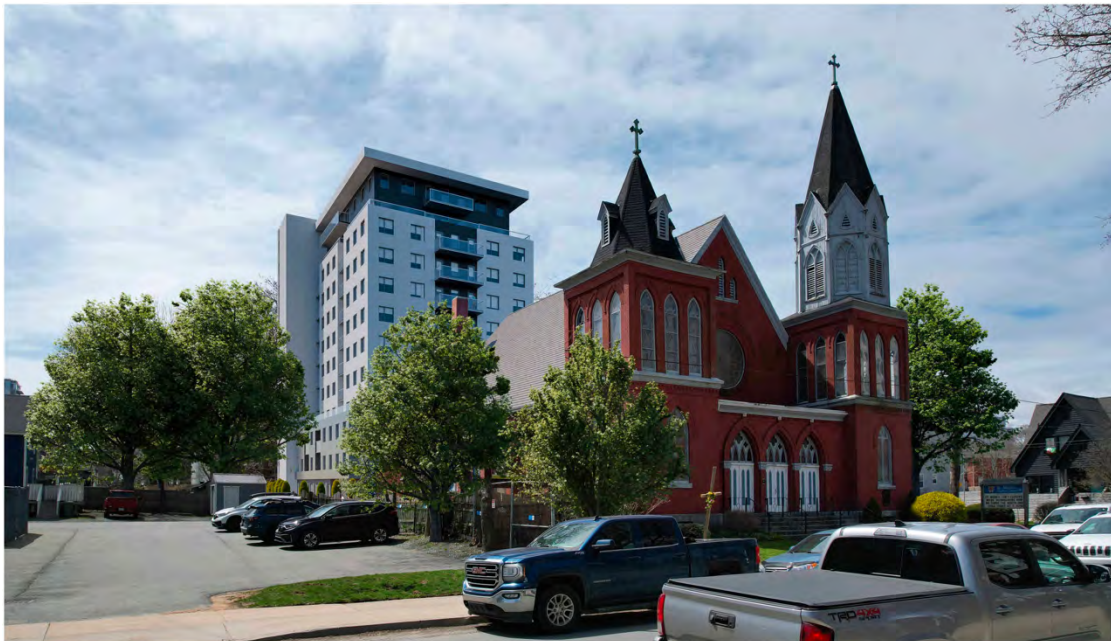
Figure 52: 3D Rendering of front and south side of church

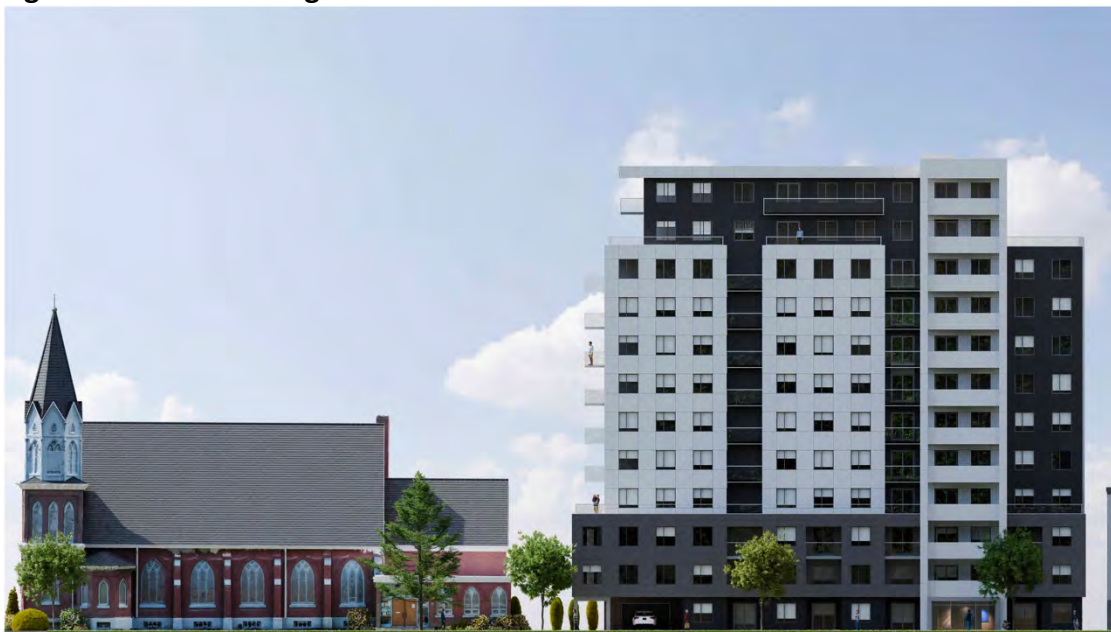
Figure 53: 3D Rendering of north side with full view of church

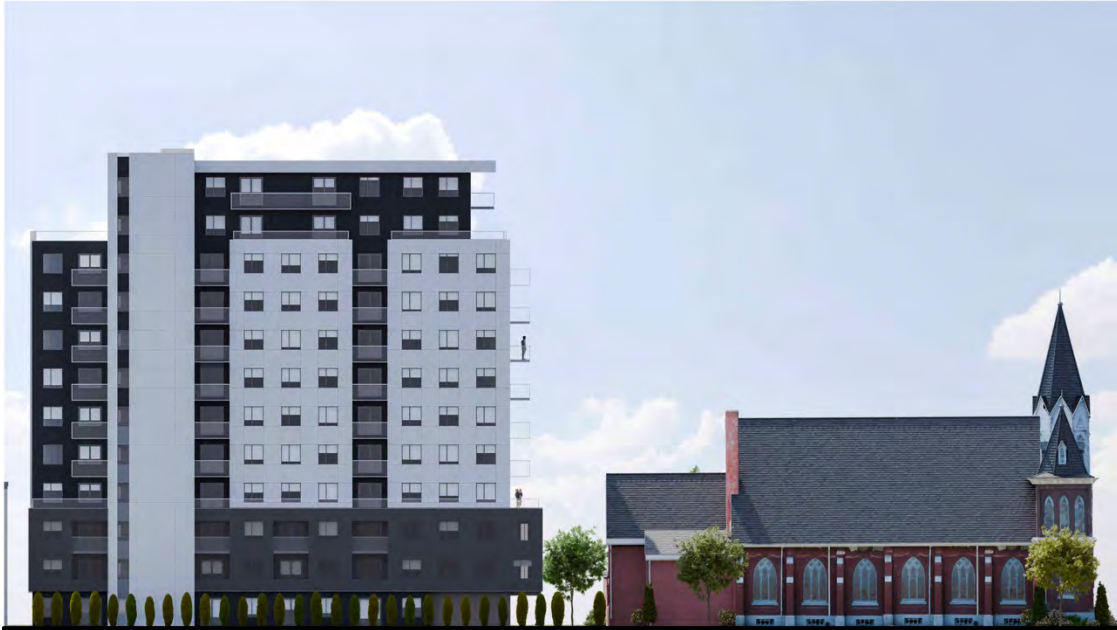
Figure 54: 3D Rendering of south side with full view of church

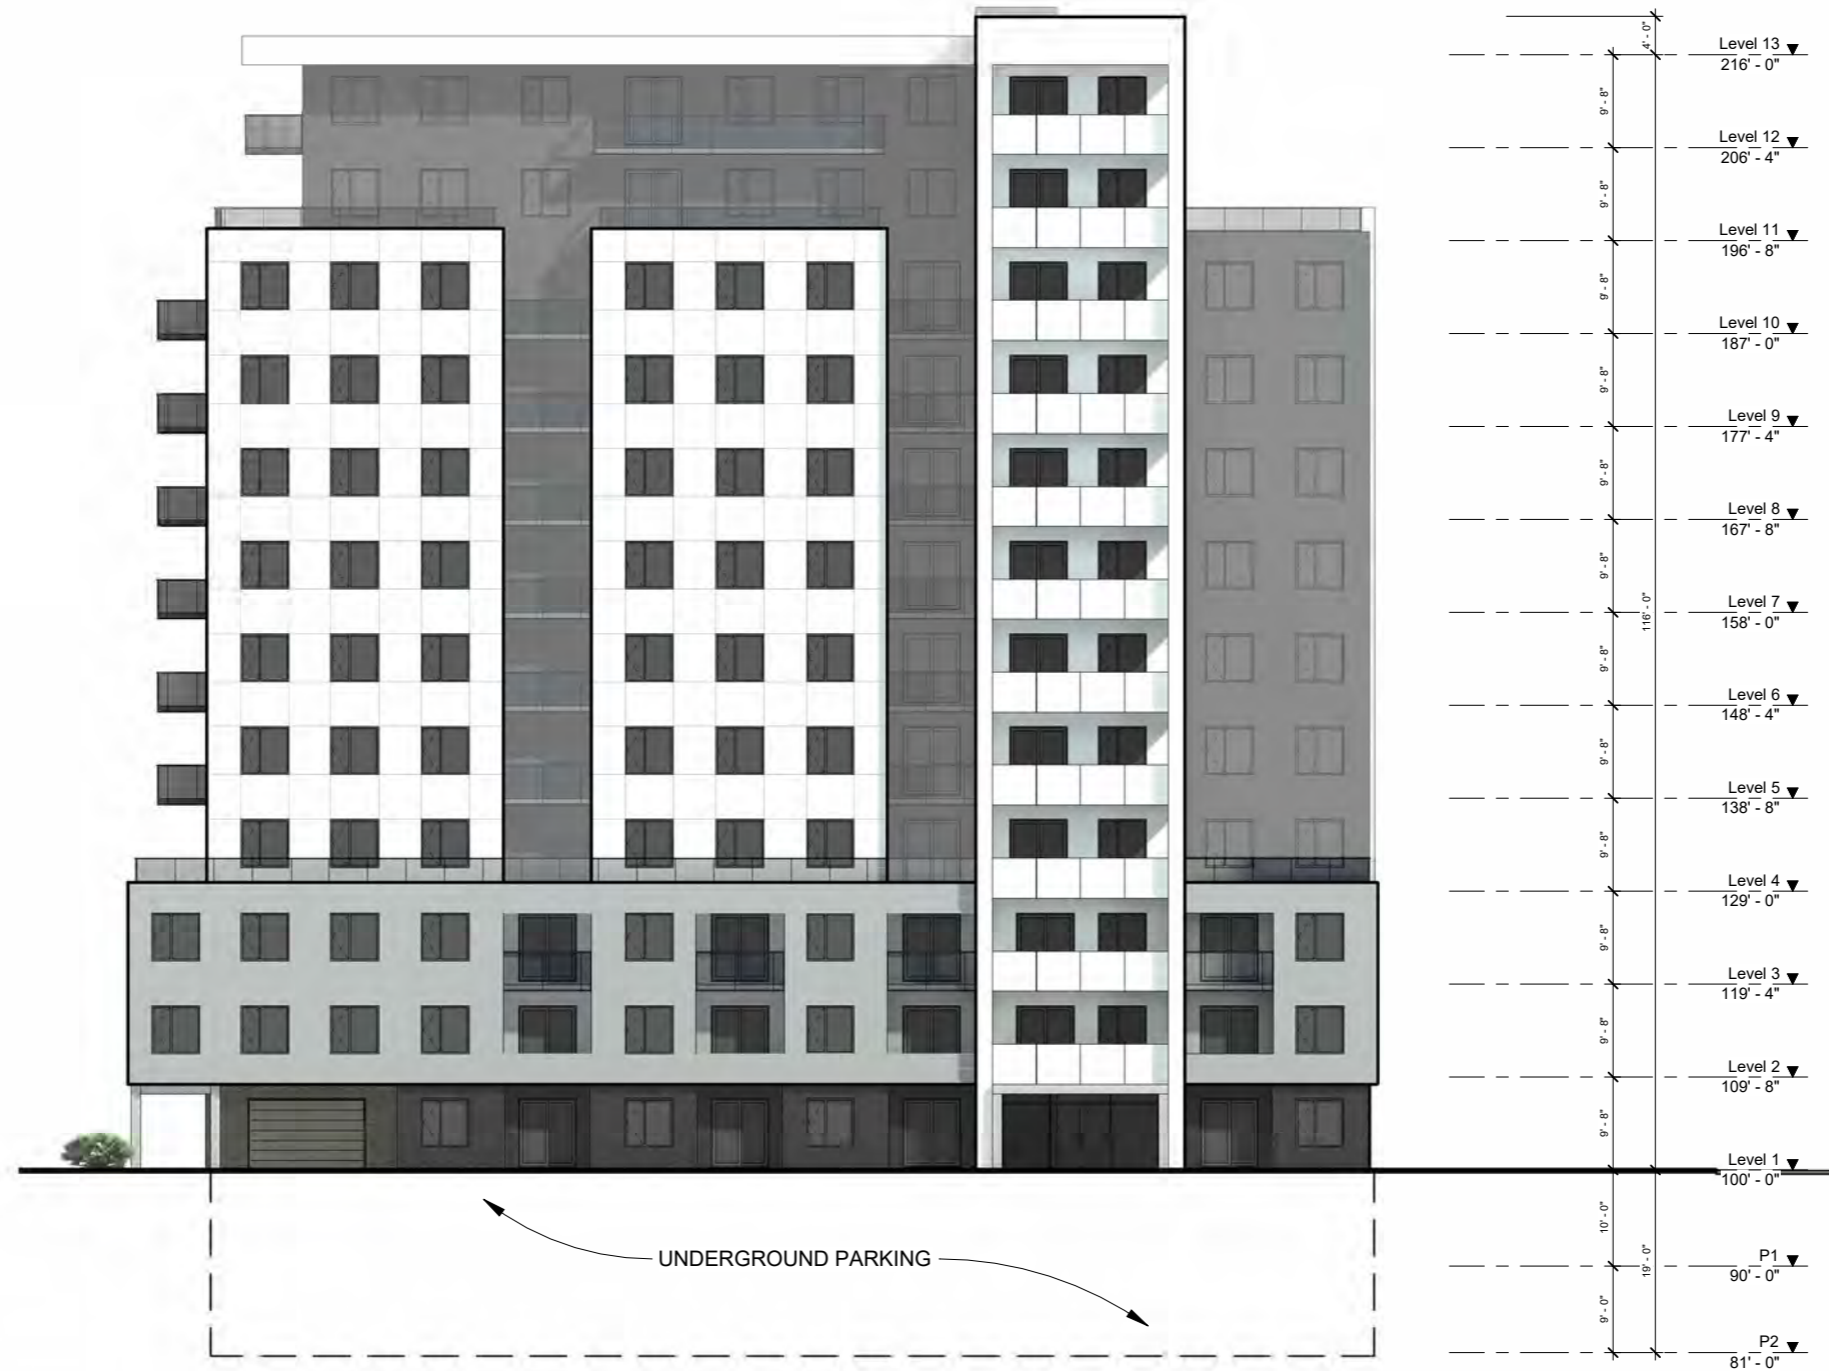
D12

North-West Elevation

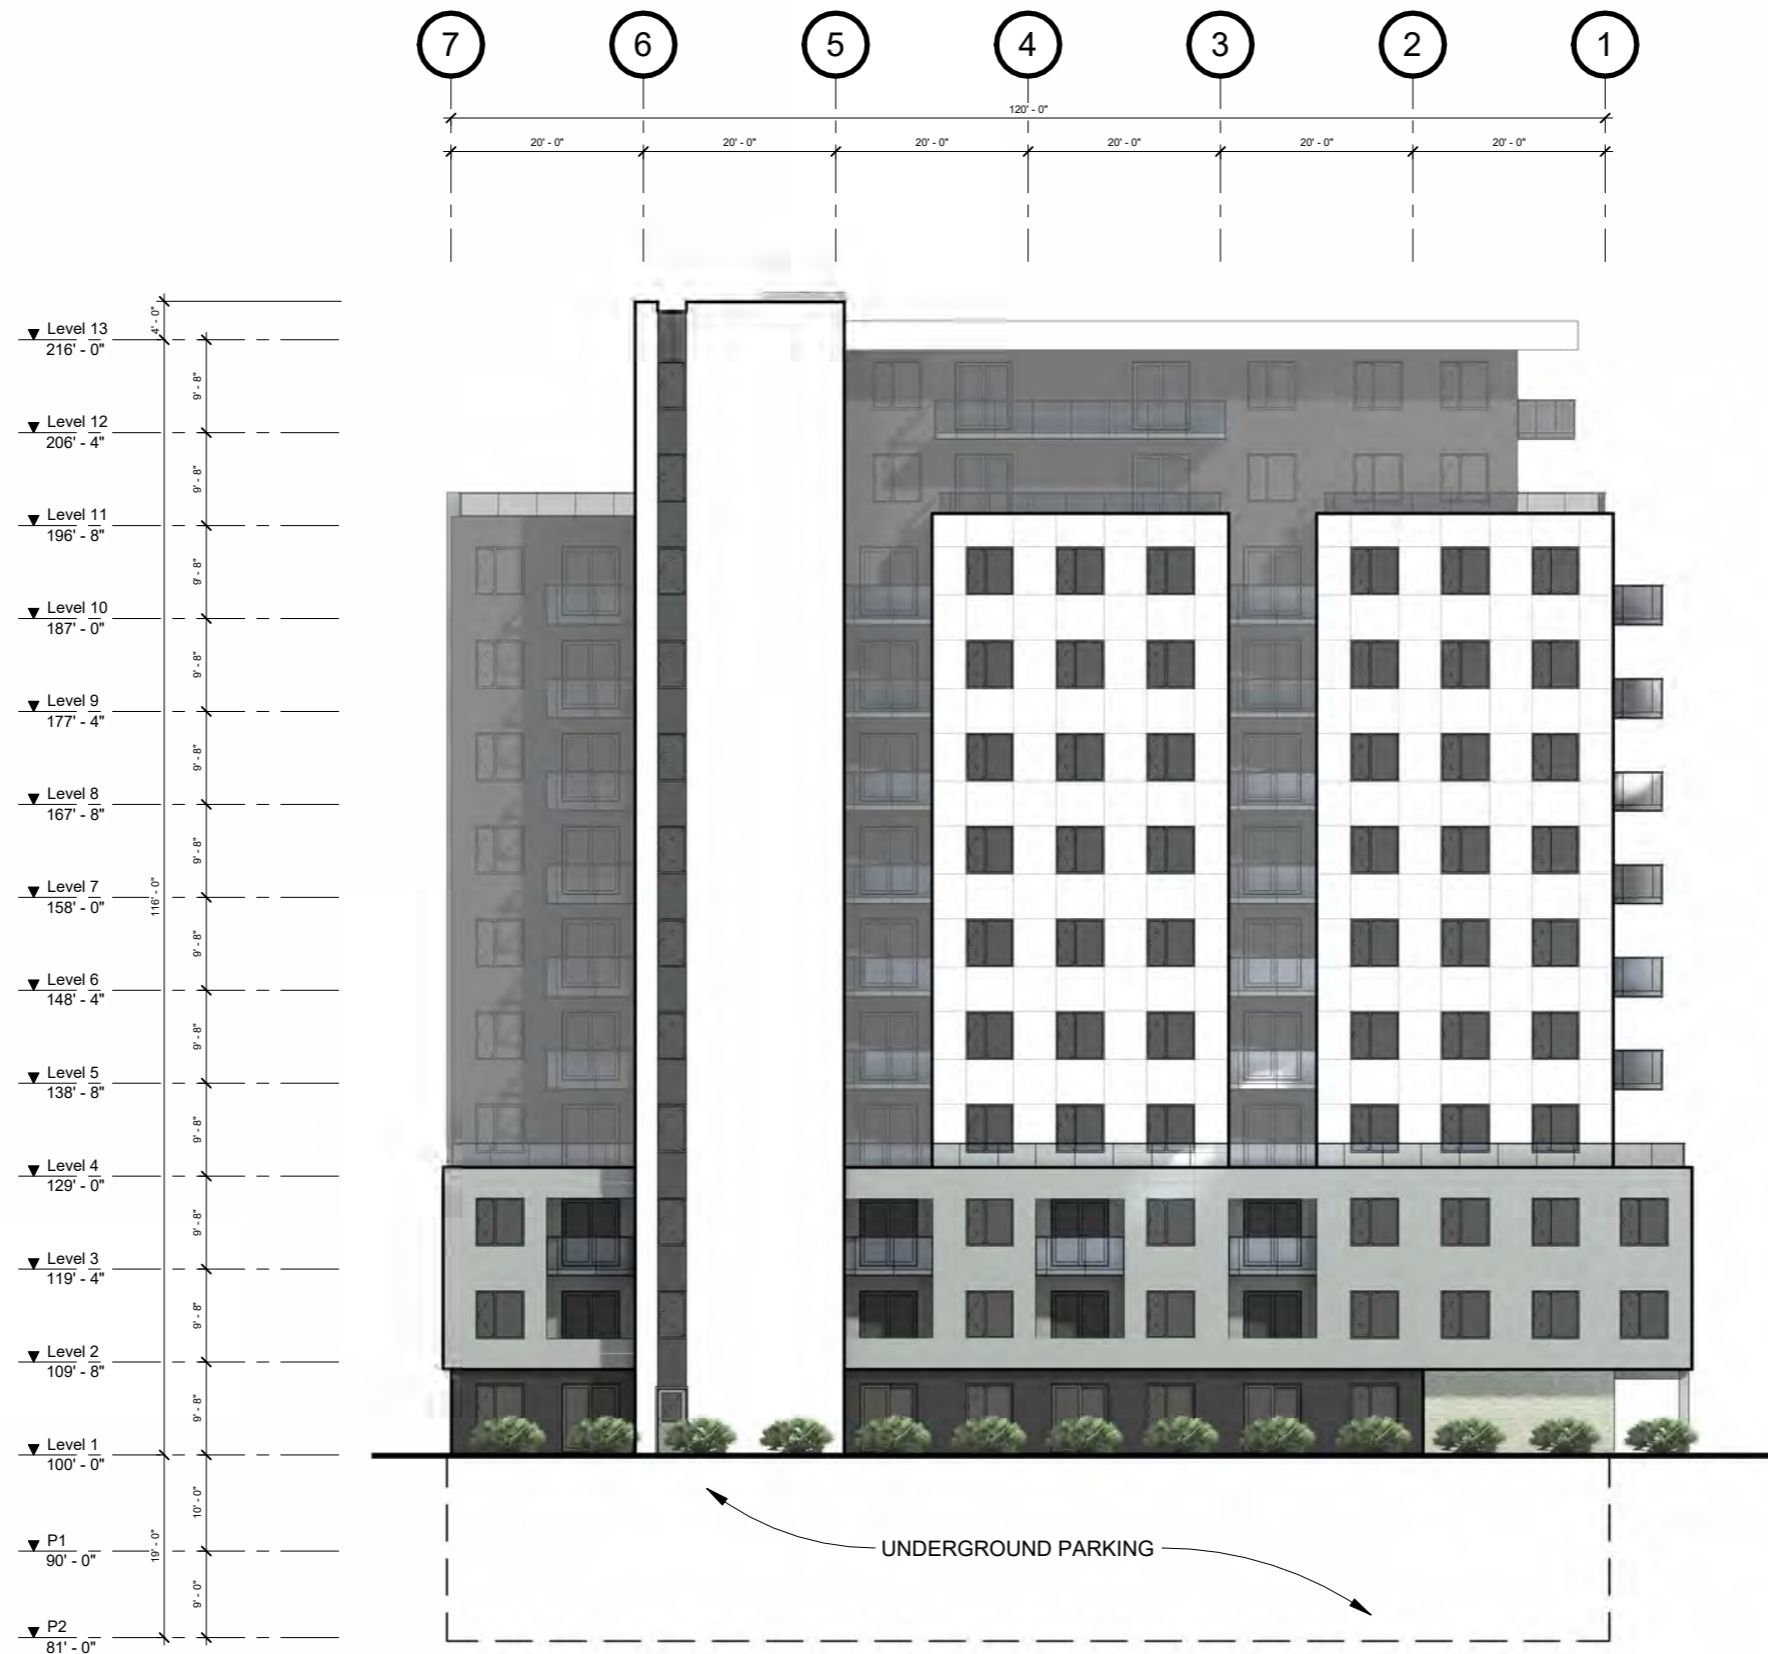
D14

South-East Elevation

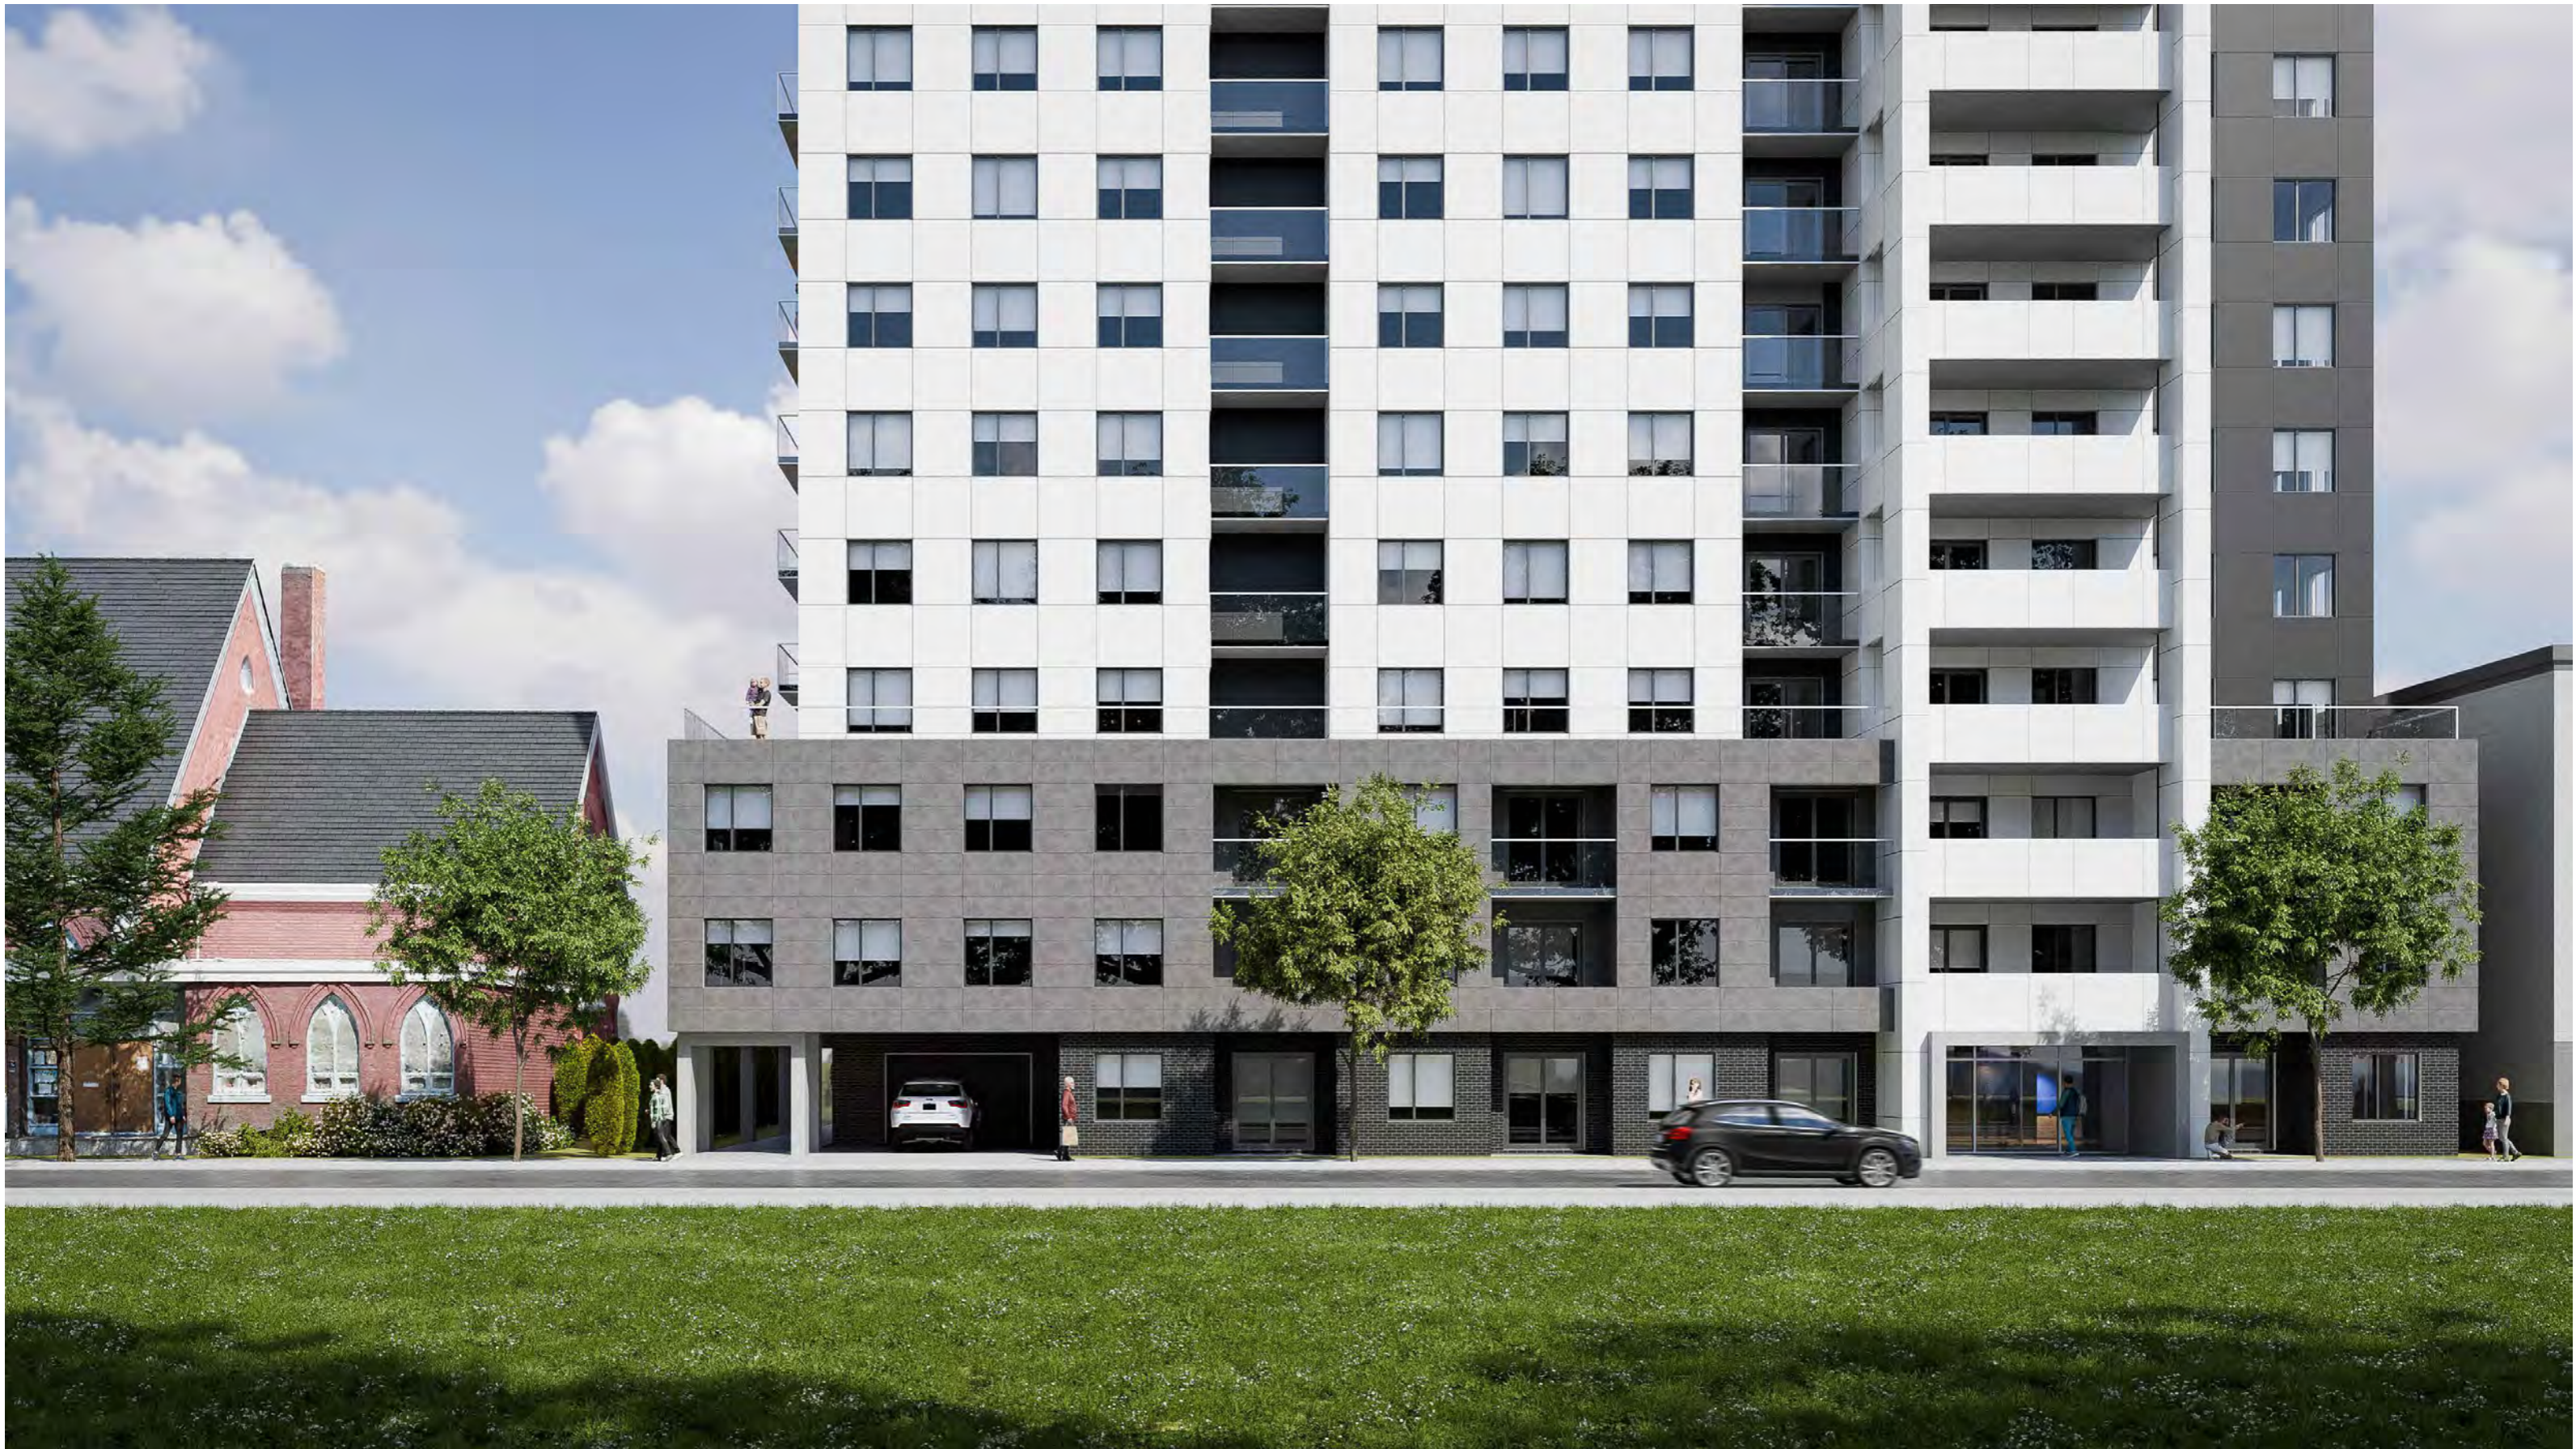
**D16**

Streetwall Perspective

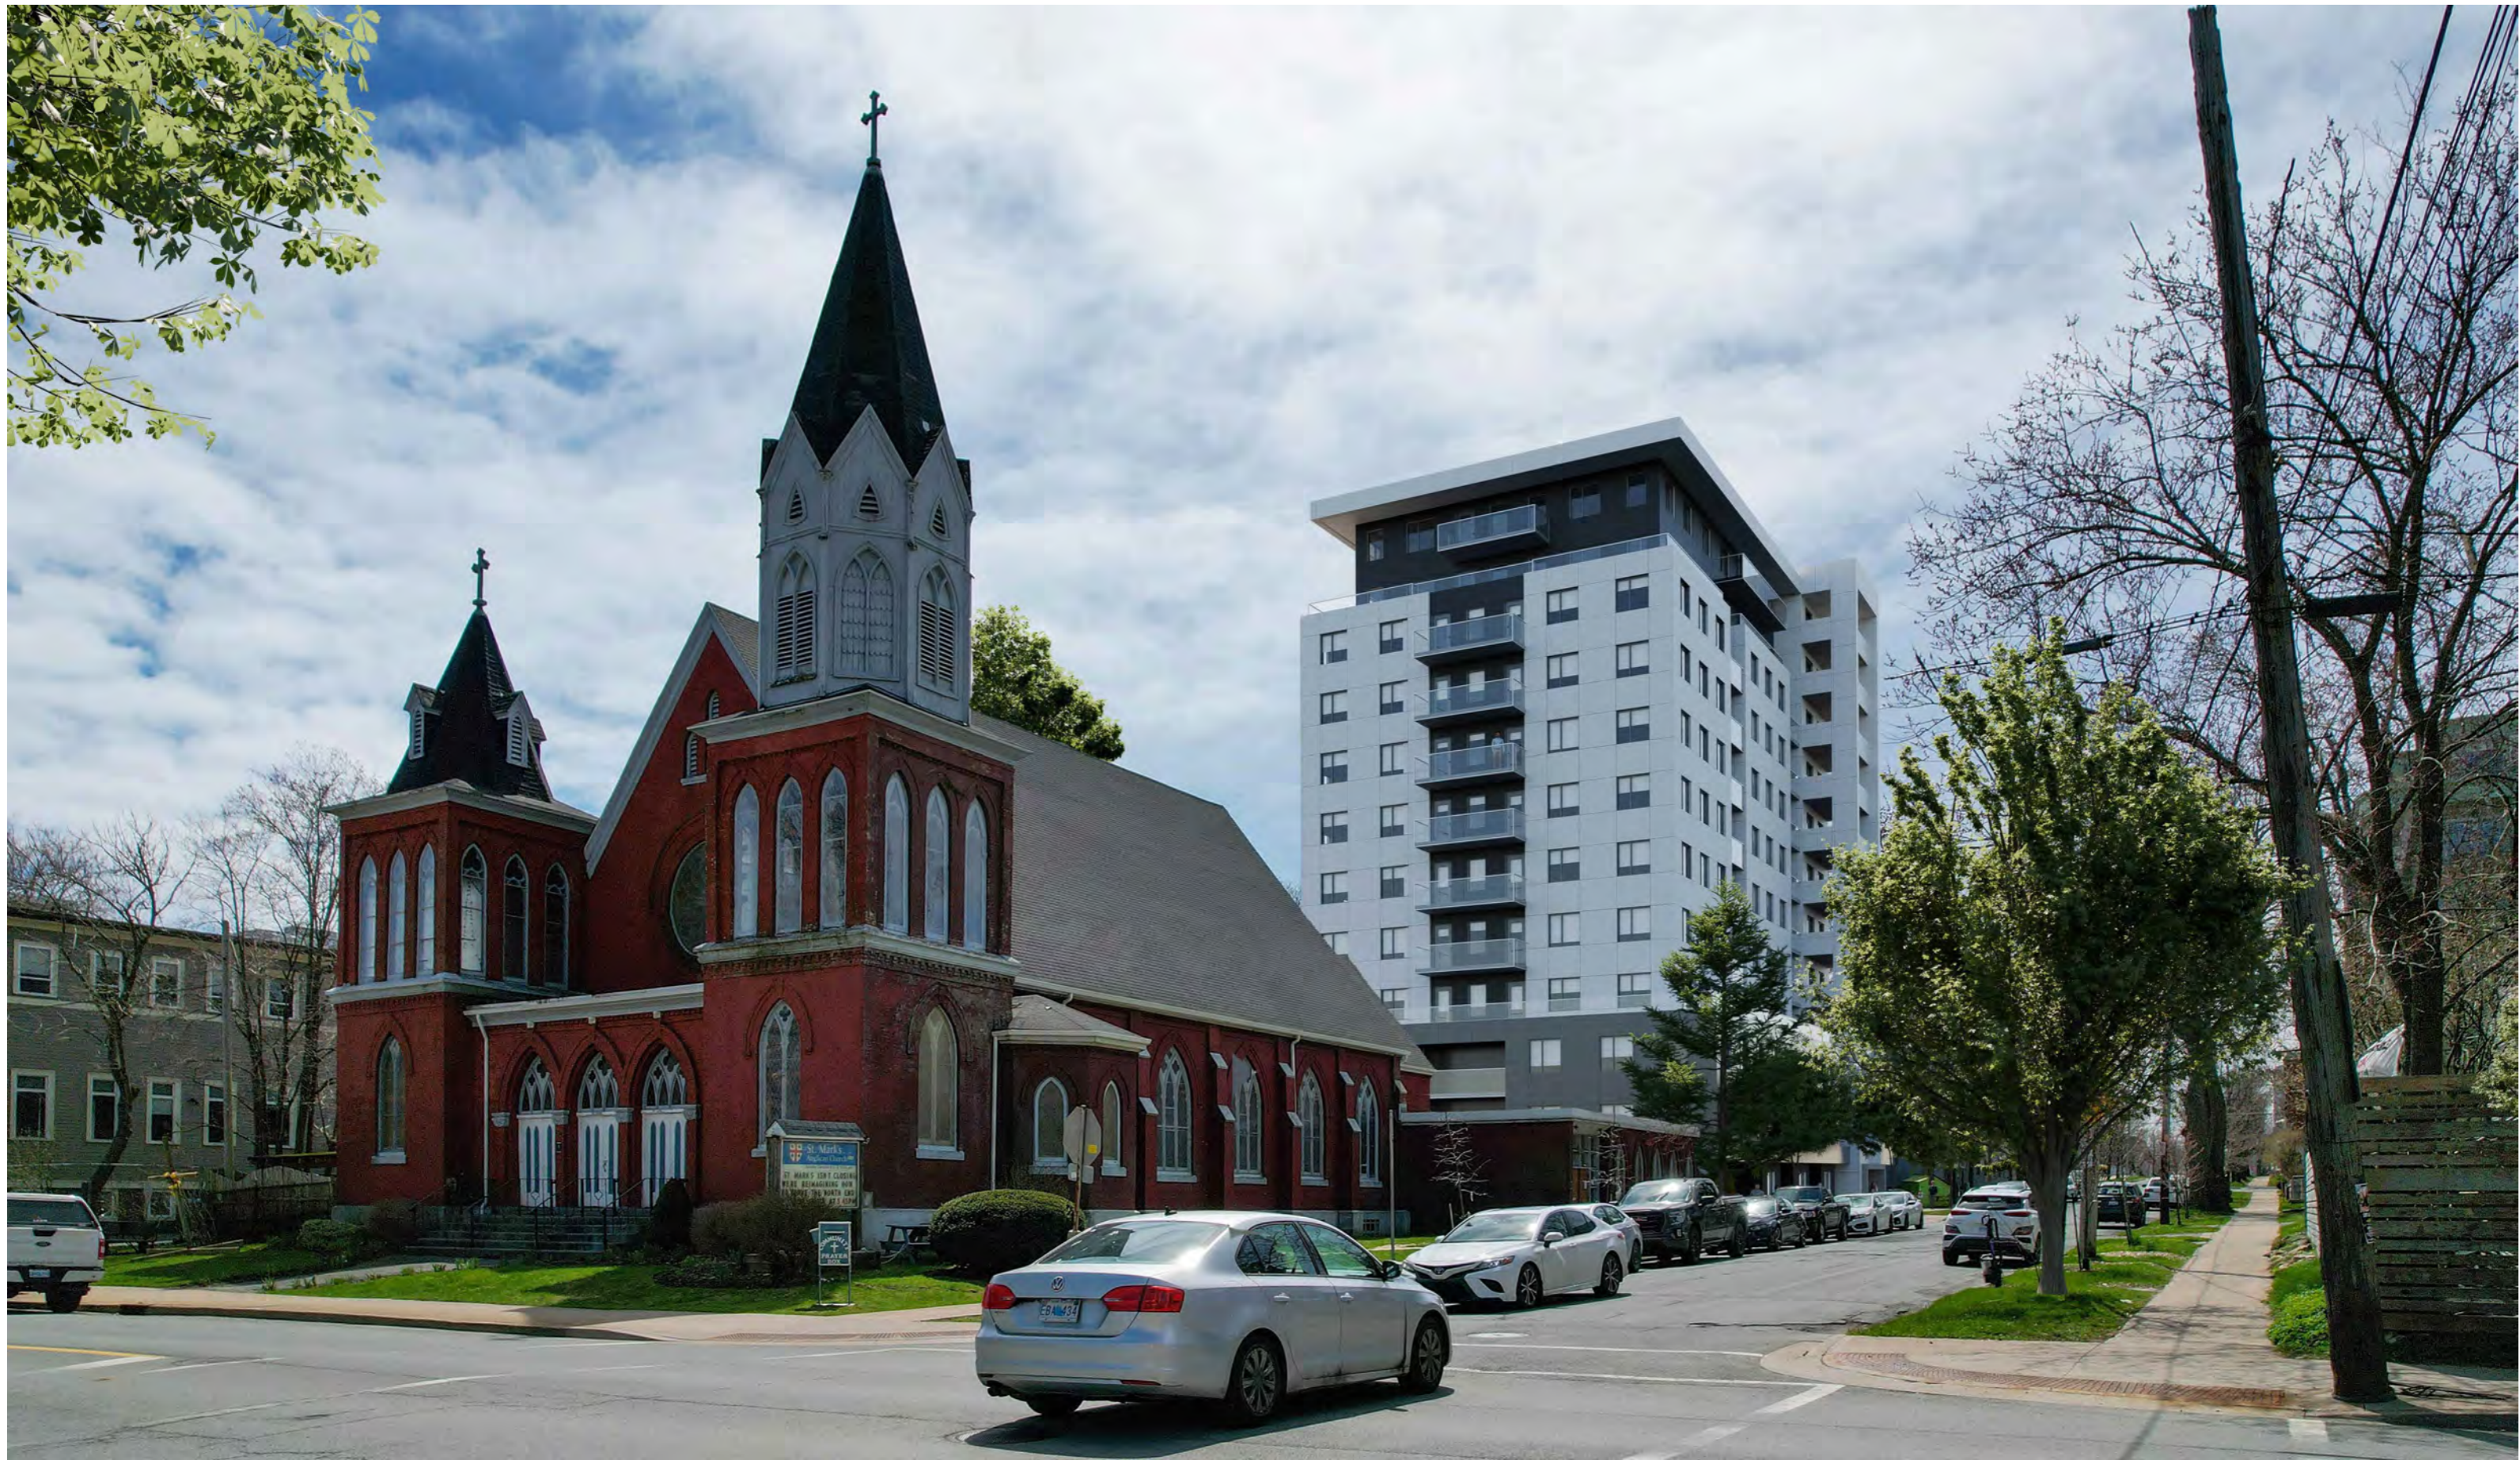
**D17**

Russell + Gottingen Intersection
