**SUBJECT:** **Case HRTG-2023-00201: Substantial Alteration to St Mark's Church, a registered municipal heritage property at 5522 Russell Street, Halifax**

# Heritage Impact Statement

St. Mark's Church, 5522 Russell Street, Halifax

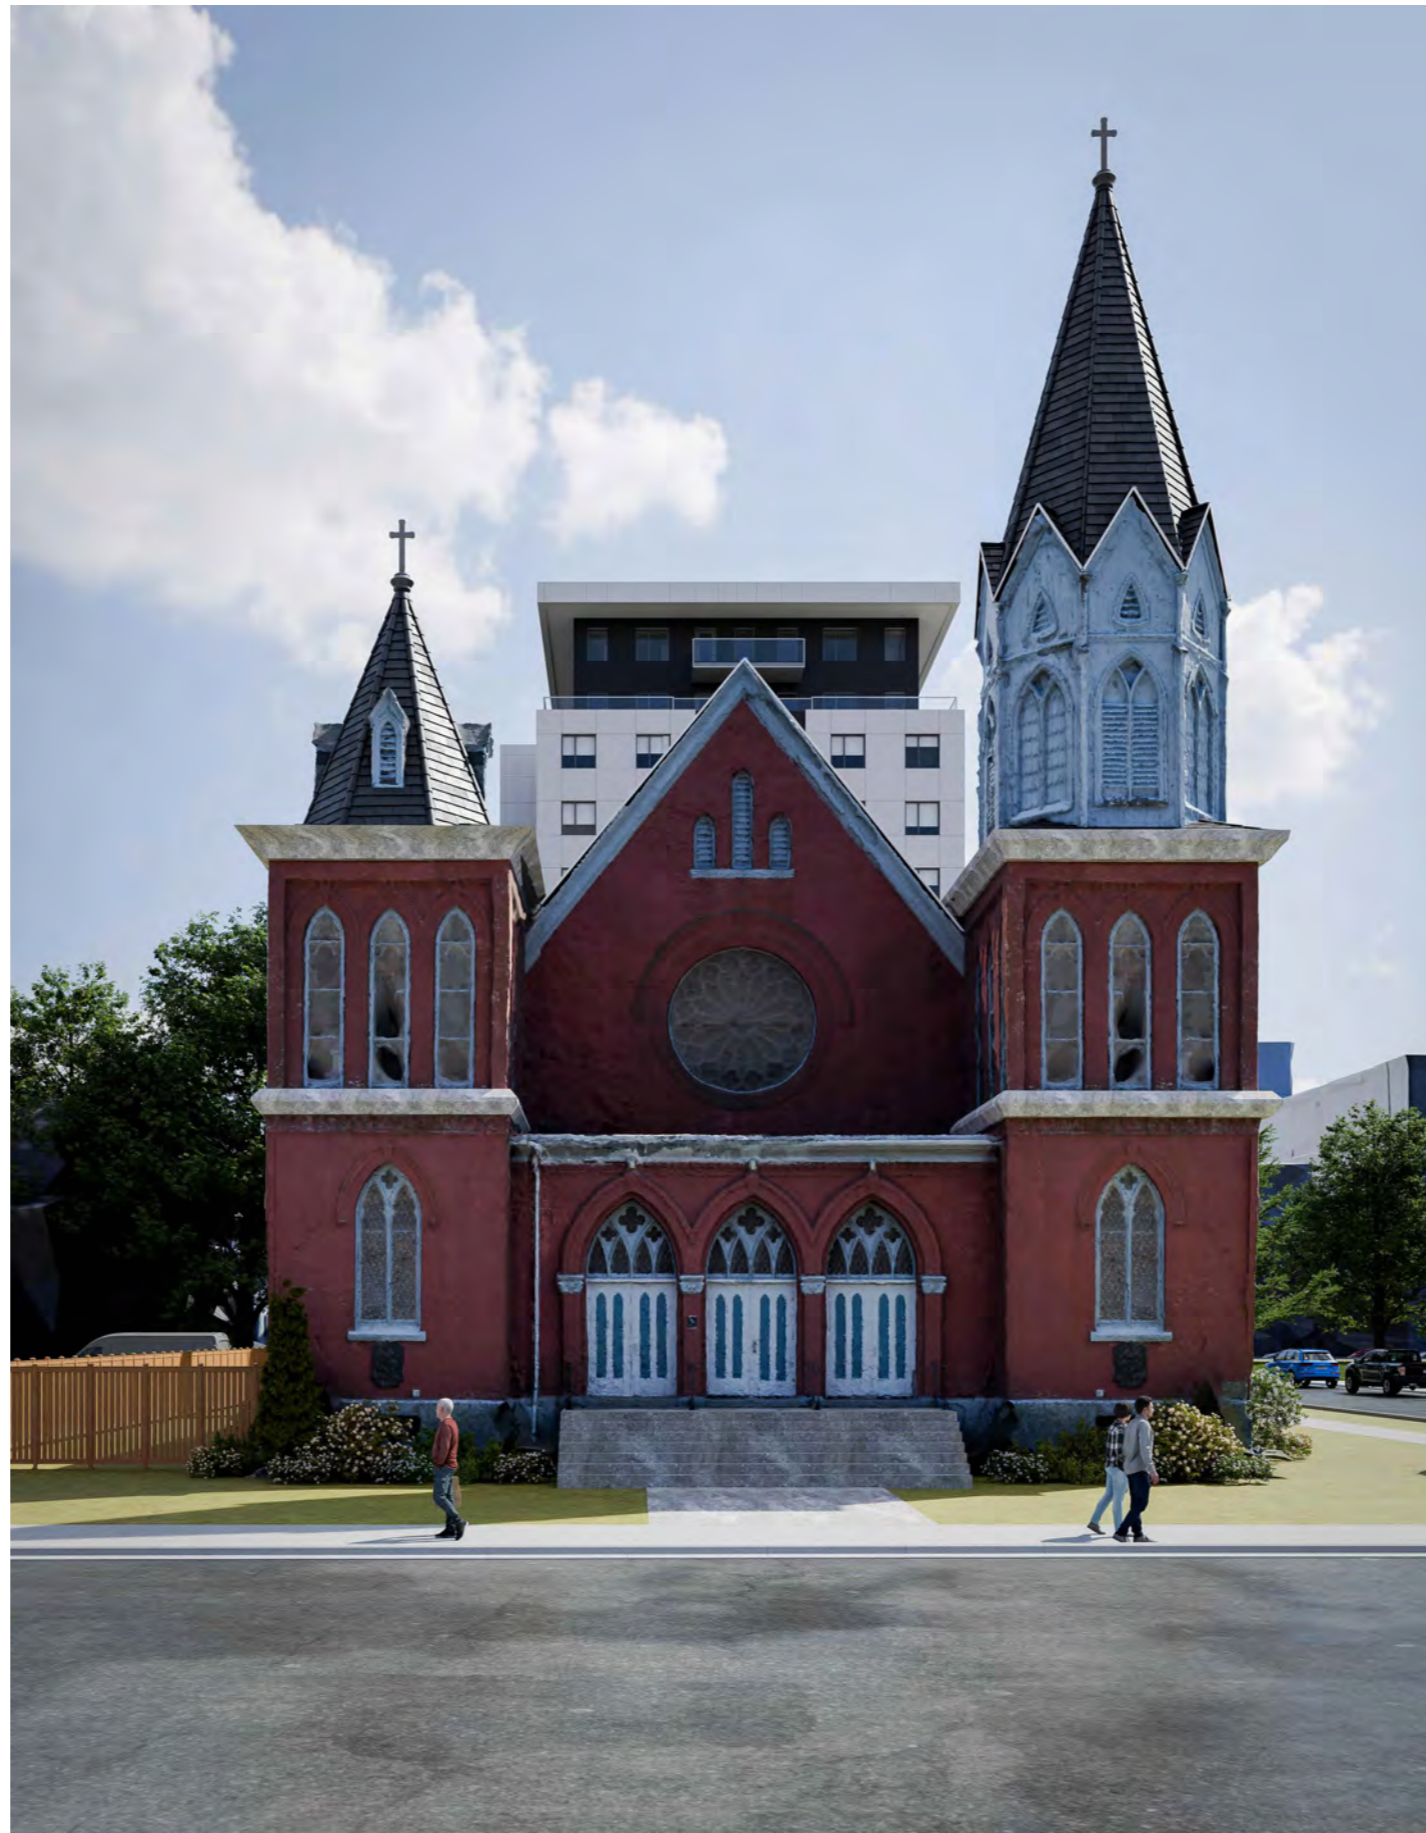
D18

Gottingen Street 1

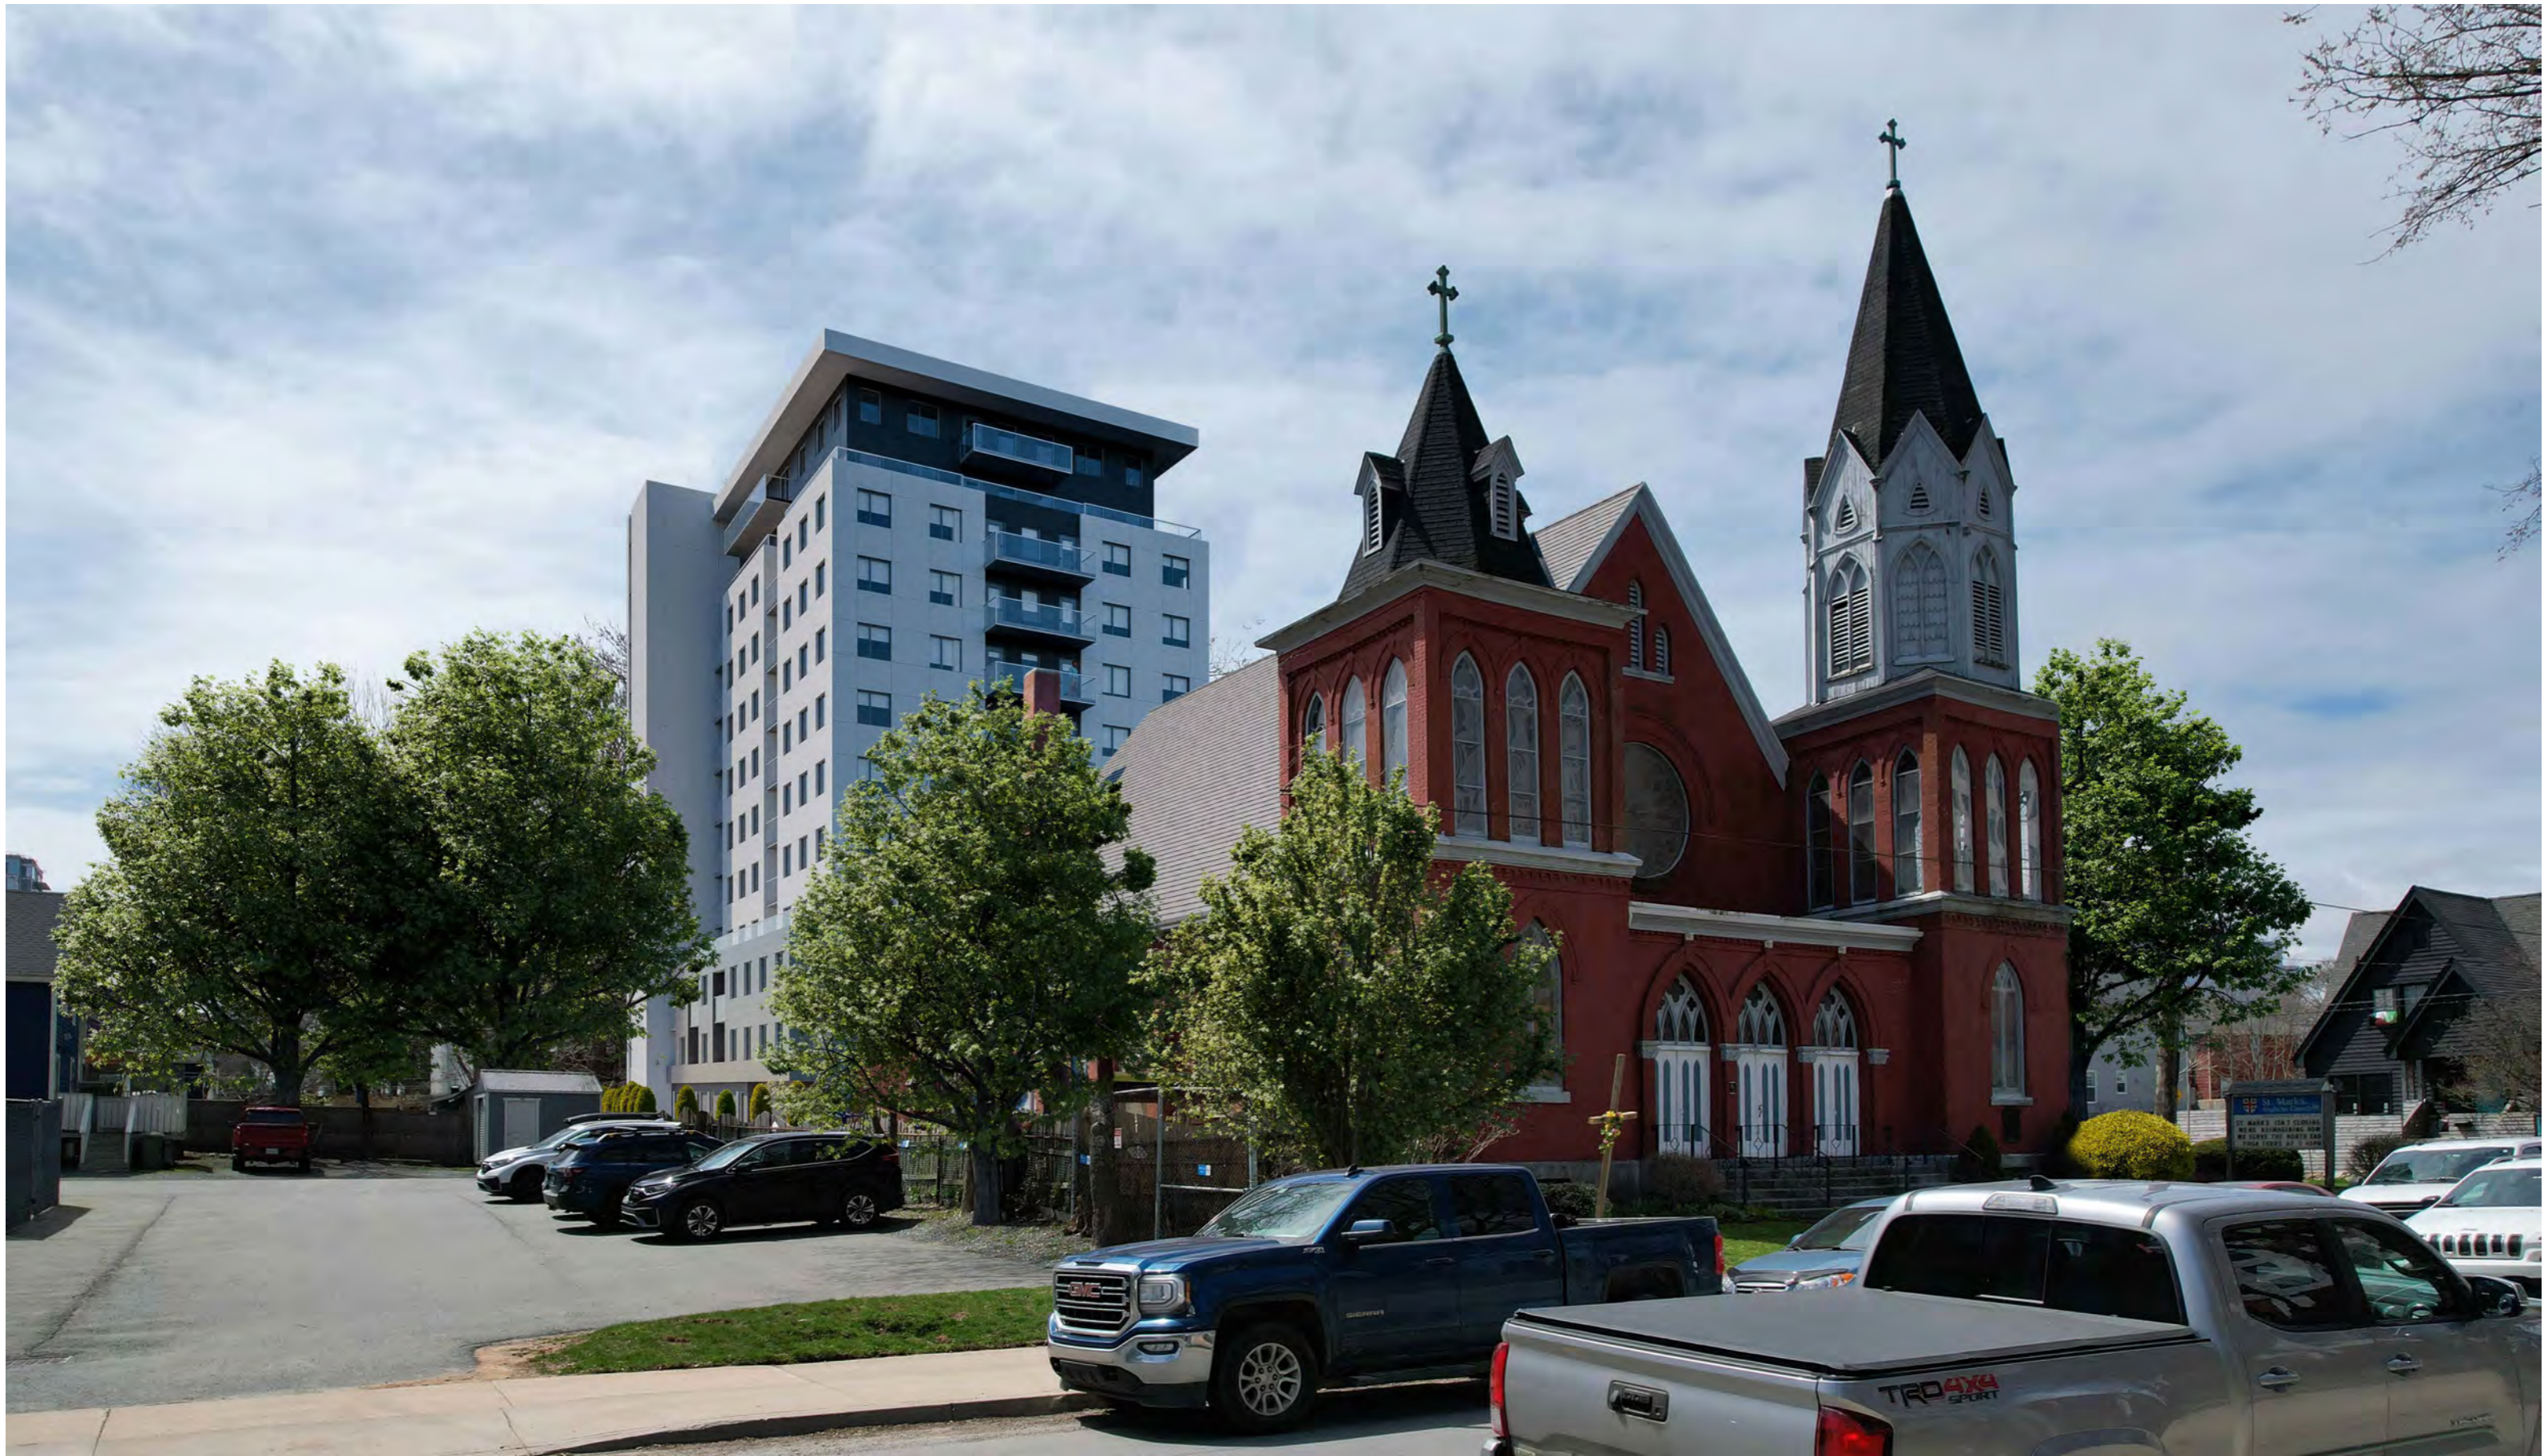
D19

Gottingen Street 2

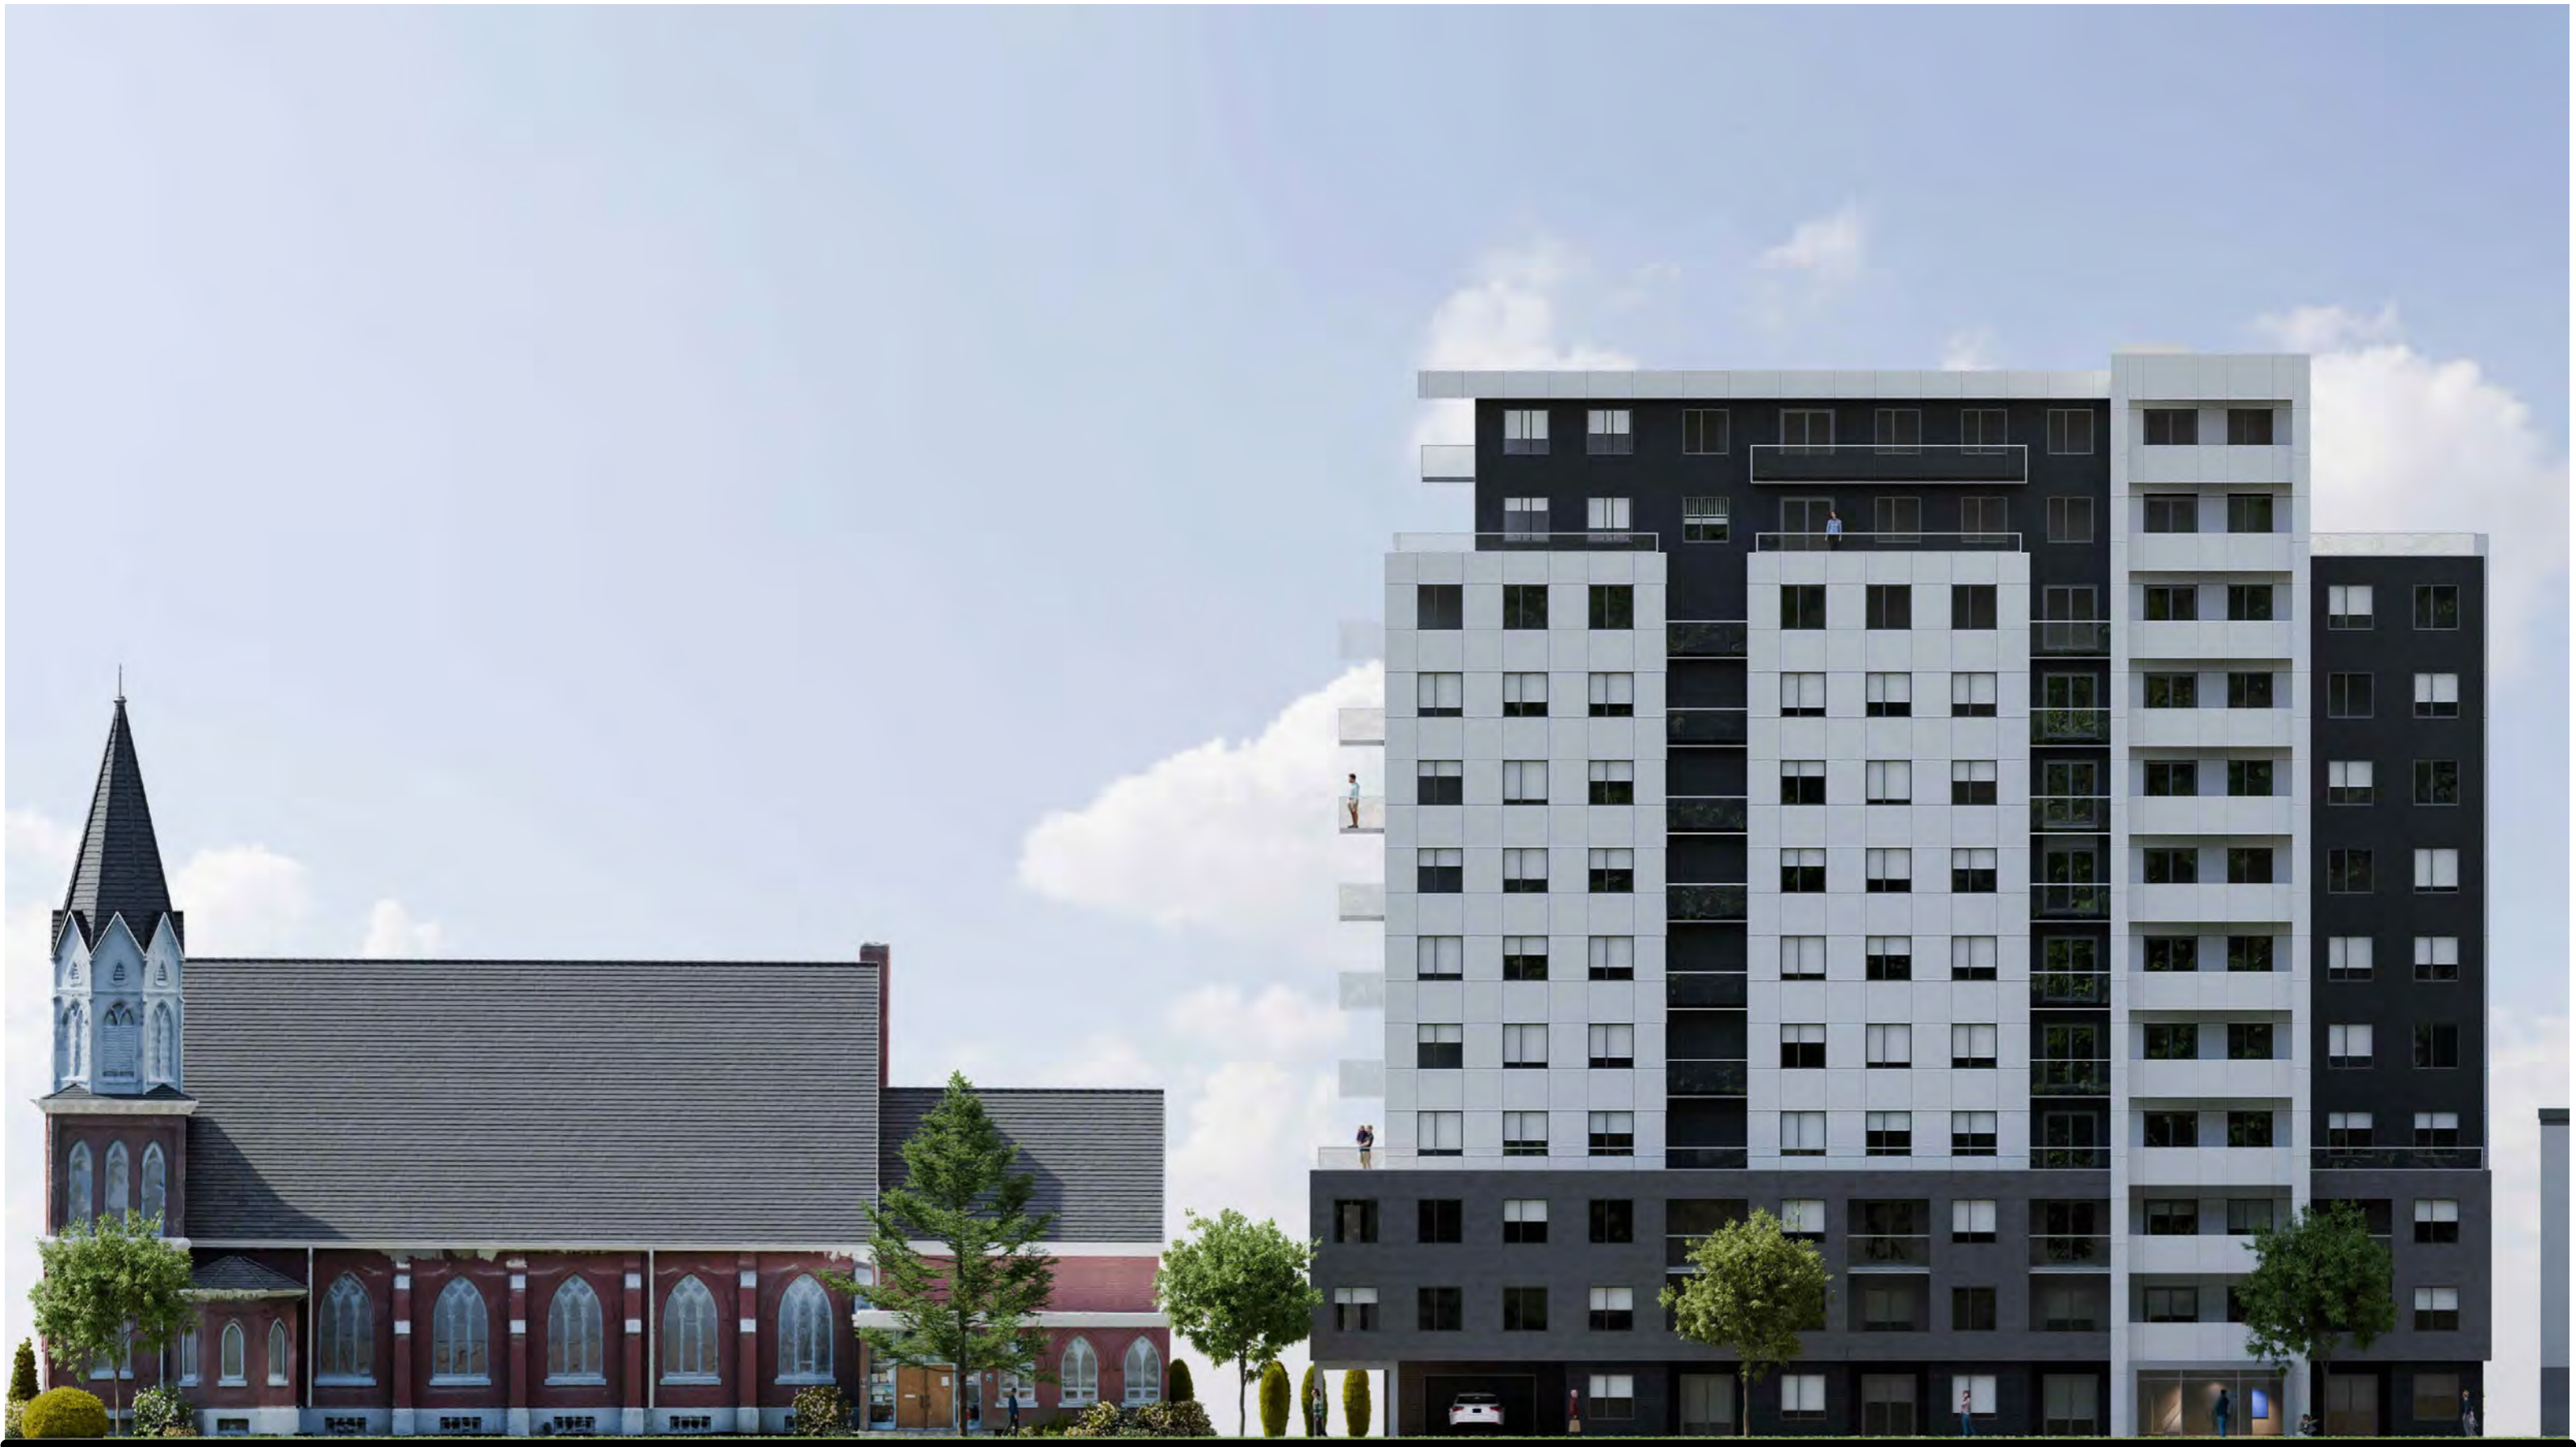
D20

North-West Elevation

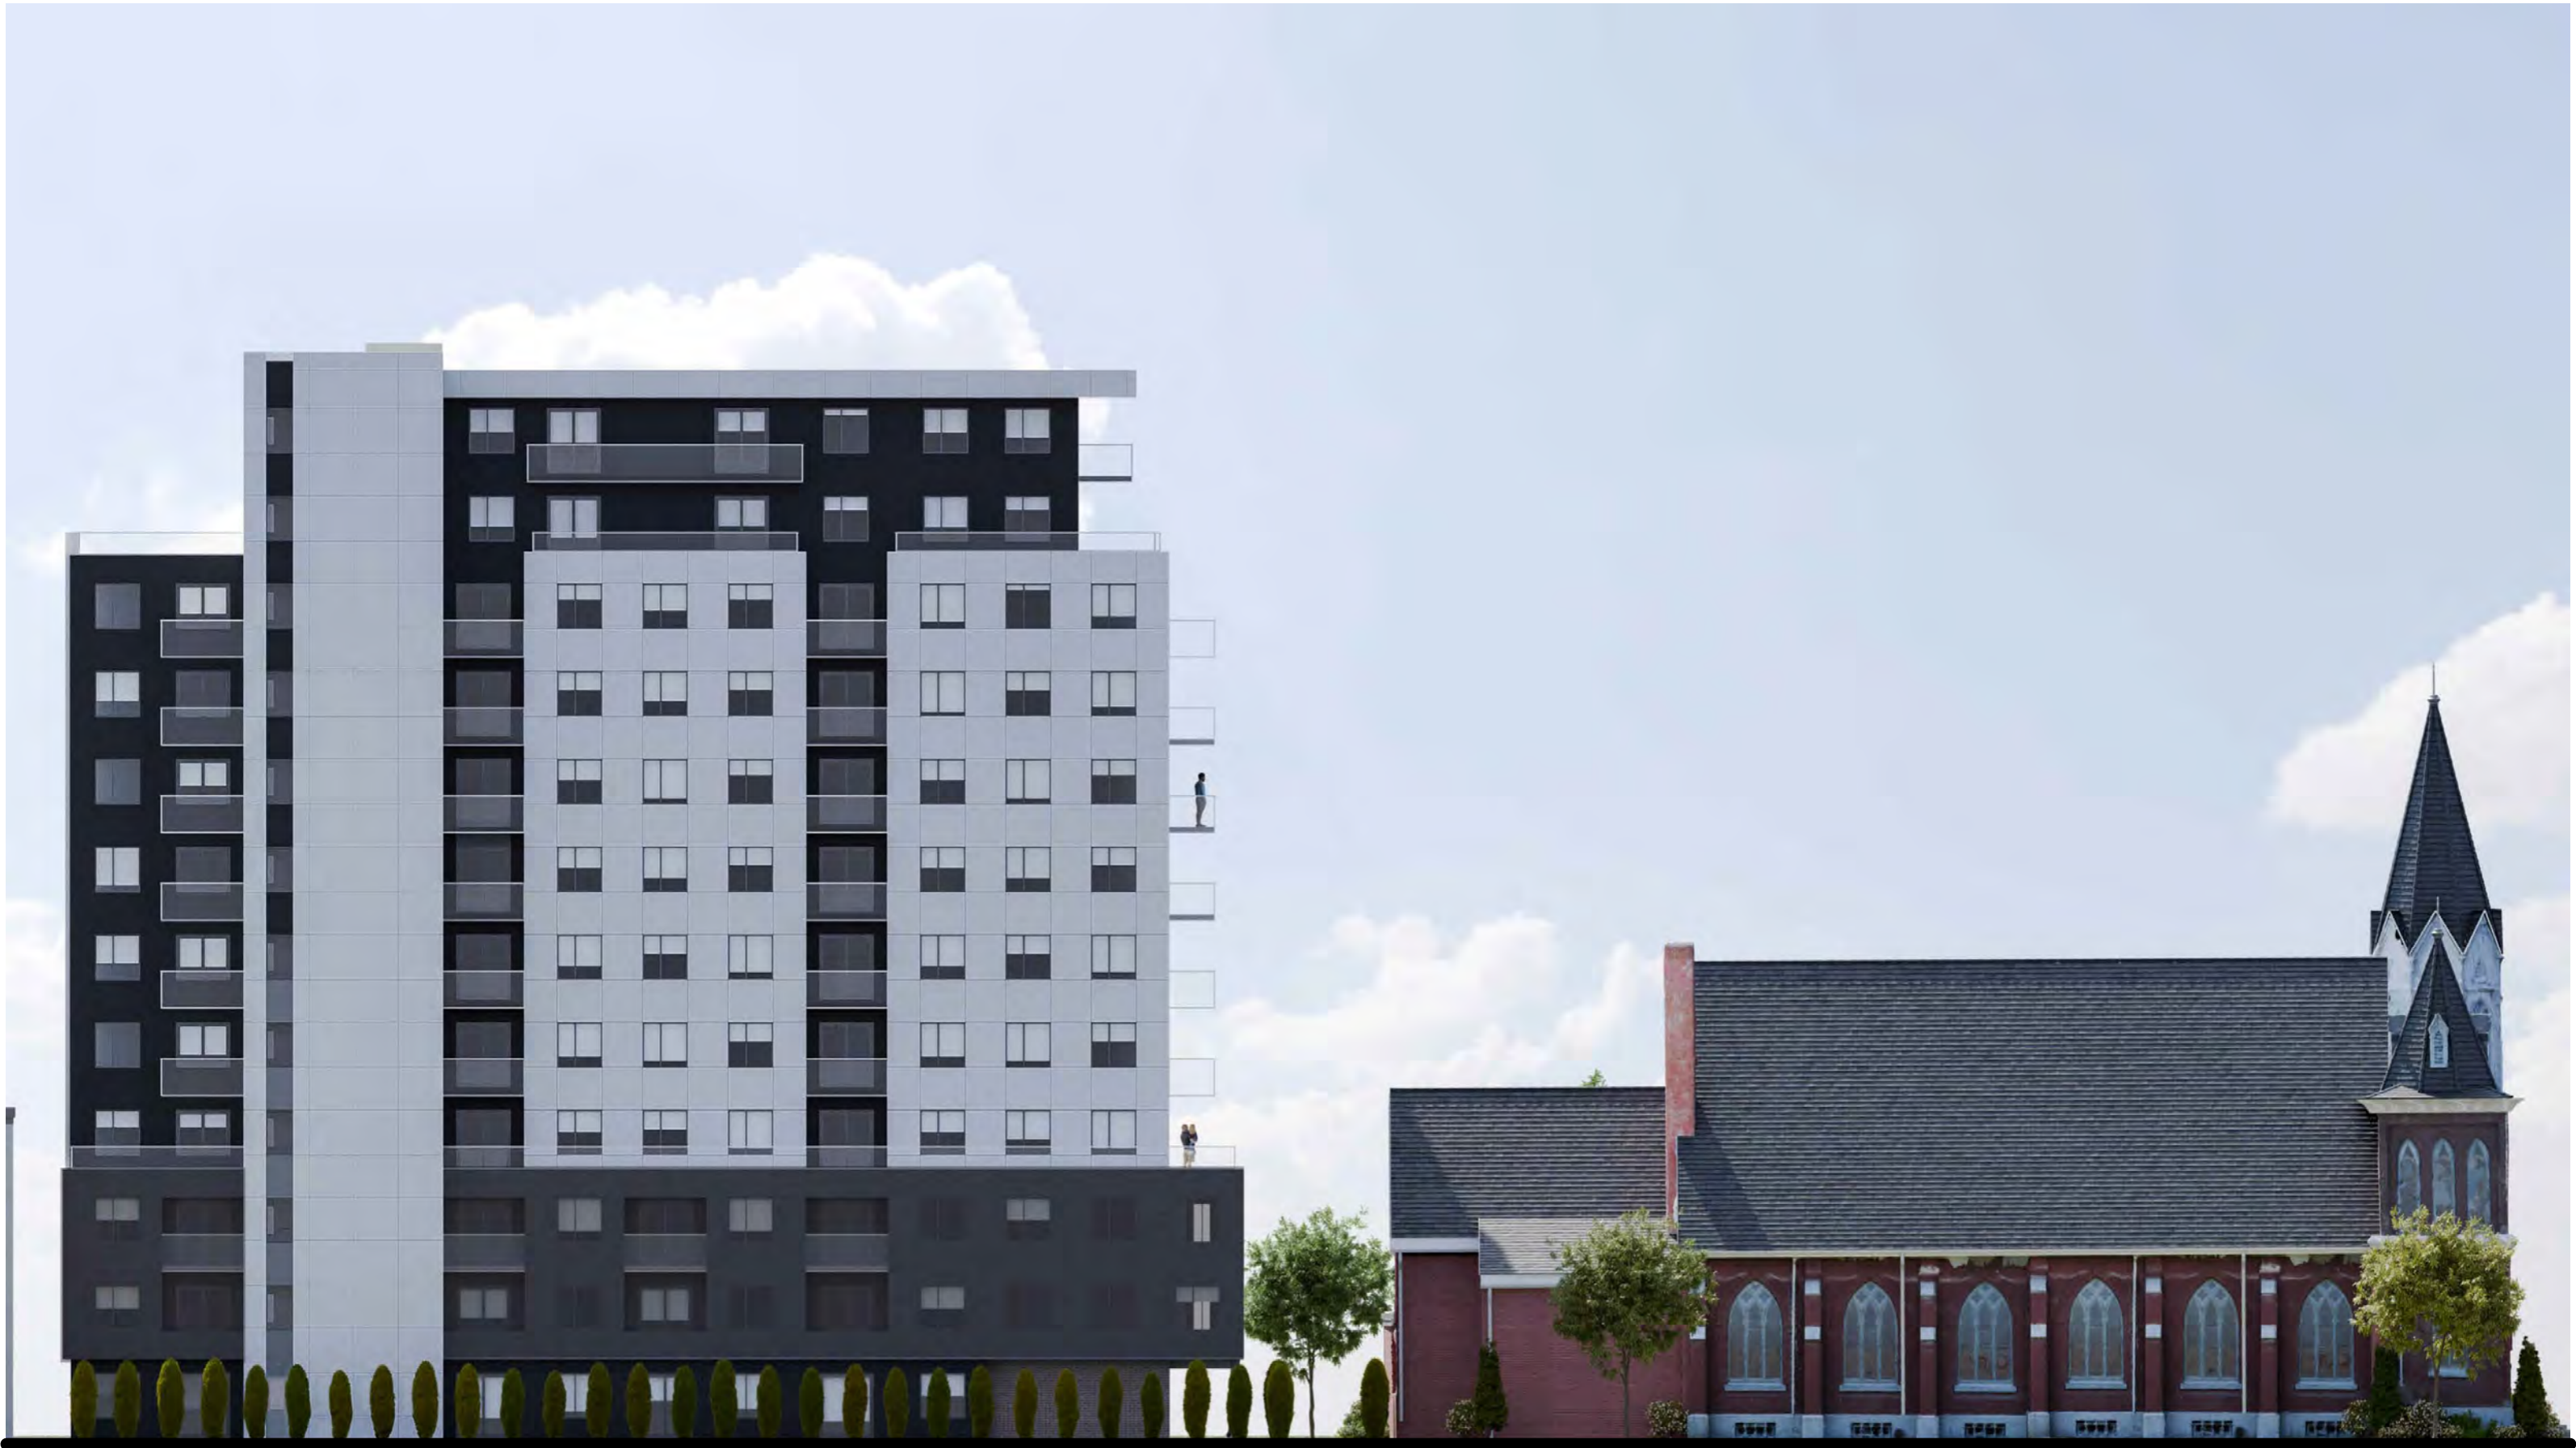
South-East Elevation
