**Item No. 1**  
**North West Community Council**  
**July 11, 2016**  
**August 8, 2016**

**SUBJECT:** Bedford West Total Phosphorus Threshold Exceedance – Spring 2016

### INFORMATION REPORT

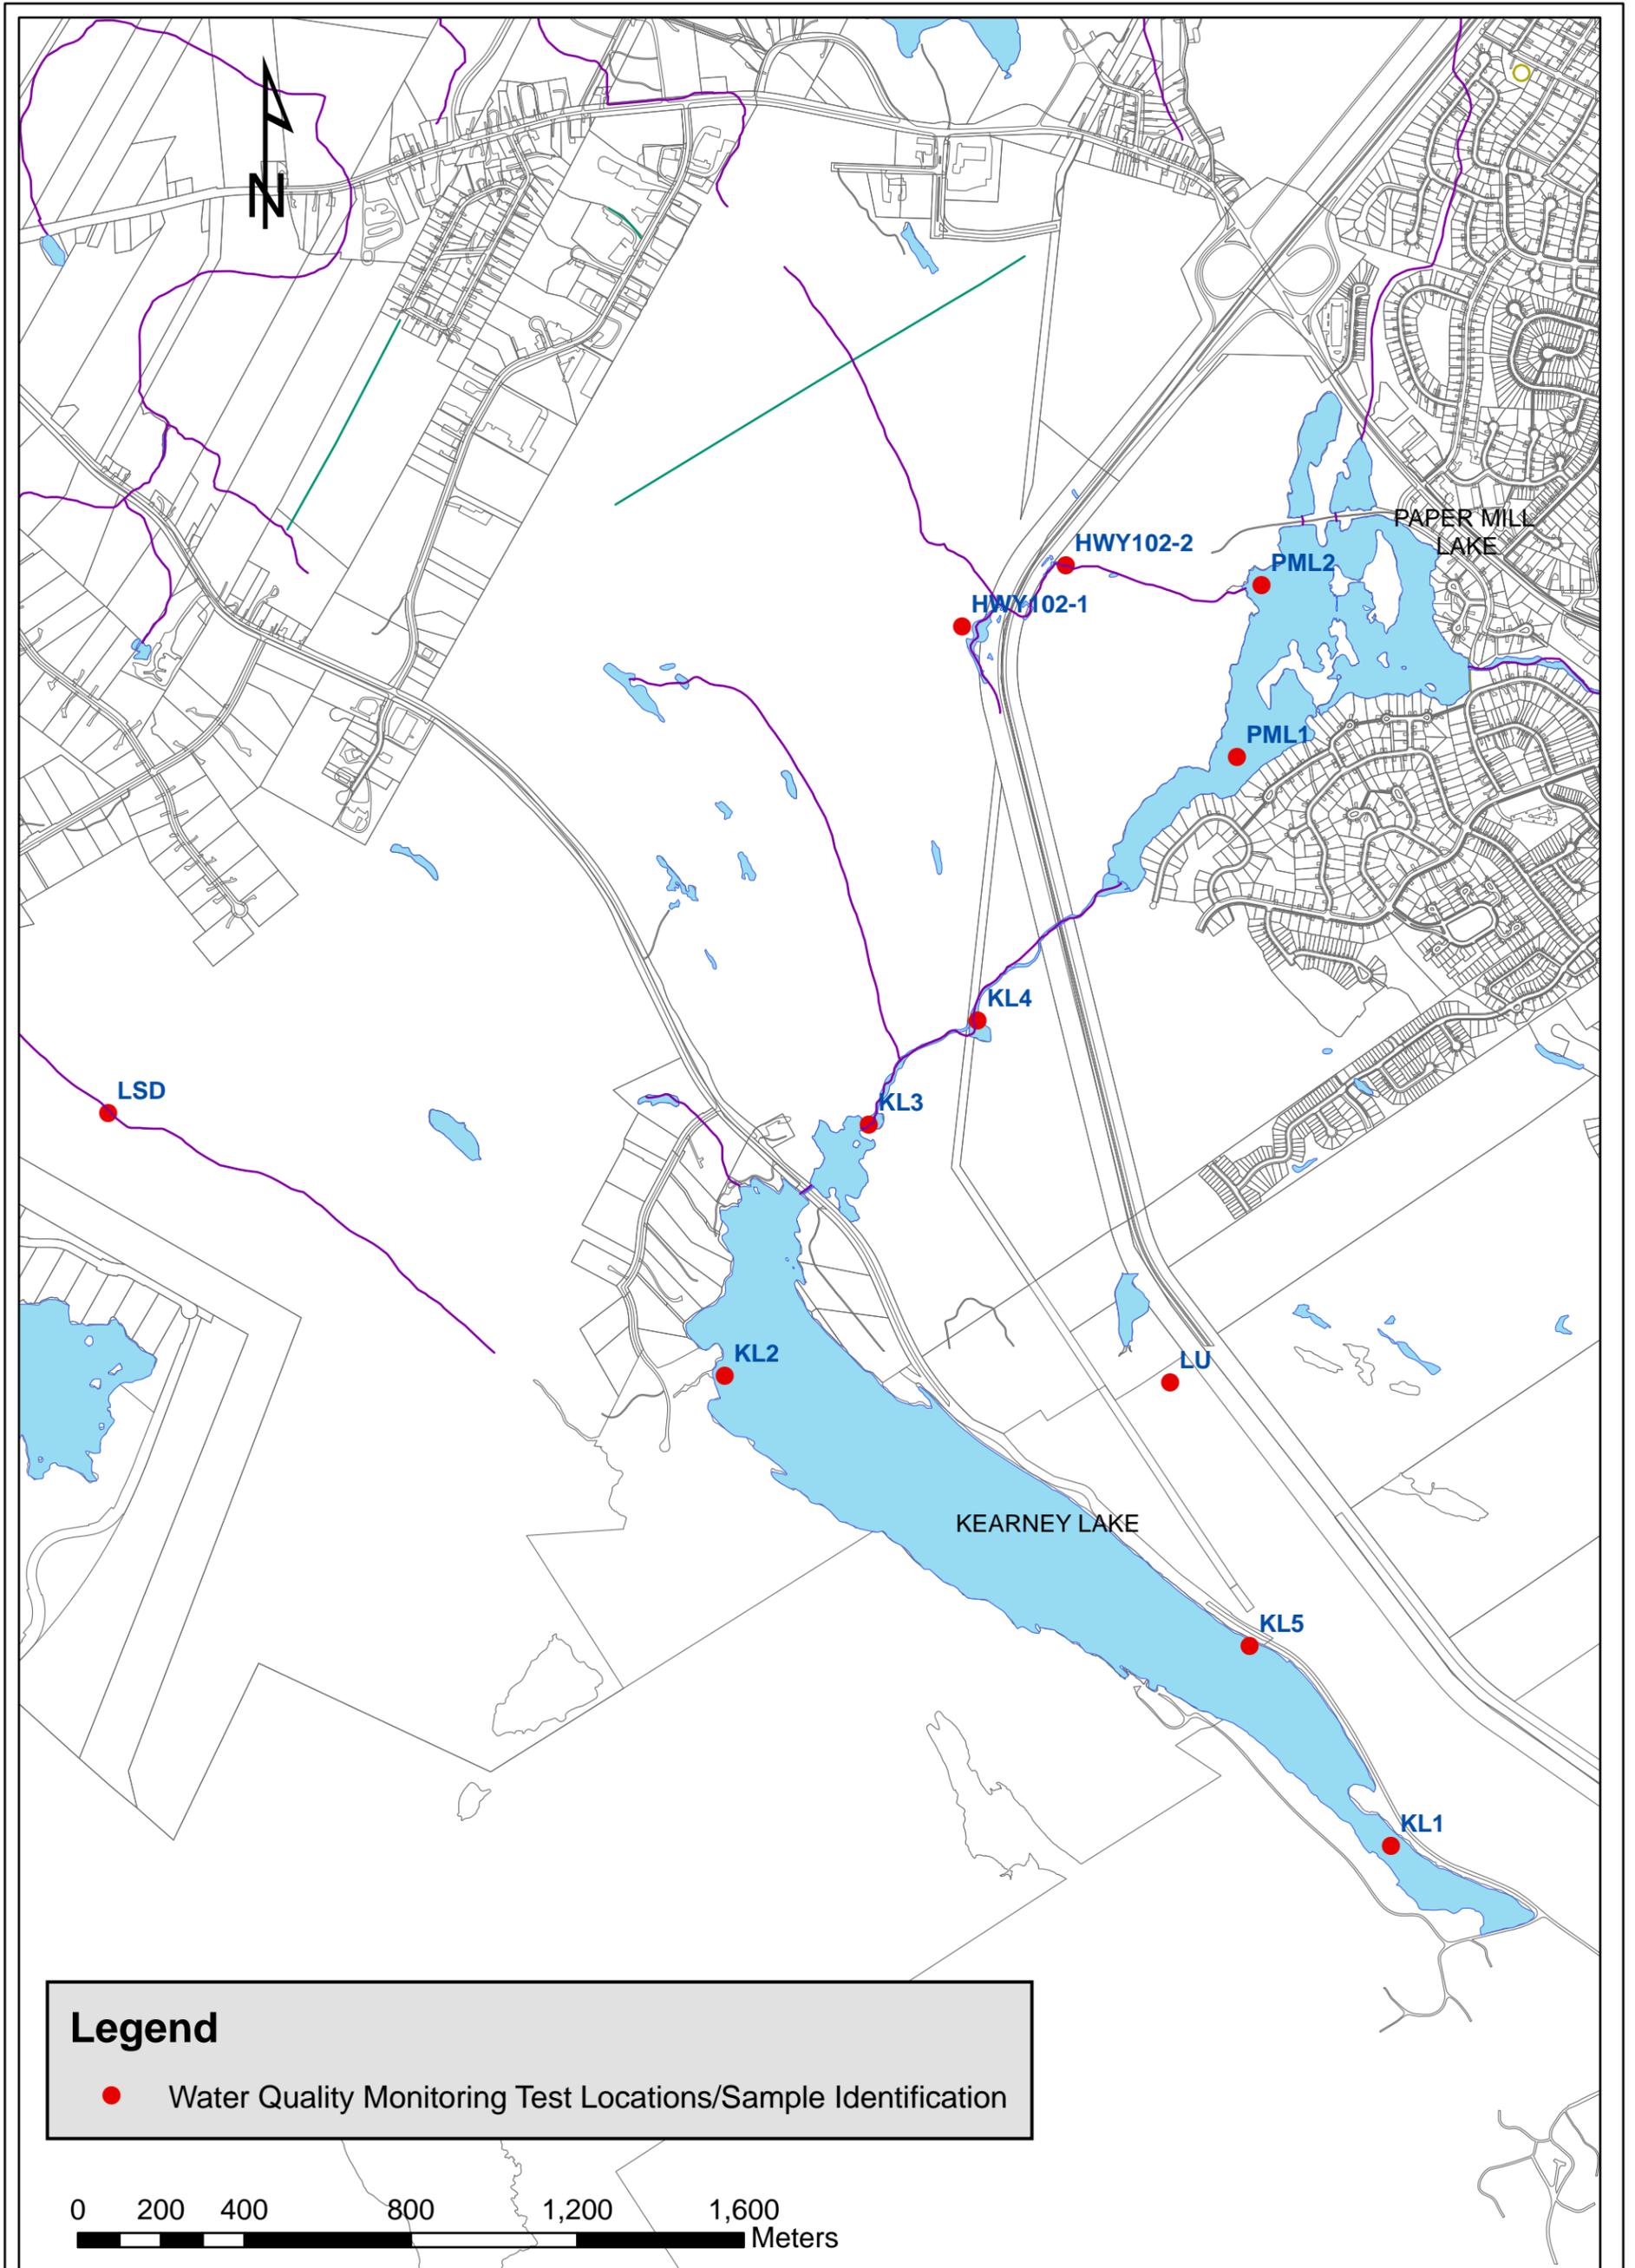
Attachment A: Water Quality Monitoring Test Locations

This report constitutes notification that total phosphorus concentrations exceeded the trigger value of 10 micrograms per Litre (10ug/L) at six of eleven stations monitored in May 2016. A map depicting the location of these stations is presented in Attachment A. A summary of TP results observed at all stations is presented below in Table 1.
