Item No. 9.1.1
Heritage Advisory Committee
September 23, 2020

SUBJECT: **Case H00483: Substantial Alteration to the municipally registered heritage property at 5241-5247 South Street, Halifax**

Attachment C:
STAIRS HOUSE
CONSERVATION MANAGEMENT PLAN

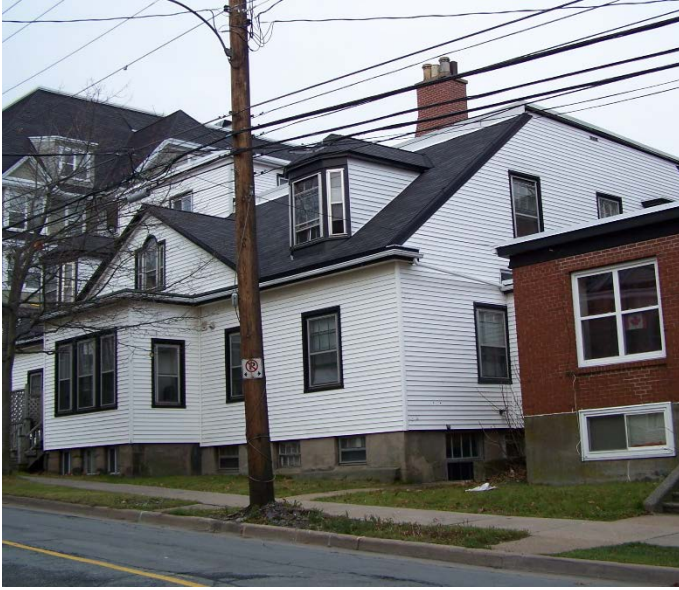
5241-5247 South Street, Halifax (c.1838)

Character Defining Elements:

- Georgian architectural style;
- Symmetrical façade with five bays, central porch entryway, and 6/6 windows;
- 1.5 storey profile and sloped gable roof on the southern (front) portion of the dwelling;
- Central pediment gable with Palladian window;
- Two uniform Scottish dormers;
- Round headed window on western wall;
- Second-storey bay window on the western wall;
- Ironstone foundation with plaster parging and faux stonework coursing;
- Brick chimney with four flues; and
- Wood shingle siding (exploratory work confirmed its presence on a portion of the building – Attachment C; page 4).

The principal dwelling, currently known as Stairs House, is an example of Halifax's early suburban growth, as the city expanded outward from its original grid. The wood dwelling, which was 1.5 storeys tall, is a Georgian-influenced cottage. Stairs House embodies the Georgian style's emphasis on classical and symmetrical design; the façade is divided into five bays and contains aligned windows, a central entryway and a pediment gable with Palladian window, which is flanked by two Scottish dormers. While the property has been modified several times during its lifespan, its original form, along with most character defining elements are largely intact.

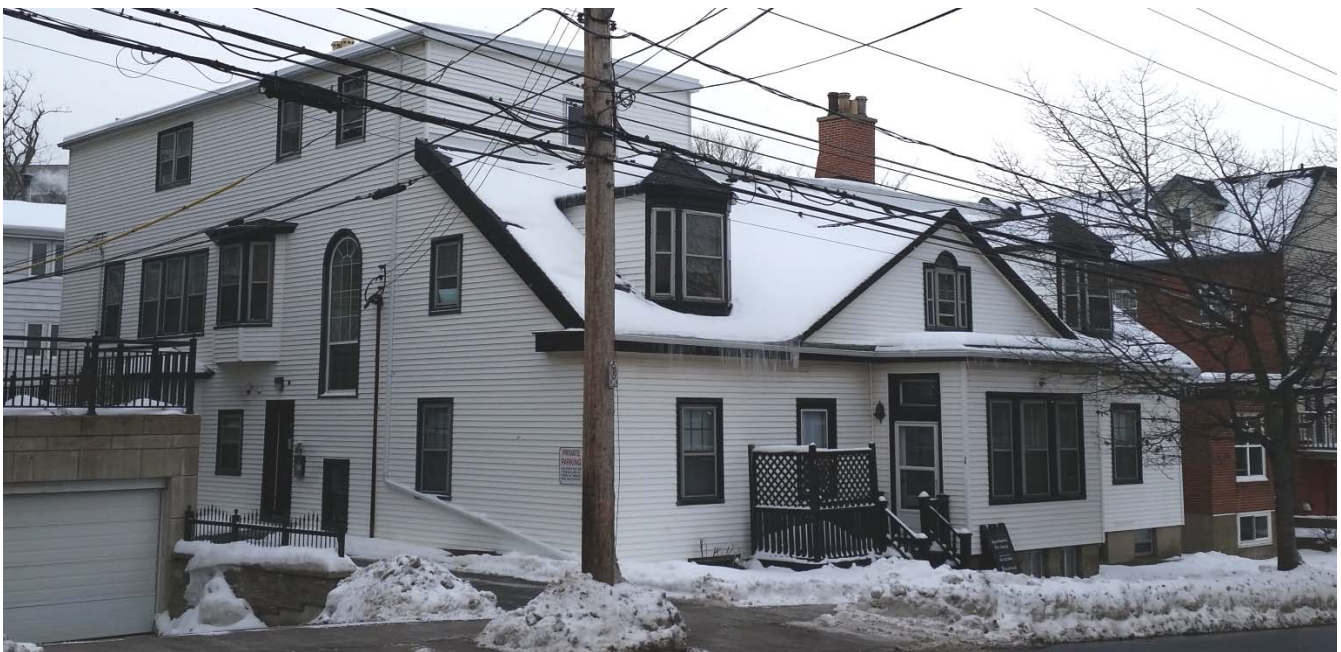
To the rear, the eastern portion of the building's roof has been raised to two storeys with a shallower roof slope. To the west sits a wing extension, approximately 26' wide and 28' deep, originally two storeys, in height, which has been later raised to three stories in height up to the main ridge line of the home.

Street view from the southwest showing rear wing with third floor addition

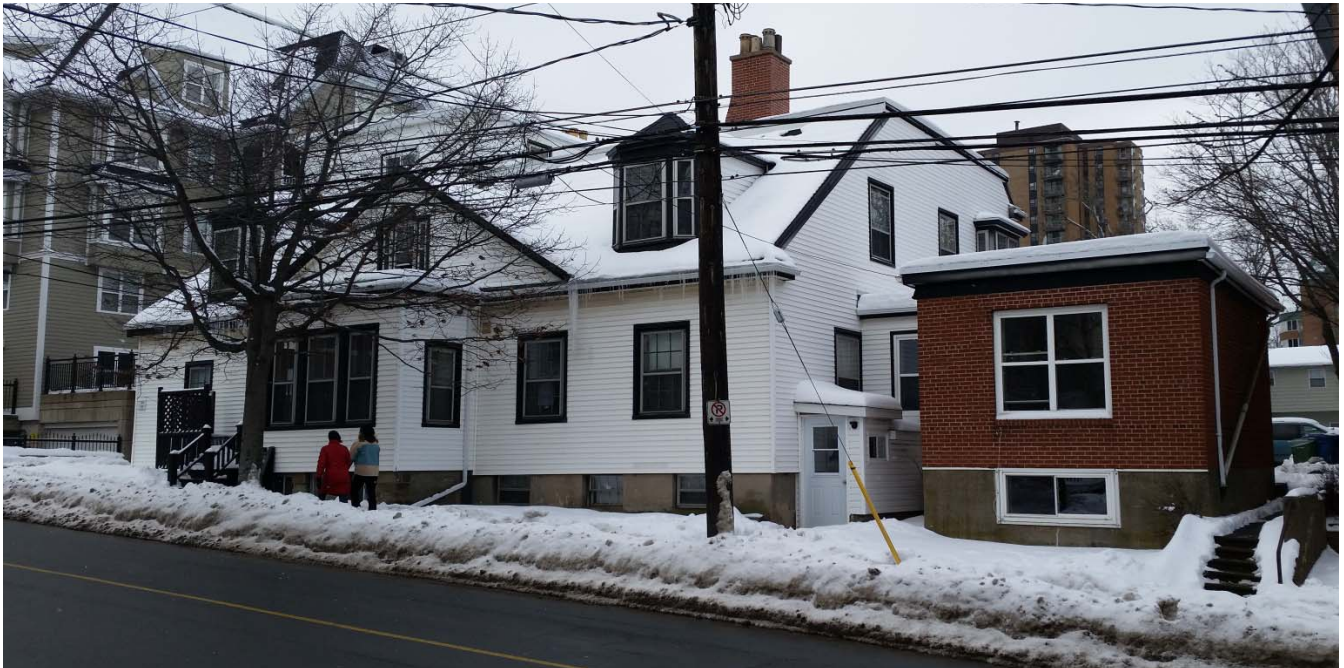
To the east of the home a narrow one storey wood frame addition has been added followed with a small brick-clad addition. Both appear to be later early-to-middle-20th century additions.

Street view from the southeast showing later one storey additions

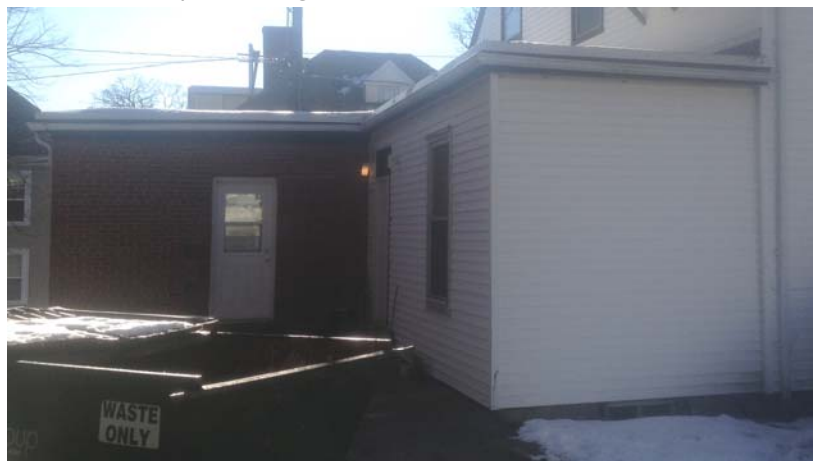
Rear of east addition

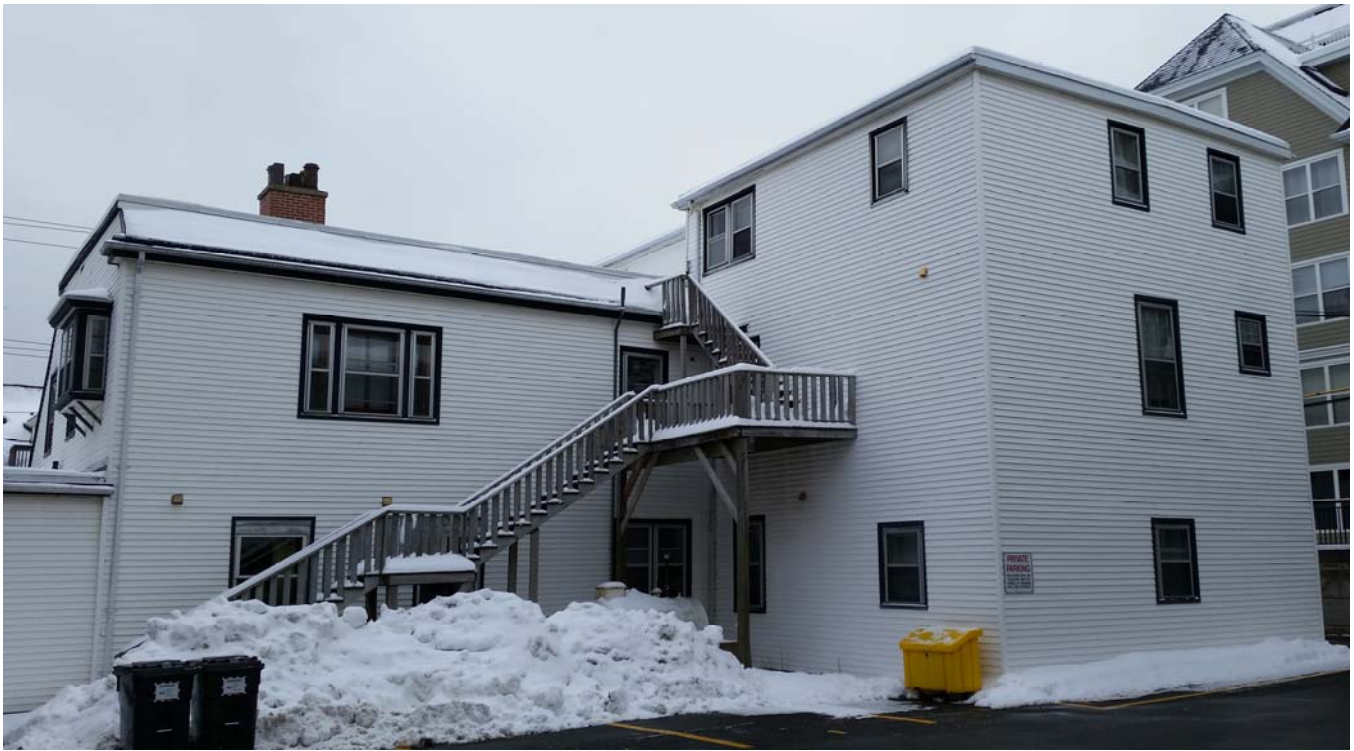
Rear elevation

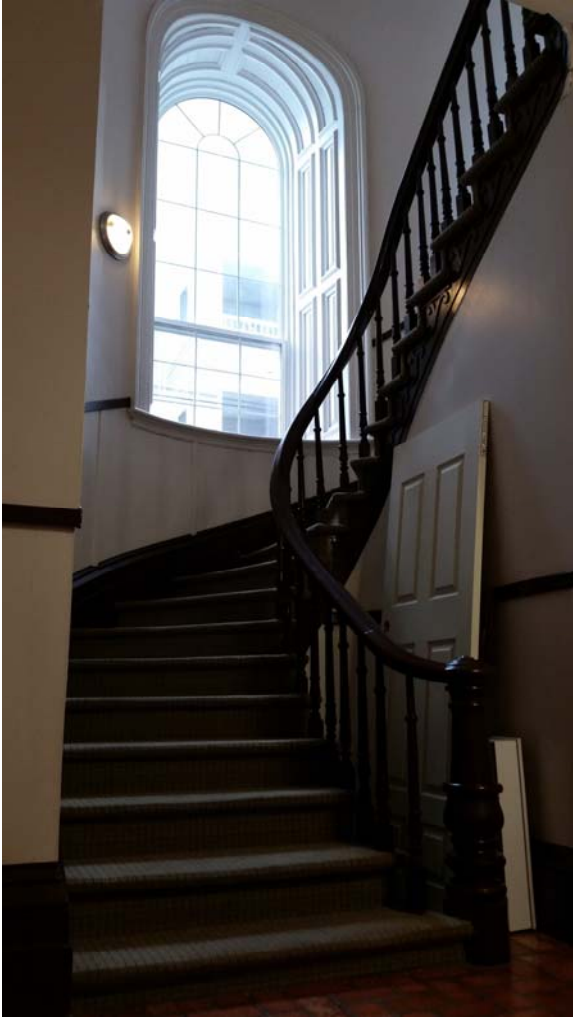
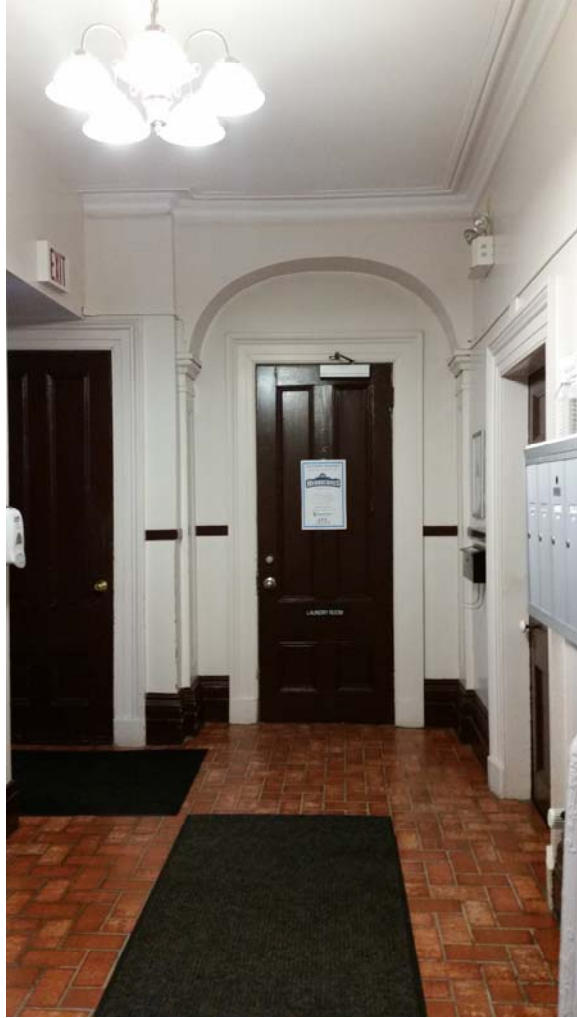
Interior western stair, and side hall looking north.

Although not expressly protected by legislation, the building is also noted for its curved interior stair, and generally remaining moldings, casings and trims, and surviving, albeit altered, original layout.

For the purposes of this report access to the interiors was limited to the public corridor, one vacant unit and the building's basement as the building is otherwise occupied apartments at this time. Based on observations, the original interiors appear to have been left largely intact, with minimal interventions made to facilitate the division of the building into apartments, subdividing larger rooms and inserting kitchens and baths. Apartment layouts generally respect the original layout of the home, with subdivide walls added in such a way as that each apartments received an original fireplace. This strategy was possible due to the generally symmetrical three main chimney breasts with front and back fireplaces.

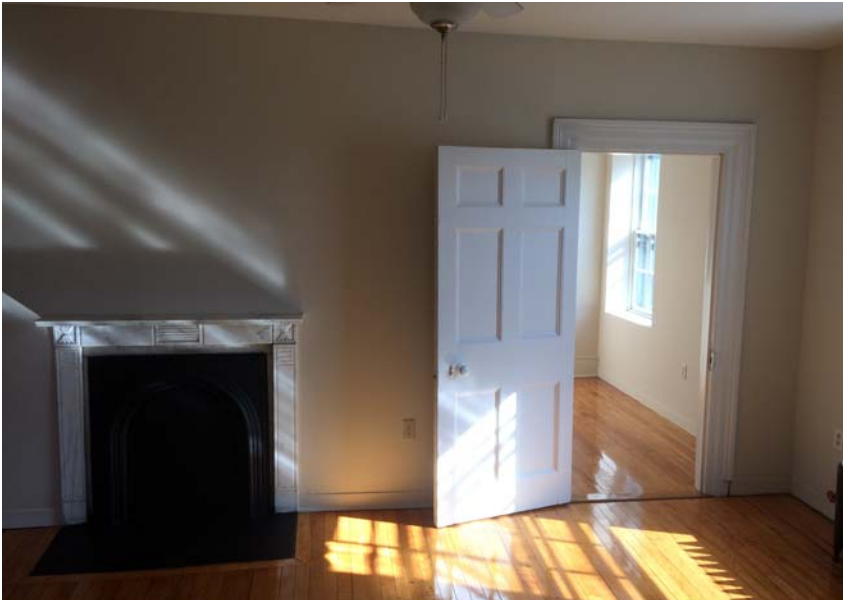
Upper floor south-east unit, south fireplace

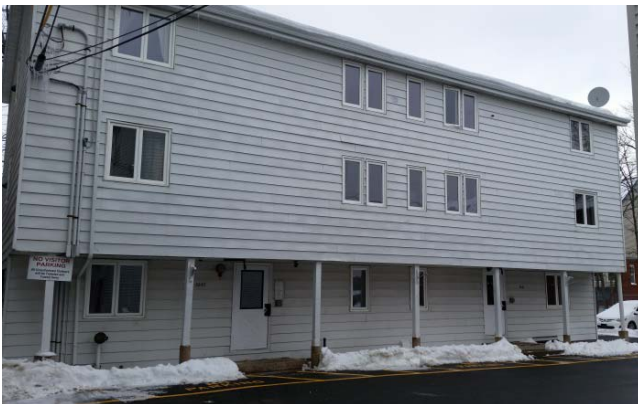
The mid-block apartment building is a three storey structure and carries the municipal addresses 5243, 5247 and 5249 South Street. It has a full basement of concrete with possibly unconfirmed thicker stone portions under its western two-thirds. Above grade it is of wood frame construction with modern clapboard cladding, approximately eight inches to the weather. The upper two floors extend out four feet to the south supported by seven wooden posts on concrete footings. Windows are modern vinyl casements. The roof is 4/12 pitched asphalt shingles. The building is fully occupied and interiors were not reviewed.

South elevation

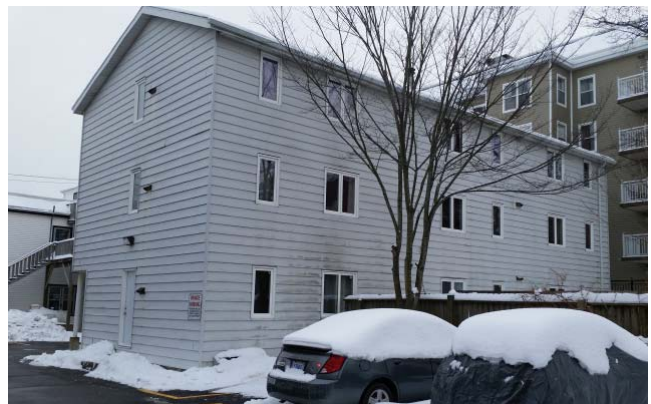
From the north-east

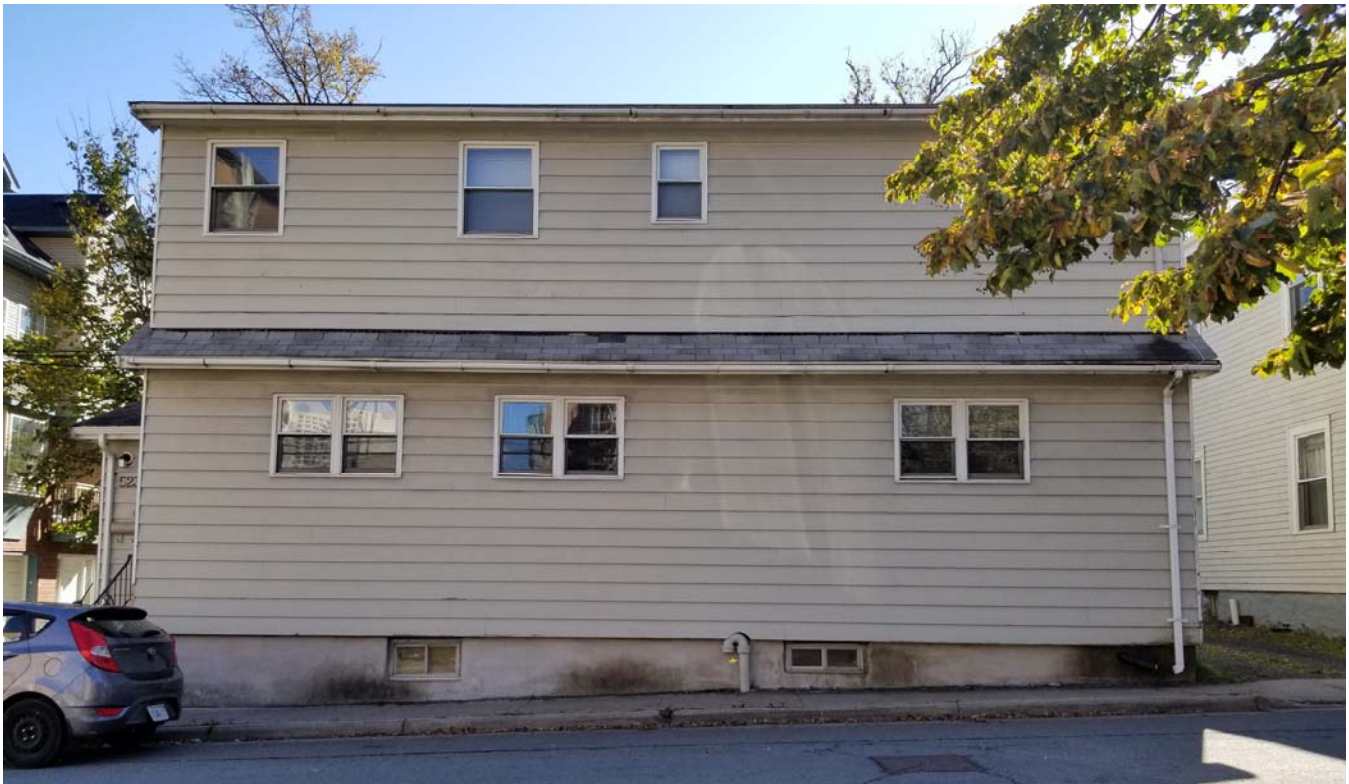
North, Harvey Street, elevation

The Harvey Street address attributed to the Stairs House, 5230 Harvey Street, is a two storey clapboard clad structure with ironstone basement foundation walls, thicker masonry ground floor walls, and a wood framed upper floor, cantilevered on the south, and a 4/12 pitched asphalt roof. A false one storey eave line extends across the north side of the building which may indicate a previous roof. Windows are generally modern, wooden single-hung.

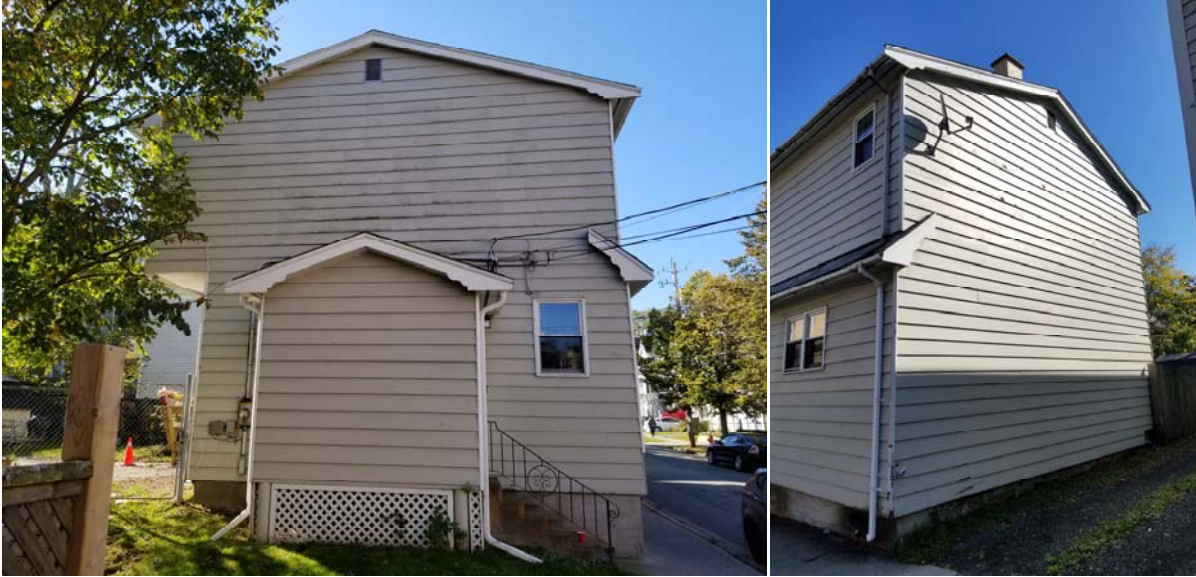
East and west elevations

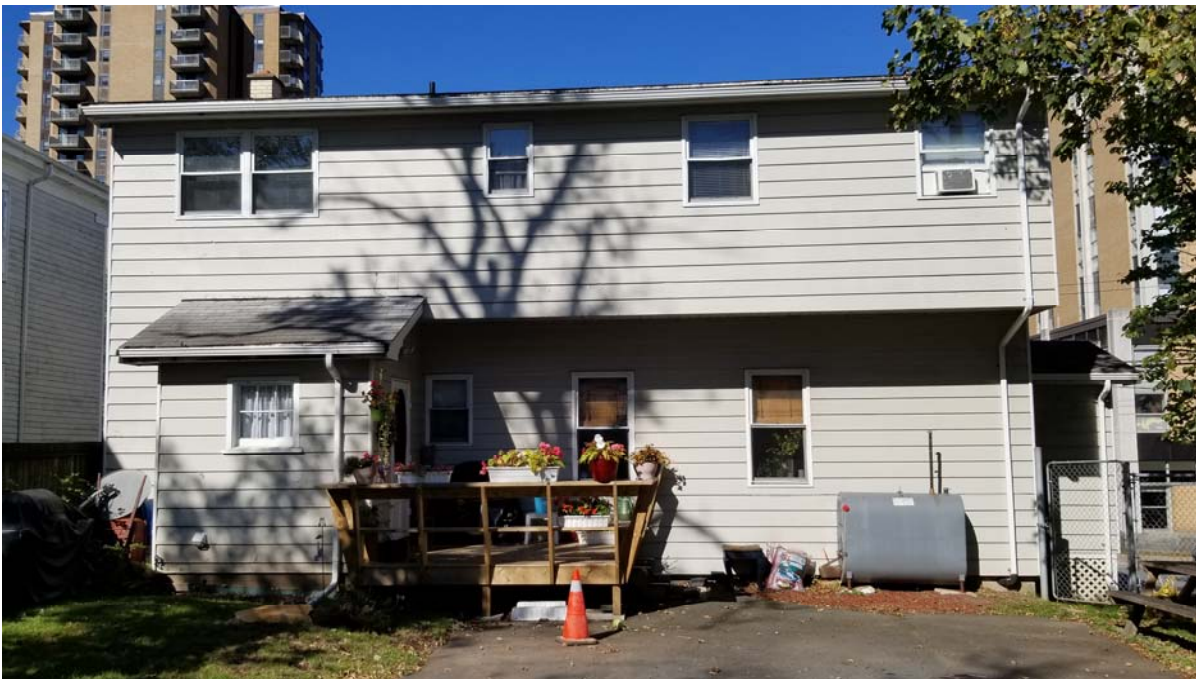
South elevation

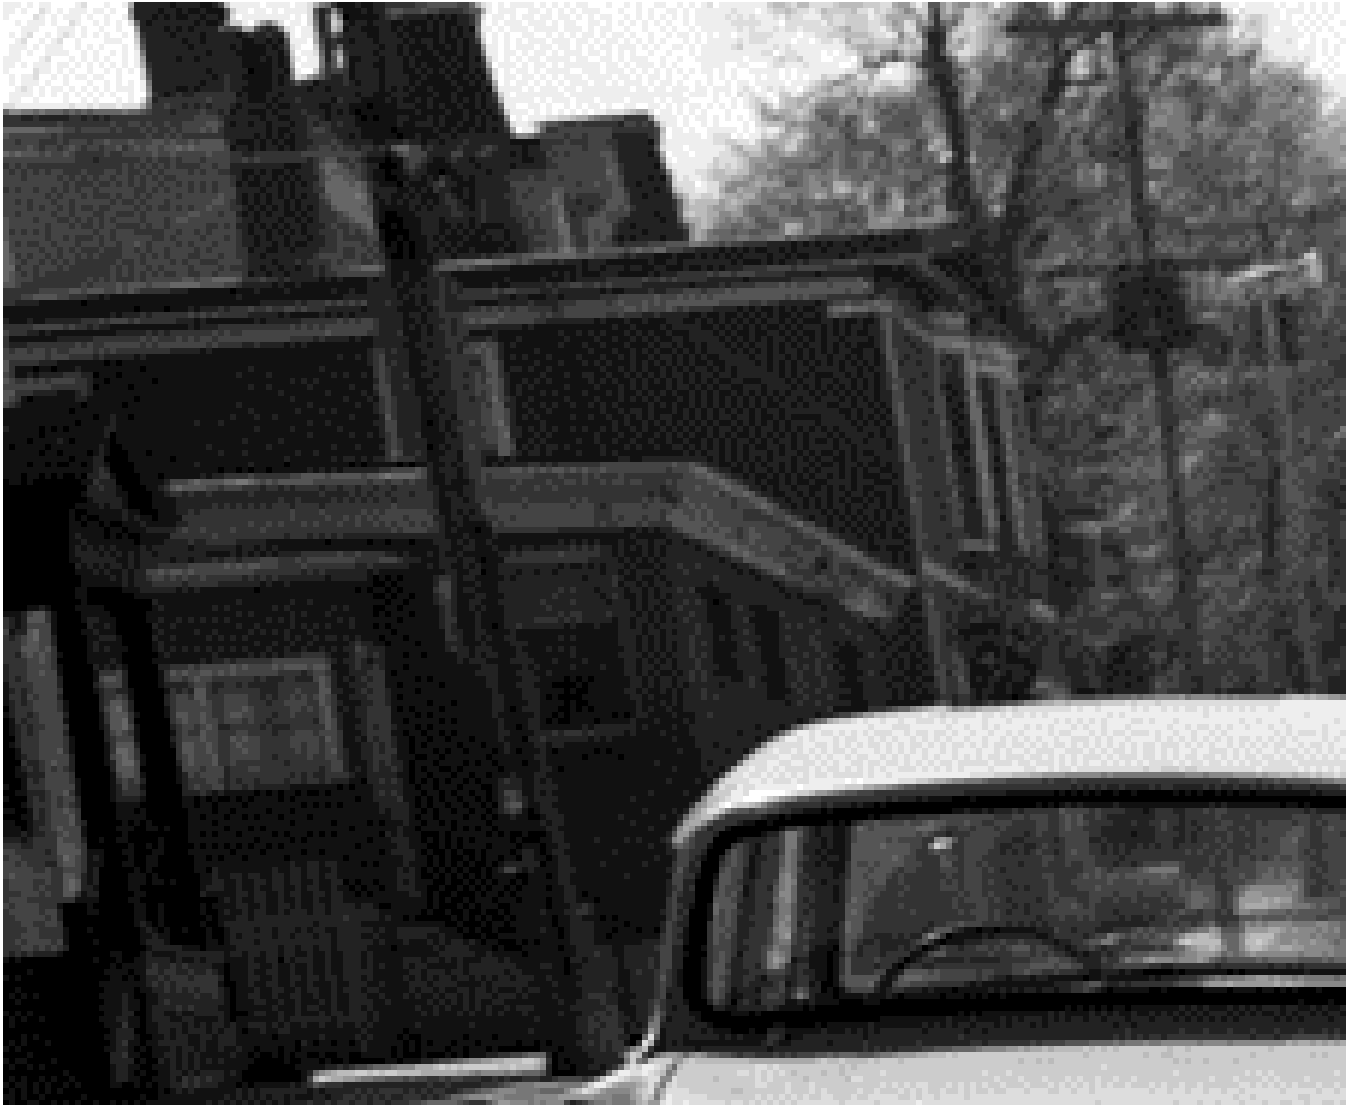
Looking west on Harvey C. 1960s⁸

The original single storey masonry structure survives within the current building and it likely pre-dates 1865. The adjacent photo indicates it had a shallow sloped roof with bracketed roof line. The building is also notable for its encroaching relationship to the street. Other than its 'stable' usage, questions remain around the original form and use of the building. It is likely clues or answers to its original form would be attainable in substantial renovation or deconstruction.

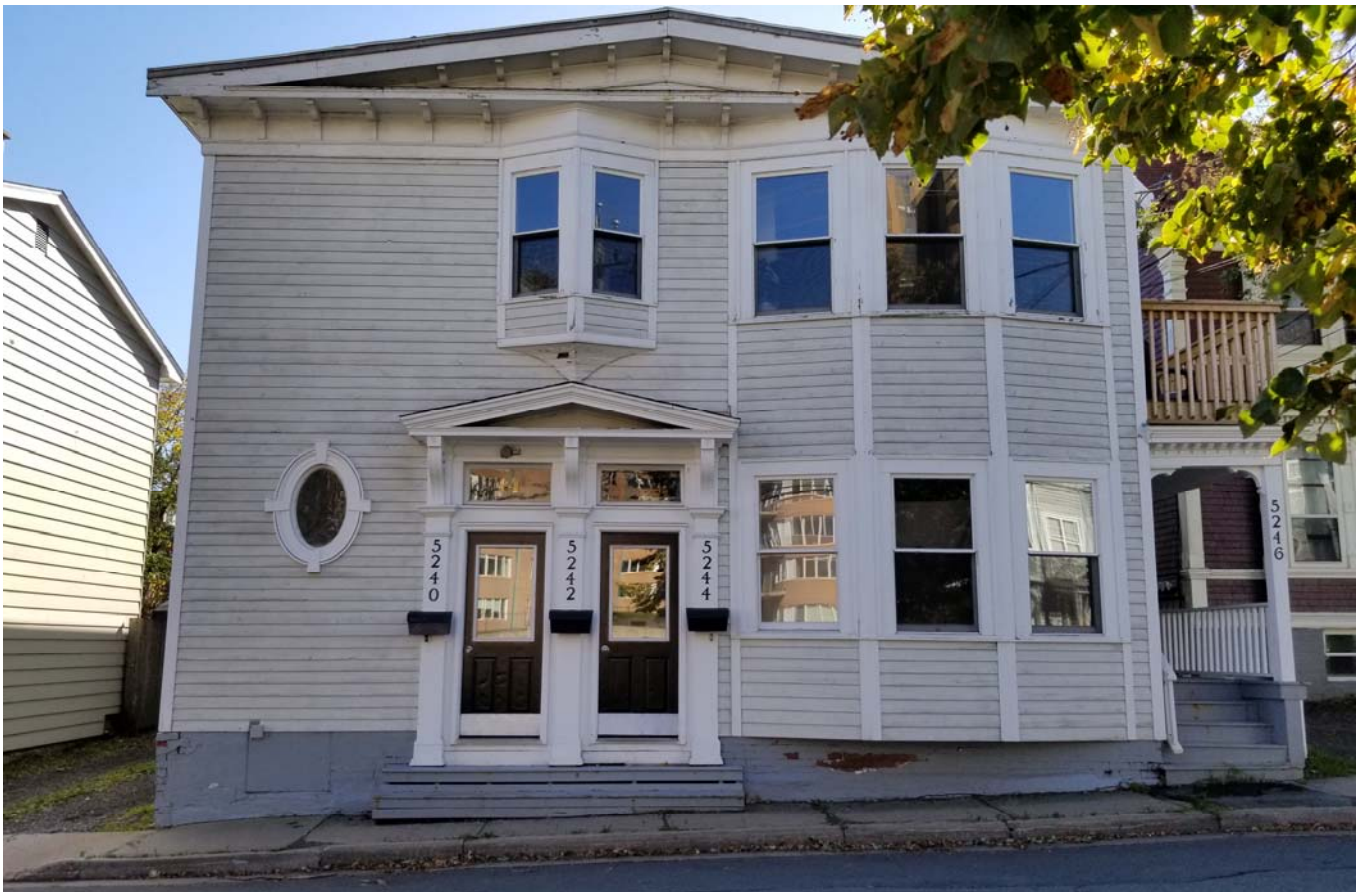
North, Harvey Street, elevation

The building at 5240-46 Harvey Street is a two storey, wood framed clapboard clad structure, approximately four inches to the weather, with classical detail and trim work. Foundation walls are brick masonry, at least above grade, and the roof is shallow pitched with bracketed and pedimented front. The street façade is composed of similarly bracketed and pedimented paired entry doors with a shallow projecting two-sided, or one-bend, bay window above, whose base scallops down to the doors pediments, and top extends to the underside of the roof's cornice. To the east of the doors is a small oval, or Oeil-de-bouef, window, presumed to highlight a stair, and to the west is a double height, shallow projecting bay window. Windows are modern replacements.

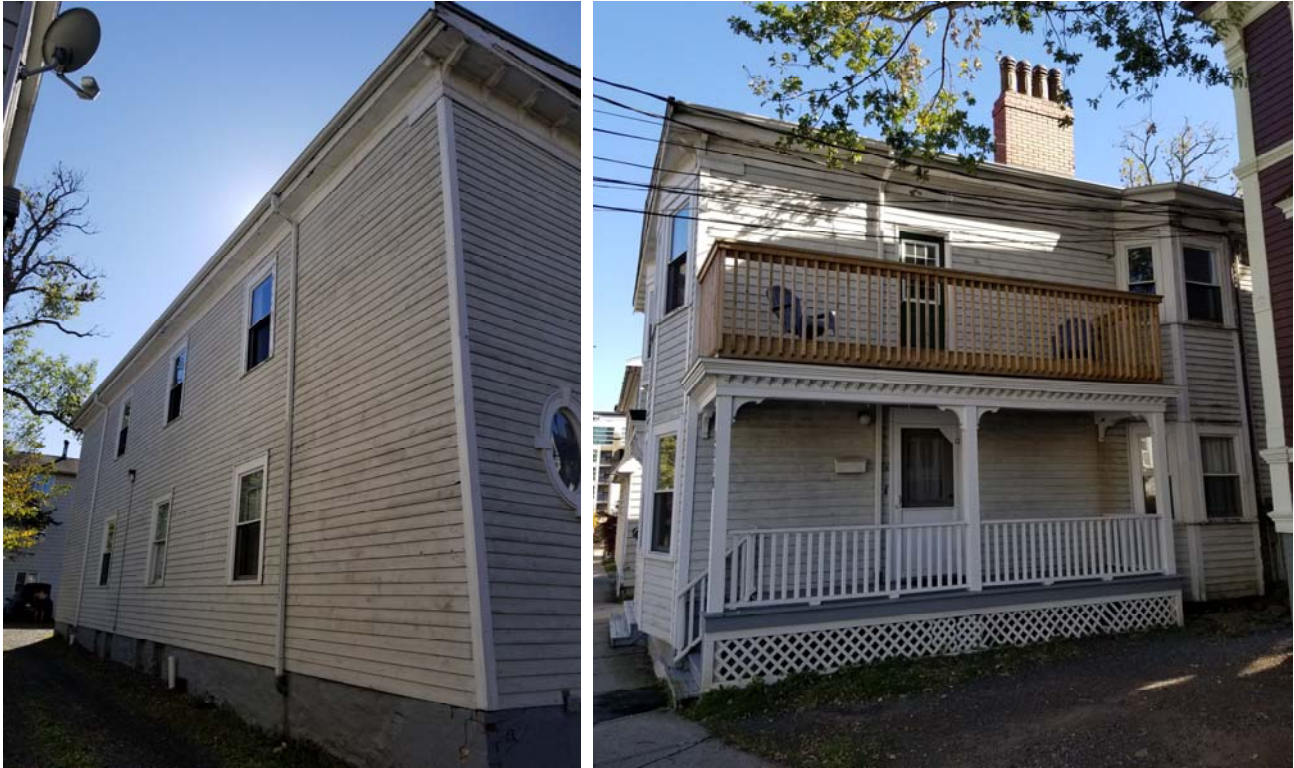
East and west elevations

To the west side is a shallow covered porch accessed from the street, and trimmed with bracketed entablature. Along the west wall is another double height bay window, this time with typical projection.

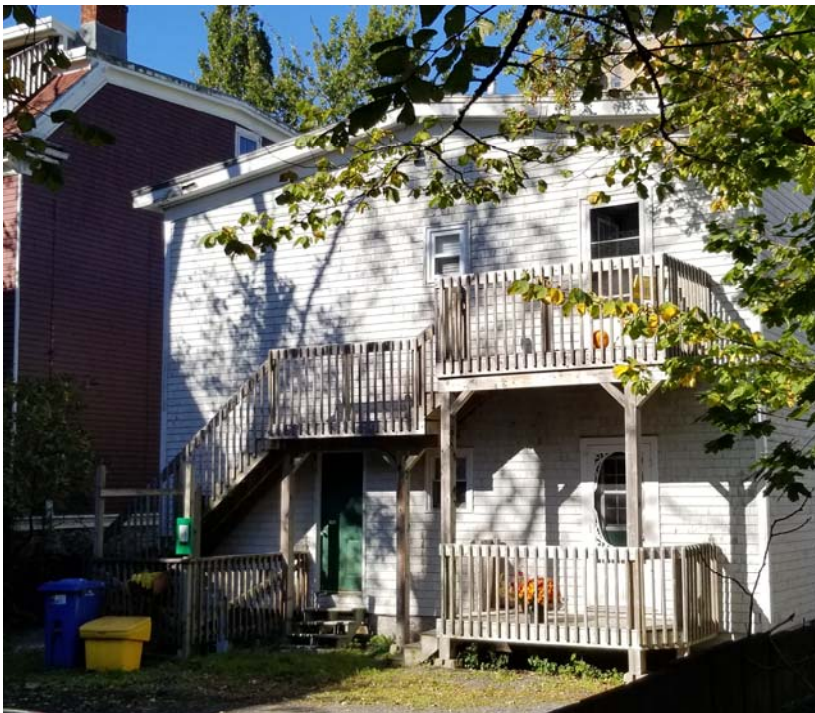
Rear elevation

The original building has been extended to the south and renovated to increase what is believed to have been an original duplex to six apartments. Building interiors were not available for review due to occupancy.

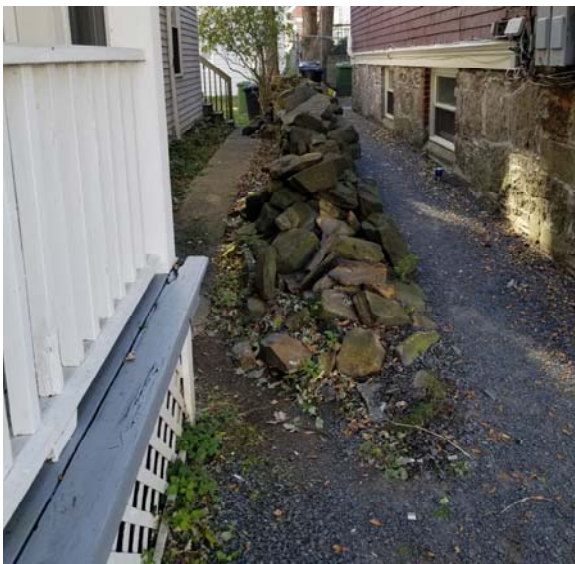
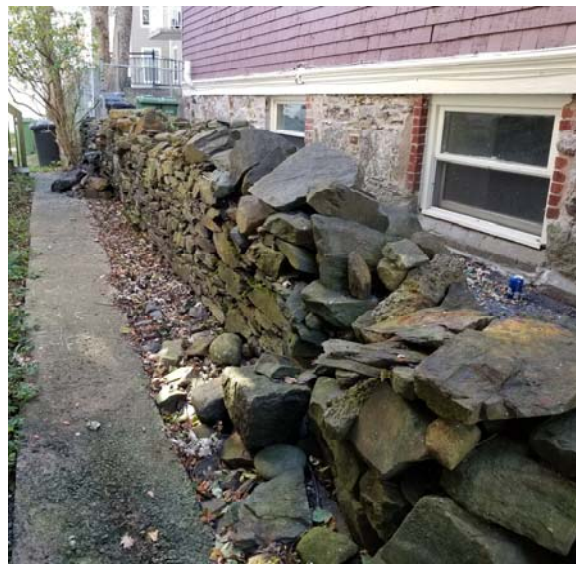
To the west side of 5240-46 Harvey Street a rubble stone wall straddles the property line with the western neighbour, running from the back of the porch to the back of the building. The wall fragment is reminiscent of the stone walls depicted in the cover illustration and known to define the fields that made up the site prior to its development. Surveys show the wall previously ran from Harvey to south street and is evident in older street views of Stairs House. The location of this wall approximates the property line shown on a 1831 map which indicates this wall pre-dates suburban expansion and represents a rare surviving portion of early Halifax fieldwork. Portions of the wall require localized rebuilding.

Western stone wall

SITE WORKS As the site is identified as an area of high archeological concern, oversight in accordance with the provincial regulations is anticipated through removals of the other buildings on the property and excavation of the site. Proper shoring design will also be required where excavating next to the home and along the remaining field stone wall on the western edge of the property. Prior to larger site excavations the damaged portions of this stone wall are to be re-laid, and the wall protected through the work with plywood coverings.

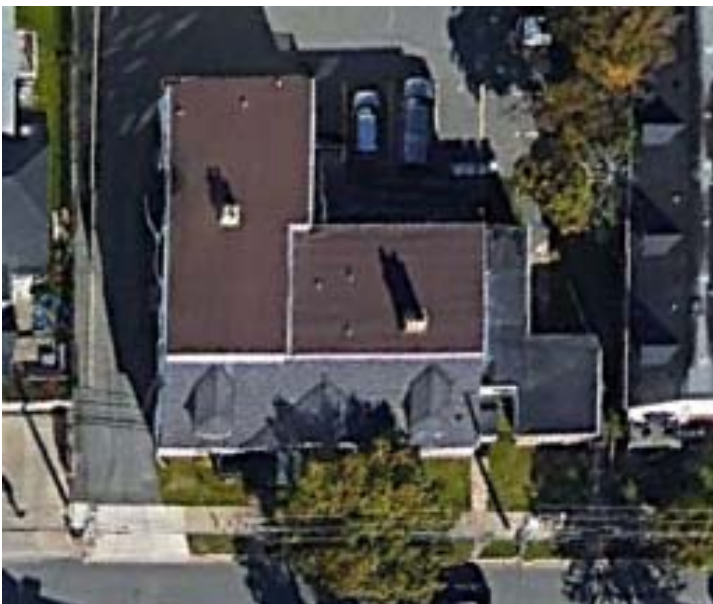
Existing building aerial view.

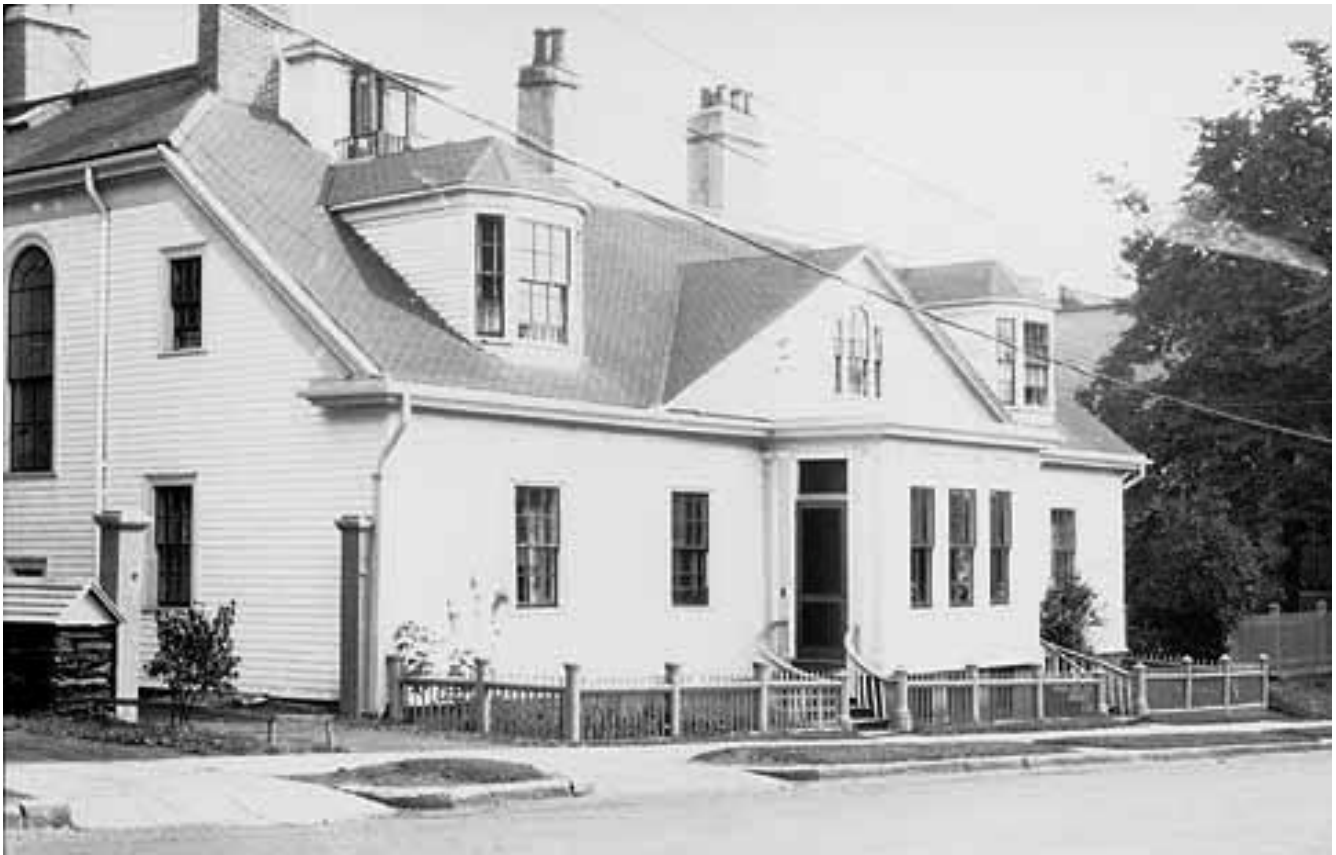
Early view looking east²⁰

Note western stone wall and entry gate posts, western roof lines, fencing and entry stairs, original chimneys, colour contrasts between siding/trims/windows and doors.

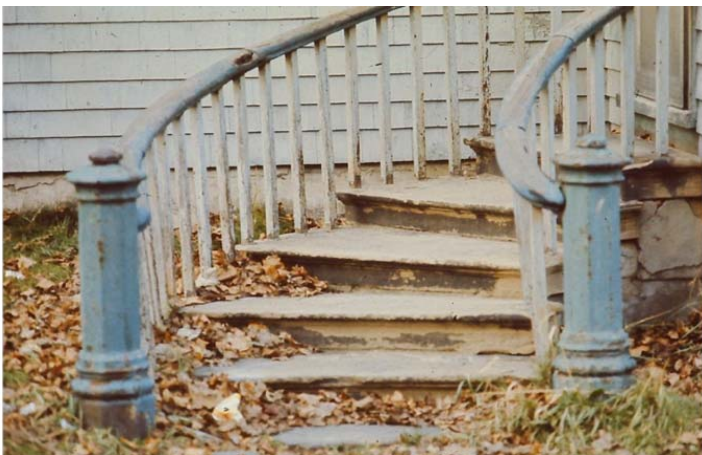
Cast-iron balustrades and newels and sandstone steps, 1974.²²

SOUTH ENTRY PORCH Site investigations indicate that the existing south entry porch may have a shingle cladding under its vinyl wrapper. This is in contrast to the classical design of the porch known from very good photographic evidence. Surviving material and design is to be confirmed with the removal of the vinyl cladding, but at present the work proposes the re-instatement of the classical detailing on the porch, its eastern door, and the curved stairs accessing both doors. It should be noted that the proposed design of the porch and its decorative iron railings and fences is likely the work of the Stairs family, with the 1865

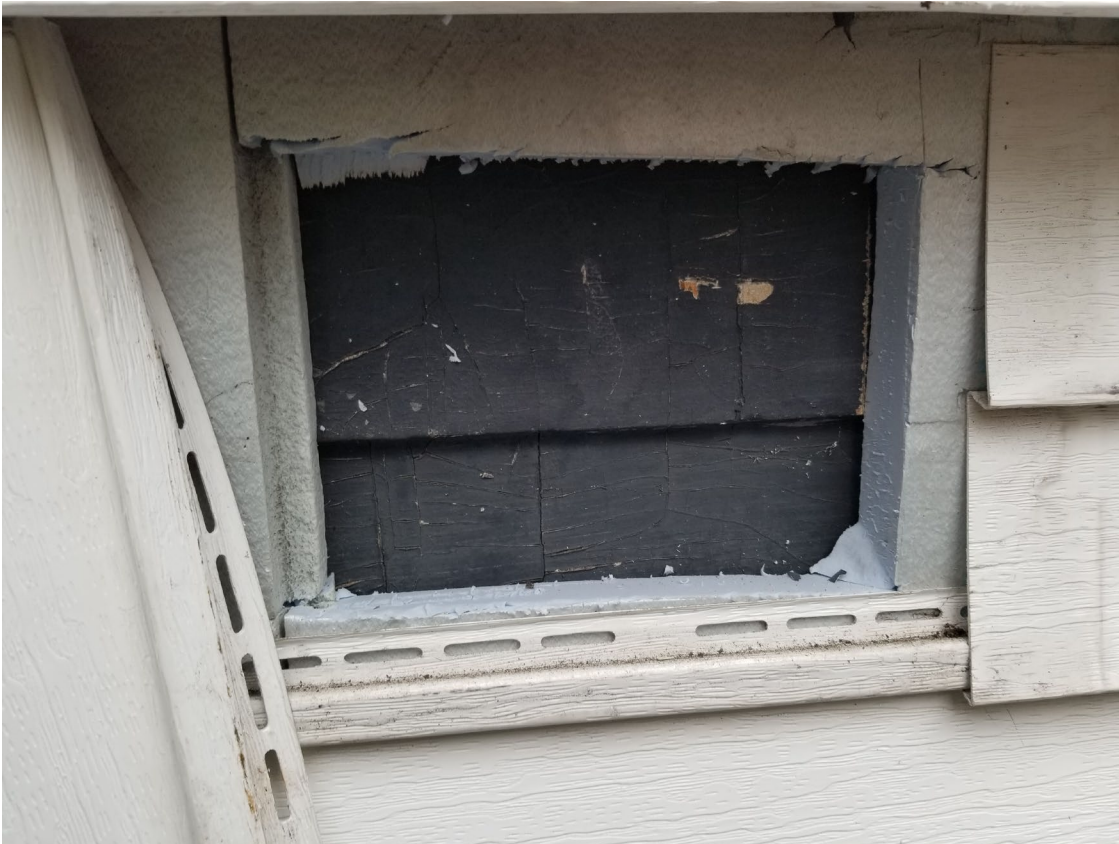
At the time of this plan, the buildings on the Stairs House property all remain as fully occupied rental units and as such access to the unit interiors has been limited. The exterior of the buildings have been reviewed on multiple occasions principally for this plan during the first weeks of March 2020. Assumptions based on observations will be presented later in this plan when discussing individual building systems. On March 11th an opening was made in the vinyl siding on the eastern ear wall of the Stairs house, exposing 1 ½" of extruded polystyrene insulation lying between the vinyl cladding and wood shingles below. Exposed shingles were in good condition with minimal paint layers, though thick enough for thin cracking to form. Note Charcoal colour.

Based on inspection of sills around the building, this insulation layer exists around the building.
