Heritage Impact Statement

Former St. John the Baptist Church, 1102 Purcells Cove Road

Halifax, June 2025

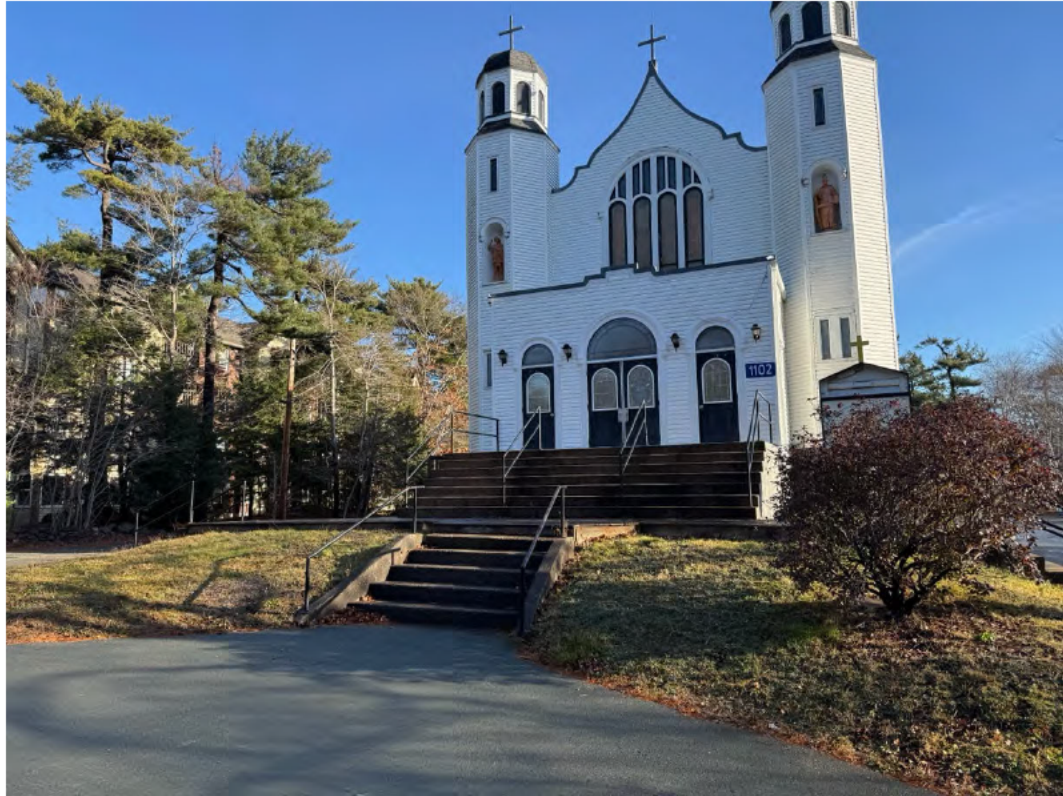
Figure 28a: Context of Former St. John the Baptist Church, 1102 Purcells Cove Road – front

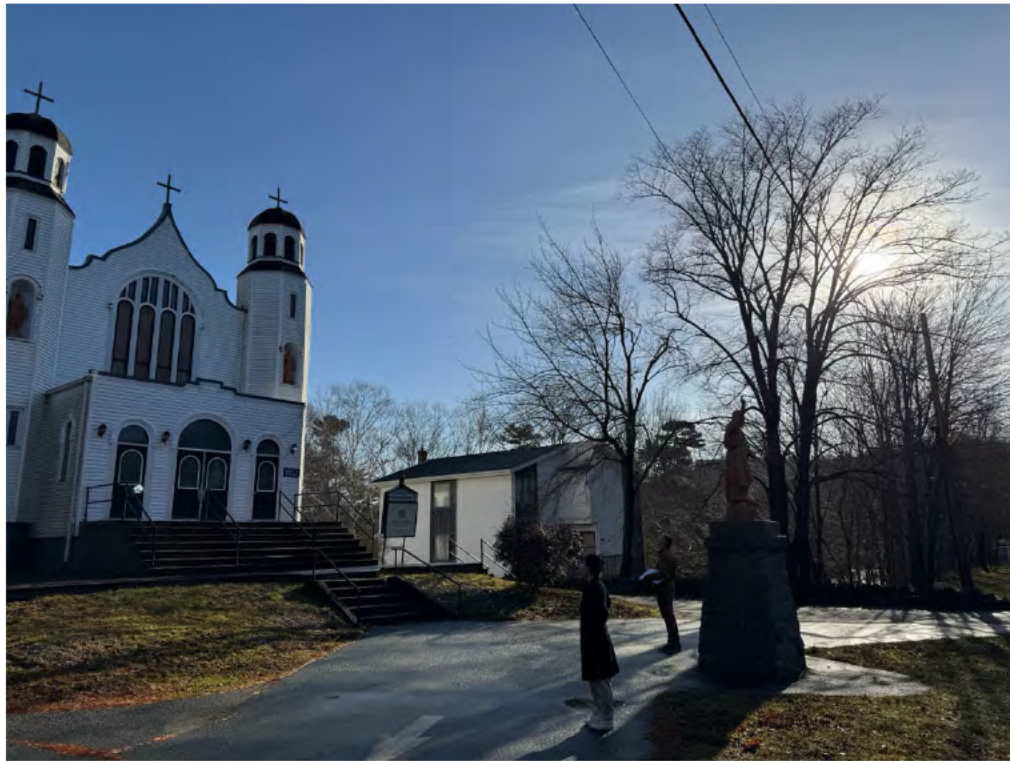
Figure 28b: Context of former St. John the Baptist Church, 1102 Purcells Cove Road – rectory on the south side and Christ the King statue set in front

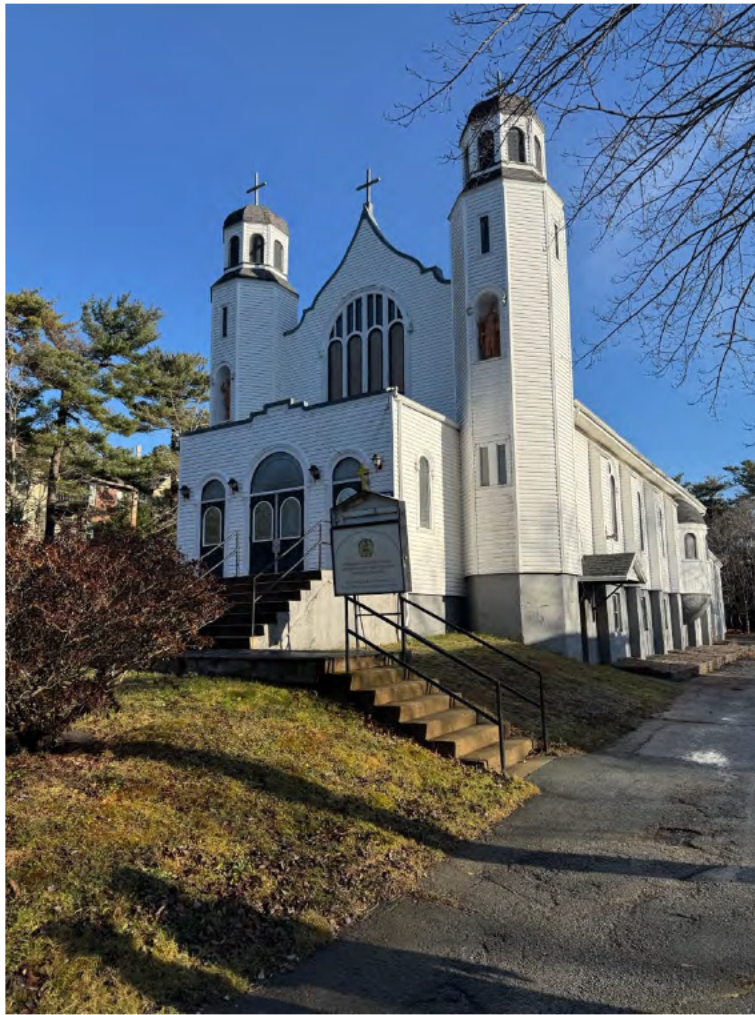
Figure 28c: Former St. John the Baptist Church, 1102 Purcells Cove Road – front and south side

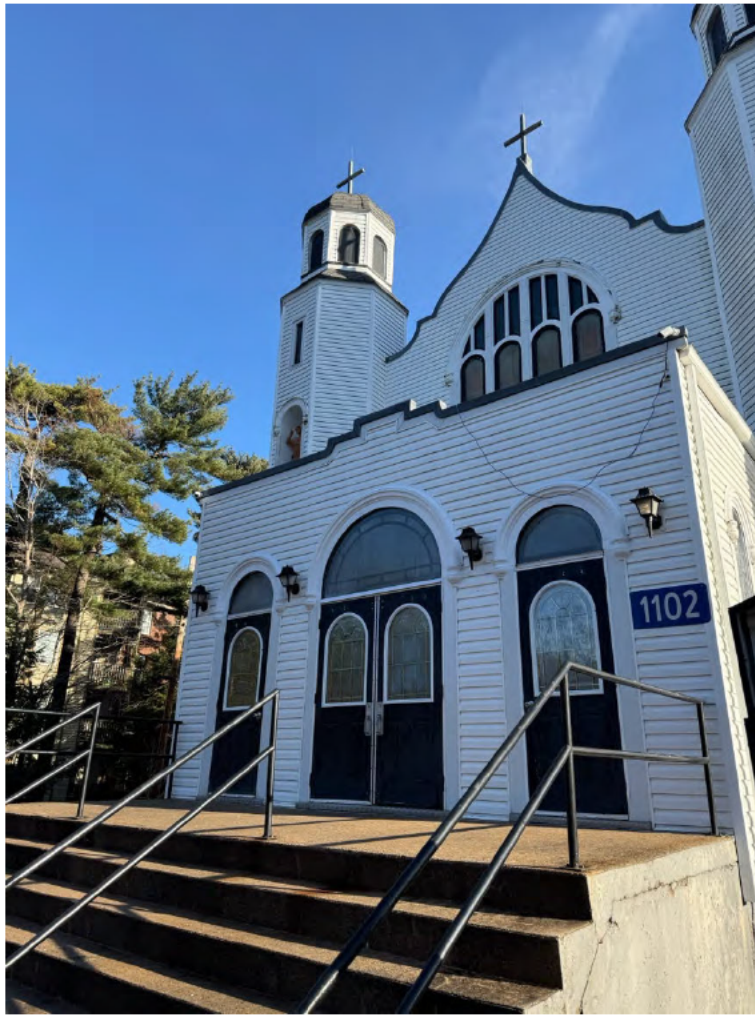
Front entry doors are in generally good condition. However, they are not original, but rather replications when the larger vestibule was added.

Figure 28d: Former St. John the Baptist Church, 1102 Purcells Cove Road – front entry

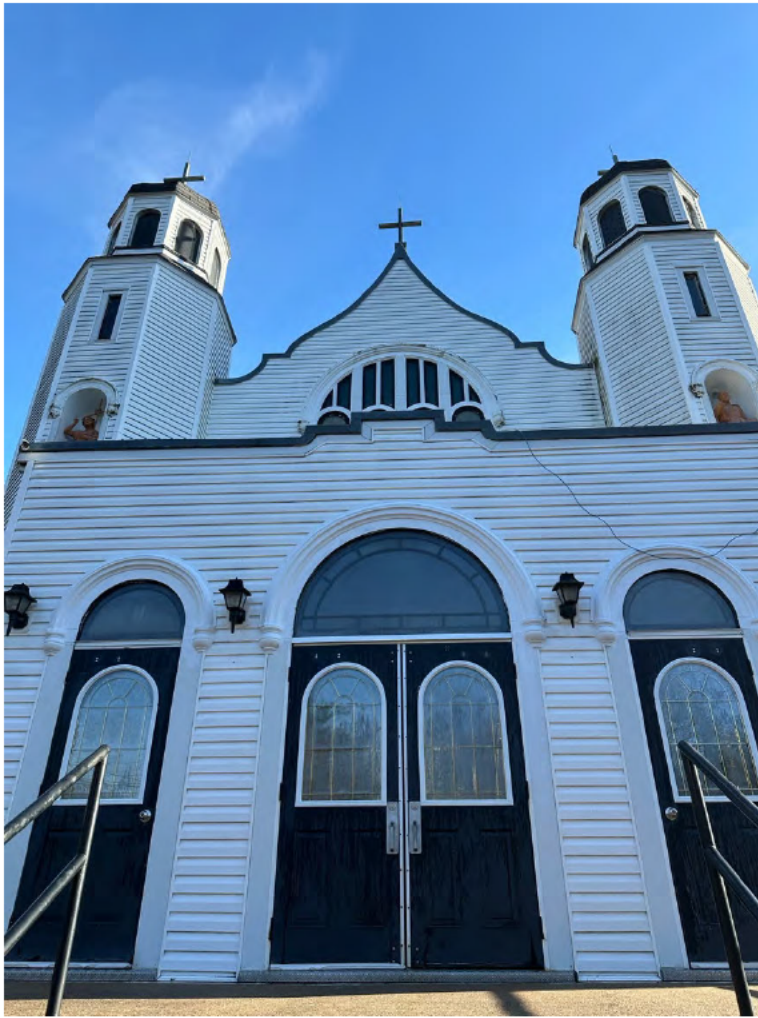
Figure 28e: Former St. John the Baptist Church, 1102 Purcells Cove Road – partial front

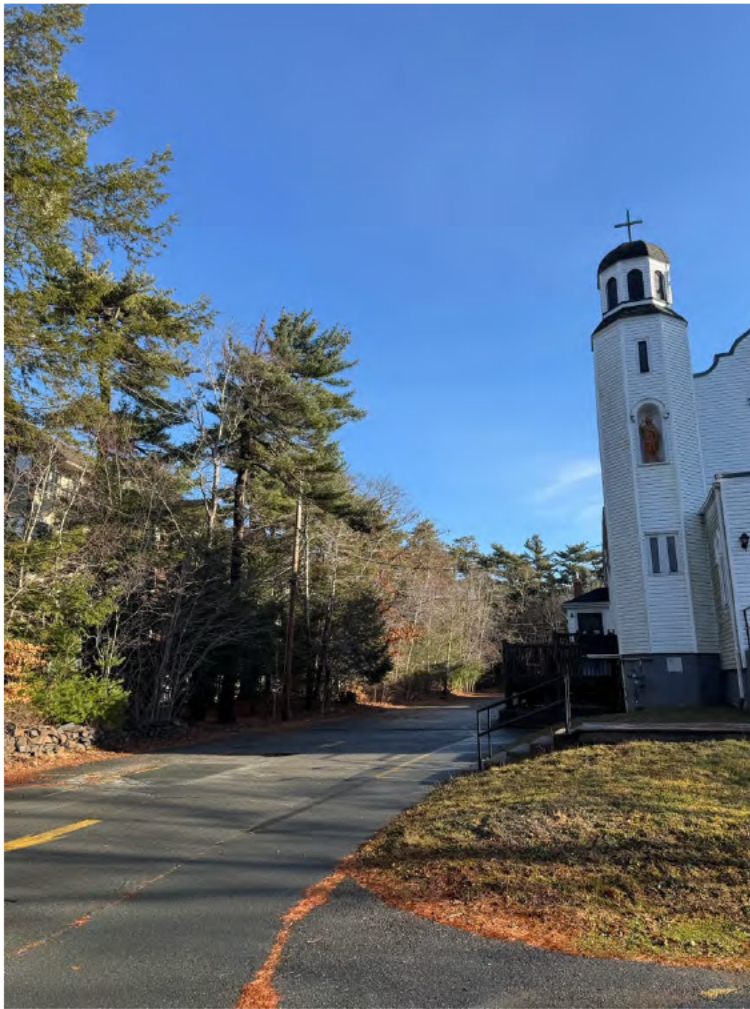
Figure 28f: Former St. John the Baptist Church, 1102 Purcells Cove Road – partial front and spatial setback on the north side

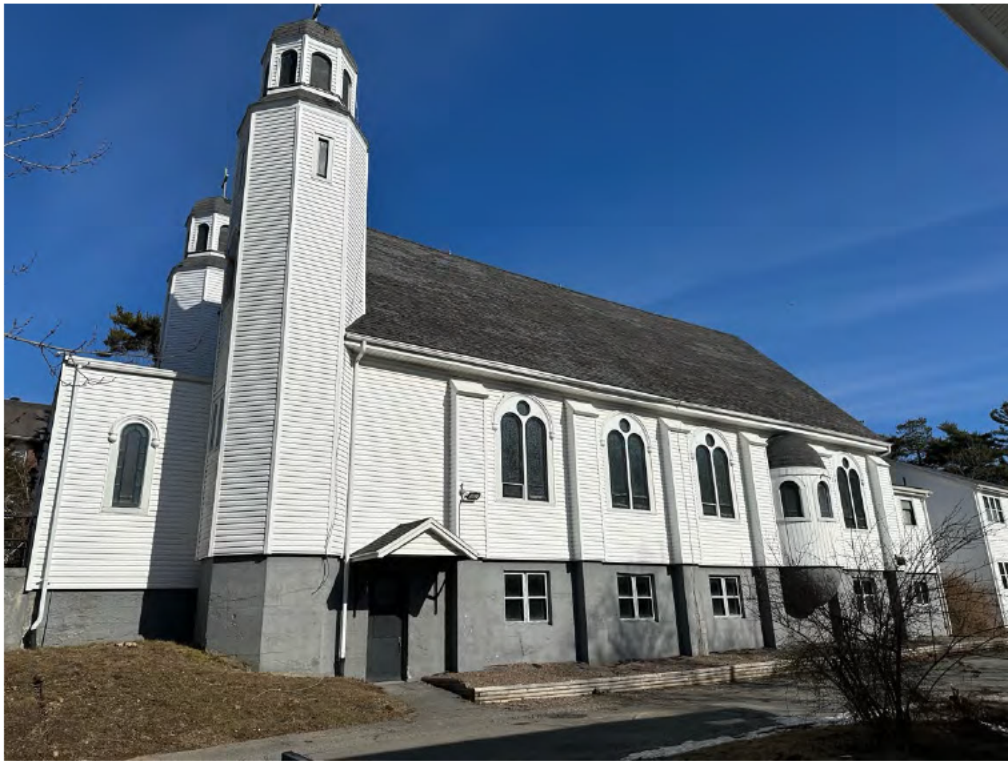
Figure 28g: Former St. John the Baptist Church, 1102 Purcells Cove Road – south side and rear addition

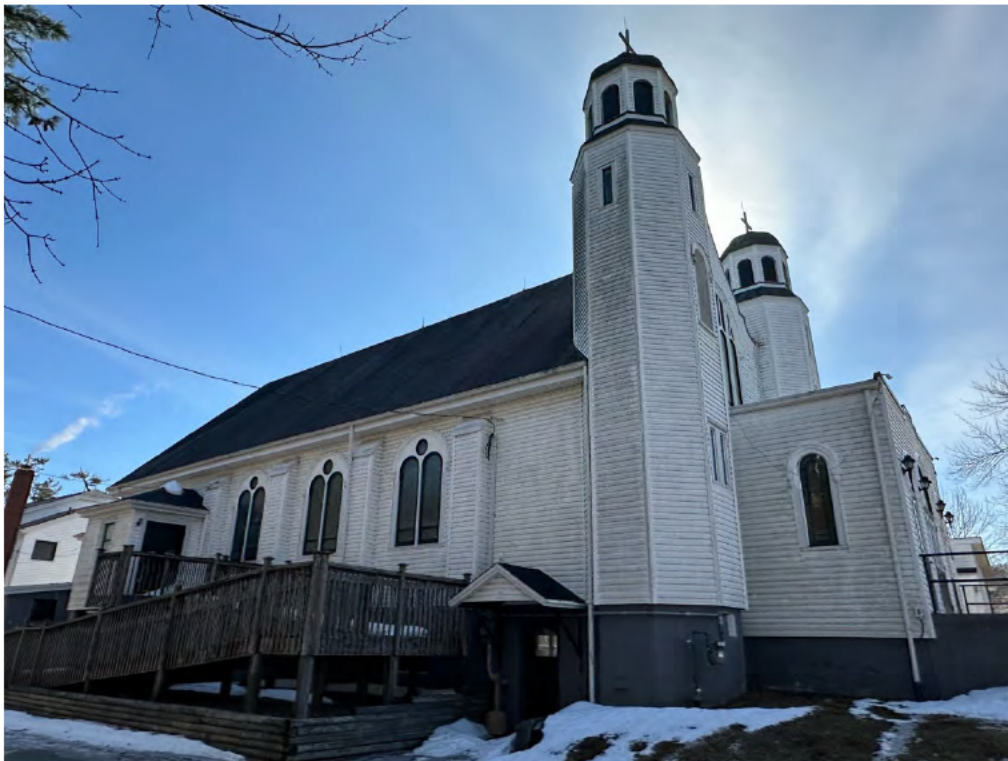
Figure 28h: Former St. John the Baptist Church, 1102 Purcells Cove Road – north side (original section)

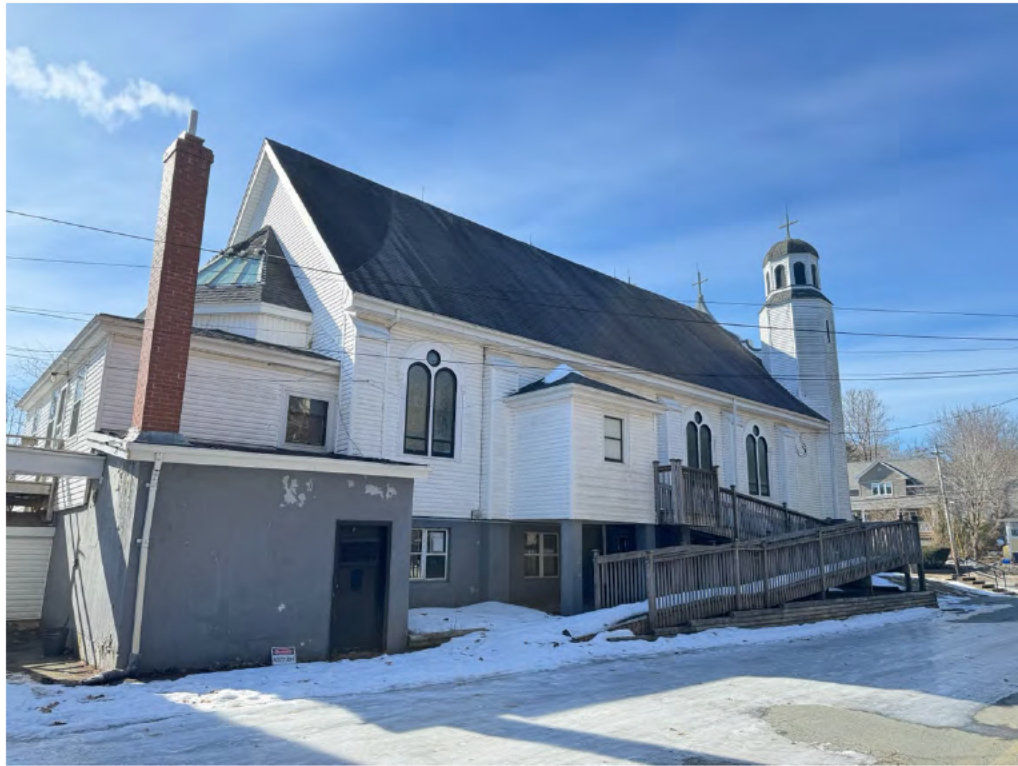
Figure 28i: Former St. John the Baptist Church, 1102 Purcells Cove Road – north side with secondary entry and ramp, seen from the rear

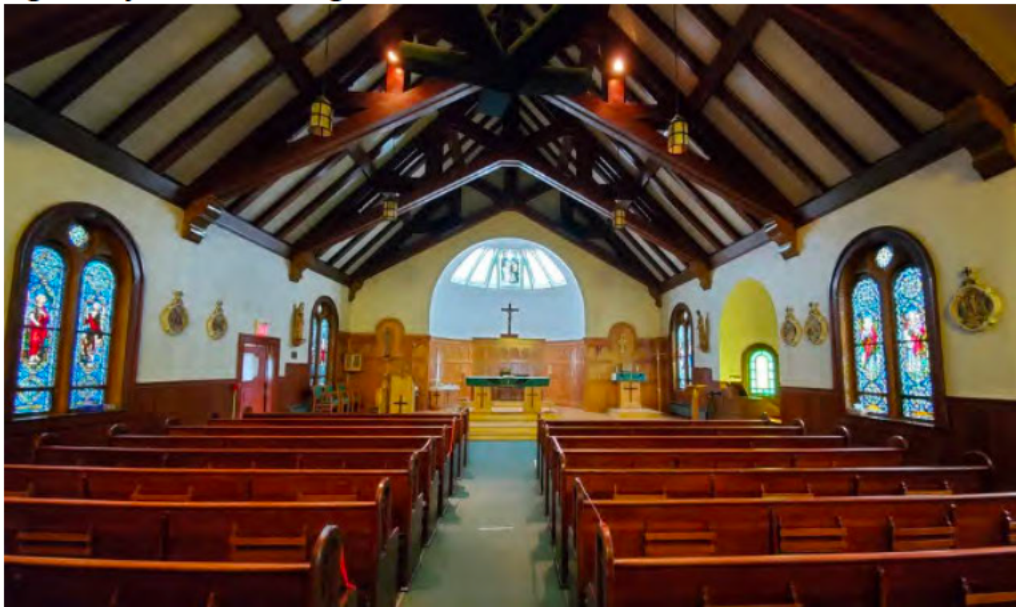
Figure 28k: Interior view toward the apse illustrating the vaulted ceiling, walls and overall spatial arrangement

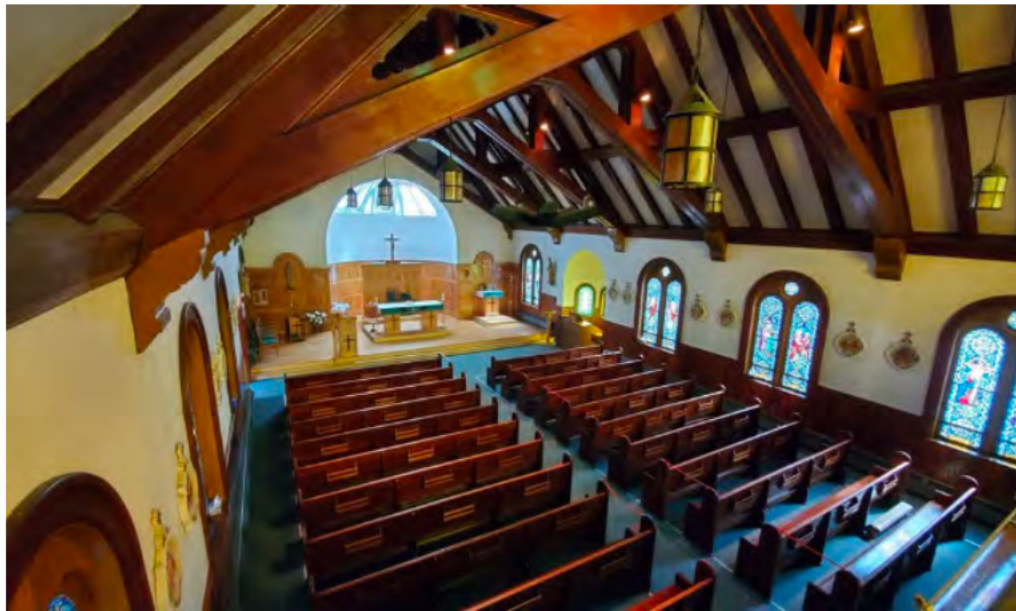
Figure 28l: Interior view toward the apse illustrating the decorative and structural wood components set into the vaulted ceiling and the walls

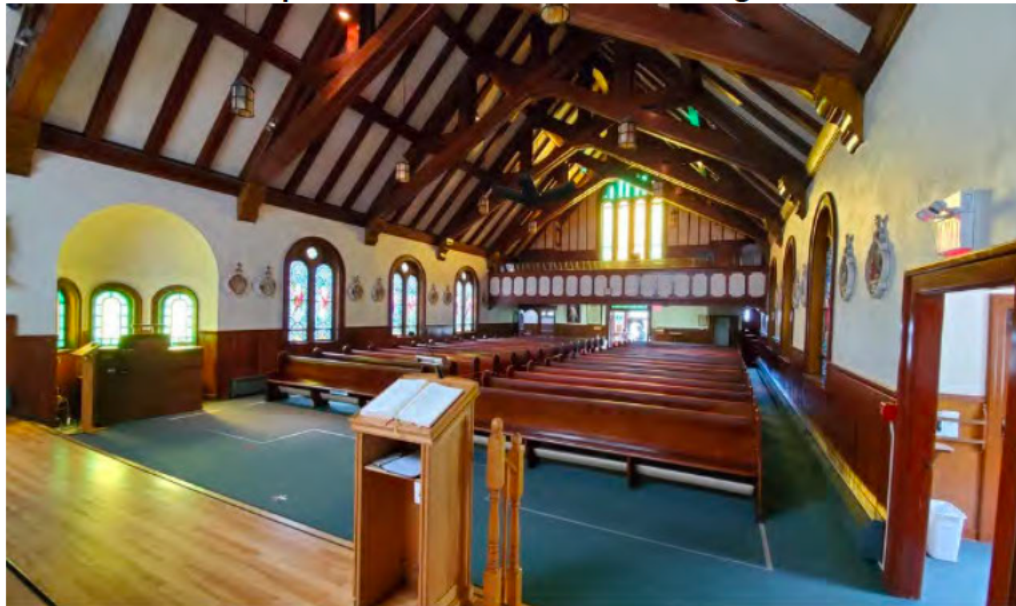
Figure 28m: Interior view from the apse toward the rear illustrating the rounded bay on the south side, the choir loft and tracery

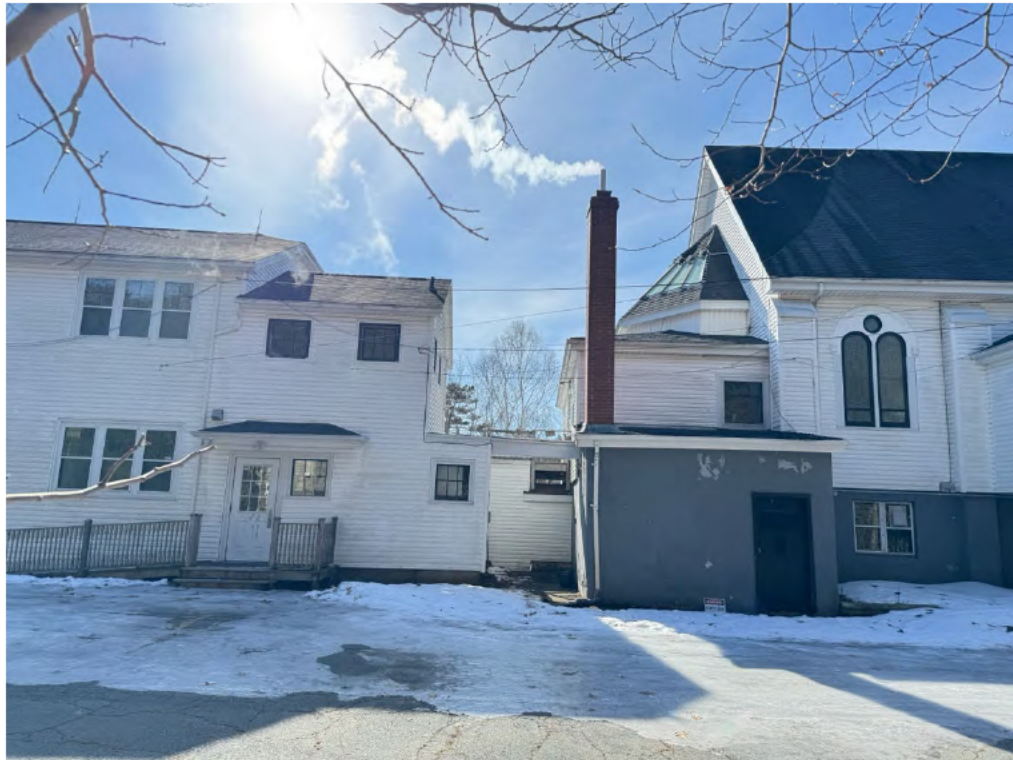
Figure 29a: Connection between Church Hall, north side

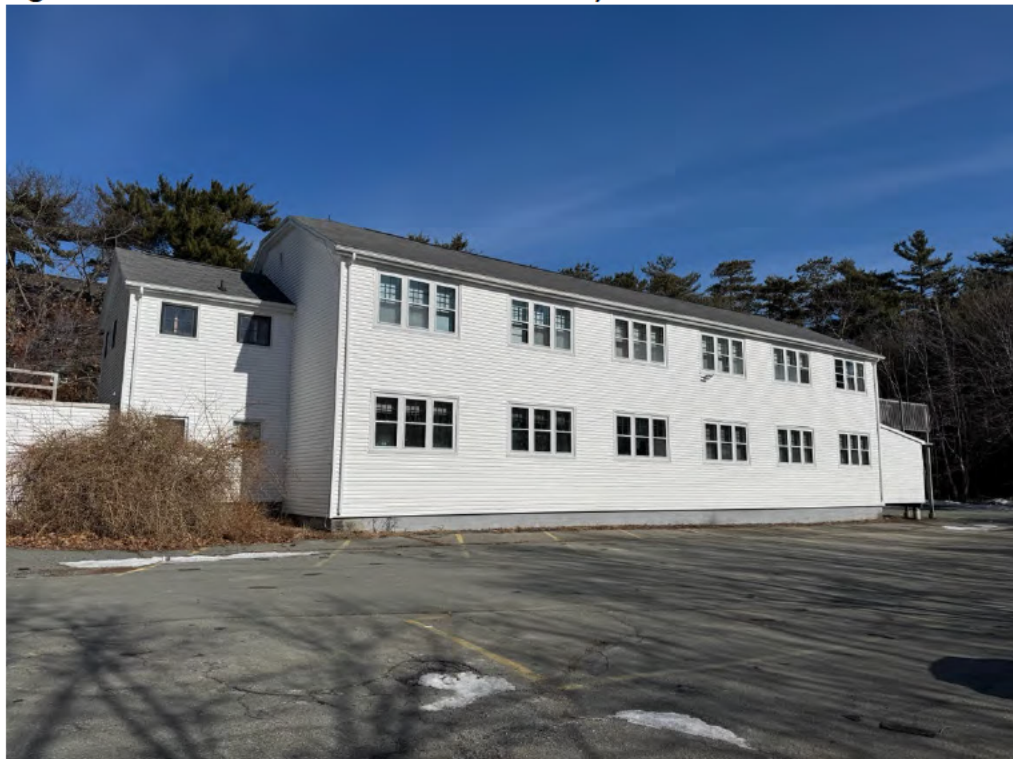
Figure 29b: Former Church Hall – south side

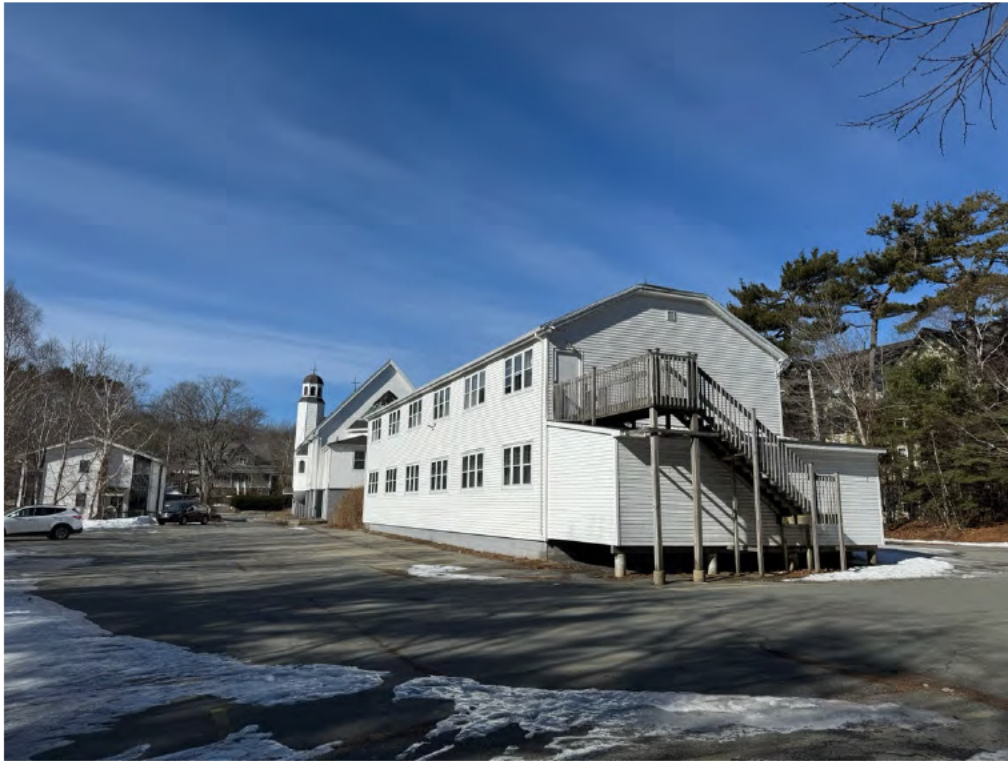
Figure 29c: Former Church Hall – rear and south side

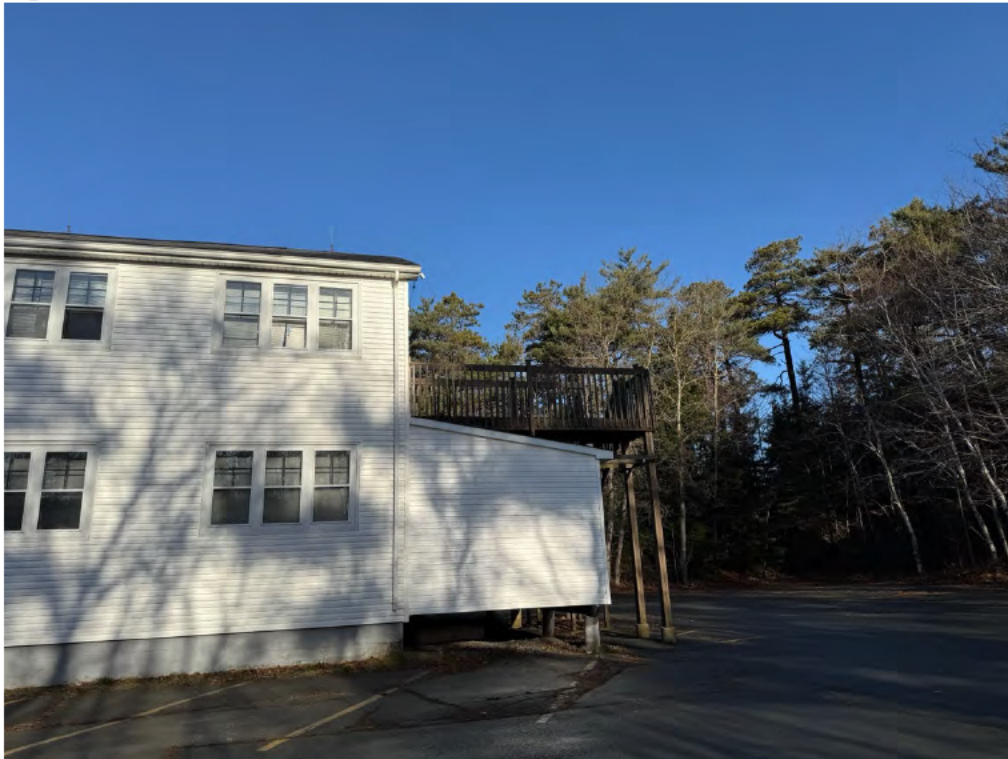
Figure 29d: Former Church Hall – south side (partial)

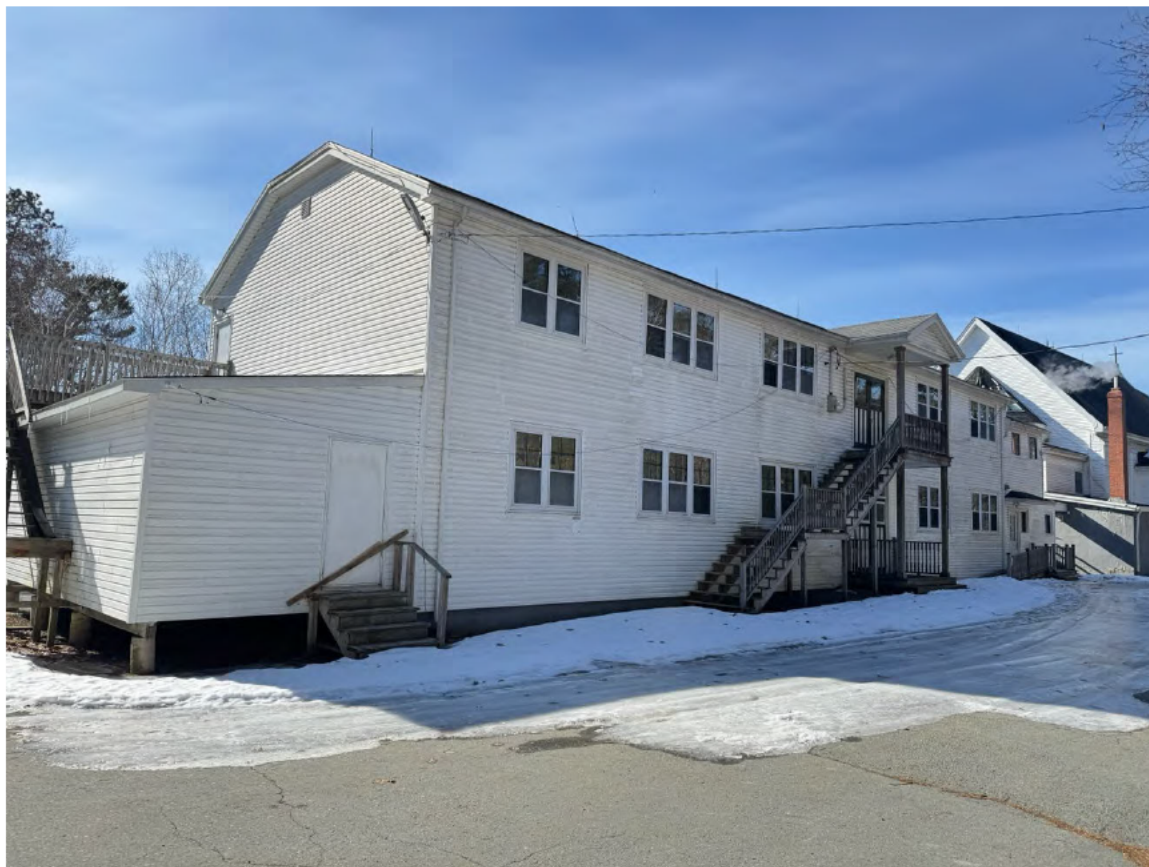
Figure 29e: Former Church Hall – north side

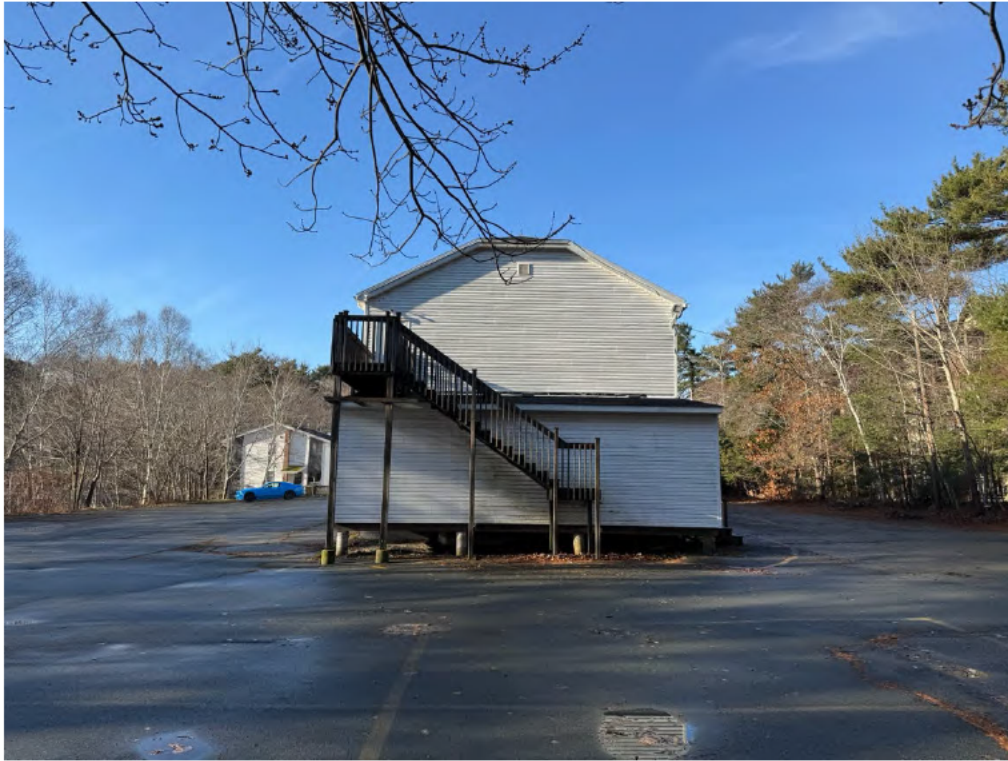
Figure 29f: Former Church Hall, 1102 Purcells Cove Road – rear

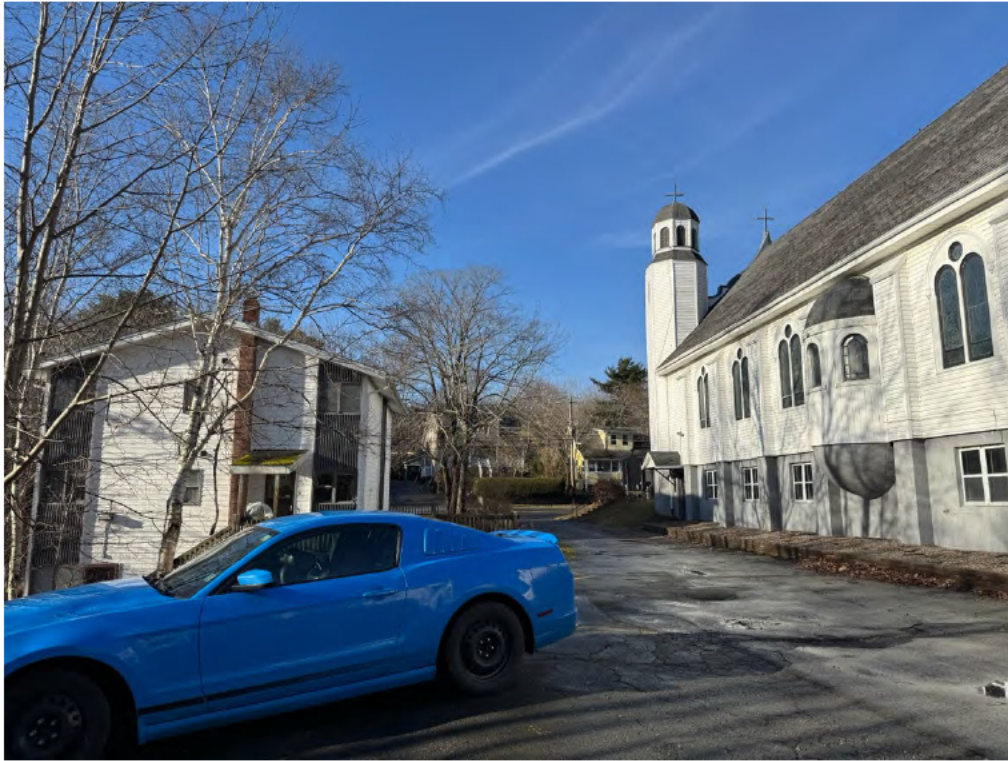
Figure 30b: Rectory, 1110 Purcells Cove Road – context from rear seen with former St. John the Baptist Church (right)

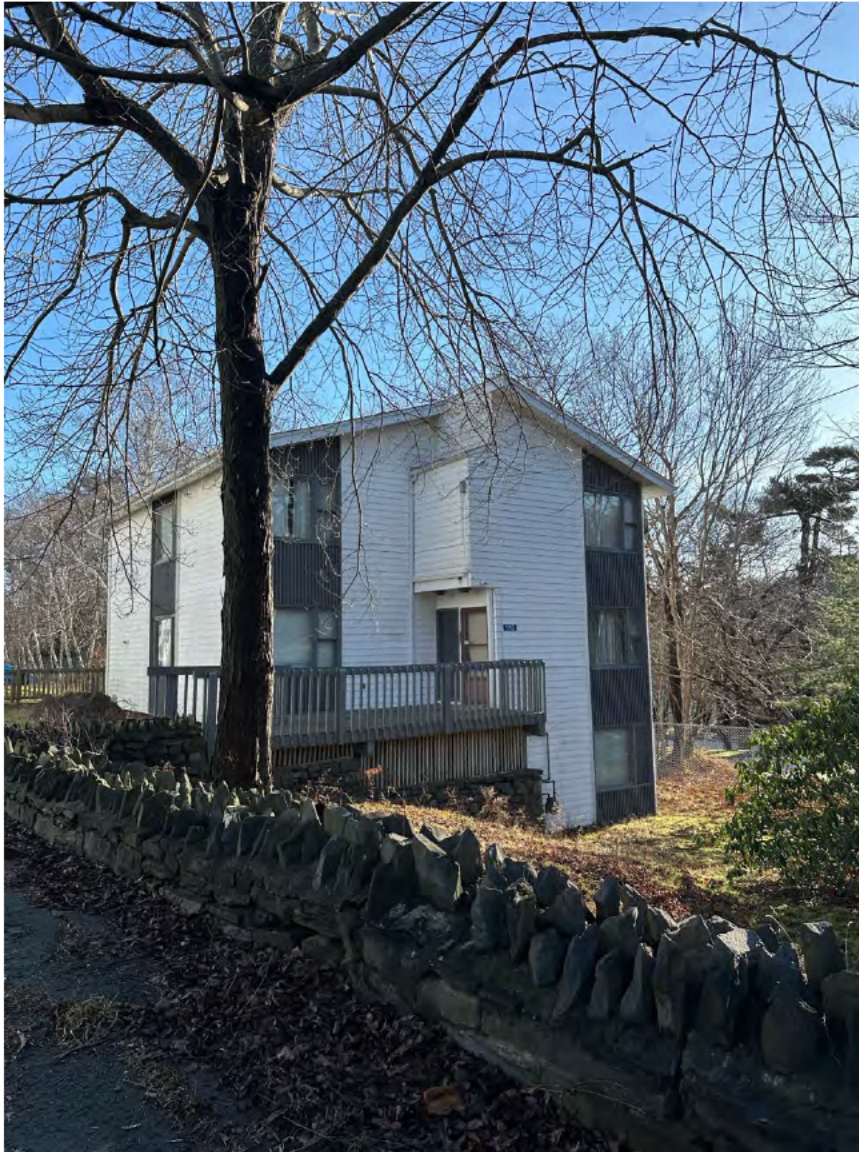
Figure 30c: Former Rectory, 1110 Purcells Cove Road – front and north side

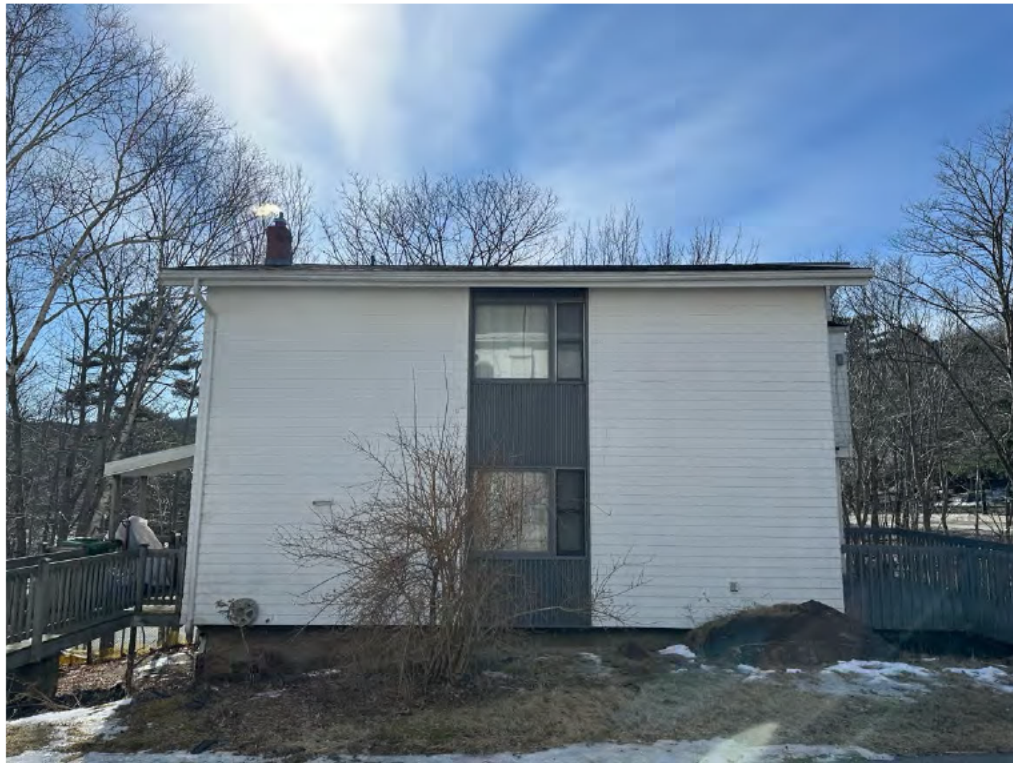
Figure 30d: Former Rectory, 1110 Purcells Cove Road – south side

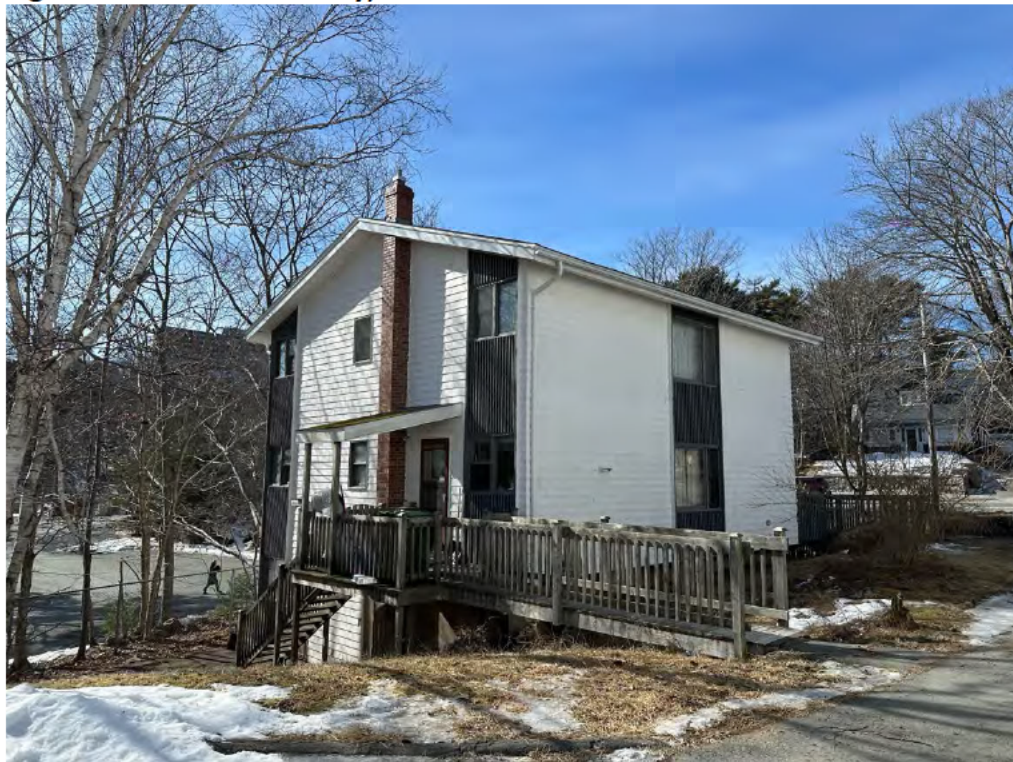
Figure 30e: Former Rectory, 1110 Purcells Cove Road – north side and rear

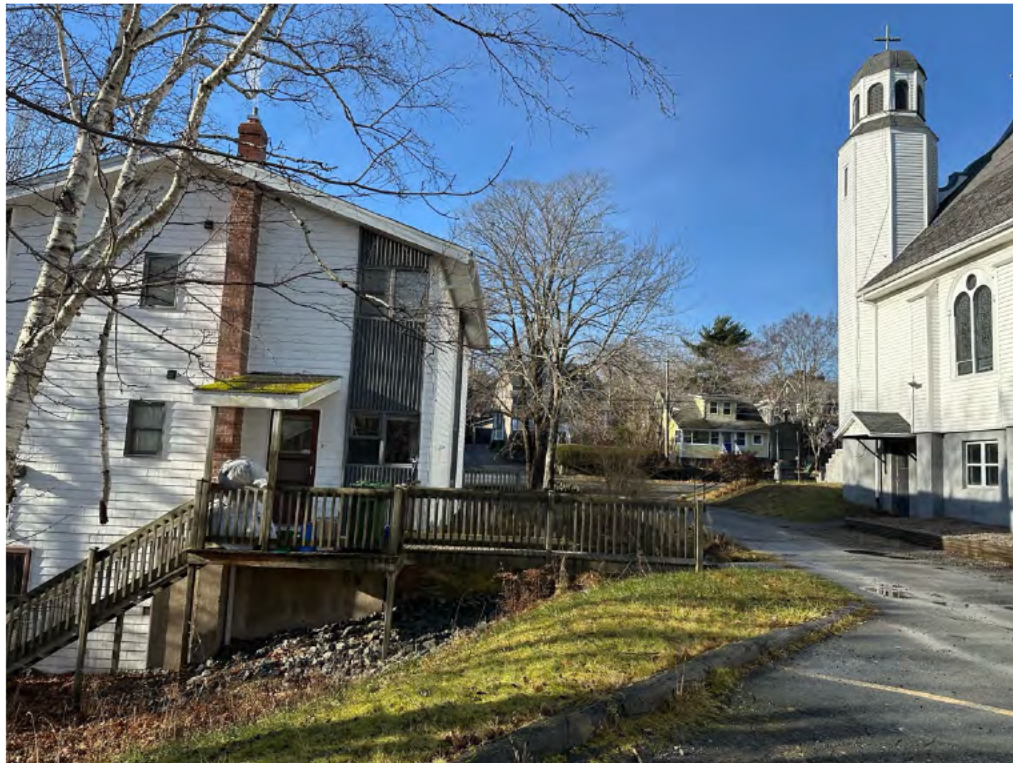
Figure 30f: Former Rectory, 1110 Purcells Cove Road – rear
