## Heritage Impact Statement

First Baptist Church, 1300 Oxford Street

Halifax, June 2025

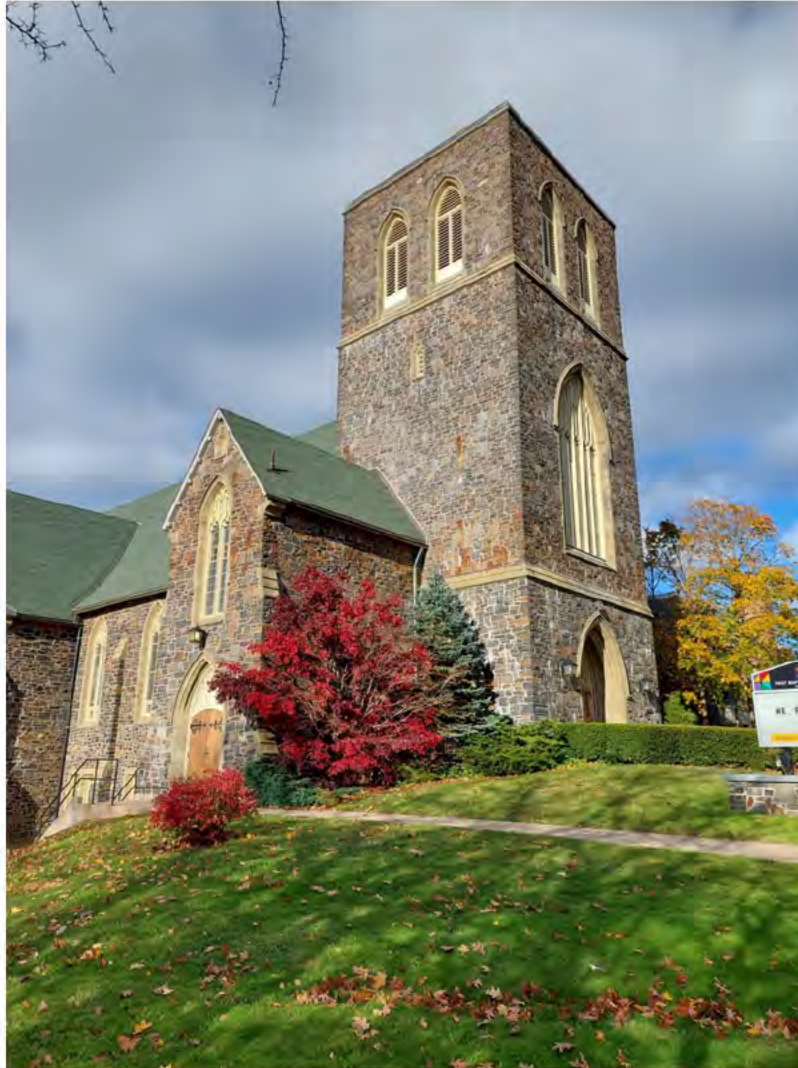
Figure 35a: First Baptist Church, 1300 Oxford Street – front (east) and partial south side

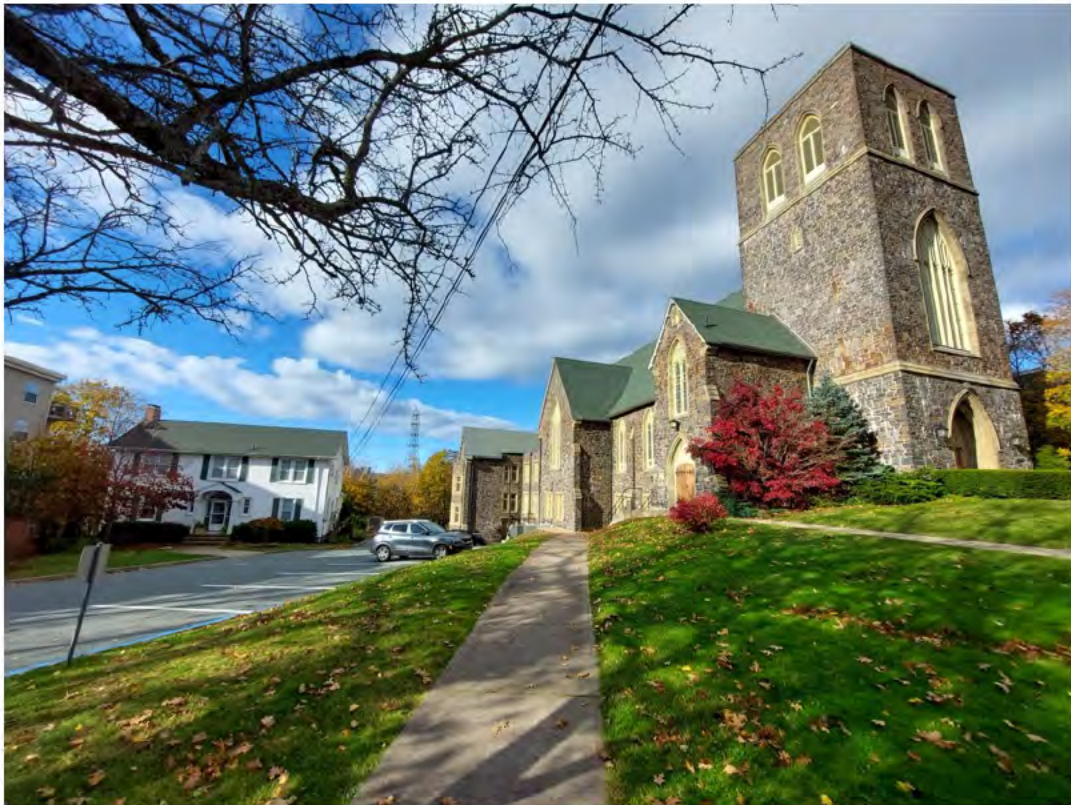
Figure 35b: First Baptist Church, 1300 Oxford Street – south side and front

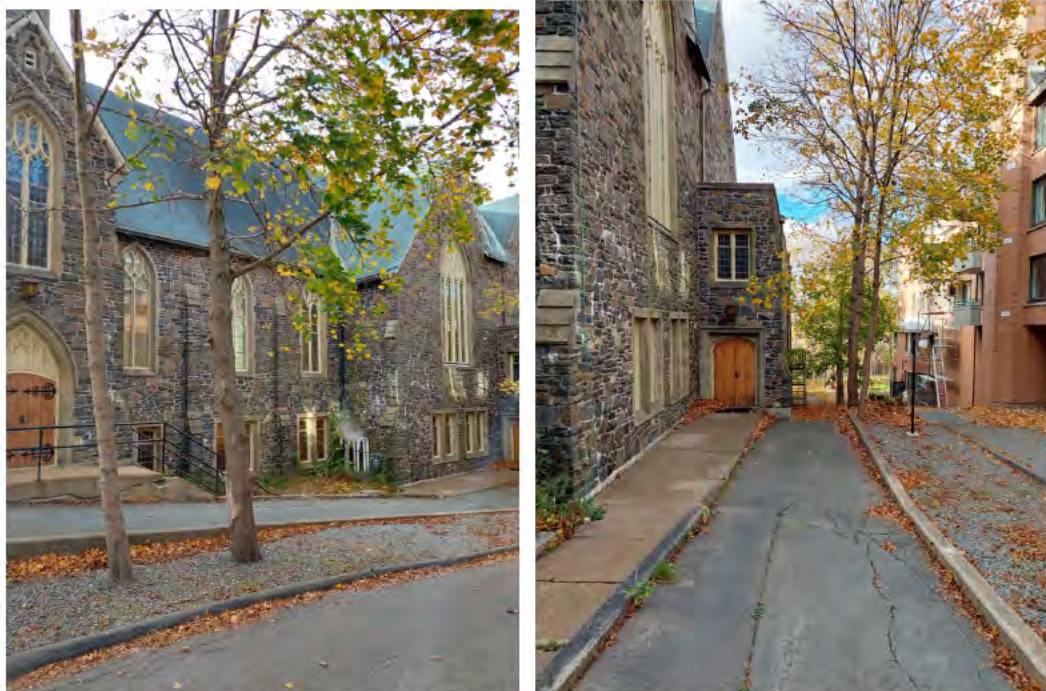
Wood frames, sills and mullions are in generally fair condition, although some are in poor condition and will need repair. These include the transept windows on all sides but particularly the south transept window. The windows have a tapered stone “trim” comprised of individual stone sections mortared in place, and poor mortar conditions were observed at the stone “trim” at the head of all windows.

**Figure 35h: First Baptist Church, 1300 Oxford Street – north side (original section). Photo on left shows the north transept window, far right. Photo on right shows the secondary entry, north side.**

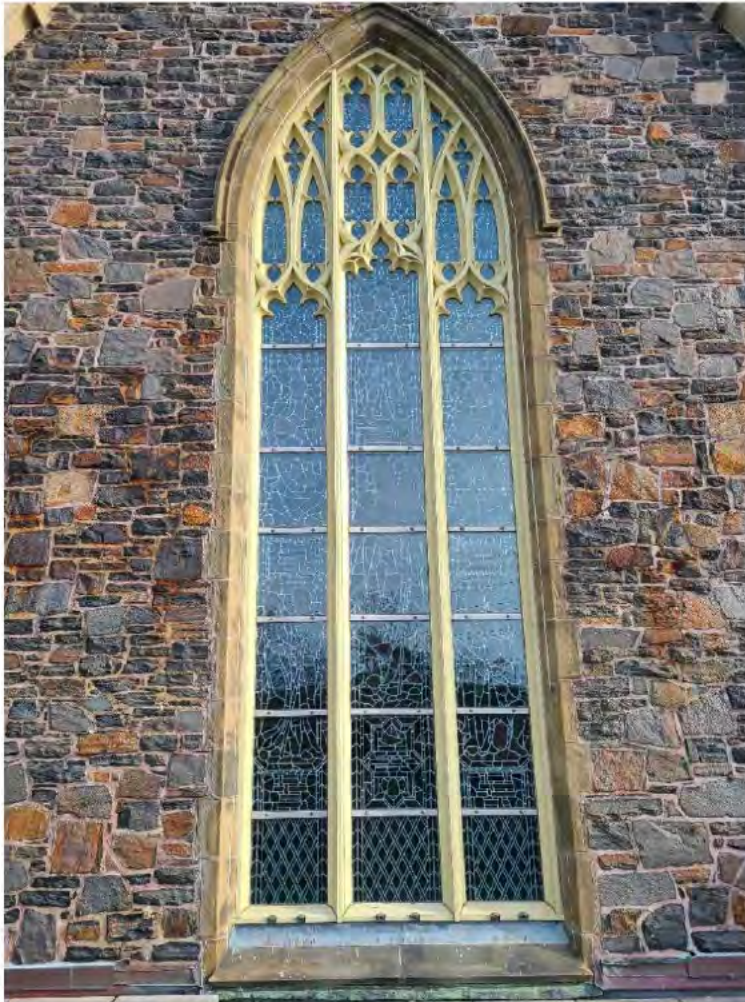
**Figure 35i: First Baptist Church, 1300 Oxford Street – west side window**
